**FINAL INVESTIGATION REPORT OF ACCIDENT TO M/s GARG AVIATION LTD., CESSNA 152 AIRCRAFT VT- SGN ON 03-09-2014 AT KANPUR.**

1	Aircraft	Type	Cessna 152
		Nationality	Indian
		Registration	VT-SGN
2	Owner and Operator	M/s Garg Aviation Pvt. Ltd., Kanpur.	
3	Pilot – in –Command	Student Pilot License holder	
	Extent of injuries	Serious	
4	Date & Time of Accident	03.09.2014; 0936UTC.	
5	Place of Accident	Near Kanpur Airfield	
6	Co-ordinates of Accident Site	Lat N 26°26.420' Long E 80°20.791'	
7	Last point of Departure	Kanpur Civil Aerodrome	
8	Intended landing place	Kanpur Civil Aerodrome	
9	No. of Passengers on board	NIL	
10	Type of Operation	Training flight	
11	Phase of Operation	Final Approach	
12	Type of Accident	Aircraft stalled and fell on roof top of an abandoned building.

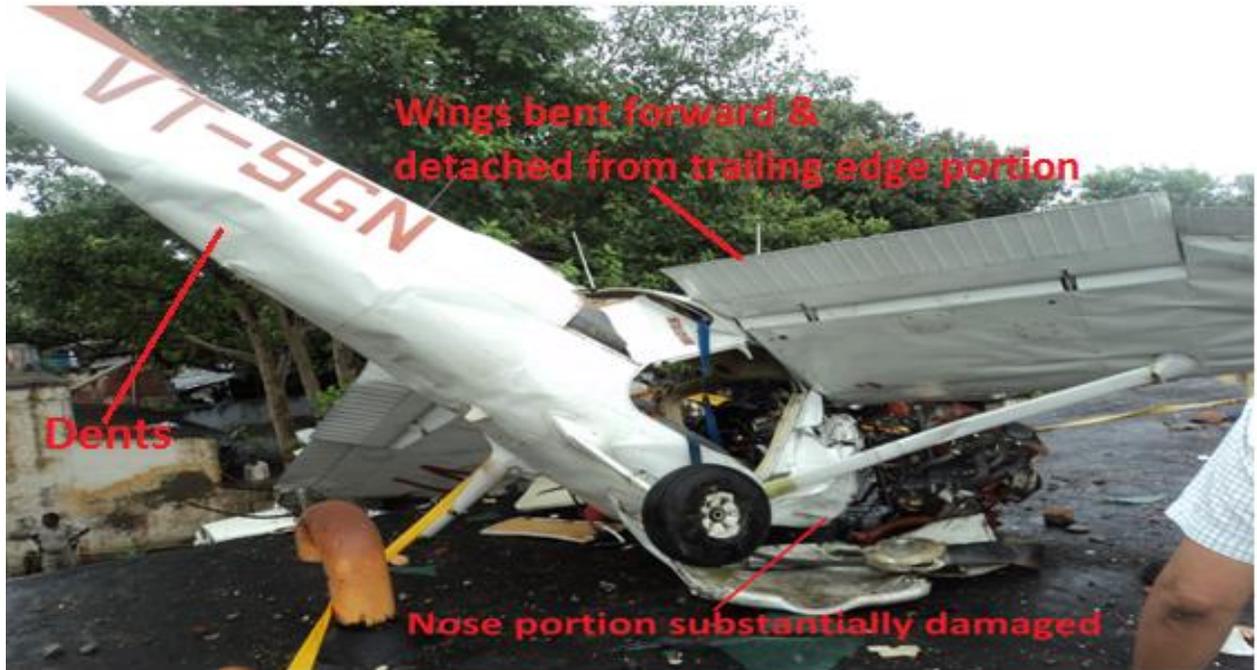
The aircraft was substantially damaged. The damages observed on the aircraft were, both the Propeller blades were bent and got dislodged from the propeller hub. The engine mount was broken as the nose portion of the aircraft was completely destroyed. The Nose landing gear had sheared off.

***Aircraft final resting position on roof top***

The front Fuselage section was completely damaged with dents on the rear section. Top & Bottom engine cowlings were completely damaged. The left main landing gear wheel had sheared-off from wheel axle. Both port & starboard wings were completely damaged. The left side control stick had dislodged from its attachment and came out of the cockpit. Both the cabin doors were deformed and damaged. All the avionics and instruments were damaged.

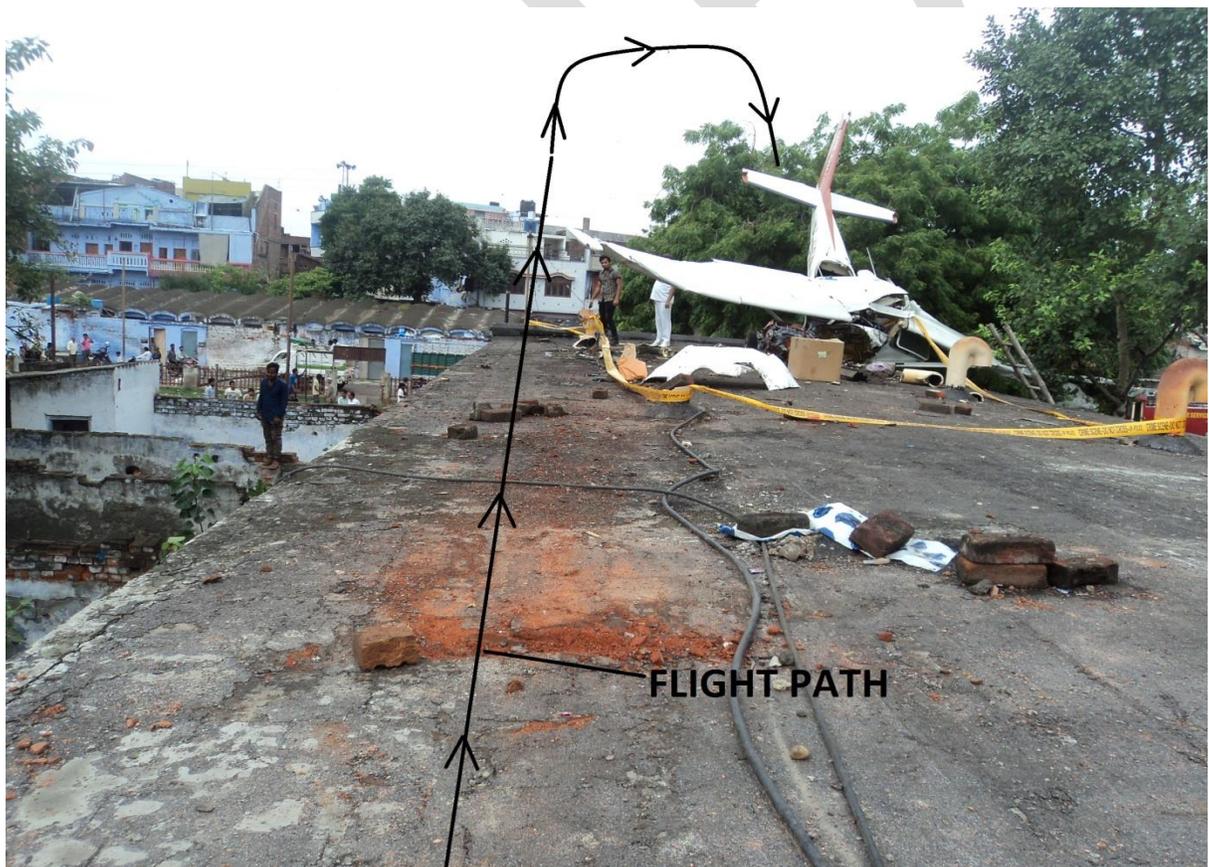
During examining of the wreckage site following observations were made. The first impact was the aircraft nose gear hitting the edge of the building and shearing off from its attachment.

***Flight path of the aircraft before impacting the building***

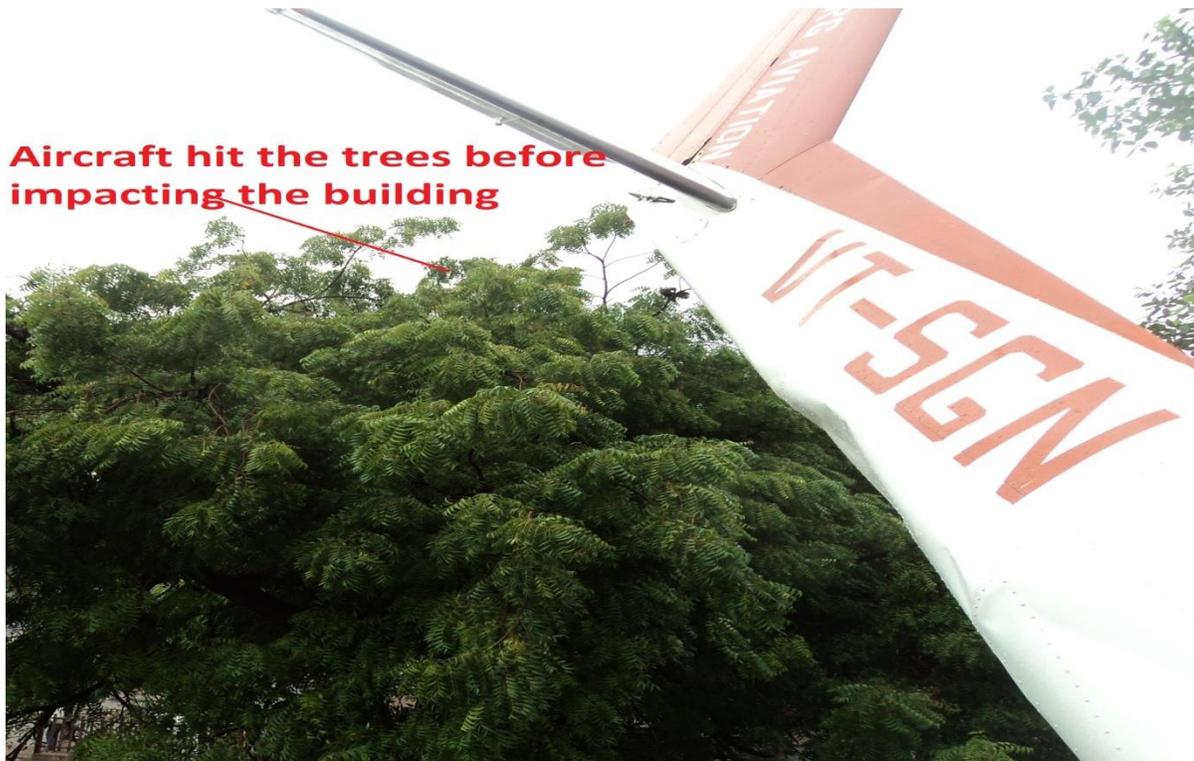
Thereafter the aircraft main wheel rolled on the building top and the aircraft got air borne again. While executing a 180 degree turn it hit a tall tree next to the building as it was evident from the dent/impact marks observed on the fuselage / wing structure and also the marks on the tree top.

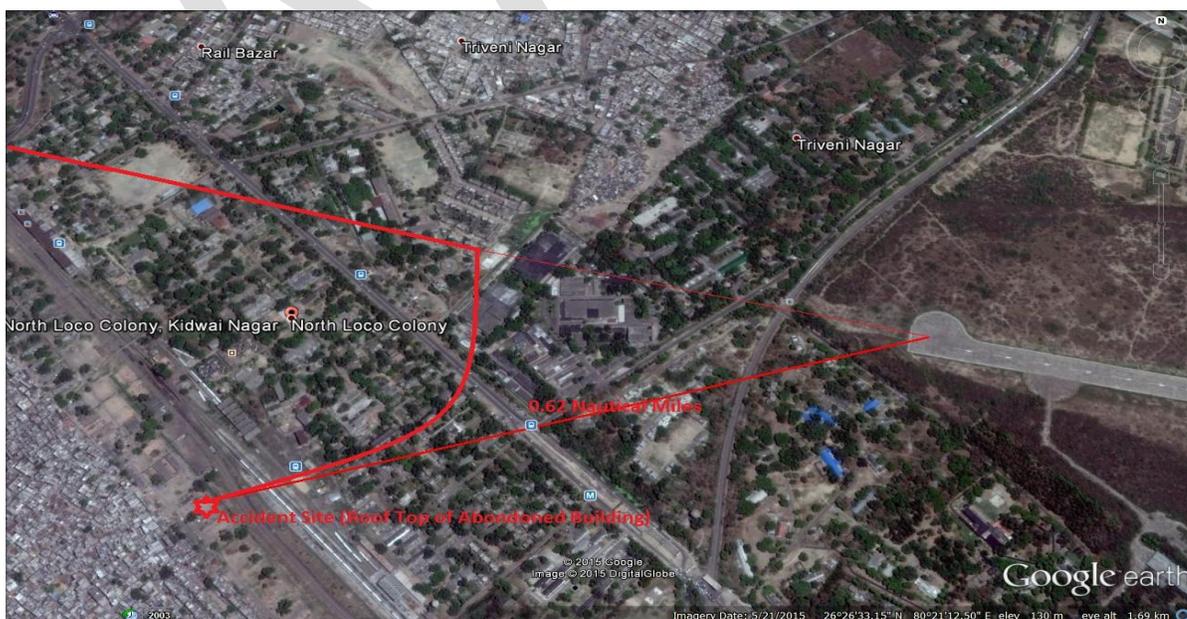
***The aircraft crash landed on abandoned building 0.62 Nm from Rwy 10***

The engine was substantially damaged as the aircraft impacted on its nose. The engine had dislodged from its mount after the impact. The LH main landing gear wheel had also sheared off from wheel axle due impact. The instrument panel in the cockpit was completely destroyed. The fuel was leaking from the fuel tank. Both the wings were substantially damaged and had dislodged from its attachments.

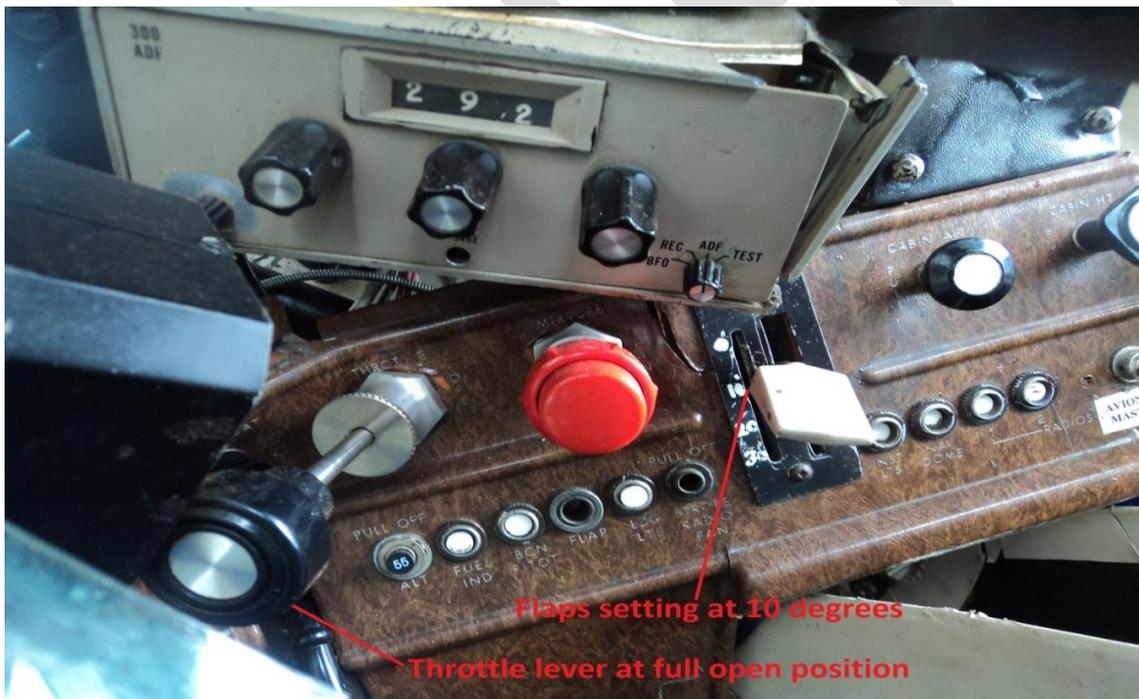
1. Both the Control columns had broken and dislodged from its position.
2. The fuel lever were in ON position
3. Master switch were in ON position and had broken from attachment.
4. Ignition switch were in "Both Position"
5. Flaps were at 10° position.
6. Throttle control was at "½ open" position.
7. Ignition key was half broken and half key was inside the ignition switch.

8. Carburettor Heat was at "OFF" position.
9. Mixture control knob was IN.
10. Strobe and navigational light switch was found broken.

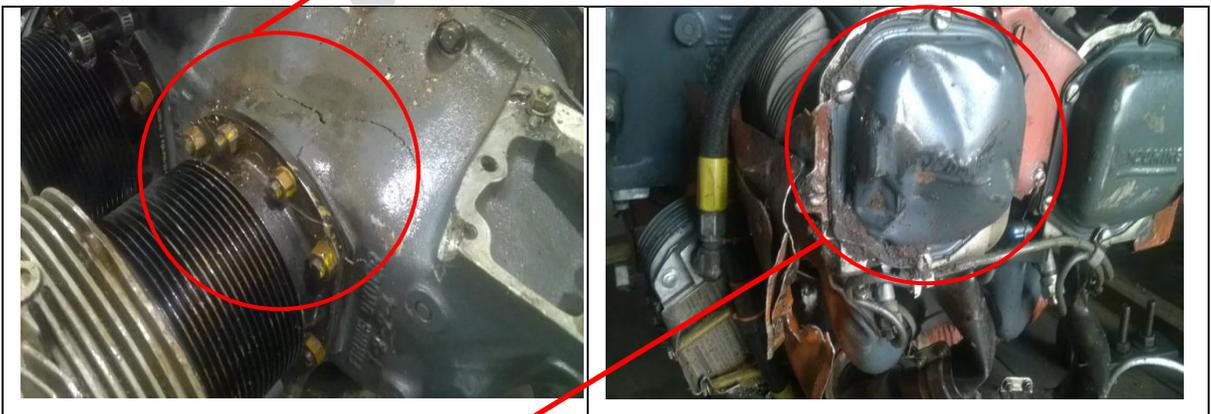
1. The engine crank case found cracked due impact.

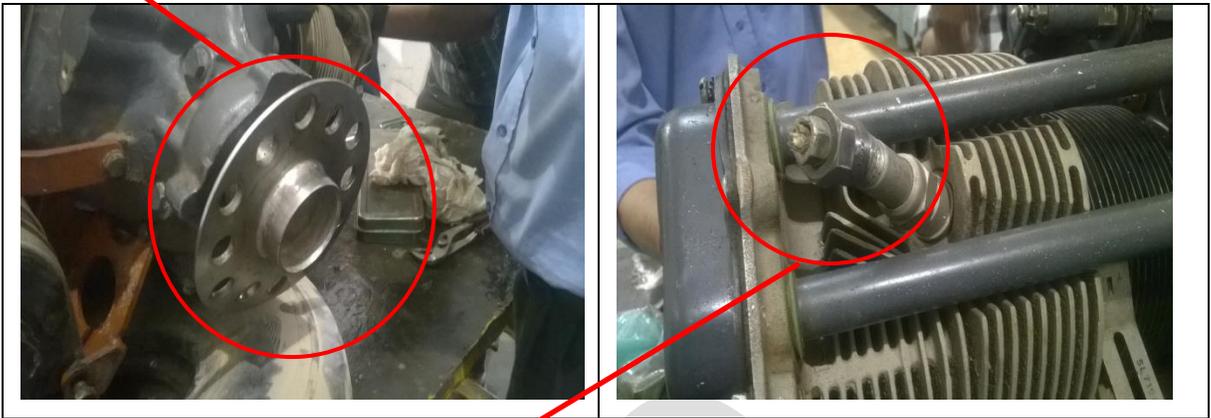
2. Cylinder No. 2 rocker box damaged.

3. Propeller flange found bent.

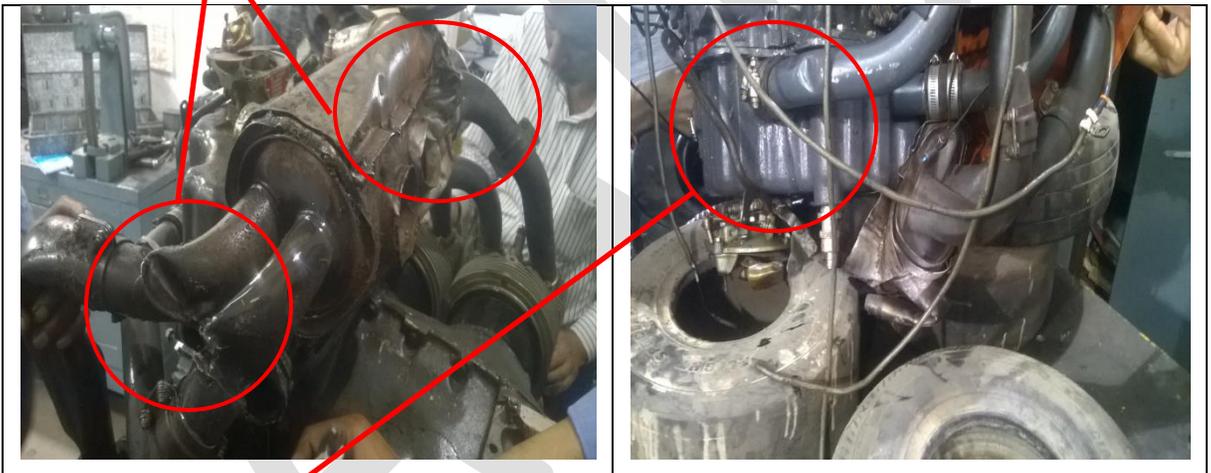
4. Cylinder No. 02 top spark plug harness broken from magneto side

5. Exhaust found damaged.

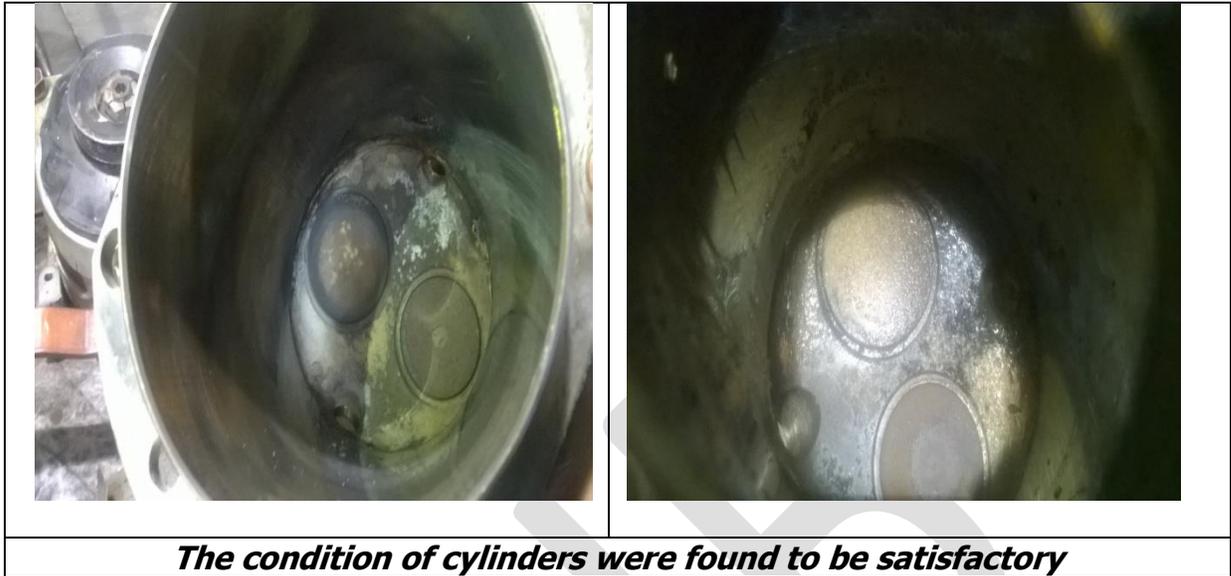
- 1) All the 04 cylinders examined and found in a good condition.

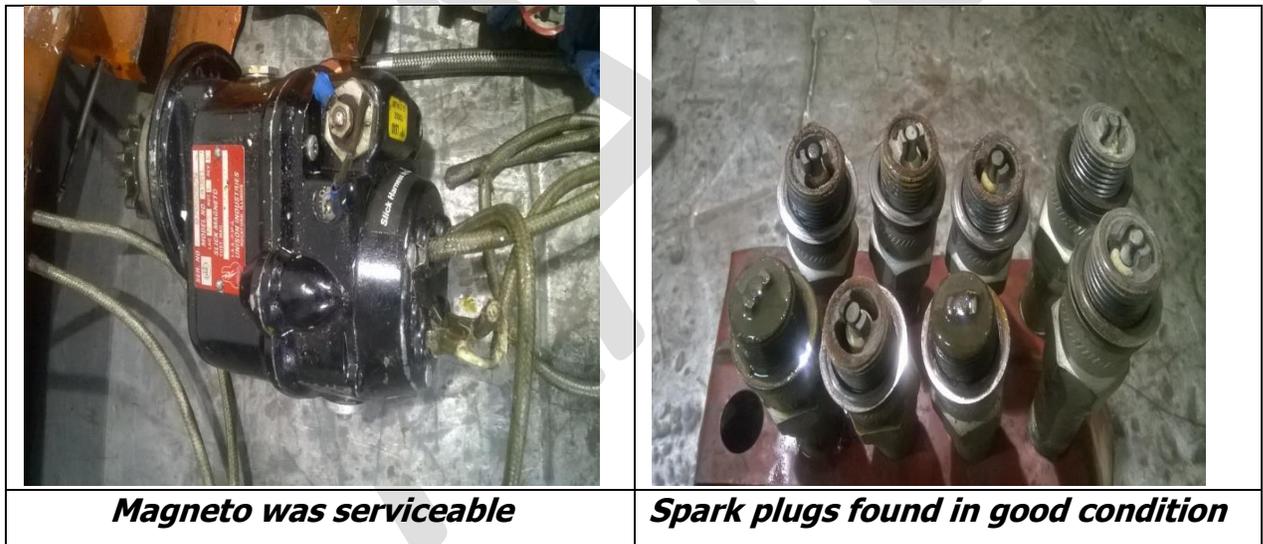
- 2) Magneto tested for its serviceability and found to be working satisfactory.

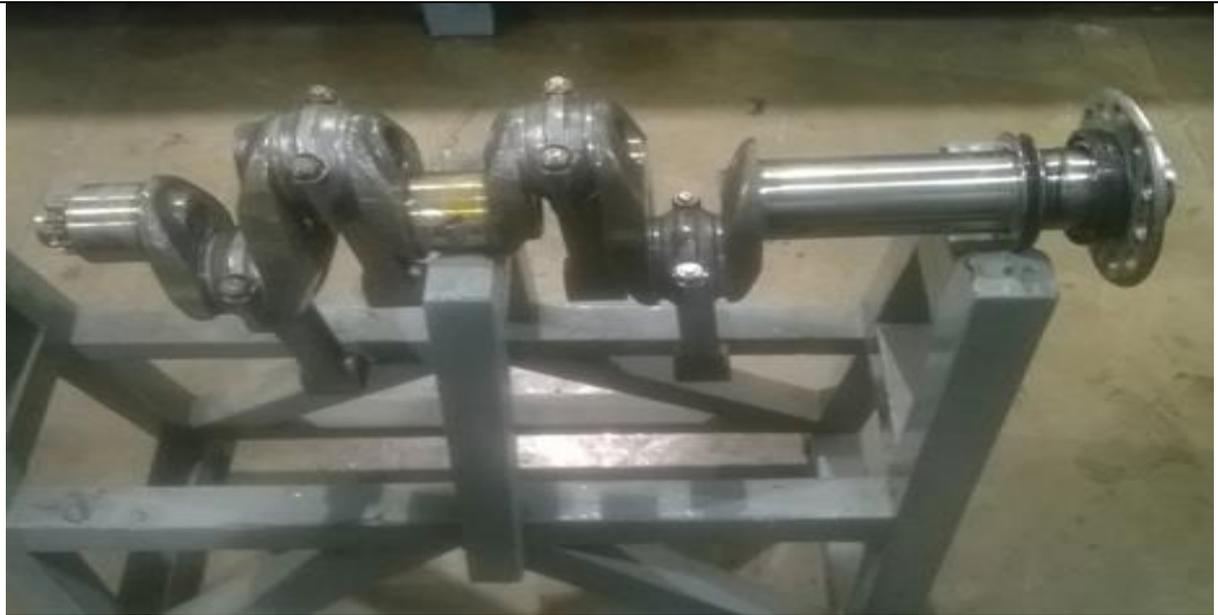
***Condition of piston/connecting rods were found to be satisfactory***
