**FINAL INVESTIGATION REPORT ON**  
**SERIOUS INCIDENT TO AIR INDIA**  
**LTD. AIRBUS A-320 AIRCRAFT VT-ESI**  
**AT COCHIN ON 21.08.2014**

**FINAL INVESTIGATION REPORT ON SERIOUS INCIDENT**

**TO AIR INDIA LTD. AIRBUS A-320 AIRCRAFT**

**VT-ESI AT COCHIN ON 21.08.2014**

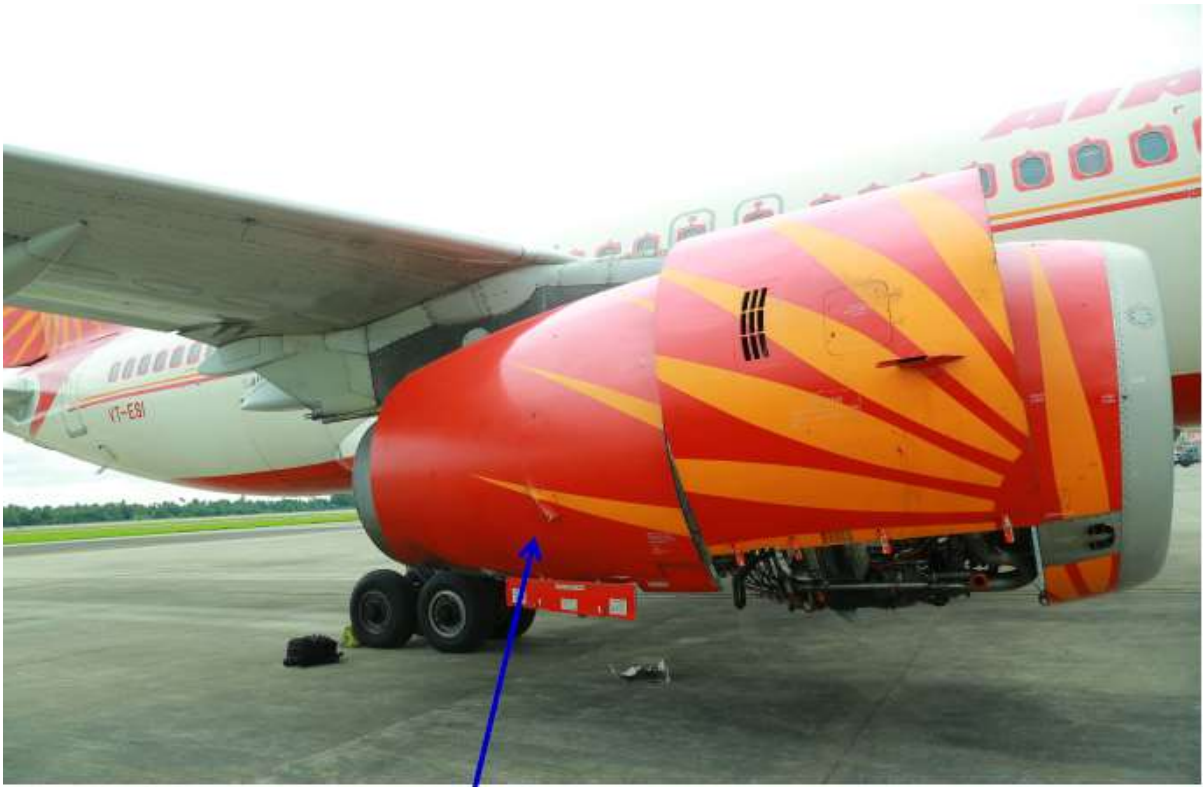
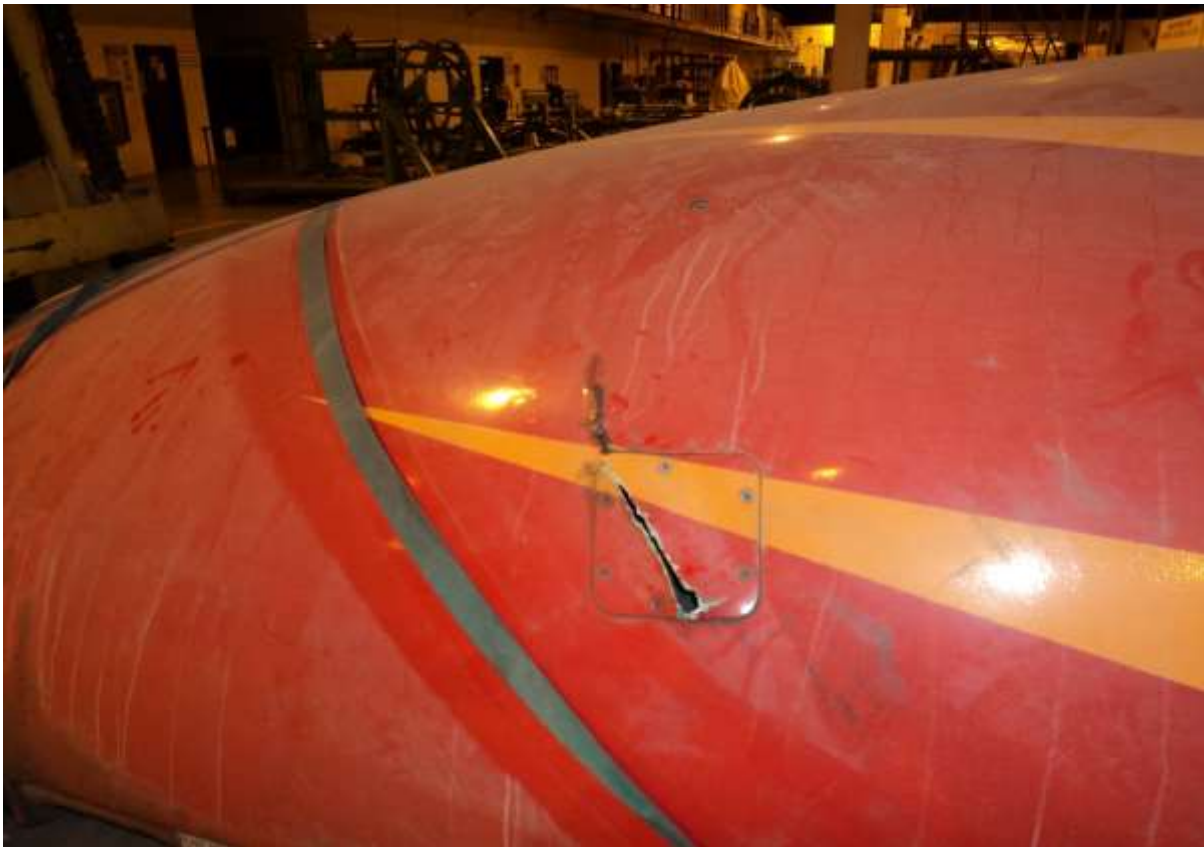
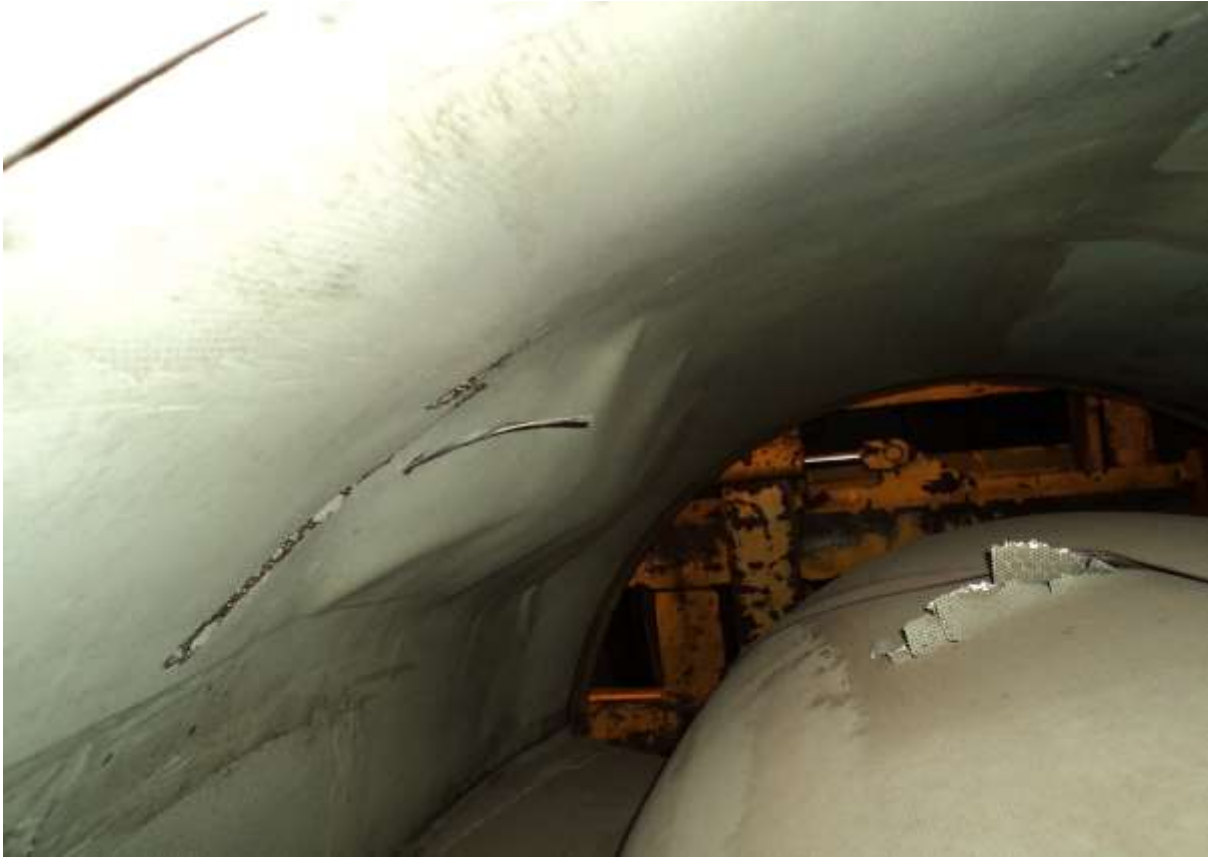
1. Outboard C Duct
  - Outer Barrel found ruptured approximately 12 inches.
  - Inner Barrel Burn mark & rupture observed
2. Inner C Duct
  - Inner Barrel found burnt at 6 O’Clock position.
3. LPT (Low Pressure Turbine) stage 4 blades
  - more than 20% of blades found damaged
  - Most of the stage 4 NGV’s (Nozzle Guide Vanes) found damaged.
4. Overheating was observed on all the latches.

#### *Damage to C Ducts*

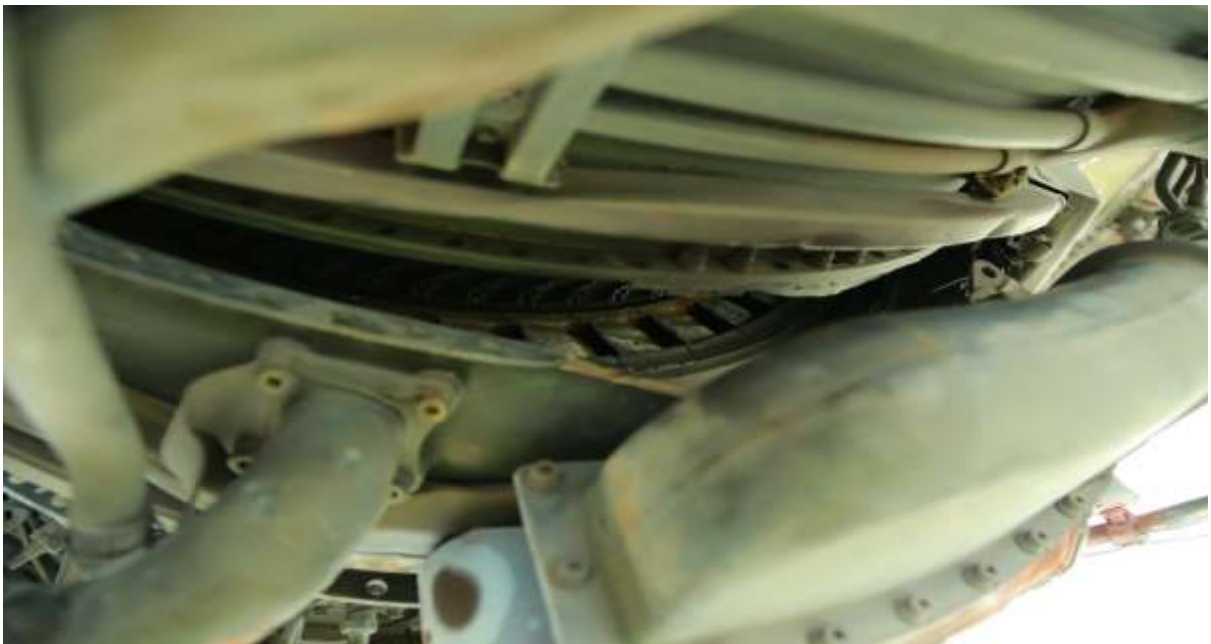
5. The turbine cooling air feed tube at 4 O' Clock position found ruptured.
6. HPT (High Pressure Turbine) case between 1 & 3 O' Clock position found ruptured open.
7. HPT case opened up and ruptured from 6 to 9 O'clock position shearing the 27 bolts on front side and 18 on rear side exposing entire HP turbine area.

*The High Pressure Turbine case breached*

circumferential direction and 1 inch long in axial direction. Another un-containment location consisted of the HPT case being torn open aft of M-flange and forward of N-flange from approximately the 9'O clock to the 6'O clock position. M-flange was separated at the 6'O clock position, and N-flange was separated at the 7'O clock position. Of the 100 nuts and bolts that should be present at M-flange, 28 were missing. Of the 100 nuts and bolts that should be present at N-flange, 20 were missing.

The tear in the HPT case originated at approximately 9'O clock position, just forward of N-flange, and extended circumferentially towards approximately 6'O clock position. The widest point of the tear was approximately 2 inches. At 6'O clock position the tear was nearly the entire width of the HPT case, approximately 6 inches the tear extended past the fractured M-flange location at 6 inches, and transitioned into an approximately 1 inch wide elongated and non-uniform hole, which terminated at approximately 5'O clock position, the remaining un-containment location was present between 1'O clock and 3'O clock. It was an elongated, non-uniform hole that was 2 inch wide at its widest location and 0.5 inches wide at its narrowest width axially.

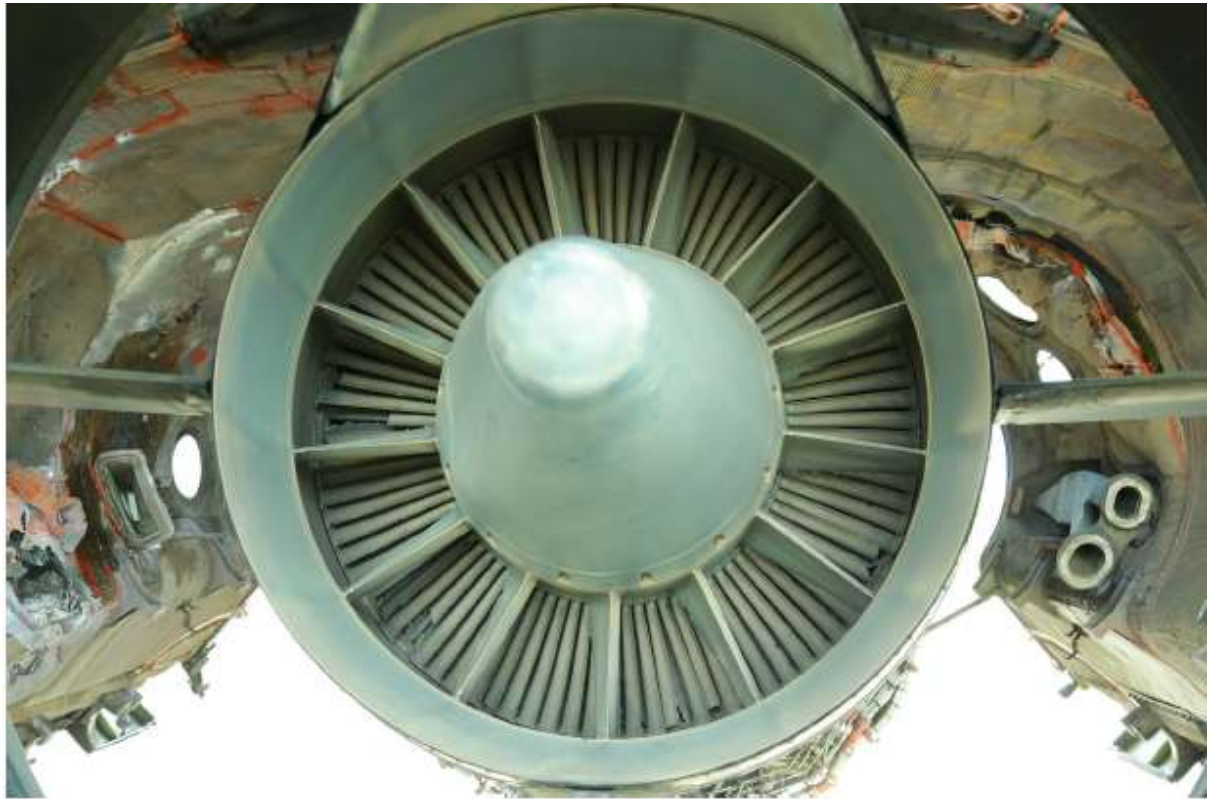
**Engine Rear View**

8. All the turbine blades of stage 1 & 2 and stage 2 NGV's found missing.
9. Turbine cooling air feed tube at 7 O'clock position found damaged.
10. HPT ACC duct found ruptured.
11. Lot of metal debris found stuck at different locations of the engine.
12. No. 2 shaft seized.
13. The No.1 shaft was found stuck and found difficult to rotate.
14. Fire bottles were found discharged.

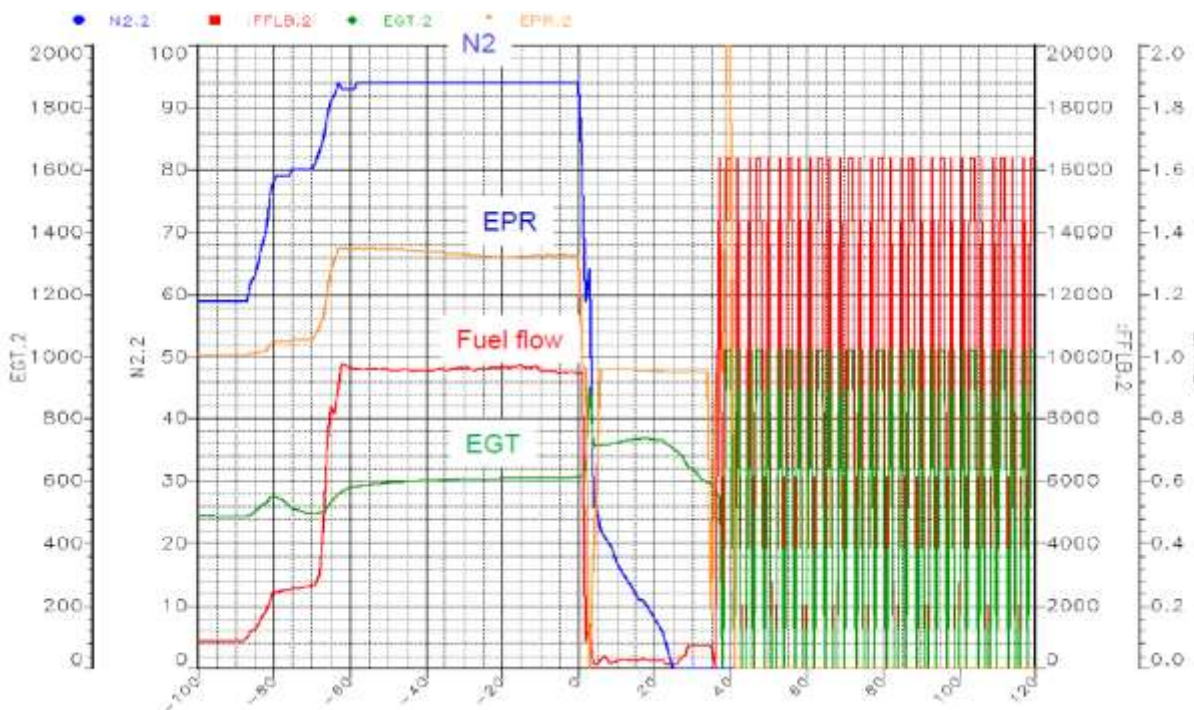
- The aircraft took-off at 15:35:49 UTC heading 270.
- After about 65 seconds of take-off i.e. 15:36:54 UTC, the Engine # 2 N2 decreases from 93 to 78, probably the time of incident.
- In another 30 seconds the Engine # 2 TLA (Thrust Lever Angle) was changed from 34 to 0.

***Engine # 2 parameters vs time with the time of incident taken at t=0.***

- Engine #2 EGT over limit sustained for approximately 30 seconds ranging from 637°C to a maximum of 735°C.
- The engine # 2 fire warning sustained for about 131 seconds.
- High engine # 2 N2 vibrations for 04 seconds.

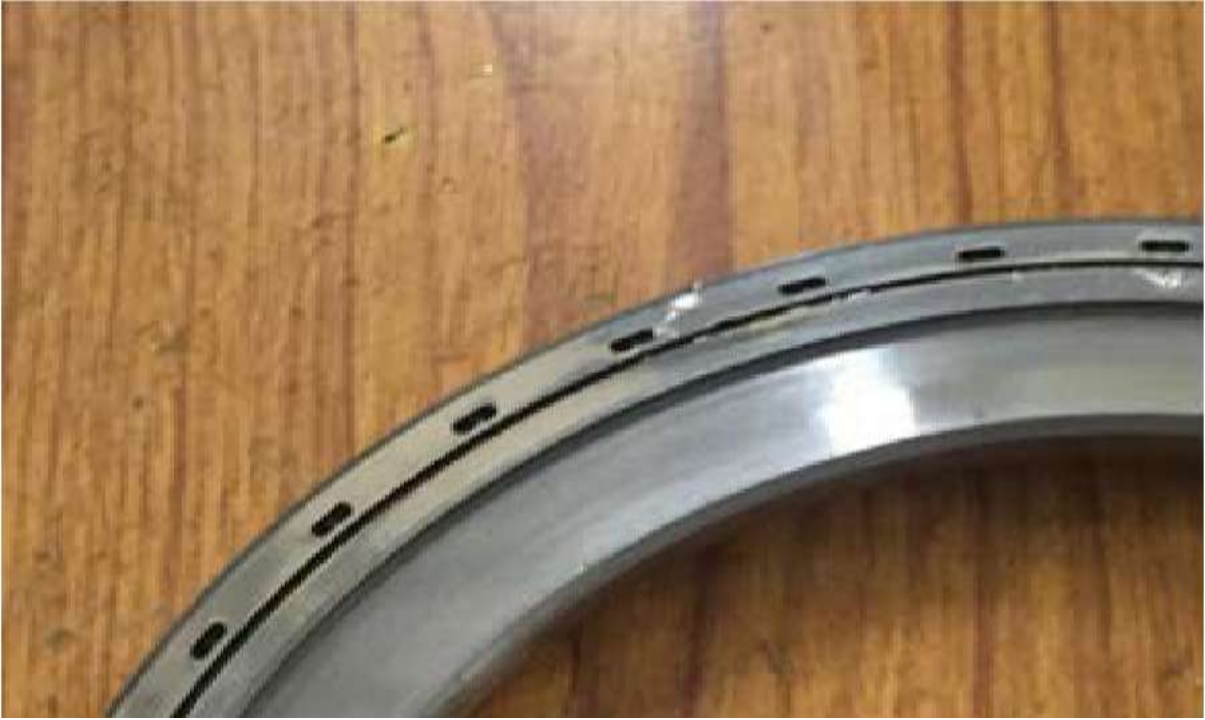
The entire lapping process was observed from beginning to end as per the JEOC process sheets. Before lapping, the IAE supplied seal plate used in the review was processed through the pre-lapping cleaning procedure. After this initial cleaning process, carbon and staining were removed but the grooves had black residue remaining. See image #1.

*Image #1 – Demonstration seal plate after cleaning and before lapping.*

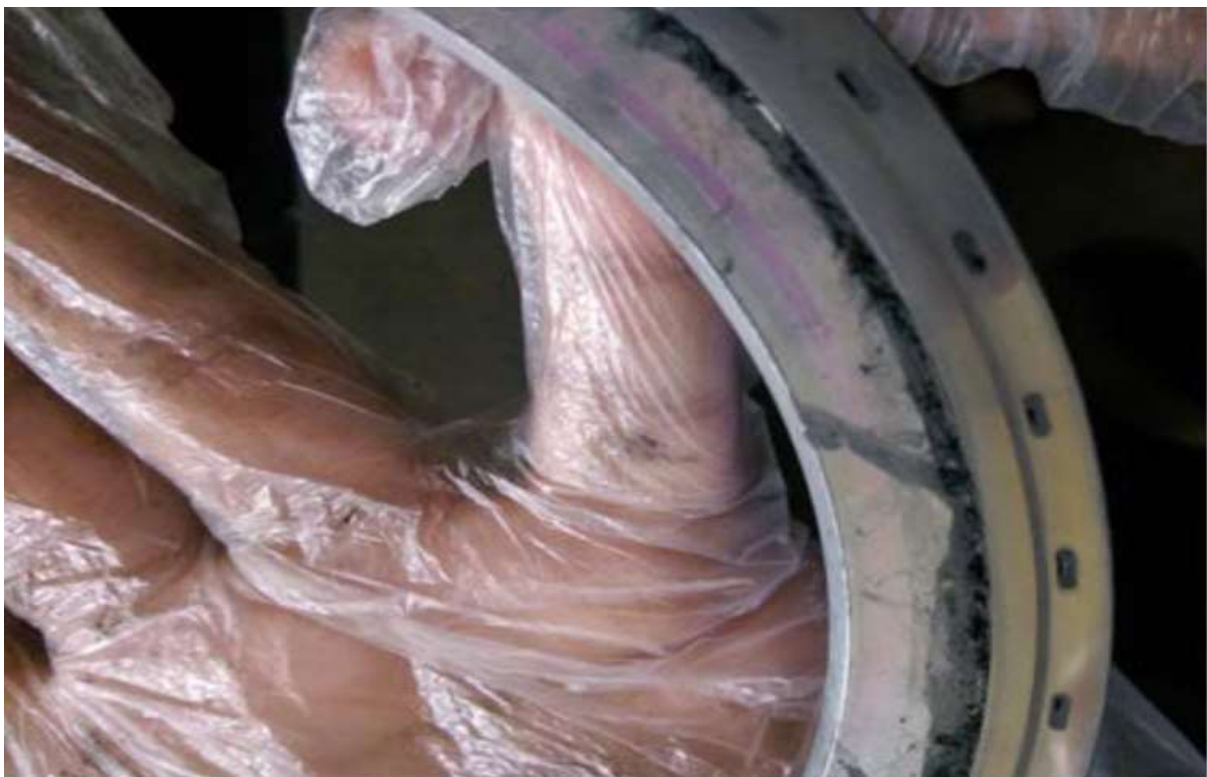
After lapping, the seal plate was removed from the machine. There was lapping residue deposited in the lubrication slots and holes present in the seal plate as depicted in image #6. The seat was run through the cleaning process and coated with preservation oil as per the EM. Subsequently, the seal plate was presented to IAE as being in a clean condition and ready for use in an engine as per the JEOC process sheets and the IAE EM. See image #7.

*Image #6 – Post lapping condition of the demonstration seal plate.*

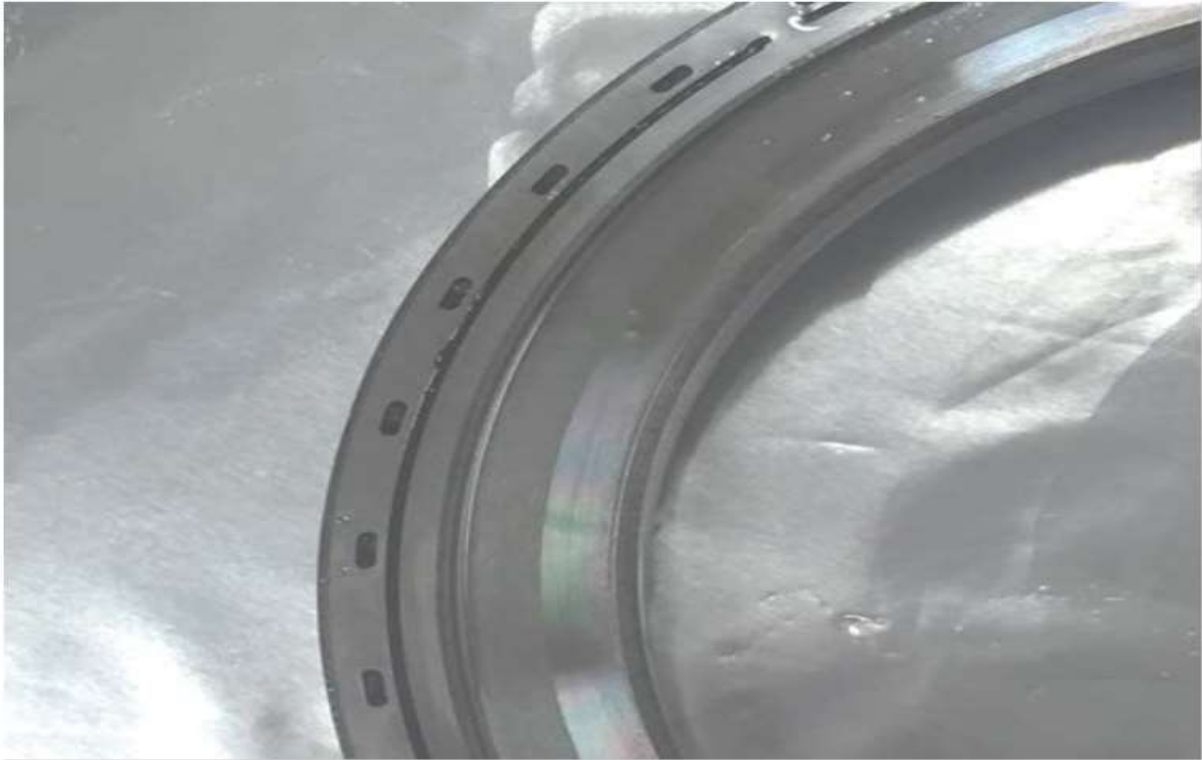
*Image #7 – Post cleaning condition of the demonstration seal plate.*

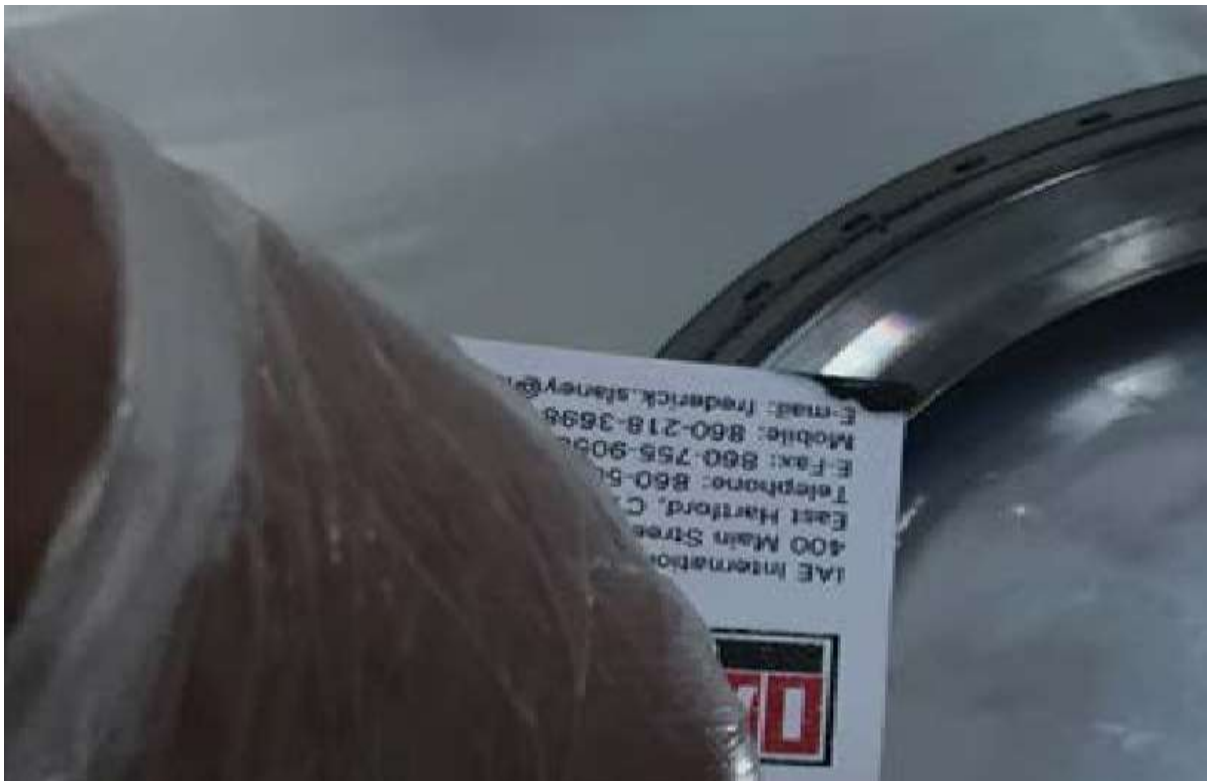
A business card of one of the IAE personnel present was run along a slot of the seal plate, allowing for a collection of lapping debris on the card. Debris was raised out of the slot during this procedure. A sample of this debris was retained, analyzed, and compared to the debris acquired from the V0118 seal plates. See images #8 & #9.

*Image #8 – Lapping debris removed from demonstration seal plate slot.*

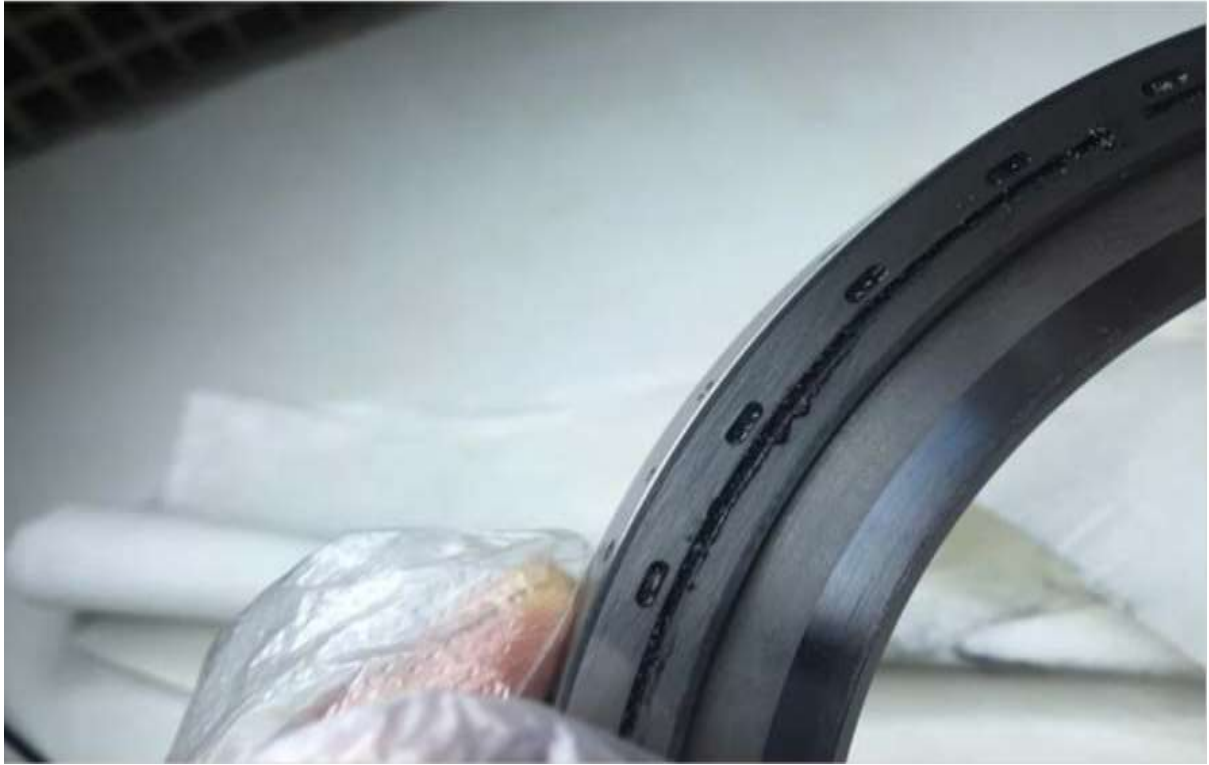
*Image #9 – Debris removed from demonstration seal plate groove after process complete.*

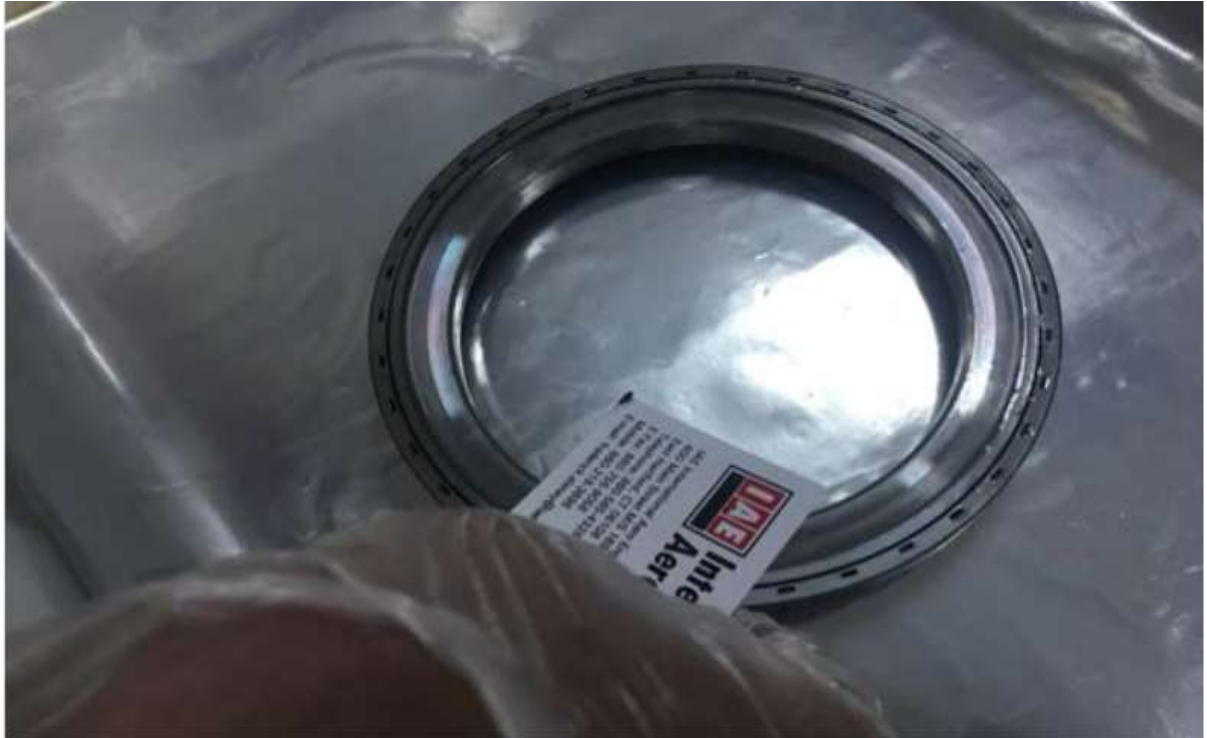
After this observation was made, JEOC personnel then physically removed as much material as possible with plastic picks and ran the part through the cleaning cycle a second time. Another business card was inserted and debris was present again but to a lesser degree than the original attempt to check for debris. See image #10.

*Image #10 – Debris removed from demonstration seal plate after second cleaning cycle.*

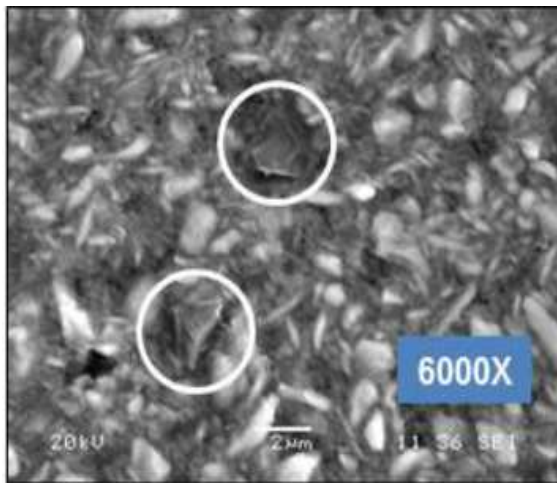
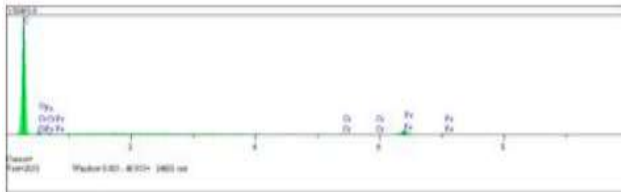
Debris from V0118 seal plate

- Diamond particles found in anti-weep grooves of Both V0118 event seal plates & JEOC Demonstration seal plate.

No. 4 seal plate of engine # 2 (V0118) was analysed and it was observed that the weep grooves and holes of the seal plate were mostly blocked with lapping debris. In order to confirm the same, on site, lapping process review was carried out at IAC overhaul shop by IAC Personnel. IAC personnel performed lapping process demo using IAE provided

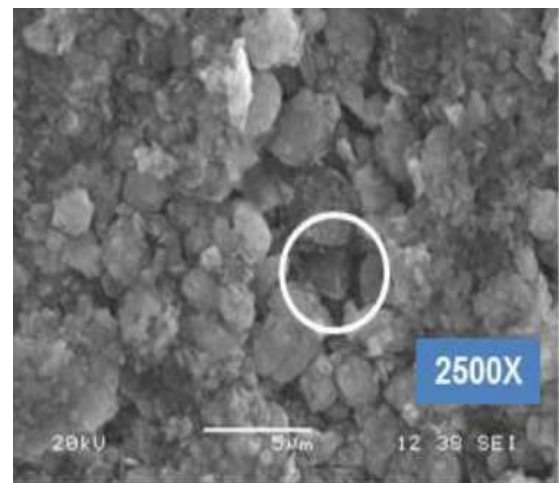
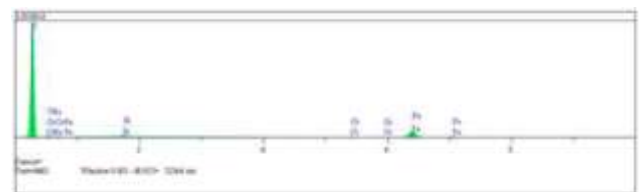
Debris from JEOC Demonstration Seal plate

V2500, #4 seal plate. After lapping, cleaning and preservation, it was observed that, seal plate weep grooves contained residual lapping debris or “slurry”. The slurry was analysed and was found to be matching with V0118 # 4 seal plate debris.

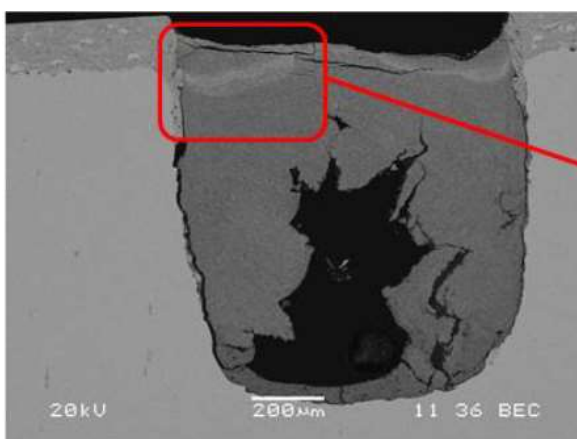
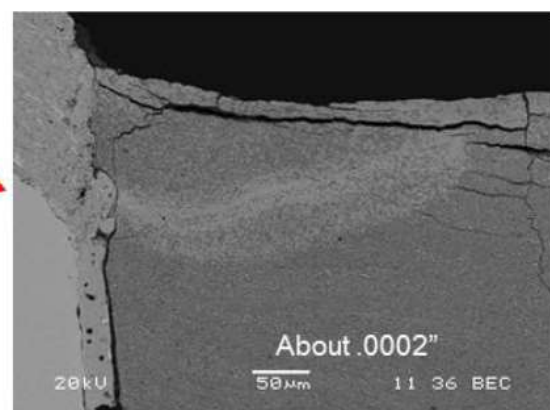
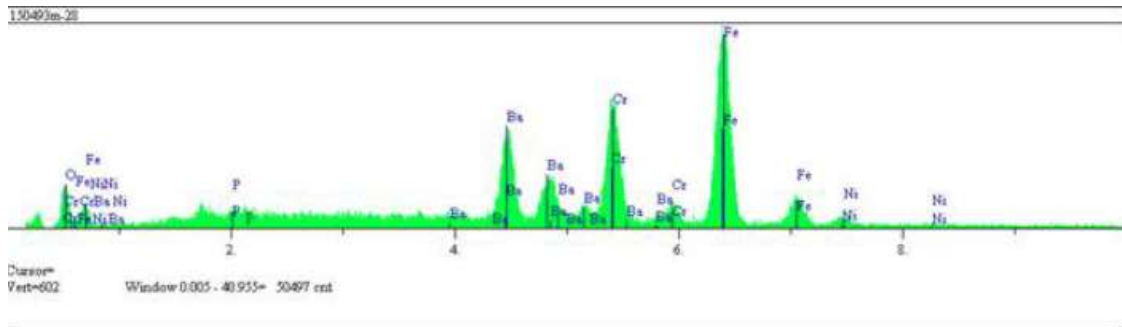
*Cross section of V0118 seal plate Anti-weep Groove*

- Chemistry and aspect ratio of metallic Debris & Diamond particles matches OEM lapping Debris.
- Diamond particles not found in environmental debris
- Barium found in anti-weep grooves of both V0118 event seal plates & JEOC demonstration seal plates; source identified as preservation fluid (AeroShell Fluid 12).

- *Barium was not found outside of V0118 Anti-Weep Groove, Therefore it was not environmental.*
