**Final Investigation Report on Serious Incident to M/s Mesco Aerospace Ltd. AS 350 BA Helicopter VT- MAB on 08-04-2014 at Chakwali Village, Near Saharanpur, U.P.**

1.	Helicopter	Type	Ecureuil AS 350 BA
		Nationality	Indian
		Registration	VT-MAB
2.	Owner		M/s Mesco Aerospace Ltd. New Delhi.
3.	Operator		M/s Mesco Aerospace Ltd. New Delhi.
4.	Pilot – in –Command		CPL (H) Holder
	Extent of injuries		NIL
5.	Co-Pilot		CPL (H) Holder
	Extent of injuries		NIL
6.	Date & Time of Incident		08-04-2014; 0610 UTC.
7.	Place of Incident		Chakwali Village, Near Saharanpur, U.P.
8.	Last point of Departure		Muradnagar, Dist. Ghaziabad, U.P.
9.	Intended landing place		Manakmau, Dist. Saharanpur, U.P.
10.	No. of Passengers on board		03
	Extent of injuries		NIL
11.	Type of Operation		Charter flight (NSOP Operations)
12.	Phase of Operation		Cruise
13.	Type of Incident		Forced landing due to Tail Rotor Pitch link failure
14.	Co-ordinates of Incident Site		Lat 29° 46' 21" N, Long 77° 30 ' 33" E AMSL 850 feet

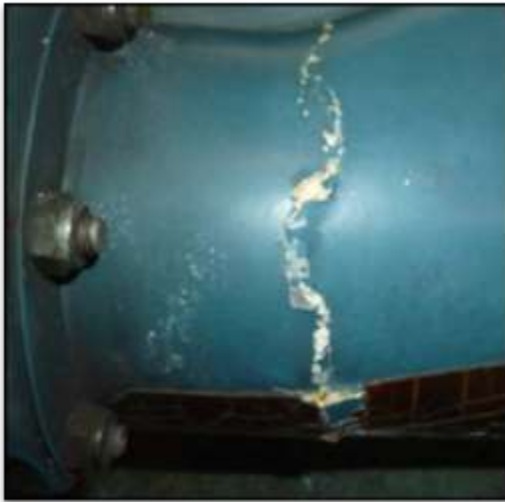
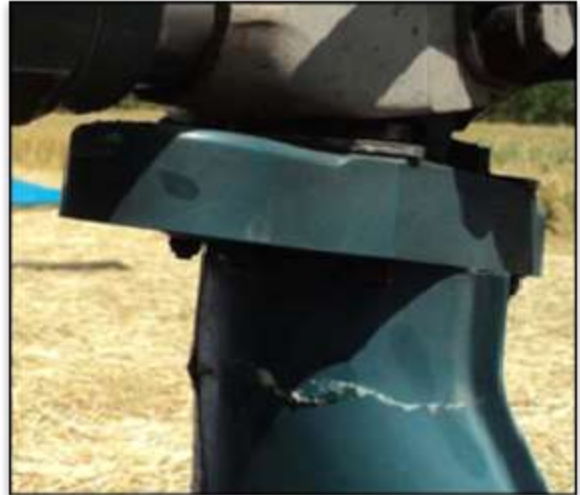
### **Damaged Tail Rotor Blade**

The damaged blade exhibited a compressive crack (blade flapping toward the tail boom) at the junction with the chin weight. The damaged blade exhibited some marks of contact with very soft object compatible with vegetation. The impact finger was bent which is consistent with the blade contact with the tail boom due a significant flapping of the blades.

The internal half-laminated bearing of the damaged blade chin weight exhibited damages consistent with several significant blade flapping toward the tail boom. The metallic support allowing the junction on the chin weight of the internal half laminated bearing of the damaged chin weight exhibited contact marks with the hub yoke which are consistent with a significant flapping toward the tail boom.

The chin weight horn of the damaged blade was missing. The chin weight of the damaged blade exhibited contact marks with tail rotor mast and the seesaw screw exhibited contact marks with the hub yoke which are consistent with a significant blade flapping toward the tail boom.

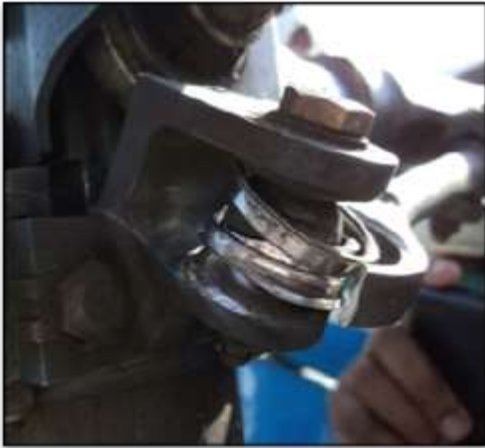
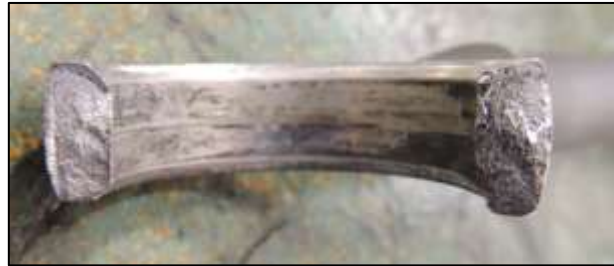
### **Failed pitch rod**

The failed pitch rod exhibited rupture on its housing at two different locations but didn't exhibit deformations which are consistent with a fatigue rupture.

The bearing ball of the failed pitch rod exhibited wear damages consistent with a long use with play in the ball bearing.

The ball bearing cage of the failed pitch rod exhibited significant wear damages (material is missing) consistent with a long use with play in the ball bearing.

The bearing ball of the failed pitch rod exhibited wear damages consistent with a long use with play in the ball bearing. The ball bearing cage of the failed pitch rod exhibited significant wear damages (material is missing) consistent with a long use with play in the ball bearing. The failed pitch rod exhibited rupture on its housing at two different locations but didn't exhibit deformations which are consistent with a fatigue rupture. The other tail rotor pitch link shows axial play, which was within limit.

The fatigue rupture of the pitch rod is probably due to a long use of the helicopter in presence of a play into one of the tail rotor pitch rod ball bearing.
