FINAL INVESTIGATION REPORT OF
ACCIDENT TO PAWAN HANS LTD. DAUPHIN
AS 365 N HELICOPTER VT-ELJ
AT MELURI ON 24/11/2015

**FINAL INVESTIGATION REPORT OF ACCIDENT TO PAWAN
HANS LTD. DAUPHIN AS 365 N HELICOPTER VT-ELJ AT
MELURI ON 24/11/2015.**

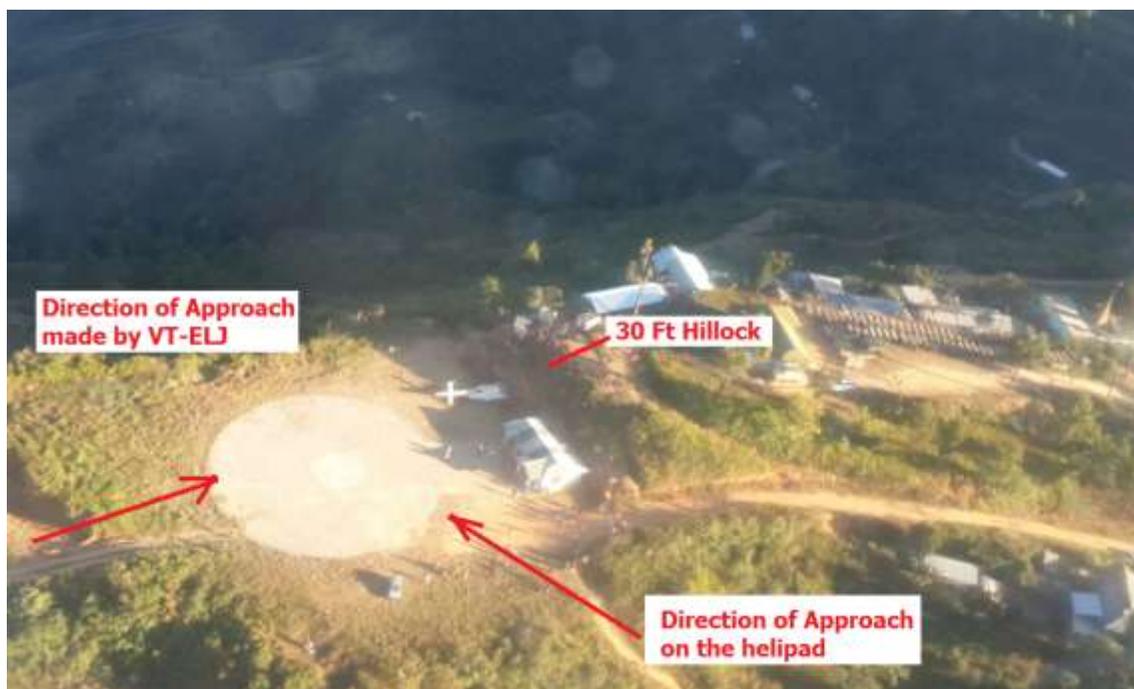
The Helipad at Meluri is a temporary helipad and on Hill Top at approx 4200 ft AMSL having two sides i.e. East and West has clear approach and take-off funnel, however towards the South there is a hillock of approx 30 feet height. The surface of the helipad was made up of concrete, which was in bad condition except the 'H' marking. Loose concrete and powdered cement were found all over the helipad. There was no arrangement of Fire Fighting and Rescue Services during the period of operation. There was no Wind sock available at helipad for guiding the approaching helicopter.

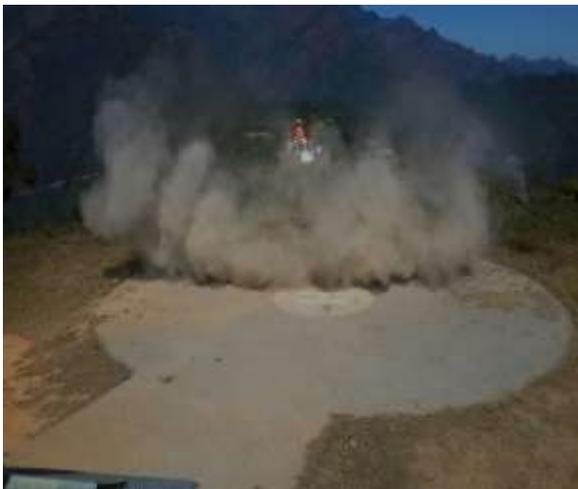
Dense Dust Bowl during Approach

The helicopter continued approach and thereafter terminating into hover. However, as he entered the area around helipad maintaining about 5-6 feet above the ground, due to the rotor downwash, a huge dust bowl engulfed the helicopter with the presence of loose mud and gravels around the helipad. The visibility of the Pilot was reduced totally due to the dust bowl. The helicopter forward speed at this moment was zero kts.

- n) As the helicopter entered the area around helipad maintaining about 5-6 feet above the ground, due to the rotor downwash, a huge dust bowl engulfed the helicopter with the presence of loose mud and gravels around the helipad.

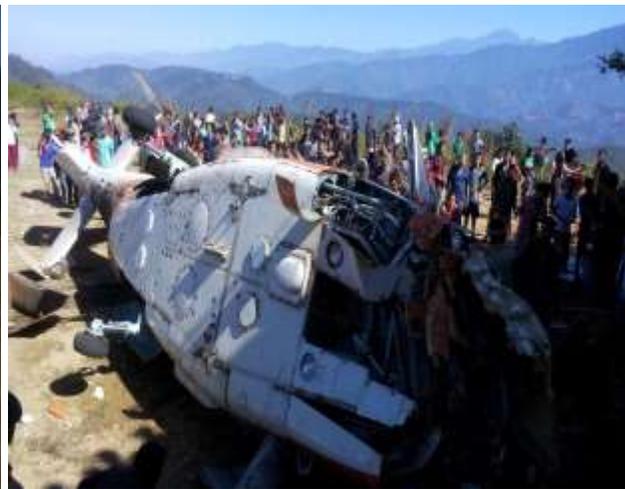
Helicopter Topped to its left after impact

- r) As the speed of the helicopter was low, the helicopter toppled on its left causing post impact fire in the aft cabin, engine compartment and front tail boom area. The helicopter suffered substantial damage.

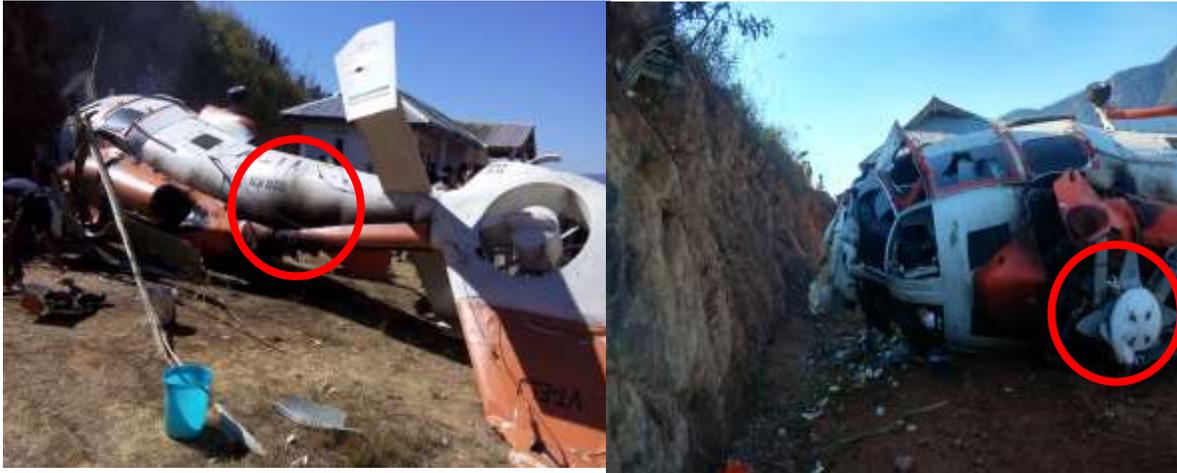
Fire marks on front tail boom area

All the 4 rotor blades sheared off from root
