FINAL INVESTIGATION REPORT ON
ACCIDENT TO M/s HIMALAYAN HELI
SERVICES PVT. LTD. AS 350 B3
HELICOPTER VT- JKB ON 23-11-2015
AT KATRA, JAMMU

COMMITTEE OF INQUIRY VT-JKB

**FINAL INVESTIGATION REPORT ON ACCIDENT TO M/S
HIMALAYAN HELI SERVICES PVT. LTD. AS 350 B3 HELICOPTER
VT- JKB ON 23-11-2015 AT KATRA, JAMMU.**

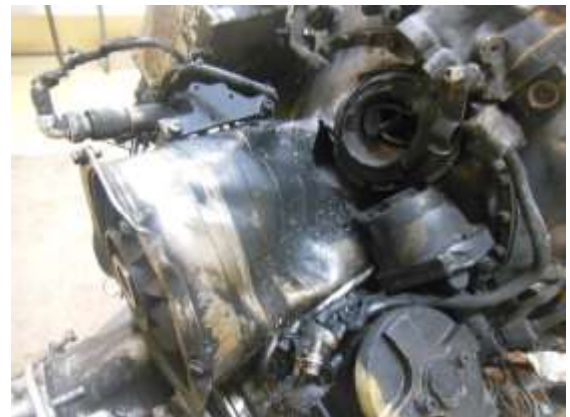
Module 2 (Axial Compressor)

The Gas Generator could not be rotated by hand. The casing was distorted and punctured in the upper part. All the blades of the axial compressor wheel were damaged and they had lost approximately a quarter of their height due to rubbing with the distorted casing. Such a level of damage indicates that the Gas Generator was rotating with power when the casing was crushed.

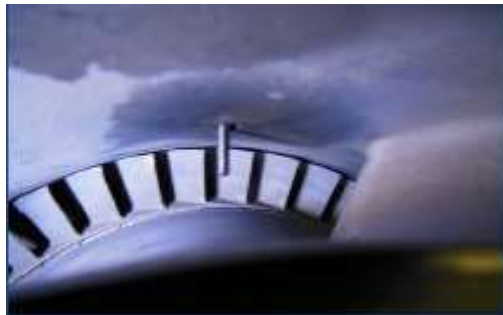
Module 3 (Gas Generator)

The module 3 casing was locally distorted and twisted. The engine was disassembled to reveal the High Pressure turbine. It was in good condition with only light tip rubbing. The blades were lightly splattered with shiny speckles indicating the ingestion of soft metallic FODs. Similarly, speckles could be seen on the Nozzle Guide Vanes' trailing edges. Such speckles originate from the ingestion of soft metallic FODs which subsequently melt when they reach the combustion chamber, thus indicating that the combustion was established in the combustion chamber at the time of the crash.

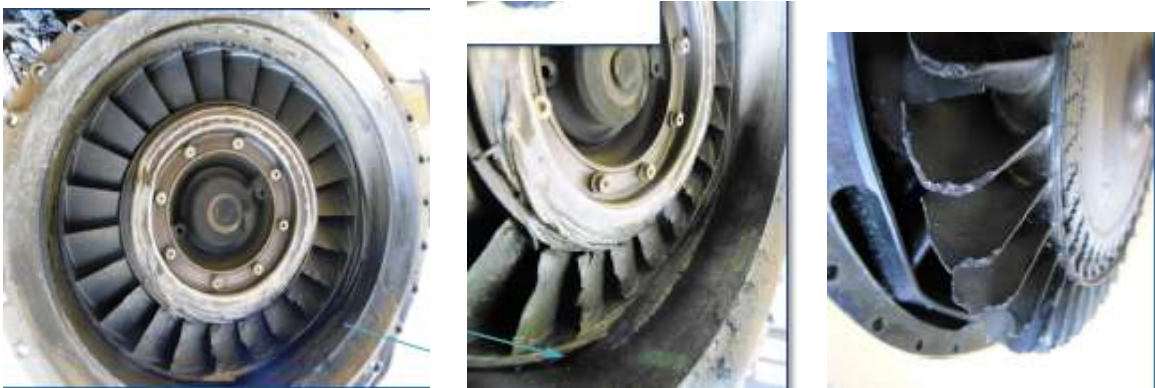
All the blades then came in contact with the shroud and lost approximately a quarter of their height. They also dug a groove in a section of the shroud corresponding to the lower position when the engine was upside-down. Such a level of damage indicates that the Power Turbine was rotating with power at the moment of the crash.

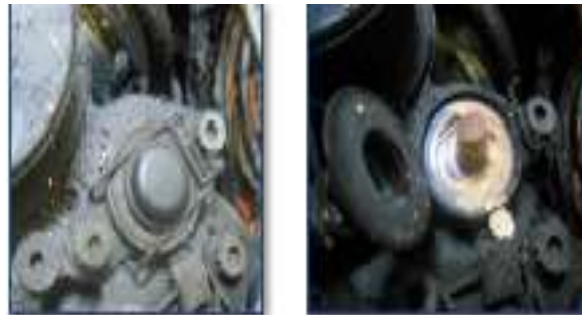
- Fuel filter and clogging indicator

The fuel filter was removed and the visual inspection showed that it was clean. The filter casing was totally dry. The clogging indicator cover was tarnished by soot and had to be opened to reveal that it had popped out. However, as the filter was clean, it probably popped out due to impact forces during the crash.
