**GOVERNMENT OF INDIA
MINISTRY OF CIVIL AVIATION
AIRCRAFT ACCIDENT INVESTIGATION BUREAU
NEW DELHI INDIA**

**REPORT ON
ACCIDENT TO M/s PAWAN HANS
DAUPHIN N3 HELICOPTER VT-PHK
AT KHONSA
ON 04/08/2015**

**REPORT ON
ACCIDENT TO DAUPHIN N3 HELICOPTER VT-PHK
NEAR KHONSA (ARUNACHAL PRADESH) ON 04/08/2015**

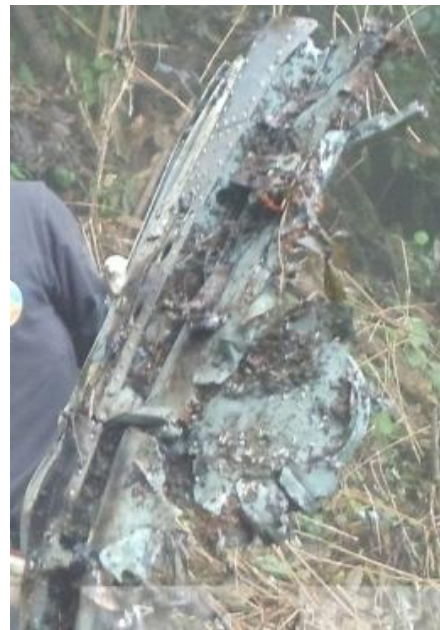
BROKEN PANELS & CONTROL RODS

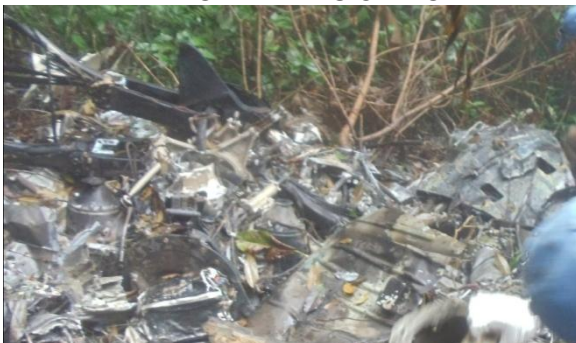
DAMAGED PARTS OF MGB

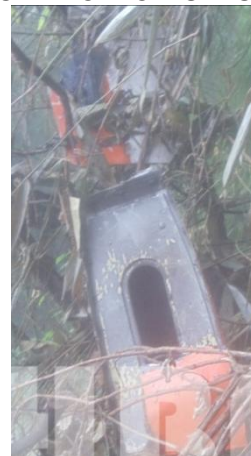
DAMAGED BOTTOM STRUCTURE

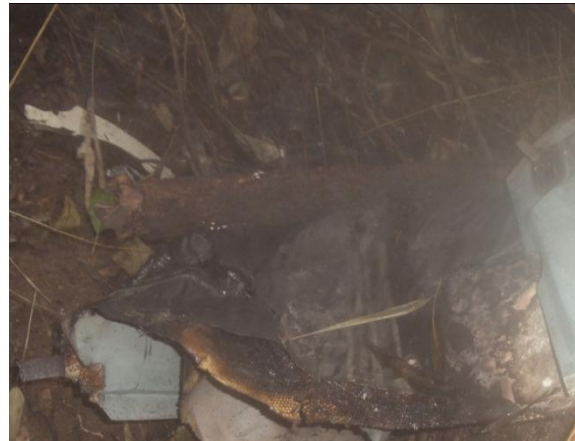
PANELS WITH FIRE DAMAGE

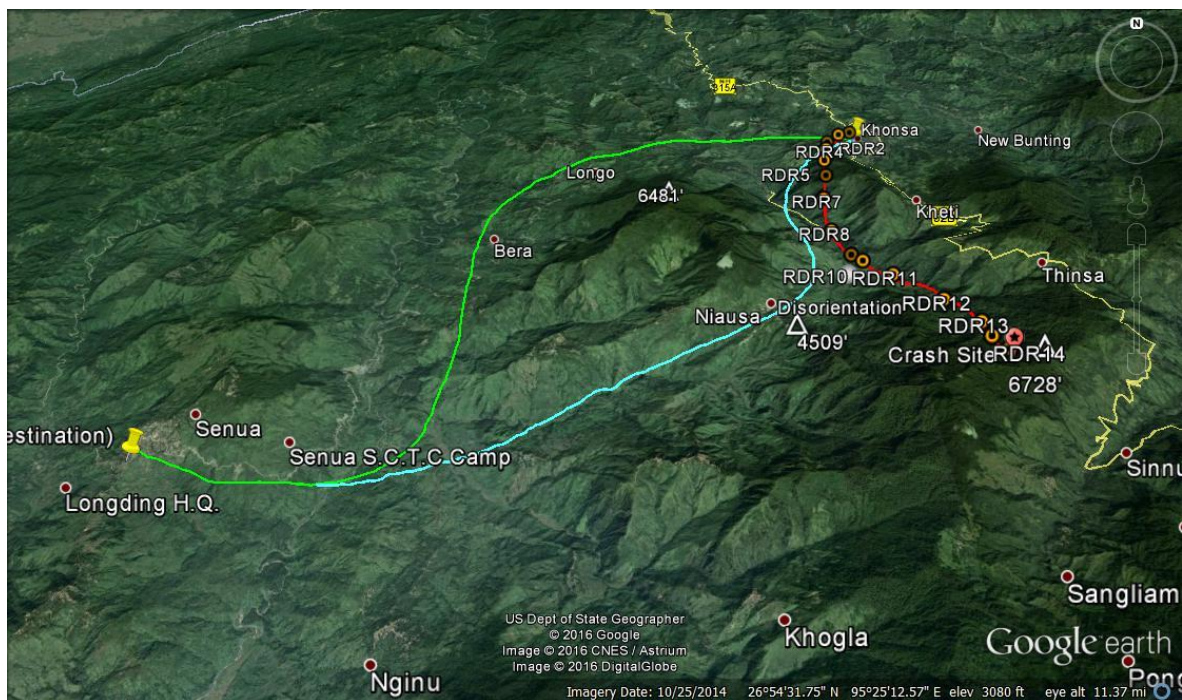
The above picture gives out the terrain very clearly and attempt has been made to depict the planned, alternate and actual flight paths taking into account

the data available from Radar plots, Flight plans, terrain study and Radio Calls given by the Pilot. The green path is for the probable planned route, blue path is probable alternate path which the PIC tried to follow due weather on the planned path and Red is the actual path followed by the helicopter.

As per flight Plan the level filed for the sector 3500 ft, which based on the average heights of the hills in the area implies that the planned route was that after take-off from Khonsa fly West towards Luthong, up till Longo and then turn Southerly towards Bera up till Senua where the PIC would have once again turned west and landed at Longding. The highest point in this route is approx 2400 feet, so with 1000 feet clearance, he had planned to fly at 3500 feet level (as given in filed flight plan by the flight crew). No other routing has terrain less than 2500 feet.

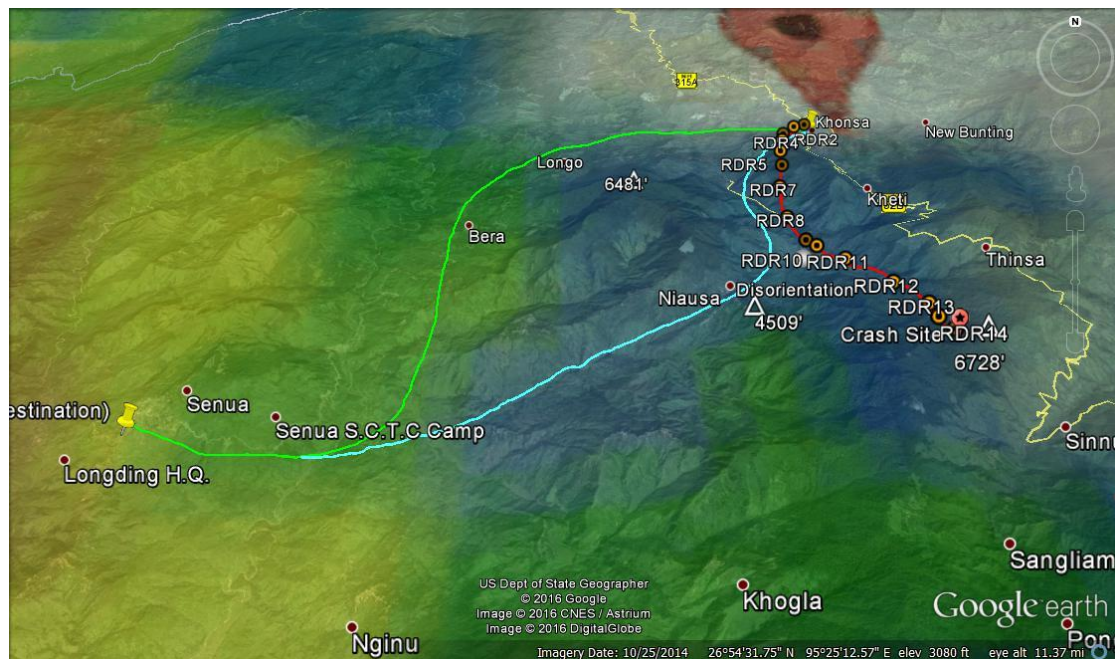
Flight Paths with Cloud Picture overlay

Cloud picture overlay of Satellite imagery, clearly gives out that there was widely spread low cloud cover and same is corroborated by weather reports and statements of people on ground. The clouds were thick and dark as per the statements of people on ground. As in the present case the weather was very bad in the area of planned routing, alternate routing available was via Niausa, for which initially the helicopter should fly south after take-off uptill Niausa and climb to 5500 feet, as altitude of Niausa is 4500 feet, there after turn right (west) and fly towards Senua and continue descending to land at Longding.

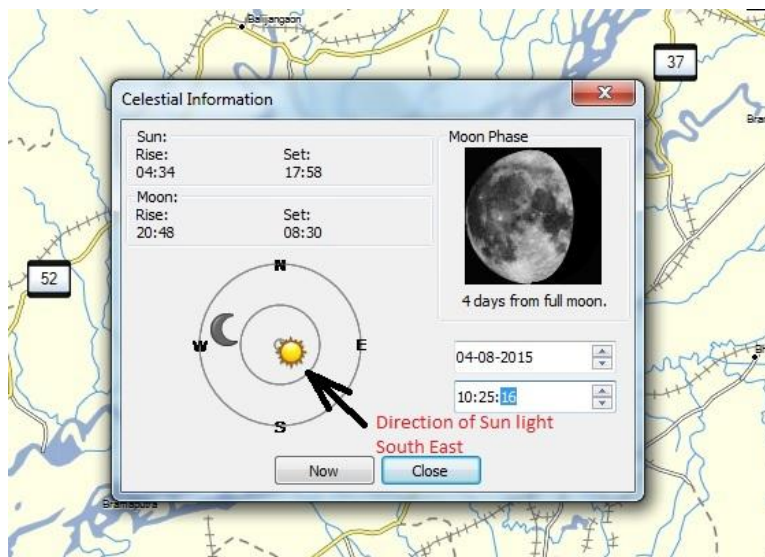
Sun Position

One more reason for pilot not taking the planned route and trying out alternate route comes out from the direction of sun (light) during the flight. Position of Sun was in South East direction. When sky is completely covered with thick clouds, in the direction of Sun, because of strong sun rays, the clouds seem to be lighter and give a feeling of less cloud thickness and reciprocal direction looks darker. This phenomenon, makes the pilot feel that it's better to fly in the direction where clouds are less and might get a clear area very soon and in the present case the direction was SE. This could had been the reason for Pilot to fly on the alternate route. The last radio call given by the pilot was of "Climbing to 5500 feet" which indicates that he was following the route via Niausa, and was
