**REPORT ON ACCIDENT TO
M/s PAWAN HANS DAUPHIN N3 HELICOPTER
VT-PWF
AT BOMBAY HIGH
ON 04/11/2015**

**AIRCRAFT ACCIDENT INVESTIGATION BUREAU
MINISTRY OF CIVIL AVIATION
NEW DELHI**

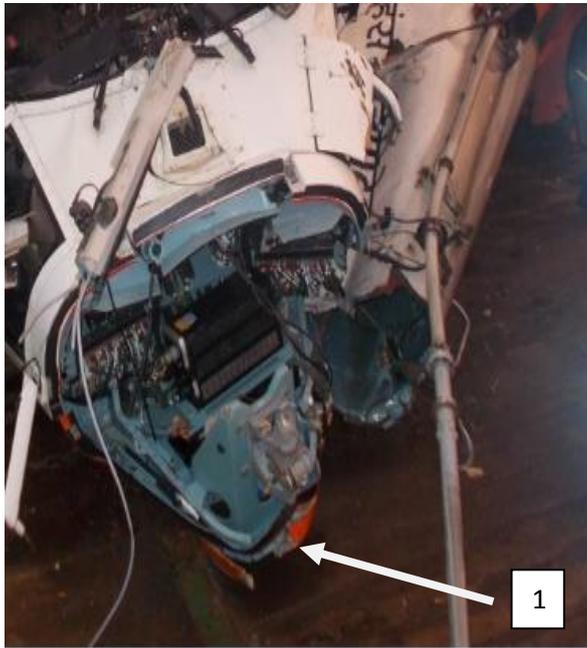
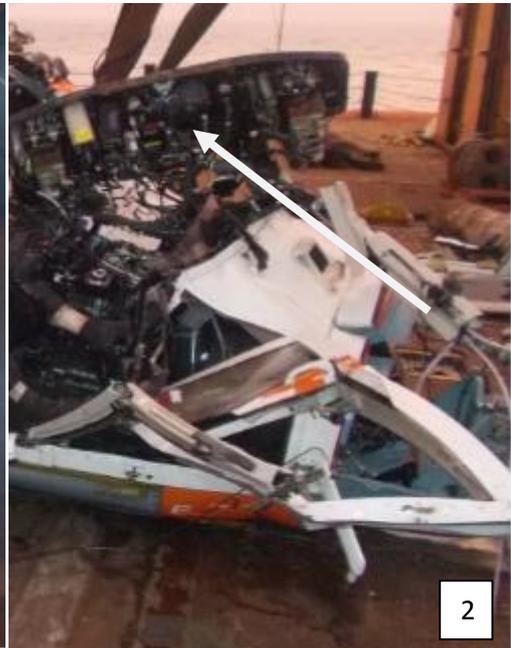
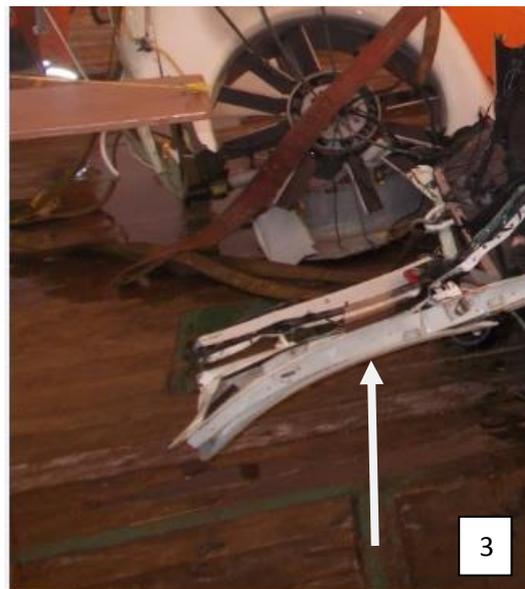
1. DAMAGED RADOME
2. INSTRUMENT PANEL (REAR)
3. DAMAGED PILOT DOOR

The instrument panel had shifted backwards during impact though complete console is in position. The co-pilot's door is totally destroyed and the damage matches with that on the left side of the structure. The front right passenger's door is though available in full with some deformations but its window is missing. Both the rear passenger's doors are available with left passenger's door broken in its lower part.

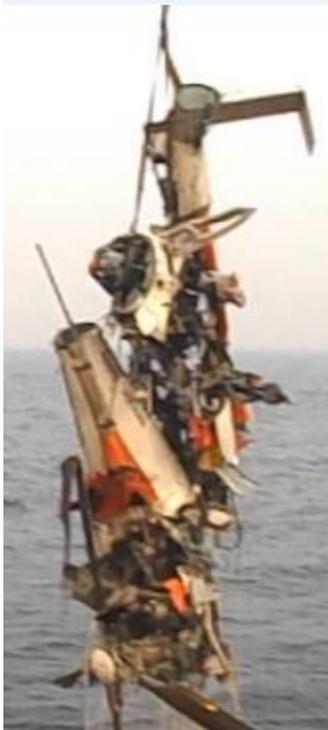
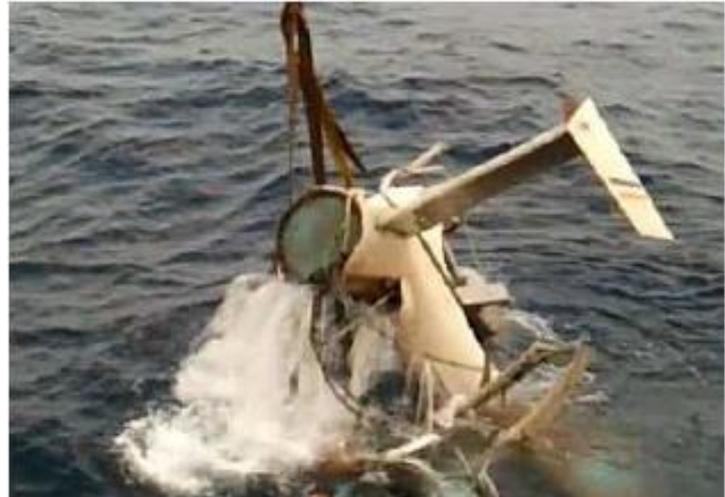
The “left side of the horizontal stabilizer and left outboard fin” assembly is broken. On the right side, the lower outboard fin is broken. The right horizontal stabilizer and the rest of the outboard fin are in position without deformation. The rear part of the fenestron housing is broken. The rest of the fenestron is complete with the blades in position without visible deformation. The rear part of the tail rotor control shaft is connected at its rear end.

- The right horizontal stabilizer in Position
- The left horizontal stabilizer was broken

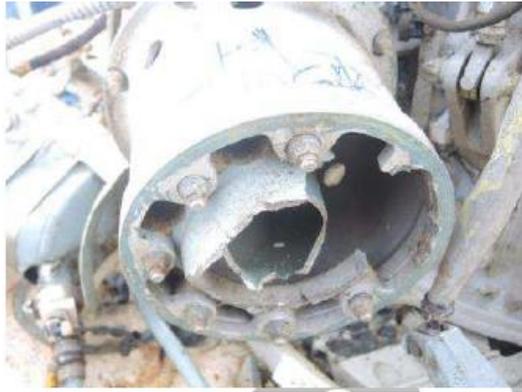
Rotational interference was identified on the outer surface of the coupling shaft. This observation showed that the left engine was running during the fracture sequence. This observation is consistent with parameters recorded on the FDR.

Part of the coupling linked with the main gearbox

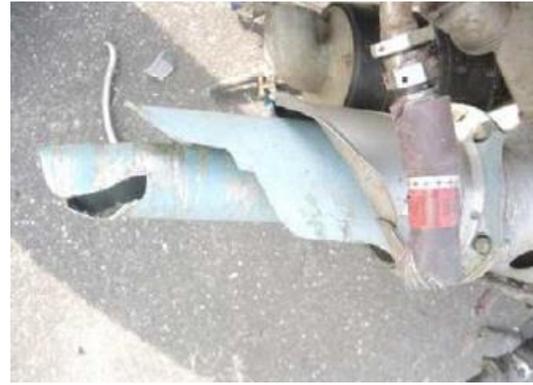
Part of the coupling linked with the engine

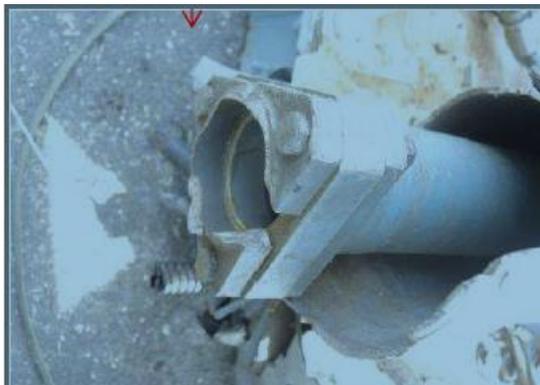
Joint at the intermediate flange

- The right coupling was broken at the MGB input flexible coupling and at the intermediate coupling flange. The fractures were static without damage prior to the accident.

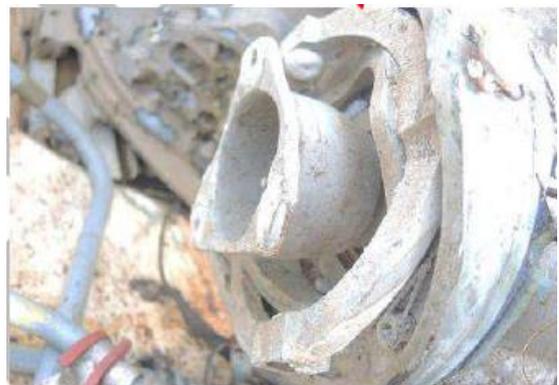
Joint at the output on the main gearbox

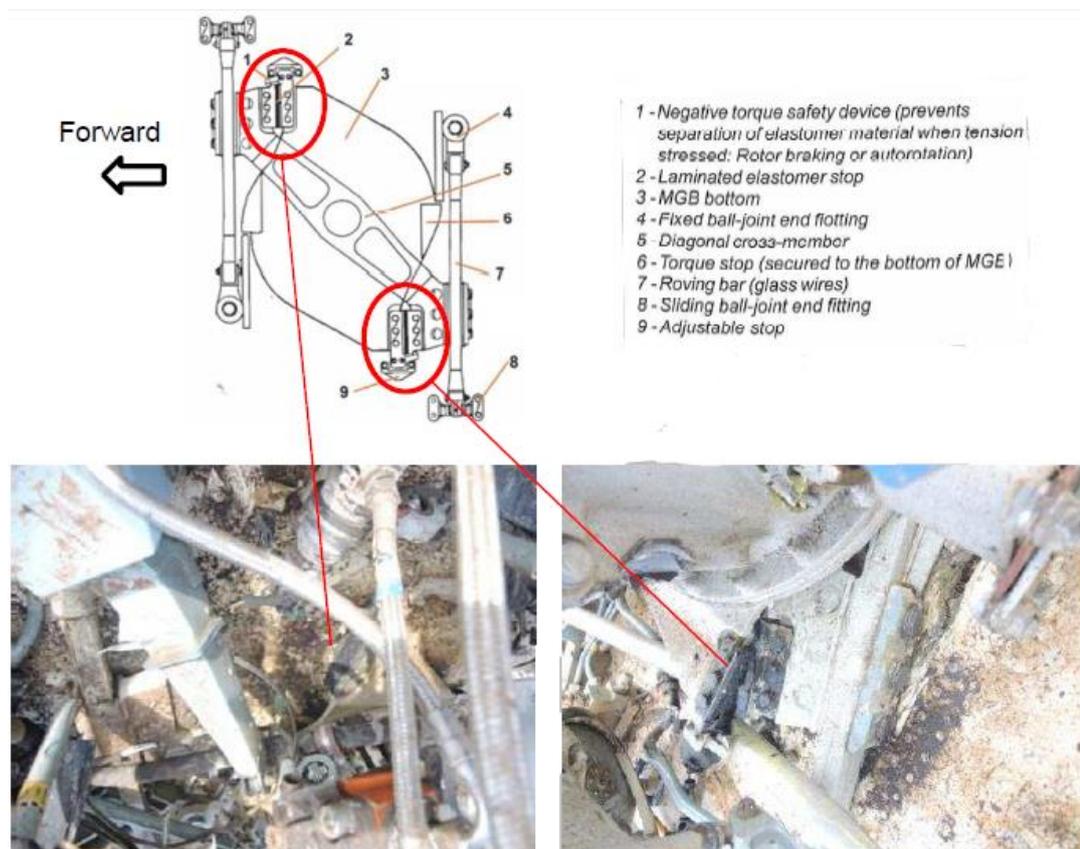
The two laminated elastomer stops were fractured and the main gearbox had turned clockwise in relation to the structure. This damage was a consequence of the crash when the powered main rotor stopped suddenly due to impact with water.

Front laminated elastomer stop

Rear laminated elastomer stop

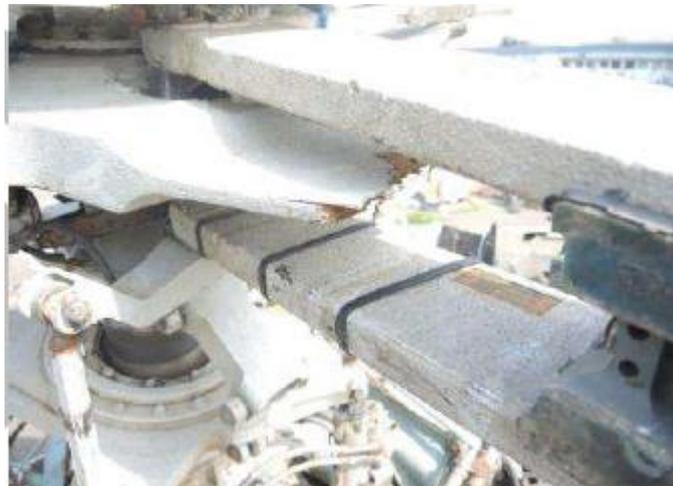
The star arm attached to the fractured black blade

The star arm associated to the black blade was fractured with an angle representative of load in the inertia direction.

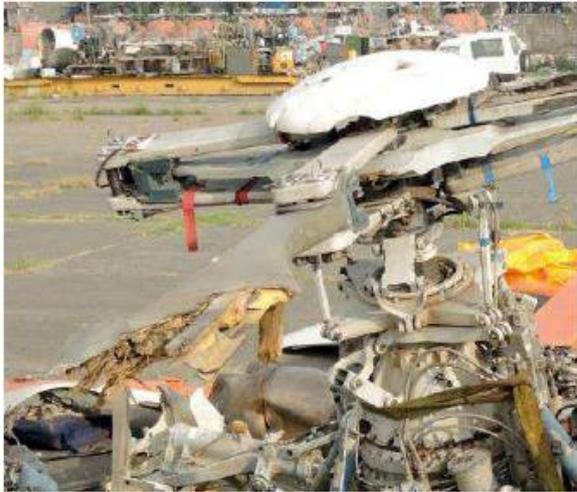
On these fragments of the black blade, no impact was identified on the leading edge. The profile of this blade was destroyed from the root toward the end.

The fragment of the black blade attached to the rotor head

Others fragments of the black blade

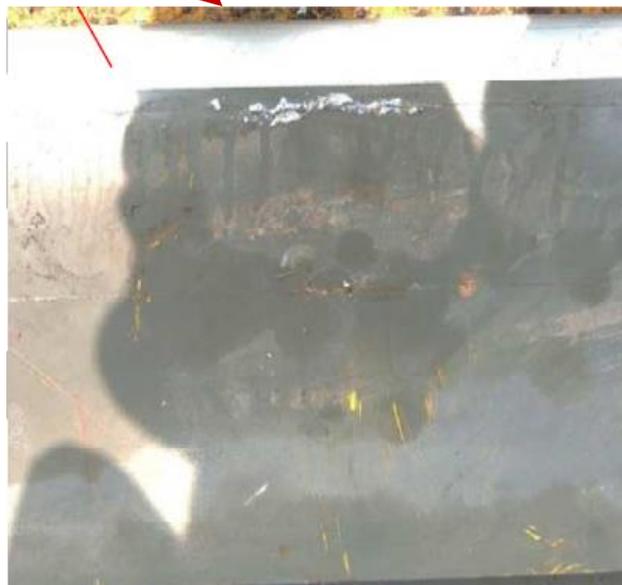
The yellow marks were at about 1.2 metres from root of the blade.

Yellow marks identified on the upper surface

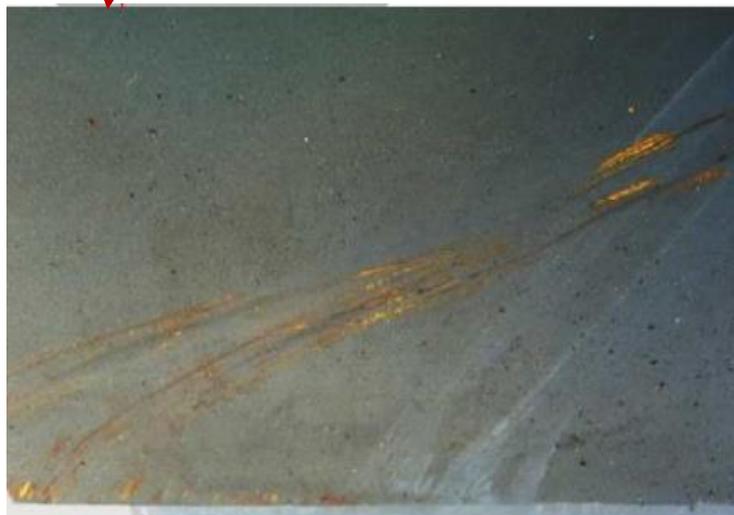
Yellow marks identified on the upper surface

On the upper side, several cracks and several yellow marks were identified. The cracks were parallel to the leading edge and located at the centre of the profile and close to the leading edge.

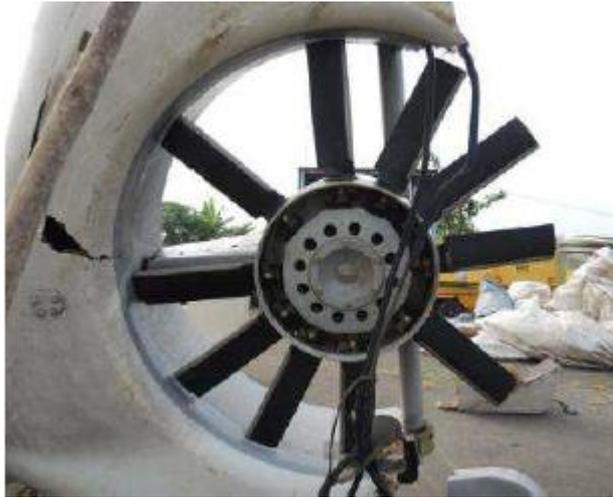
All of the tail rotor blades were in position on the hub. One blade was fractured by bending close to its root.

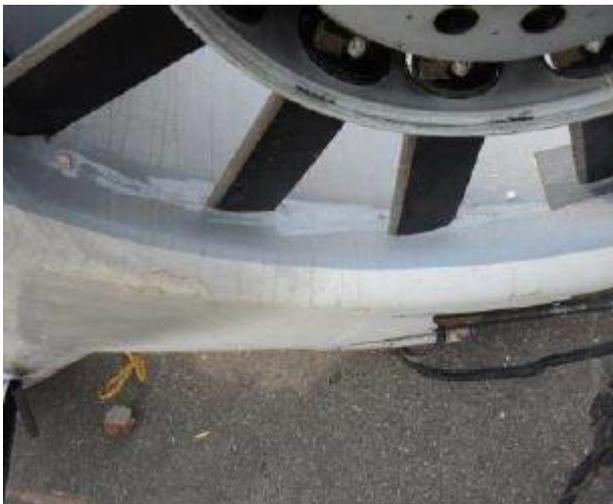
Scuffing identified on the fenestron duct

Several rotational interferences were identified on the fenestron duct due to contact with the blades. This observation showed that the fenestron was rotating when the structure of the tail rotor began to be damaged and deformed.

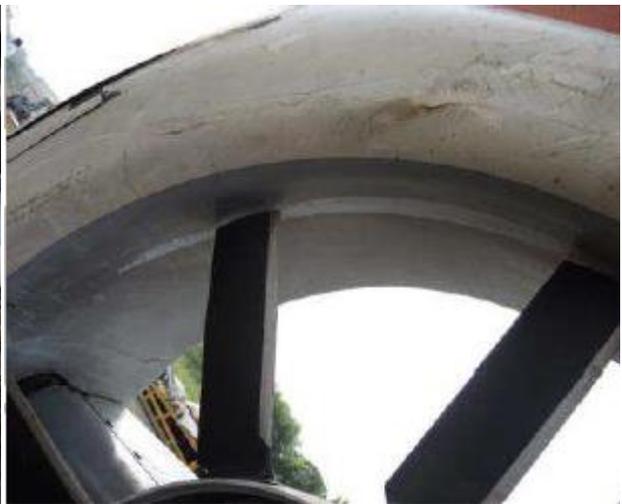
Scuffing identified on the fenestron duct

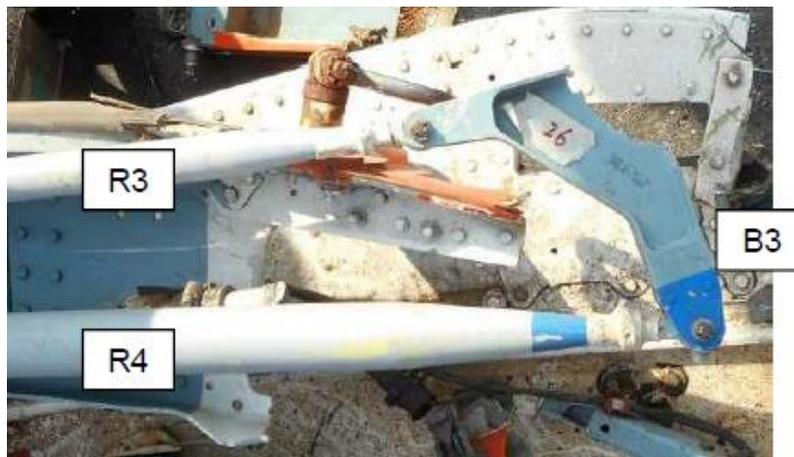
Broken bellcrank B3

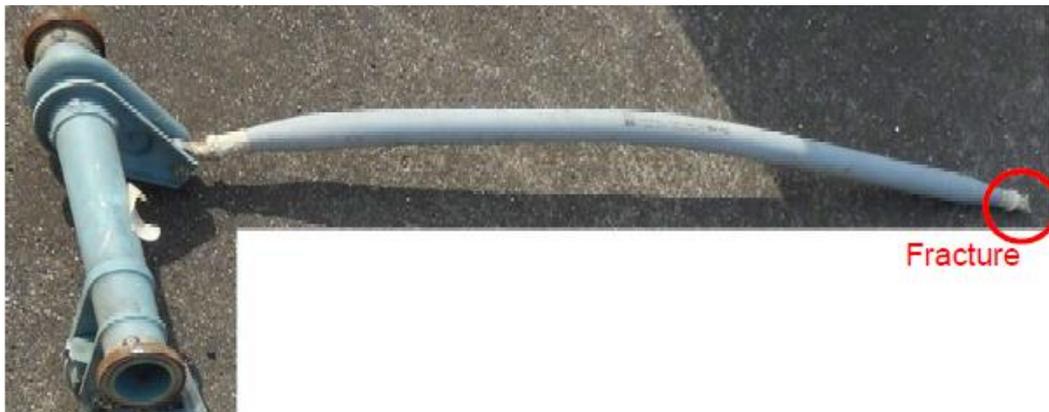
Broken rod R17 and RH mixing unit disconnected from the structure

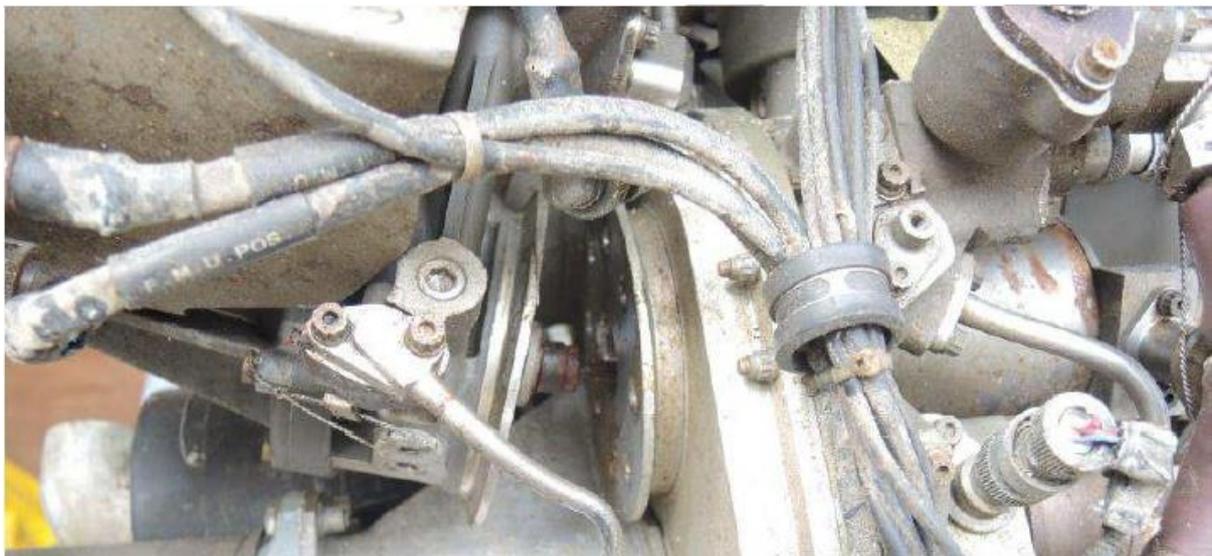
Pump shaft of the and metering unit assembly disconnected from the engine
