**FINAL INVESTIGATION REPORT OF
SERIOUS INCIDENT TO M/S AIR INDIA
A321 AIRCRAFT VT-PPD
ON 15.02.2015 AT MUMBAI.**

**FINAL INVESTIGATION REPORT ON SERIOUS INCIDENT TO AIR INDIA,
AIRBUS A321 AIRCRAFT VT-PPD AT MUMBAI ON 15/02/2015**

| 15. Type of Occurrence | : Tail Strike |

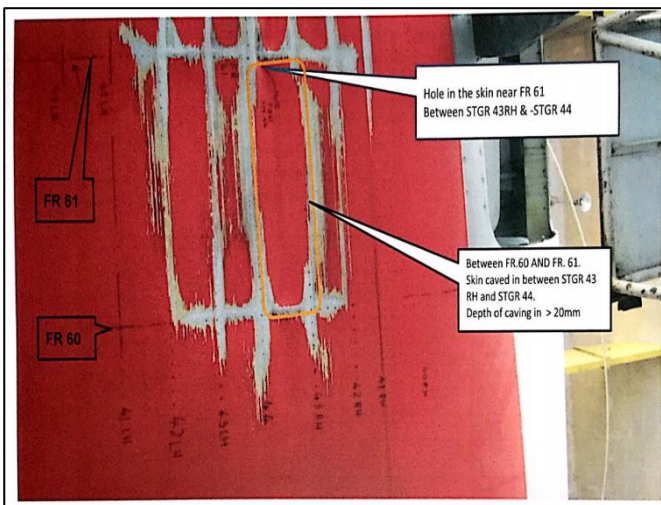
1. AFT fuselage Station no. 17 and Station no. 18 suffered damage of skin and internal structure due to tail strike and contact with the runway.
2. Airframe Frame no. 59 to Frame 68 suffered damage.
3. Frame No. 61 deformed and flattened at bottom.
4. Frame No. 62 heavily distorted and cracked.

Aft Belly damaged during tail strike

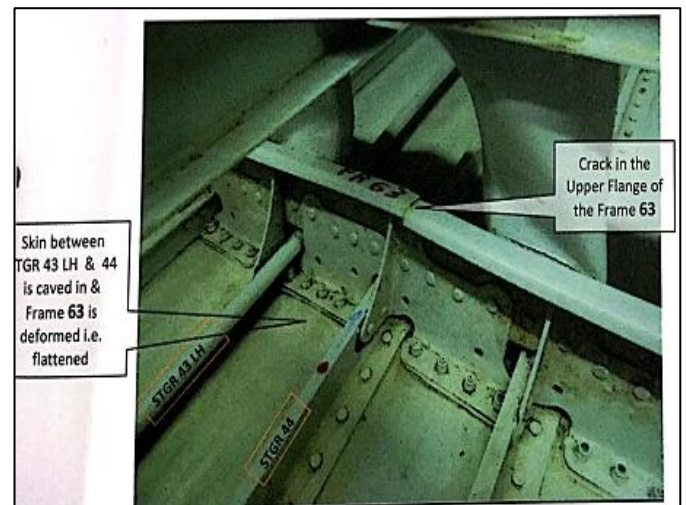
Aft frame No.63 cracked due tail strike

5. Crack was observed on the upper flange of frame 63.
6. Both the main landing gear shock absorbers, sliding tubes, wheels and tyres exceeded the design load limits.
7. Through and through hole was observed between the stringer no 43RH and 44RH.
8. Cargo Door support beam was damaged.

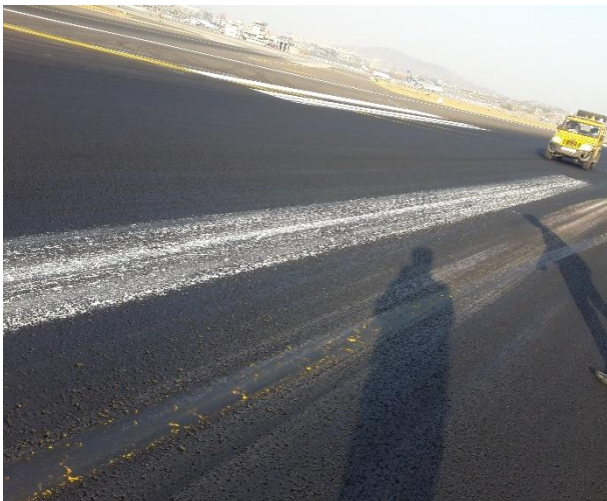
Belly scrape marks on the runway

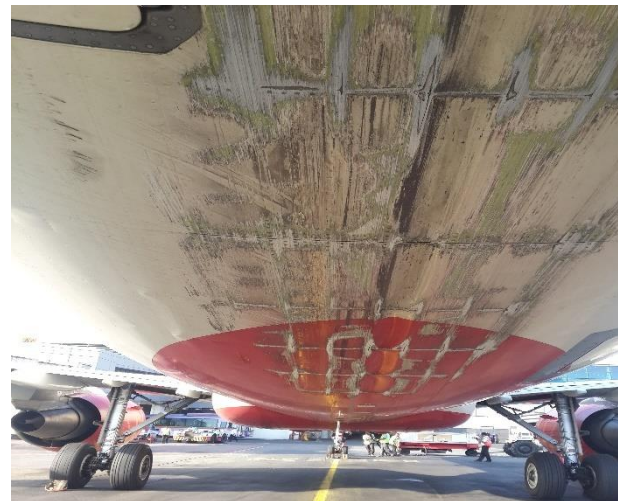
Damaged aircraft belly

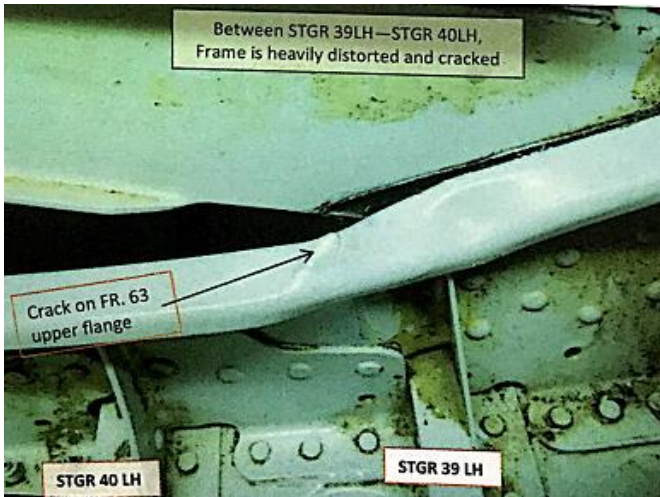
Crack on the Frame 63 rear upper flange

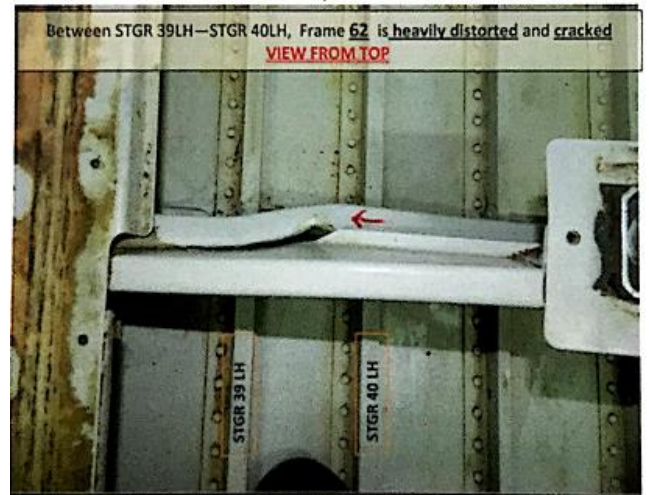
Frame 62 heavily distorted

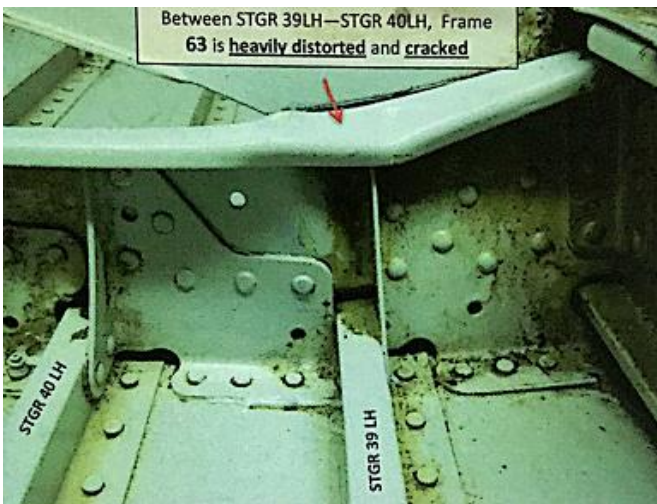
Frame 63 heavily distorted and cracked

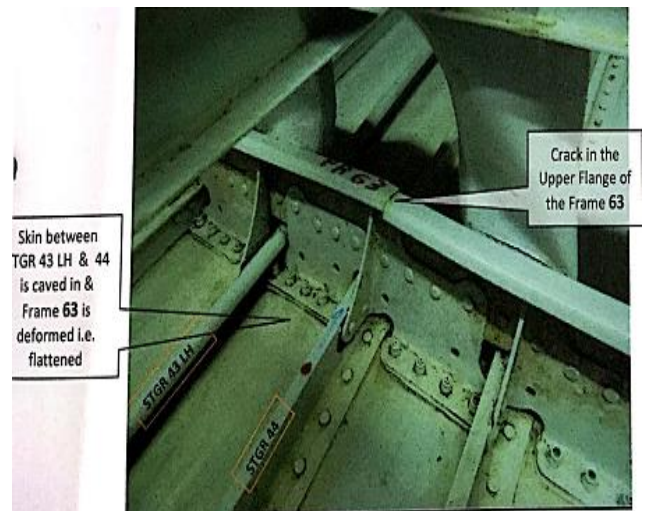
Skin between stringer 43 & 44 badly deformed.

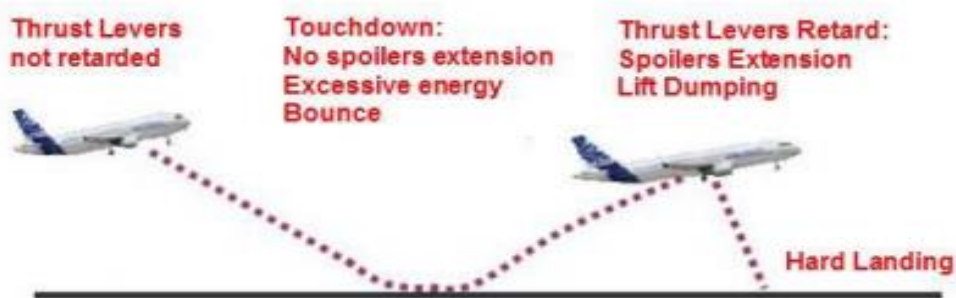
As the aircraft was fitted with two different SEC standards (SEC 112 in positions 1 & 2 and SEC 123 in position 3), the ground spoiler extension was controlled with two different extension logics, depending on the SEC controlling each spoiler. As the energy of the first landing associated with the nose up order maintained at touchdown and the inhibition of the full ground spoiler extension caused a high bounce. The partial extension of the ground spoilers 1 & 2 at touchdown did not sufficiently decrease the lift to reduce the severity on the first

Aircraft fitted with older version SEC112 without Phase Lift Dump function

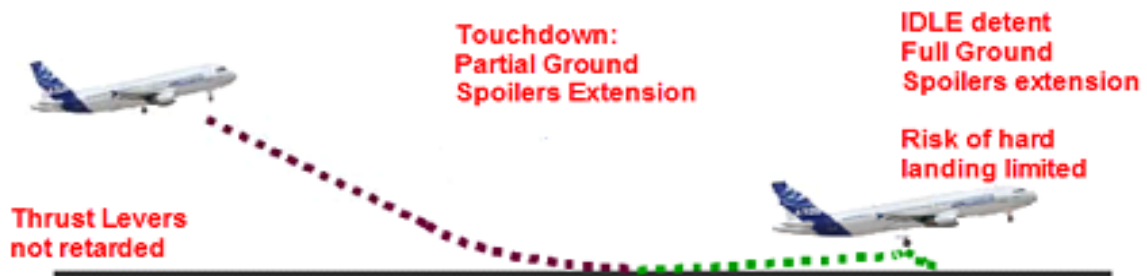
The aircraft VT-PPD was fitted with two different sets of SEC. The Ground spoilers 1 & 2 were controlled by SEC 123 in position 3 which was the modified component and the SEC 123 contained the feature of Phased Lift Dumping (PLD) function. This function enables the ground spoilers to extend with a partial deflection (10°) in order to reduce the severity of a probable bounce at landing in case of an inappropriate thrust lever handling during the flare.

Aircraft fitted with modified version of SEC123 with Phase Lift Dump function

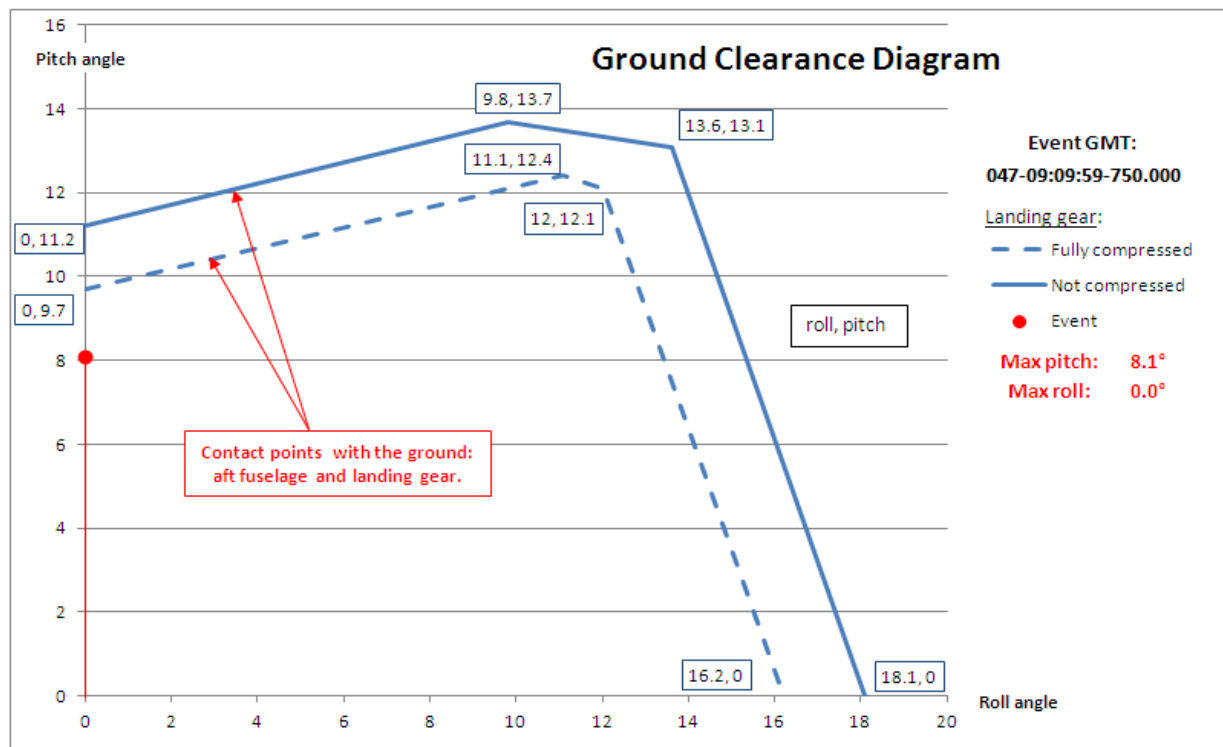
In accordance with the following ground clearance diagram, with the main landing gears fully compressed, the aft fuselage enters in contact with the ground when the pitch angle exceeds +8.1° associated with the full ground spoiler extension significantly reduced the lift and caused the second severe hard landing.

The maximum pitch angle recorded by the DFDR at touchdown (+8.1°) is smaller than the pitch limit indicated by the ground clearance diagram (+9.7°) this probably taking into consideration the resolution of the recorded parameters, the aircraft fuselage flexibility and the aircraft dynamic at touchdown. However, the "DRAINMAST HEATER AFT" message recorded by the PFR at GMT 09:10, the damage report and the damages recorded on the aft belly further to the event enable to confirm that a tail strike occurred at that time.
