**FINAL REPORT ON ACCIDENT TO M/S ALCHEMIST AIRWAYS PVT.  
LTD. KING AIR C-90A AIRCRAFT VT-EQO NEAR KAIR VILLAGE,  
NAJAFGARH, NEW DELHI ON 24.05.2016**

**FINAL INVESTIGATION REPORT ON ACCIDENT OF M/S ALCHEMIST  
AIRWAYS PVT. LTD. KING AIR C-90A AIRCRAFT VT-EQO NEAR  
KAIR VILLAGE, NAJAFGARH, NEW DELHI ON 24.05.2016**

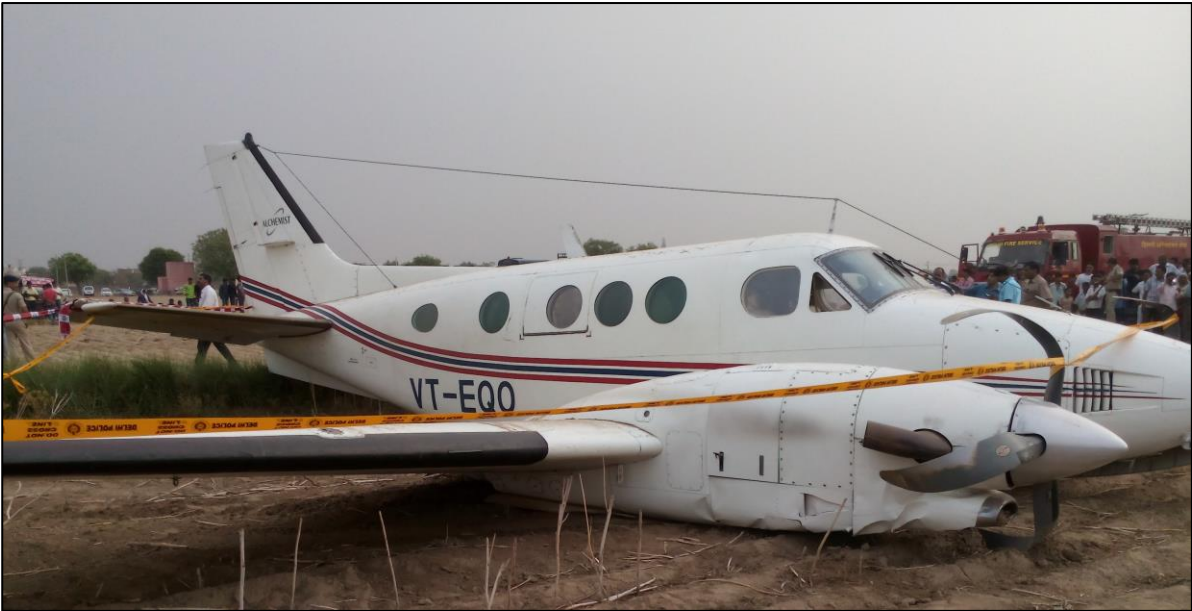
Aircraft forced landed on its landing gear and travelled for about 350 ft as visible by the wheel marks. Thereafter, aircraft hit the road which is almost three feet high. Due to the impact with the road, both main landing gears of the aircraft were damaged.

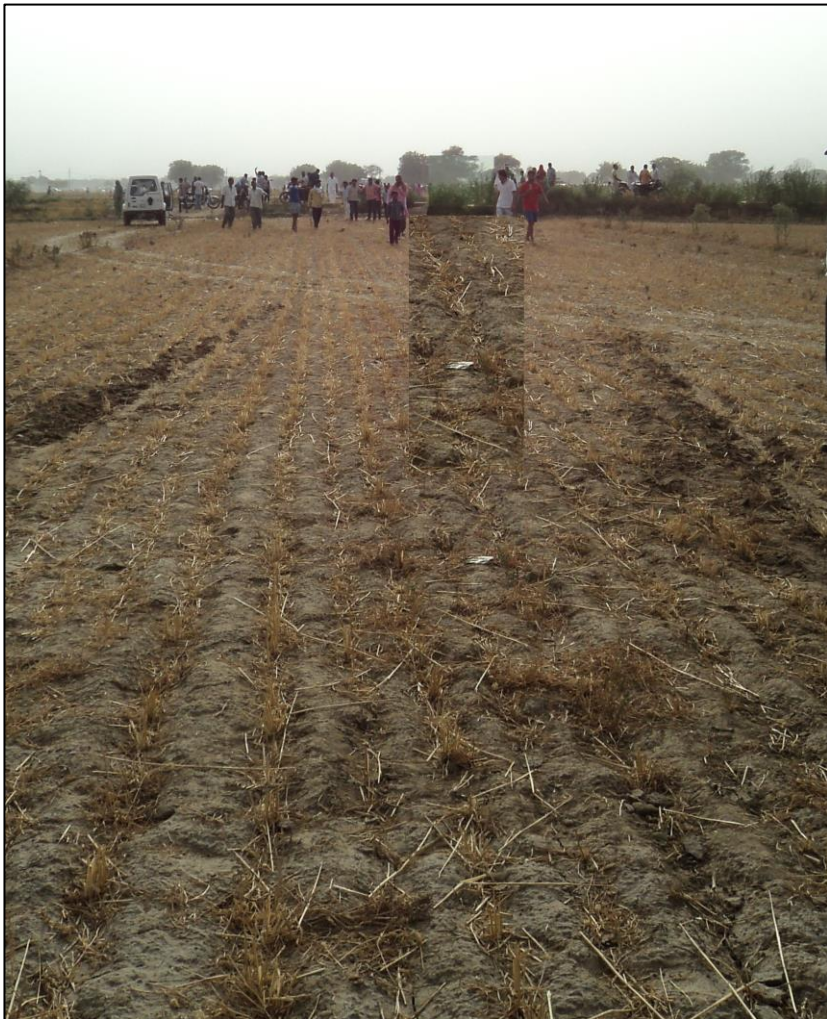
After the impact with the road, aircraft bounced and floated in air for a few seconds before coming to final rest.
