FINAL REPORT ON ACCIDENT INVOLVING
HAWKER 900XP, AIRCRAFT VT-LTA
BELONGING TO TO M/s LARSEN AND
TOUBRO AVIATION LTD AT CHENNAI ON
06/07/2016

Jasbir Singh Larhga
Chairman, Committee of Inquiry

Capt. Nitin Anand
Member, Committee of Inquiry

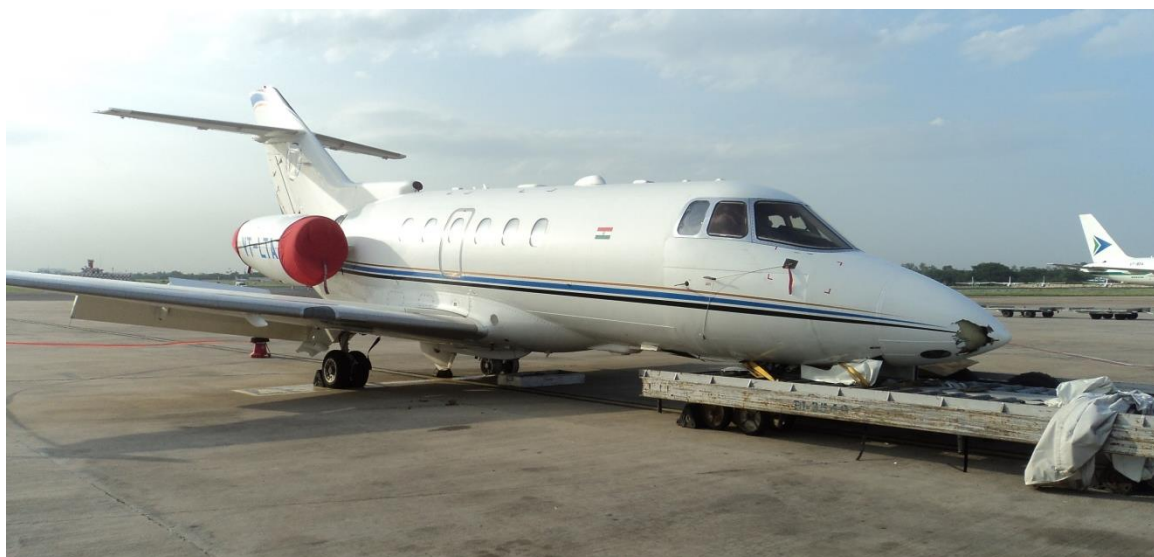
The aircraft suffered substantial damage in the accident. The Nose Radome was damaged due to hitting the edge lights. The Nose LG had sheared off. The nose fuselage under body was found damaged exposing various hydraulic oil lines. Avionics Bay was also damaged. There were several dents on the LH wing leading edge and bottom surface. Apart from that, LH wing tip light was also broken. The flap on the RH wing was also damaged. The LH Main Landing Gear wheel tyre was detached from wheel and found in pieces. MLG hub was completely exposed and damaged.

Fig: 1 Aircraft after Removal from Runway

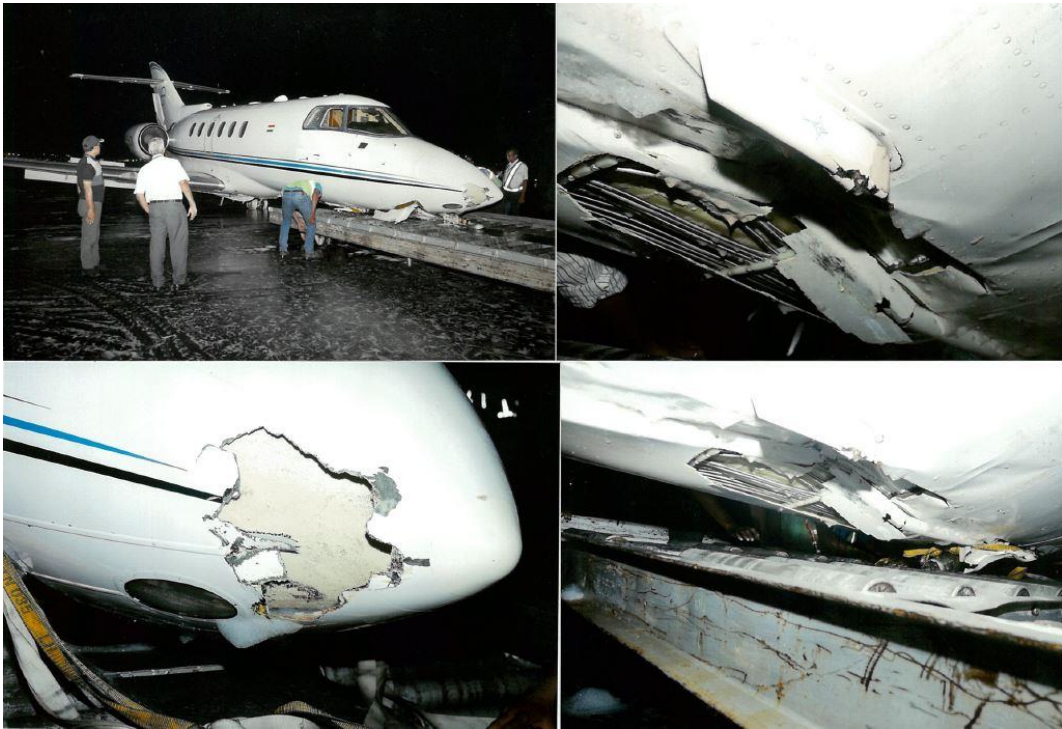
- The lower belly fairing running from Frame #04 to 12 was badly damaged. The metal tubing inside were exposed and damaged. Traces of Hydraulic Fluid leak were observed in the area. The attachment point on the adjacent structure was also damaged.

Fig: 2 Damage to radome and nose section

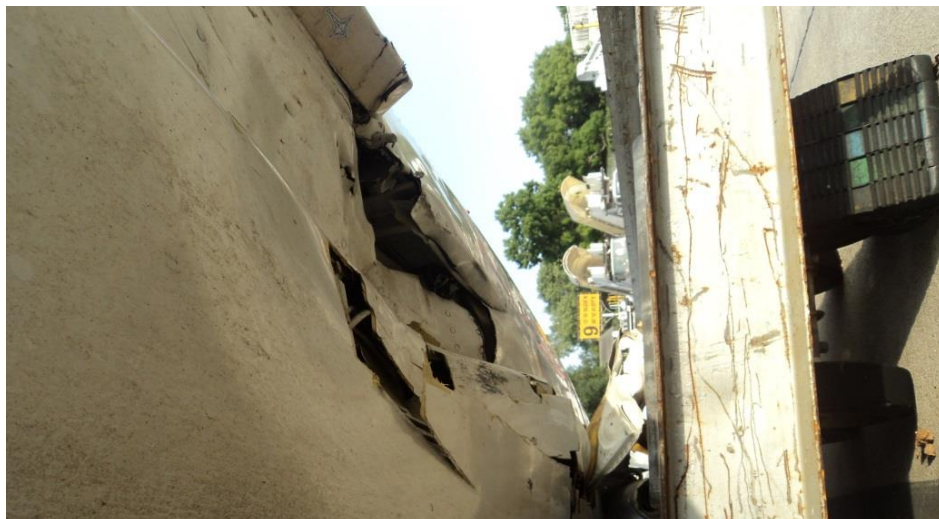
- The LH & RH side door attachment structure also damaged.
- The radome was punctured by impact with the runway edge lights causing a big opening on the right side.
- There were some dent and minor scratches on the bottom side skin between Frame 3 & 4. There was deep penetration between Frame 6 & 8 on lower skin.

Fig: 3 Damage to nose section lower portion

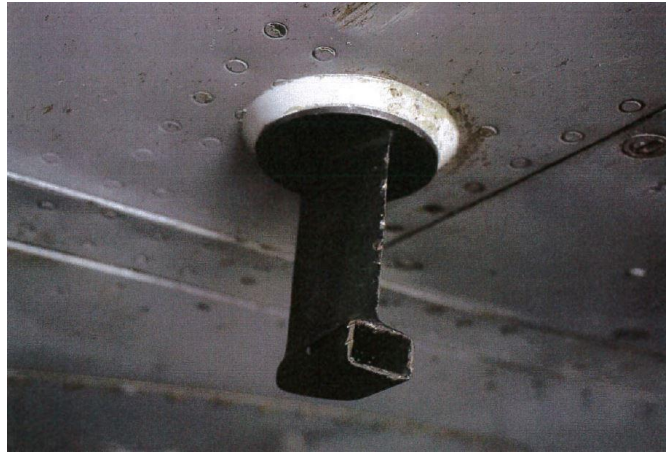
- RH Marker Antenna and adjacent mounting structure were badly damaged.
- The area between Frames 9B to 10A on the bottom structure was badly damaged and there was deep penetration.
- TAT probe was damaged

Fig:4 Damage to TAT probe

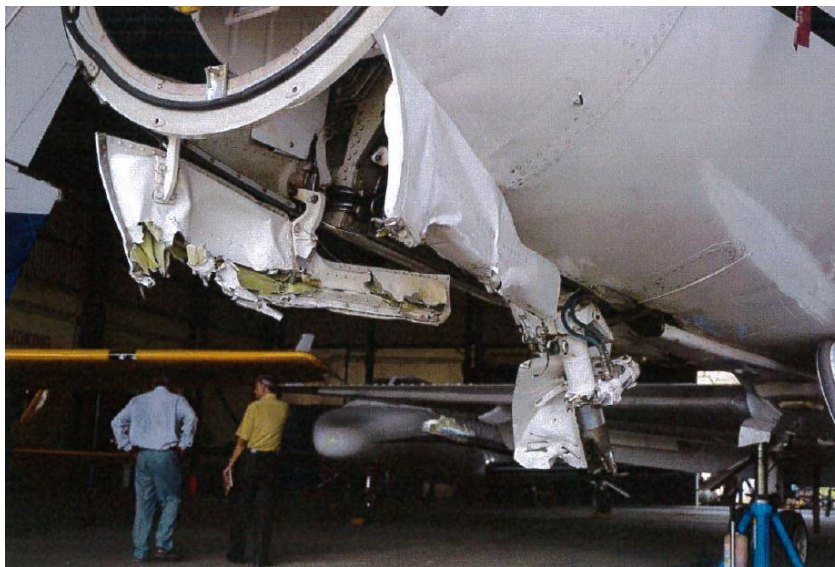
- Nose Landing Gear assembly and lower drag brace were damaged beyond repair. Both LH & RH Side Door and Rear Door were damaged beyond repair.

Fig:5 Damage to NLG and NLG door

3.1.10 Nose Landing gear of the aircraft broke and caused the nose section to impact the ground. The impact resulted in structural damage due to which crew was left with no control over TLC, Airbrakes, rudder etc.

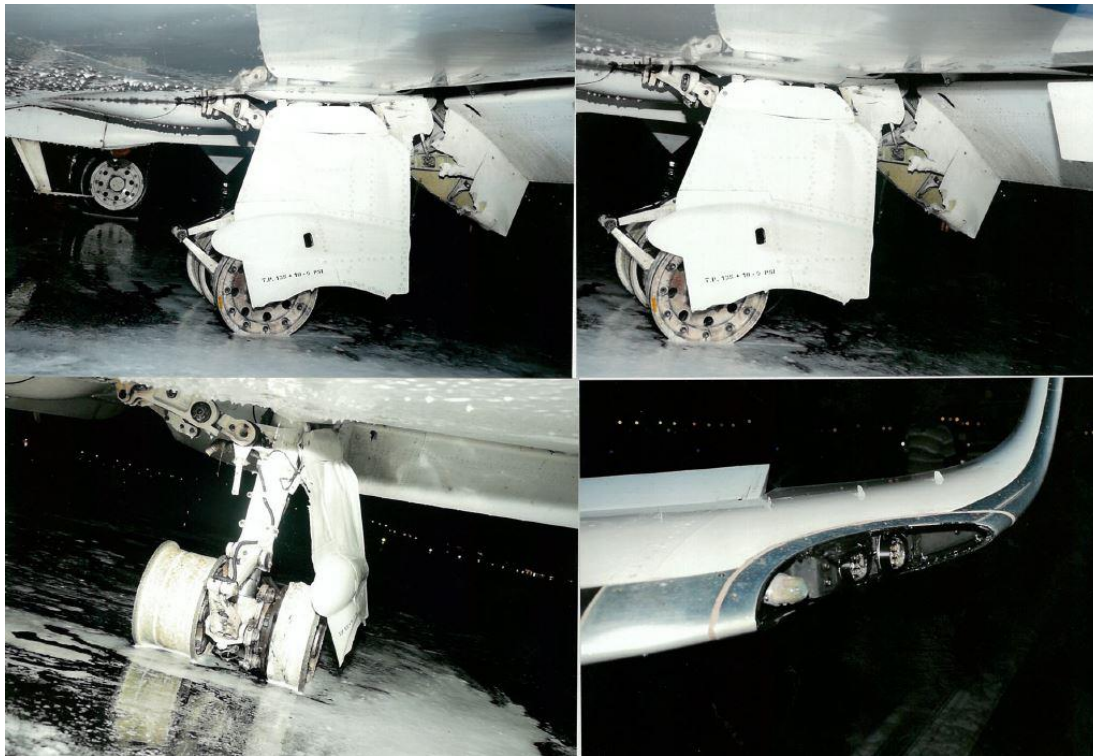
- LH Main Landing Gear inboard and outboard doors were damaged. Outboard door spring strut was broken.
- Both wheel hub of LH landing gear were damaged beyond repair. Tyres were missing. The outboard brake and brake tubing were damaged. The forward Support Bracket had cracked and forward support structure near the actuator attach point was damaged.

Fig:6 Damage to RH MLG and wing tip

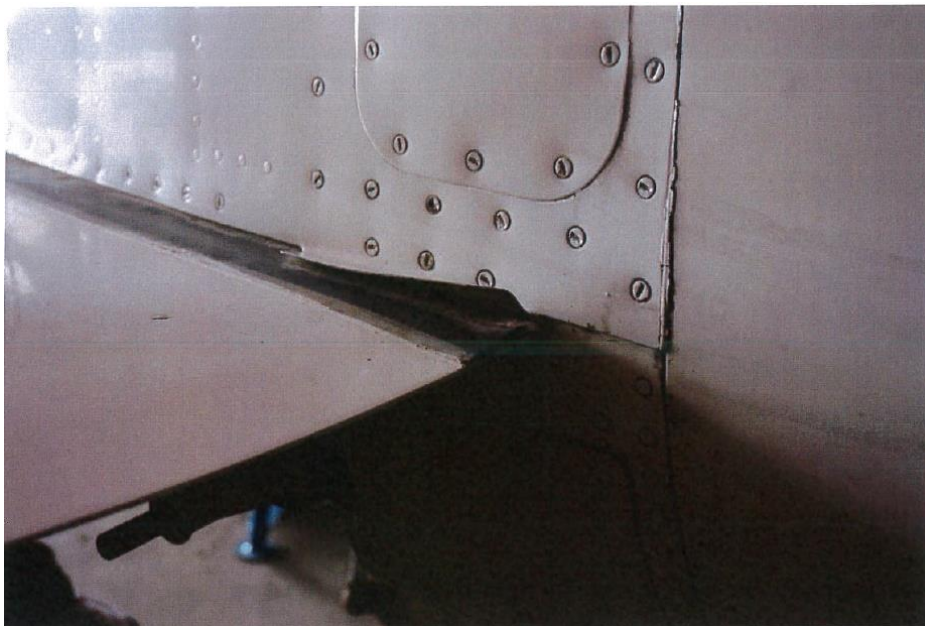
- The LH Flap Drive shaft from Flap Actuator to Wheel well was broken, Flap Actuator Fairing was also damaged.
- LH Wing Trailing Edge Lower Fairing between Spoiler and Flap Actuator was deformed and damage. The LH winglet static wicks were missing and Wing tip Light assembly and lense was broken.

Fig:7 Damage to LH wing

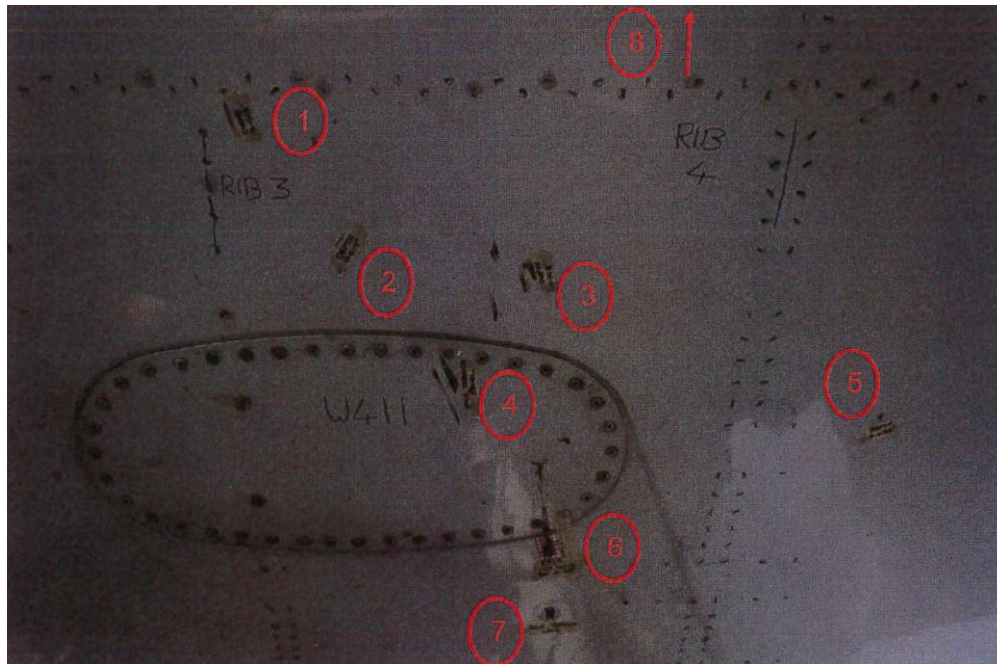
- LH Wing outer most manhole panel had got deep dent and chipped. Aft of this manhole, wing lower skin had got chipped. There were 6 minor chips in the lower skin of between Ribs 3 and 4 and 1 chip between Rib 4 and 5.

Fig:8 Damages on LH wing

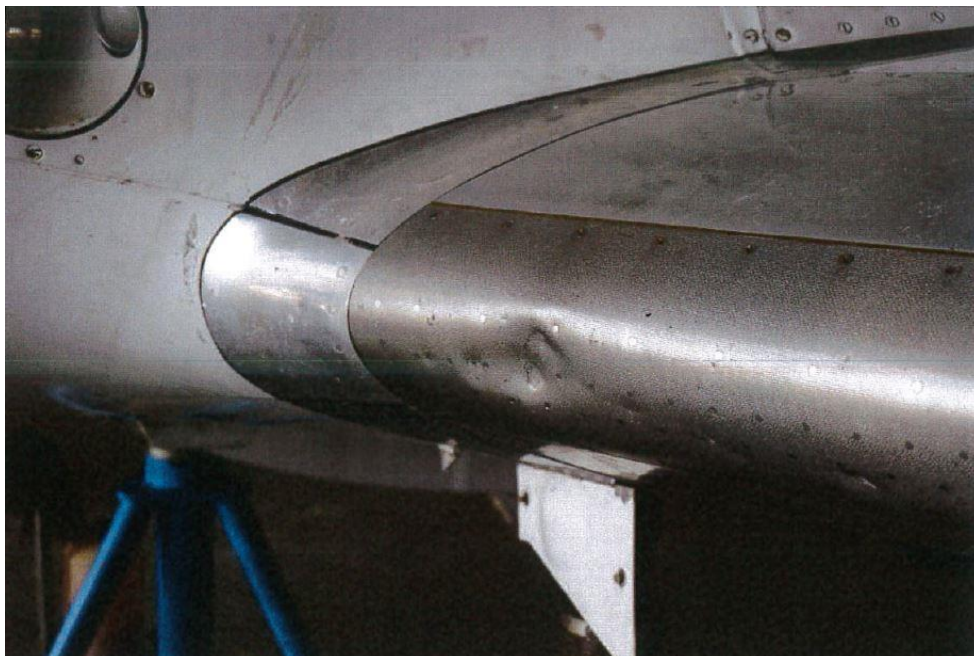
- LH Wing inner most TKS Panel had deep dent and there were many scratches and dents on the top and bottom surface of the leading edge.

Fig:9 Damage to TKS panel of LH wing

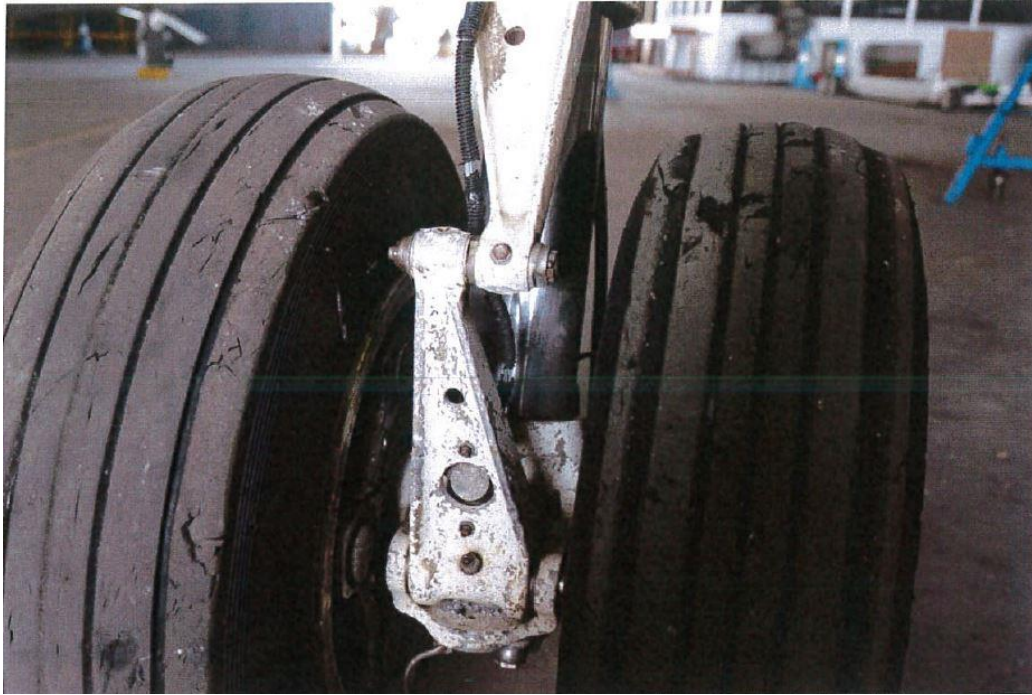
- Both the tyres on RH Main Landing Gear (MLG) were damaged and had cut marks. The brake lines were damaged and leaking. There was a minor scratch on the outboard Main Landing Gear door.

Fig:10 Damage to the RH MLG tyres

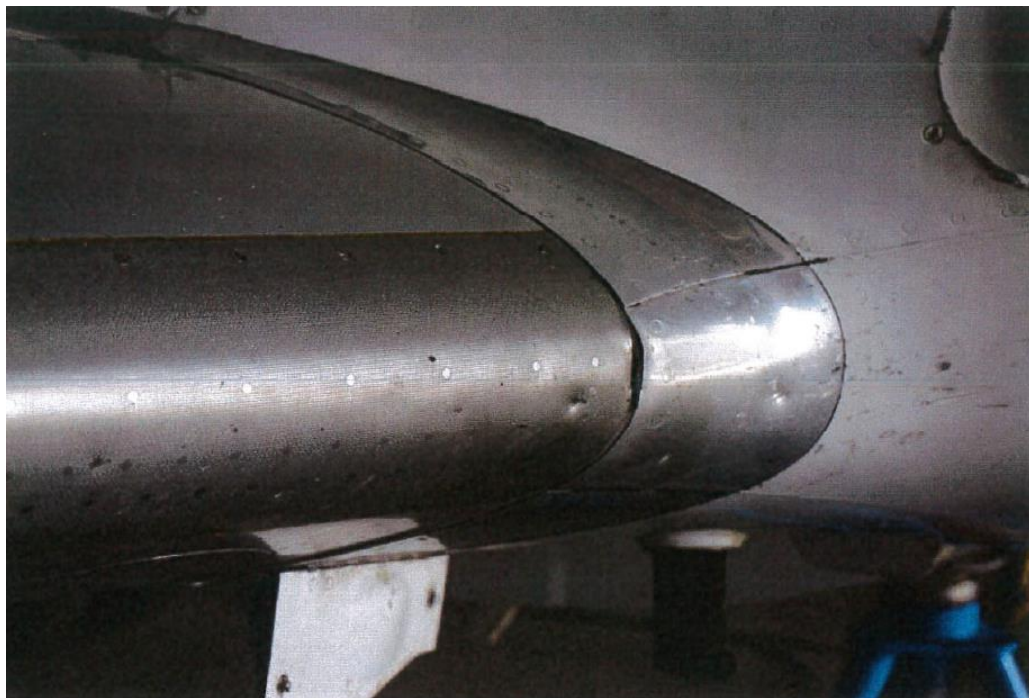
- RH Wing attach fairing leading edges had minor dents with scratches. Dent was also observed on the inboard of innermost TKS panel. Top winglet static wick was missing along with the base.

Fig:11 Damage to TKS panel of RH wing

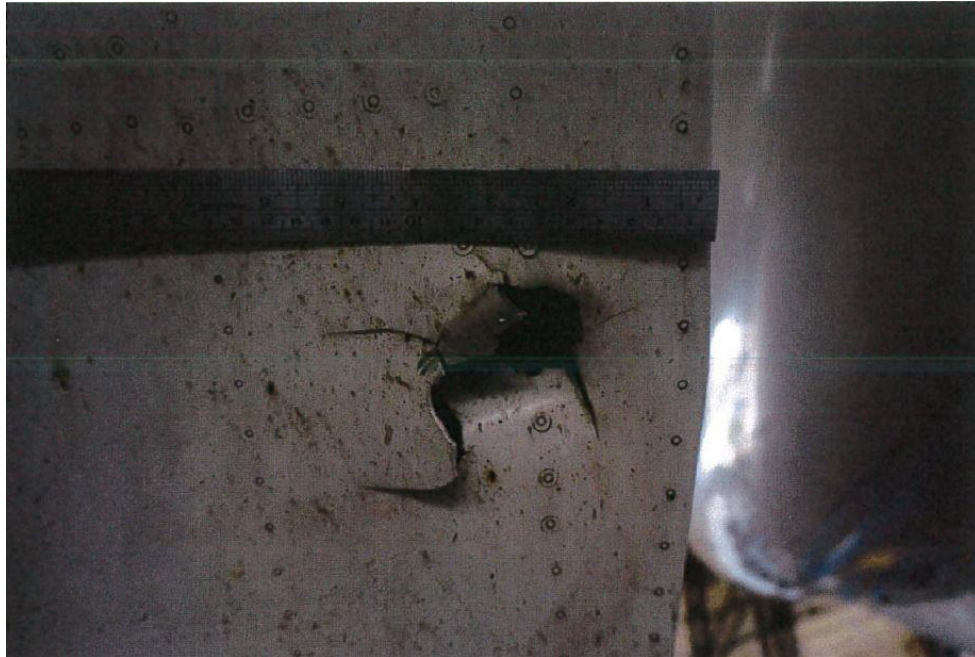
- Inboard section of RH Flap (I/B of Flap Actuator) had hole through the top and bottom skin. Also the trailing edge has got dent and minor crack

Fig:12 Damage to RH flap

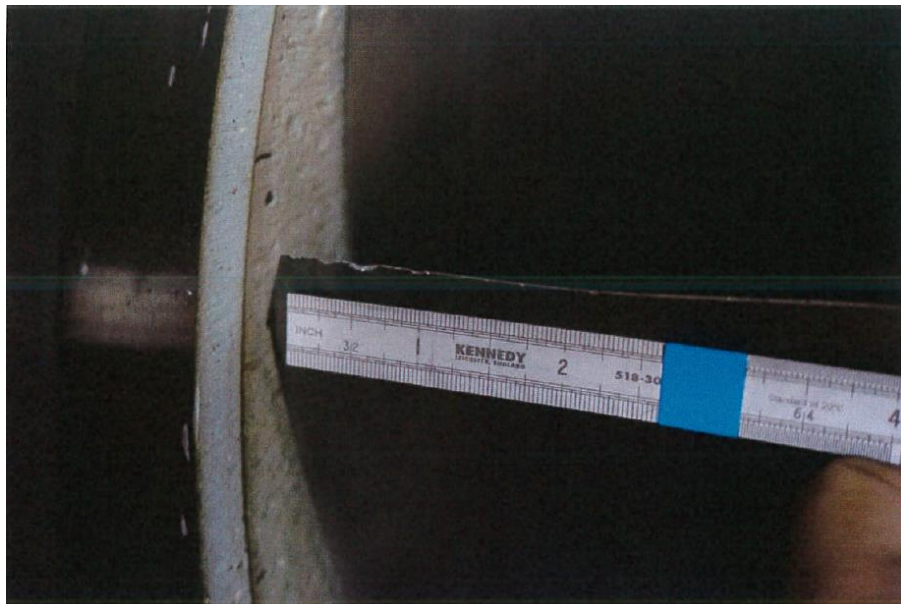
- Minor nick marks were seen on fan rotor blades of LH Engine.
- The fan rotor blades of RH Engine had got minor nicks and 04 blades were bent at the tip.
- Acoustic Liner of the Fan Rotor Blade has got minor damage and traces of Oil were found on the inner fan duct.

Fig:13 Damage to the RH engine blades

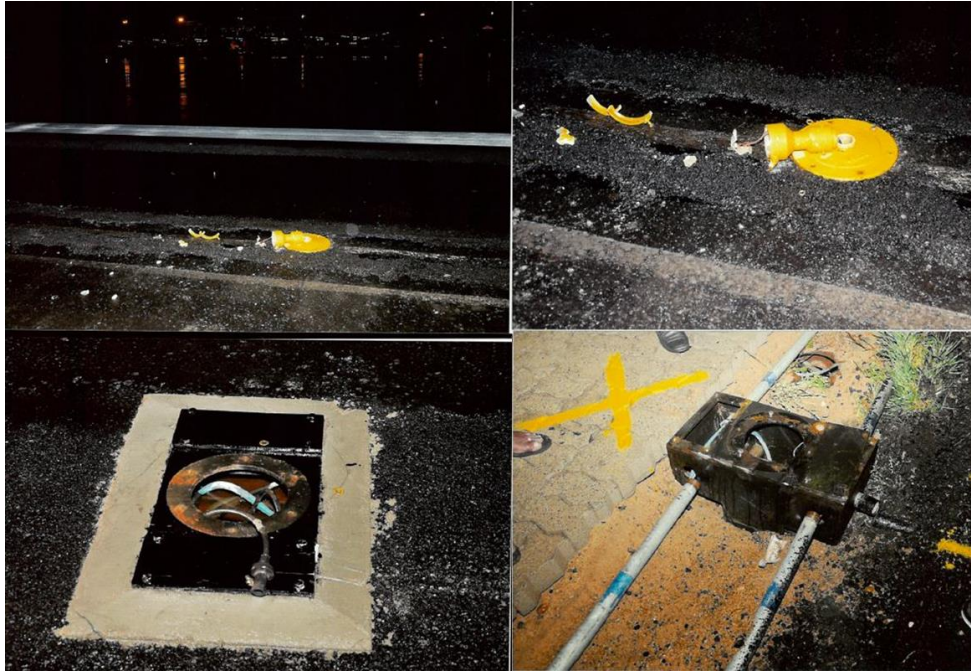
Apart from the damage caused to the aircraft, 13 runway edge lights were broken due to impact with the aircraft.

Fig:14 Broken edge lights and junction box

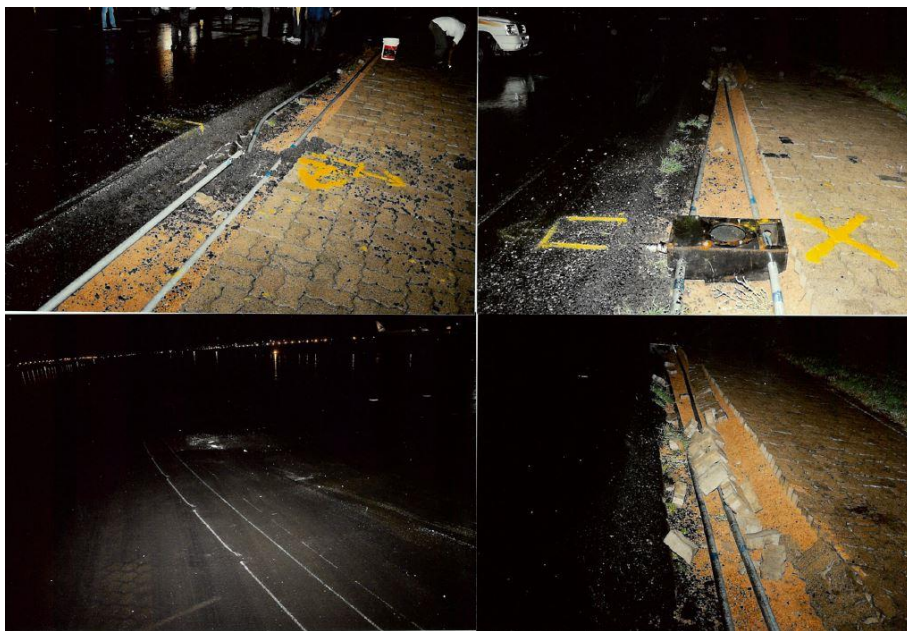
Runway widening work was in progress and aircraft went over surface which was still under construction. Aircraft tyres went over electrical conduits and junction box causing them to get damaged and also causing the tyres to get cut and burst.

Fig:15 Damage to underconstruction pavements and wire conduits
