**FINAL INVESTIGATION REPORT ON ACCIDENT
TO AMAN AVIATION & AEROSPACE
SOLUTIONS (P) LTD.**

**ROBINSON R-44 HELICOPTER VT-PHB
ON 11-12-2016 NEAR JUHU, MUMBAI**

**AIRCRAFT ACCIDENT INVESTIGATION BUREAU
MINISTRY OF CIVIL AVIATION
GOVERNMENT OF INDIA**

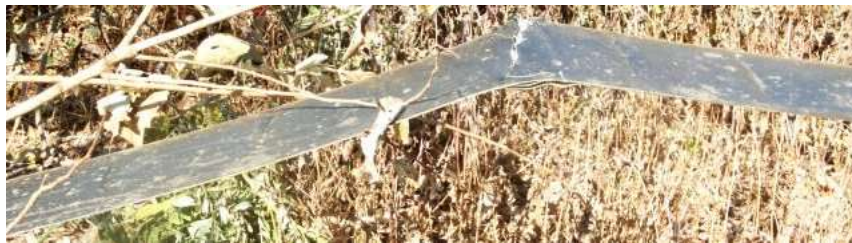
- ✚ The cockpit was completely destroyed and burnt. All the cockpit instruments were burnt.
- ✚ The cyclic/ collective were found dislodged from its mount and were found broken.
- ✚ The rotor blades were intact but one of the rotor blades was found cracked at 40% span from root section and the other was found having dents at the lower surface and delaminated at various sections throughout its span.

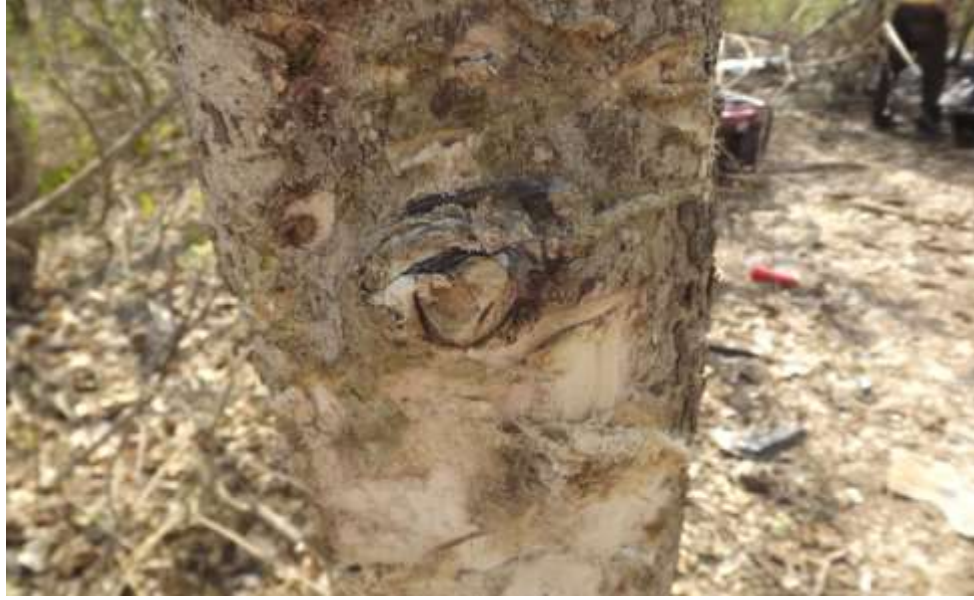
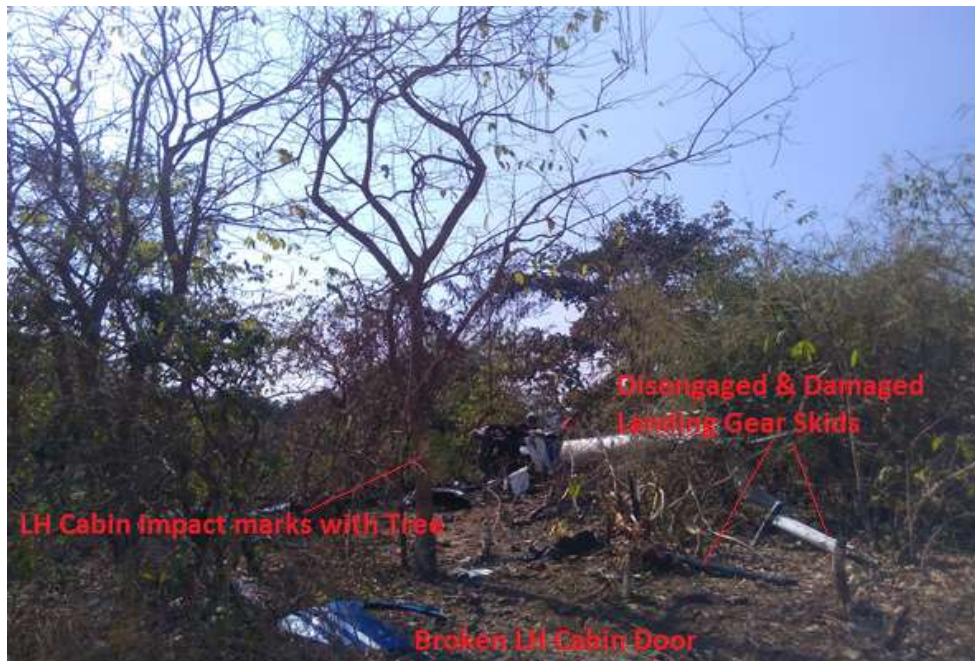
As per the evidences collected and inspection of the accident site the helicopter impacted the trees. The helicopter left side cabin hit one of the trees as evident from the glass pieces found stuck on the tree and a broken part of the cabin door was found lying alongside the tree.

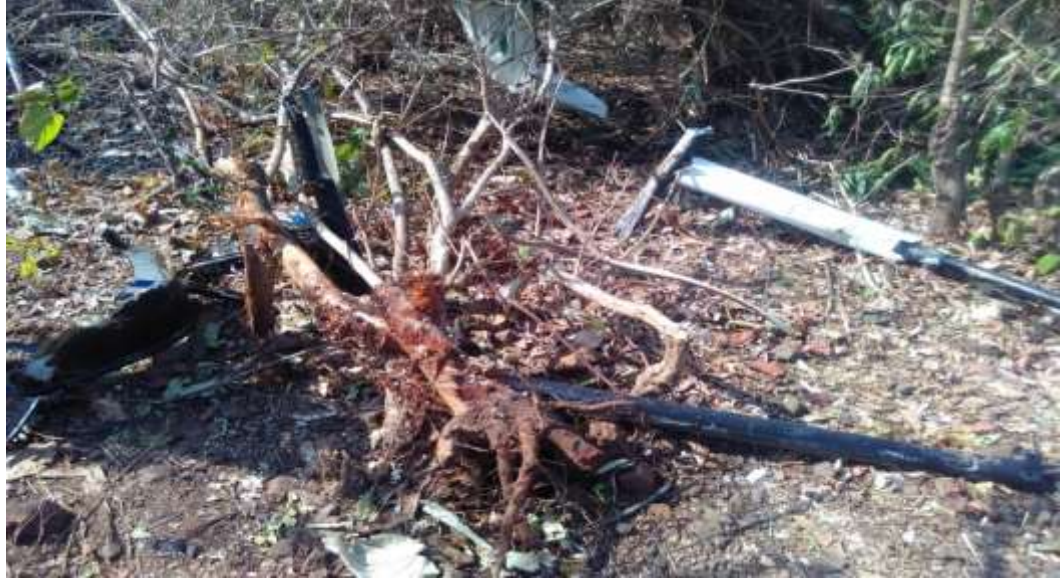
The helicopter turned to its right side after hitting trees as landing gear skids impacted the tree. Finally, the helicopter impacted the ground on its right and immediately caught fire.

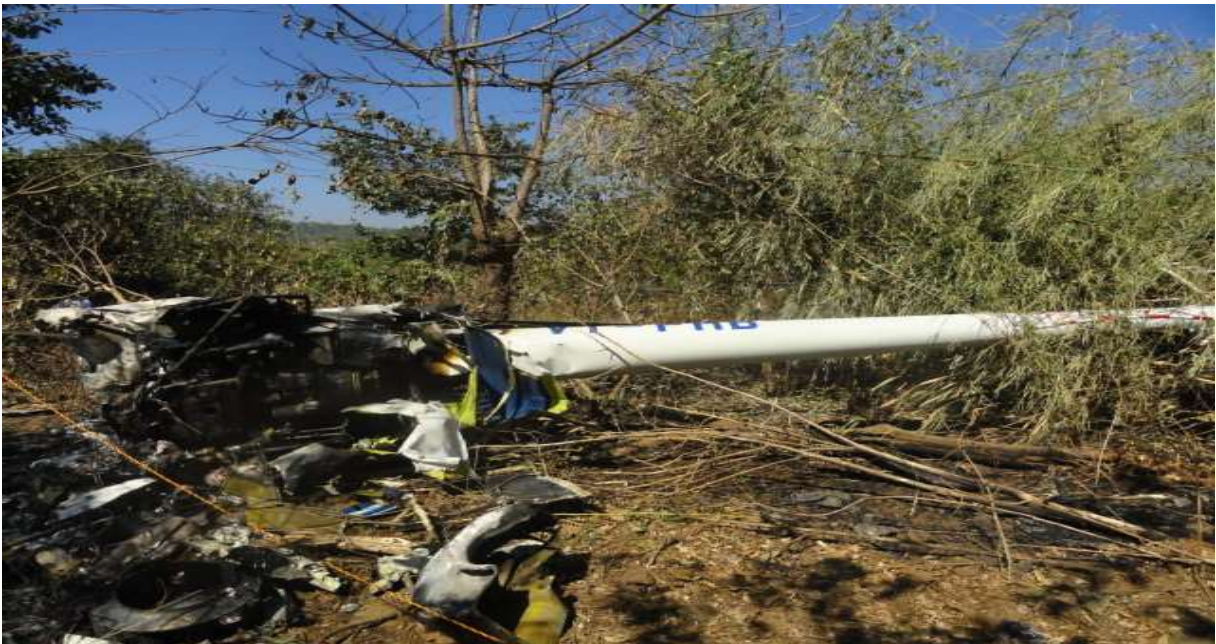
- ✚ Wreckage found lying on ground on RH side.
- ✚ Helicopter found lying on ground facing south and tail on north side.

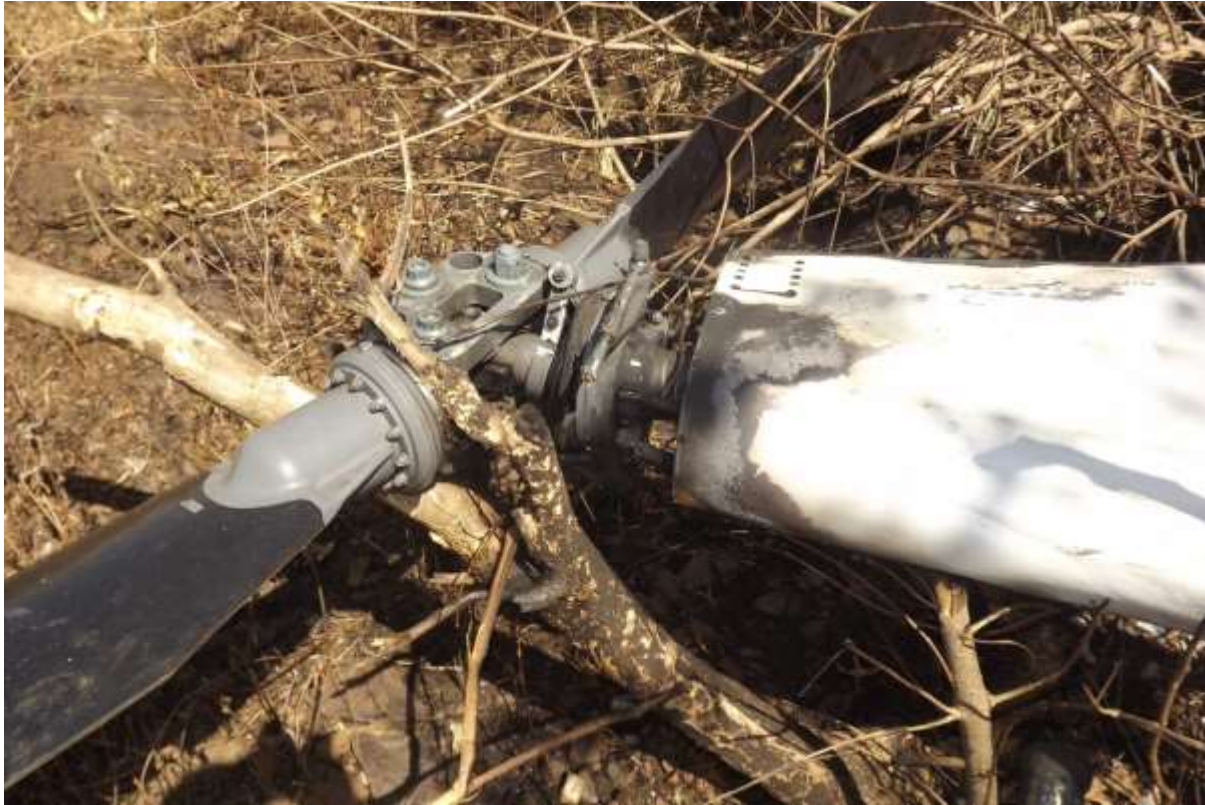
MRH got entangled with a tree and came down by uprooting the tree.

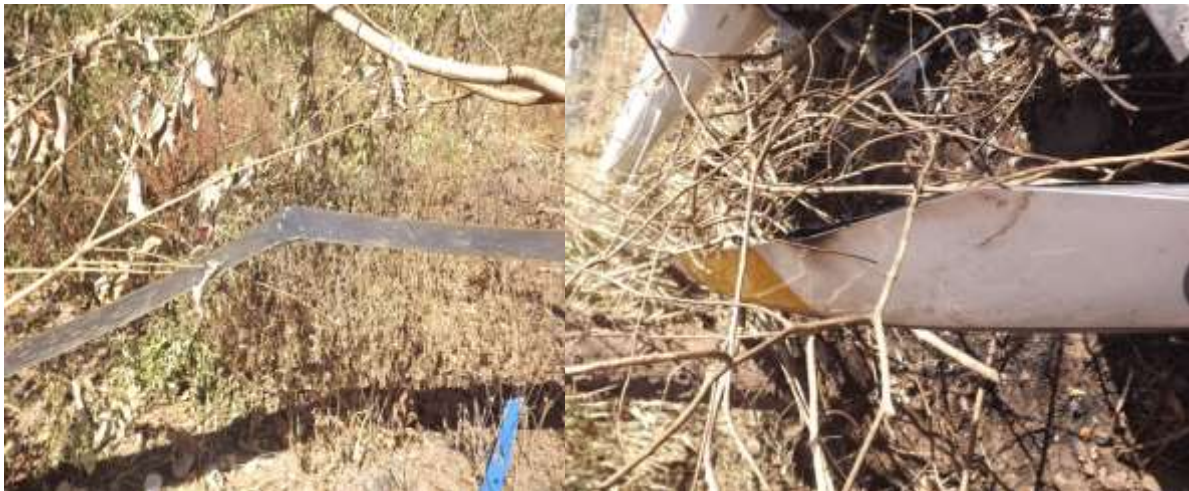
Both main rotor blades damaged due to impact but stay connected on mast hub.

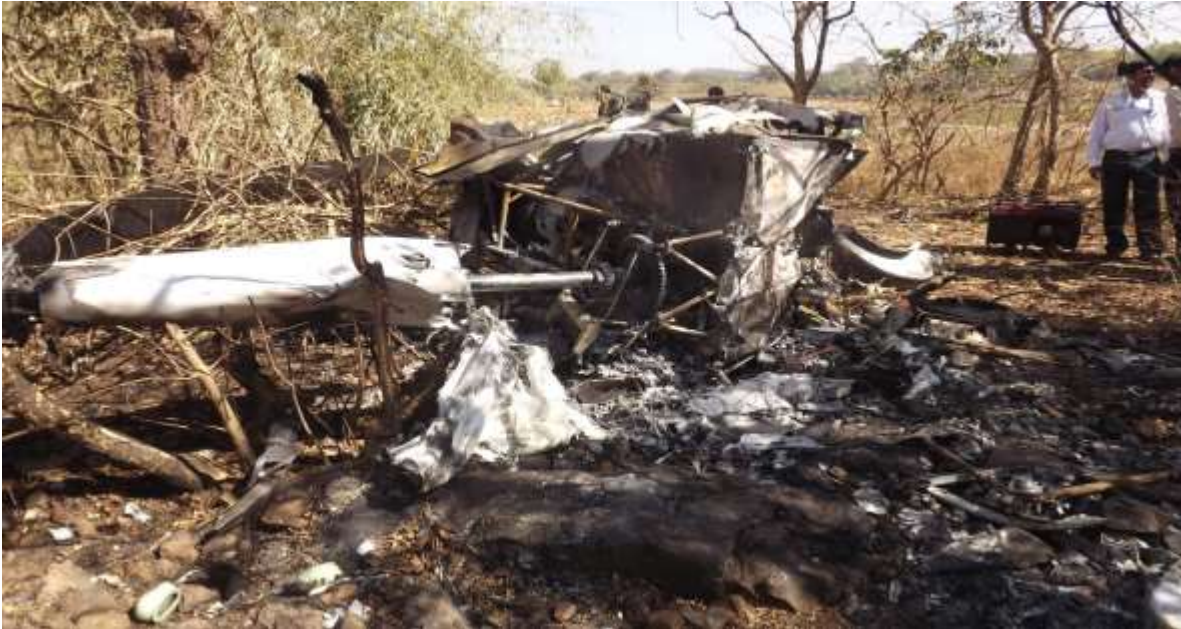
Front part (Cockpit/Cabin) of the helicopter completely burnt.

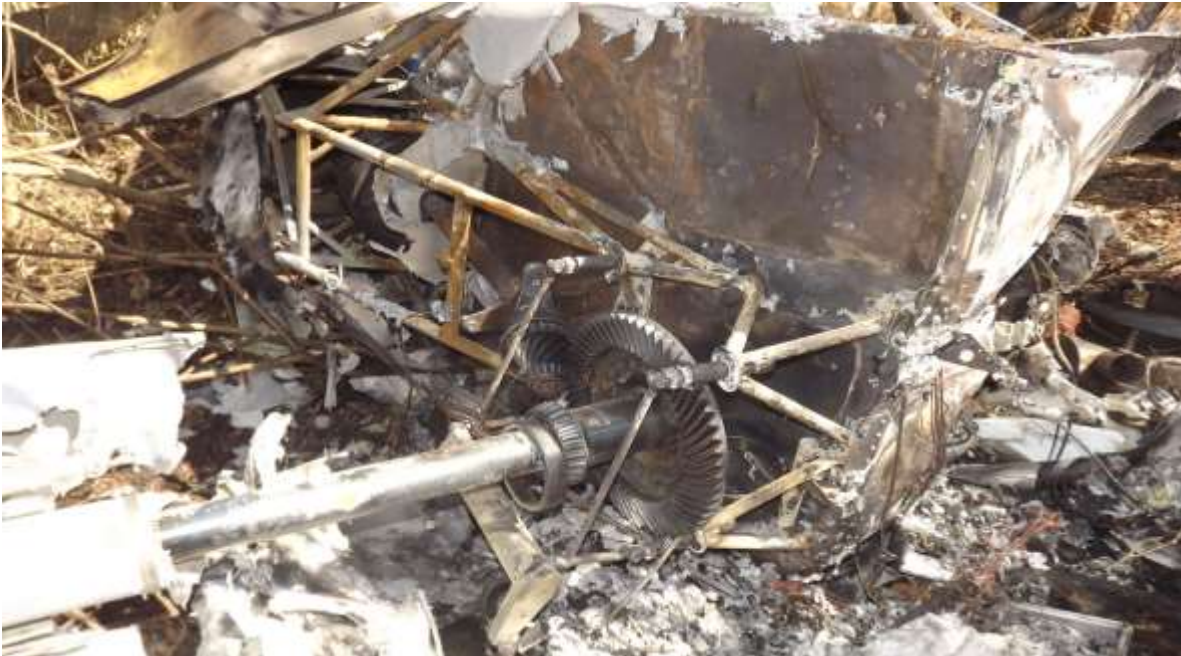
- ✚ Passenger and crew deck area of the helicopter found burnt and missing.
- ✚ Small pieces of wreckage found scattered all around.
- ✚ Parts of the trees found burnt due to wreckage fire.
- ✚ MGB cowlings melted and gears visible.

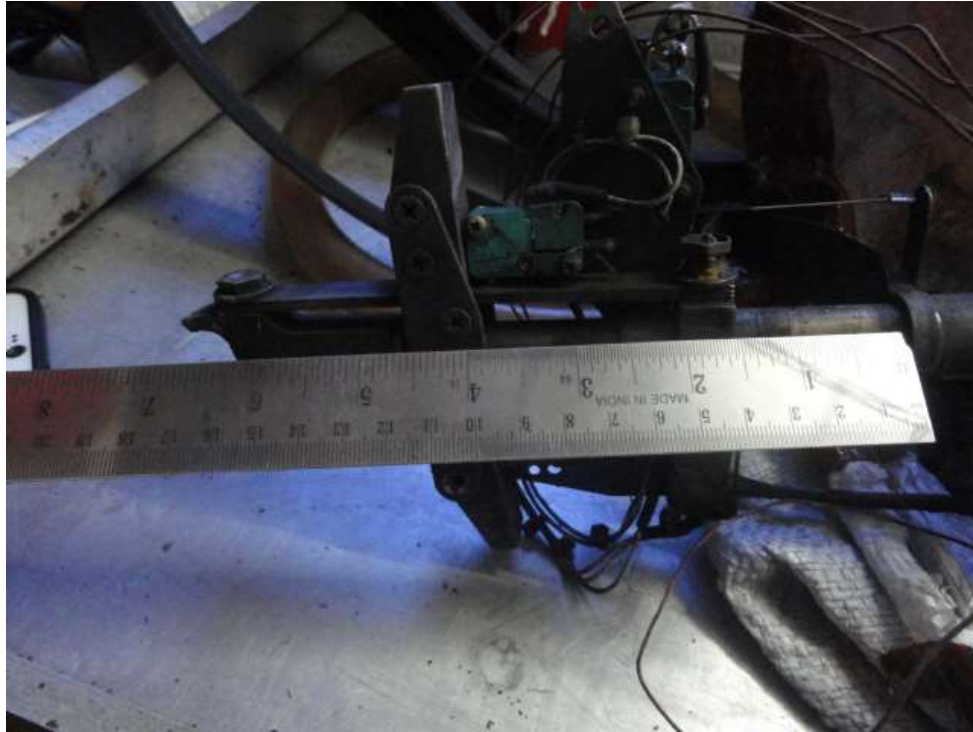
- ✚ MR mast fairing damaged, push pull tubes for cyclic and collective burnt and broken due to impact.
- ✚ Clutch assembly burnt and broken due to impact, actuator motor found in full extended position, upper limit switch & restraint found intact in place.

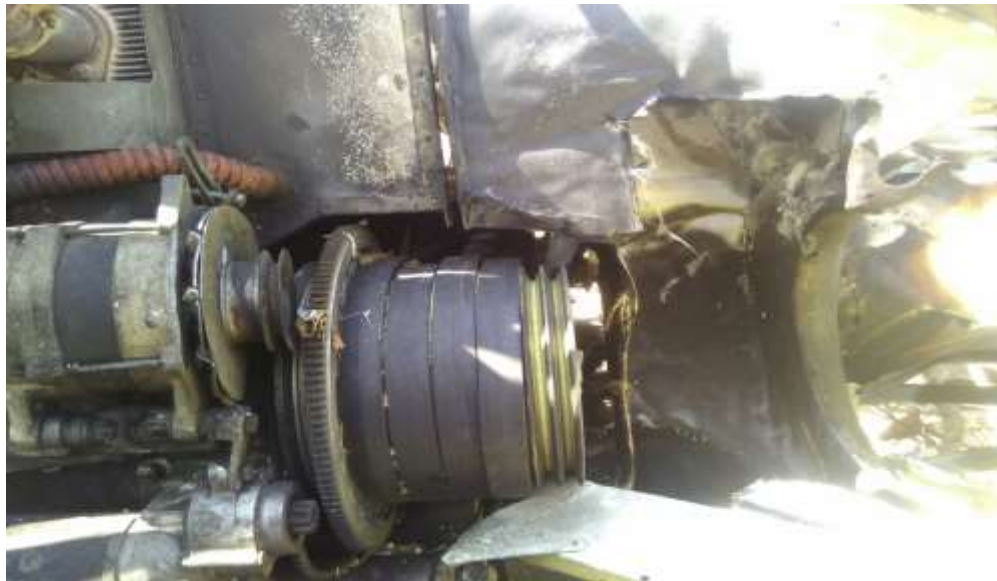
- ✚ Clutch V belts (drive belts) were found intact but burnt from upper sheave.

After the accident, the clutch V belts (drive belts) were found intact at lower engine sheave but had burnt from upper sheave. The grooves were clear and had no indication of relative rubbing of the V belts. As the belts have burnt no further investigation could be carried out on the belts but physical condition appeared to be normal.

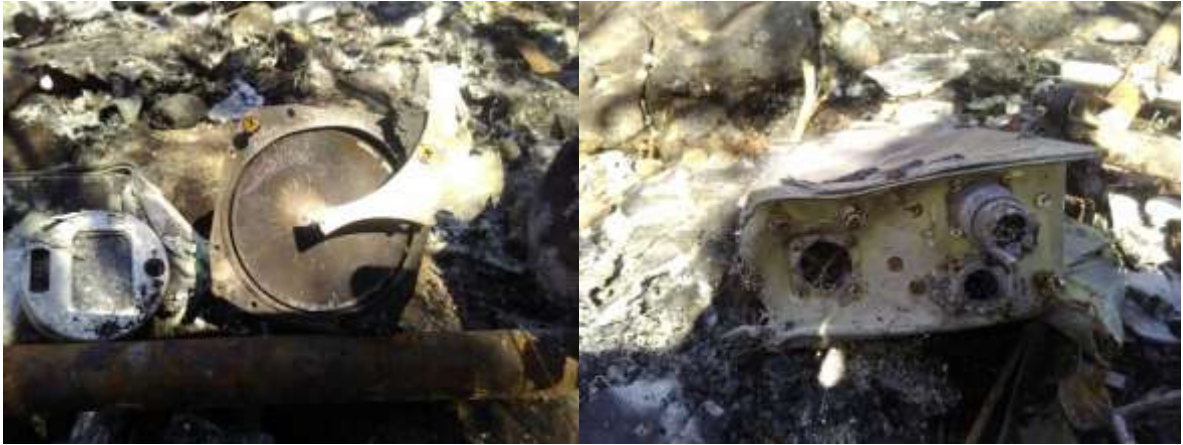
- ✚ Complete cockpit instrument panel radio equipment's found damaged and burnt. It was not possible to take instrument readings.

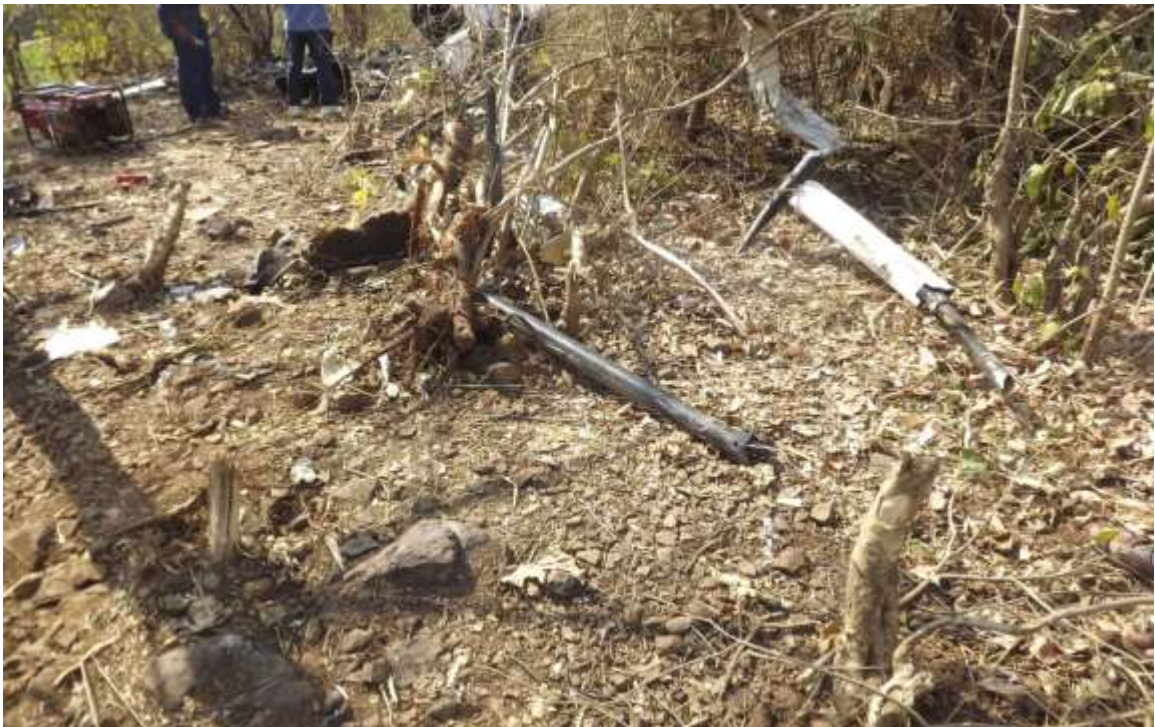
- ✚ All airframe parts, doors, panels, exhaust pipe, induction tubes, carburetor broken & separated from the airframe and engine.

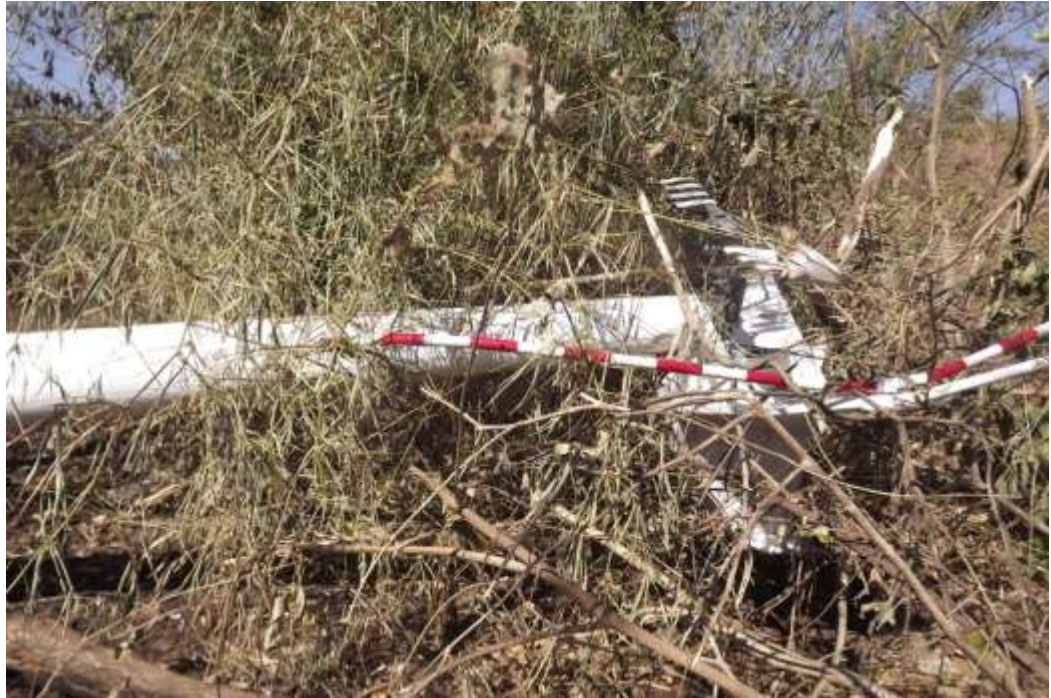
- ✚ Landing gear skids broken and separated in pieces due to impact with ground/trees.
- ✚ Tail rotor gear box & tail rotor hub found intact on tail boom with no apparent signs of damage.

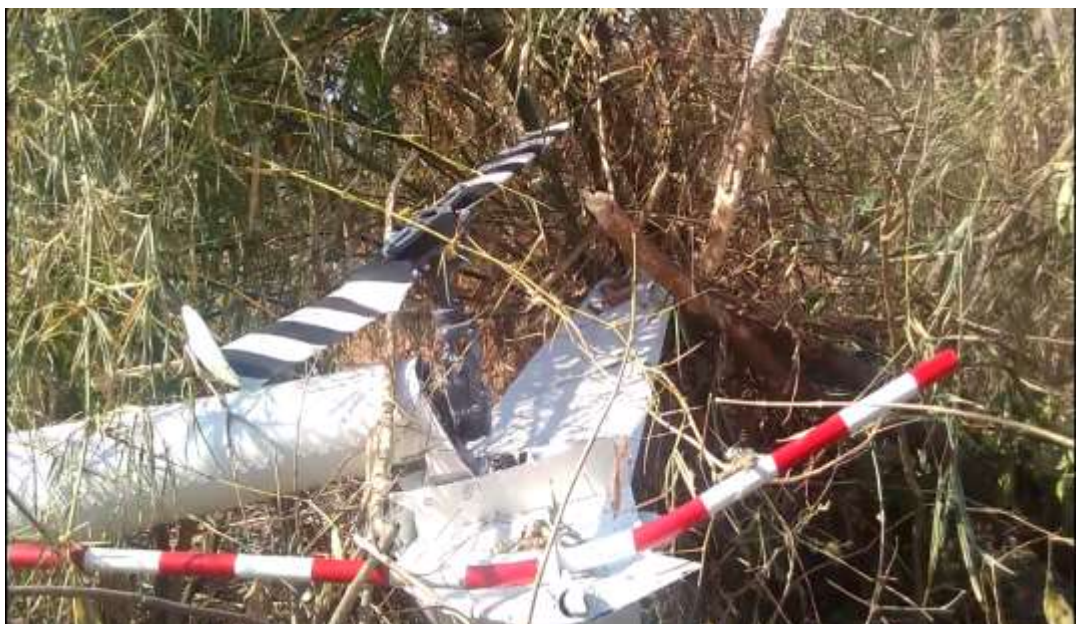
- ✚ One Tail Rotor Blade (TRB) found intact and undamaged, second TRB found intact with bent on the tip due to impact with tree.

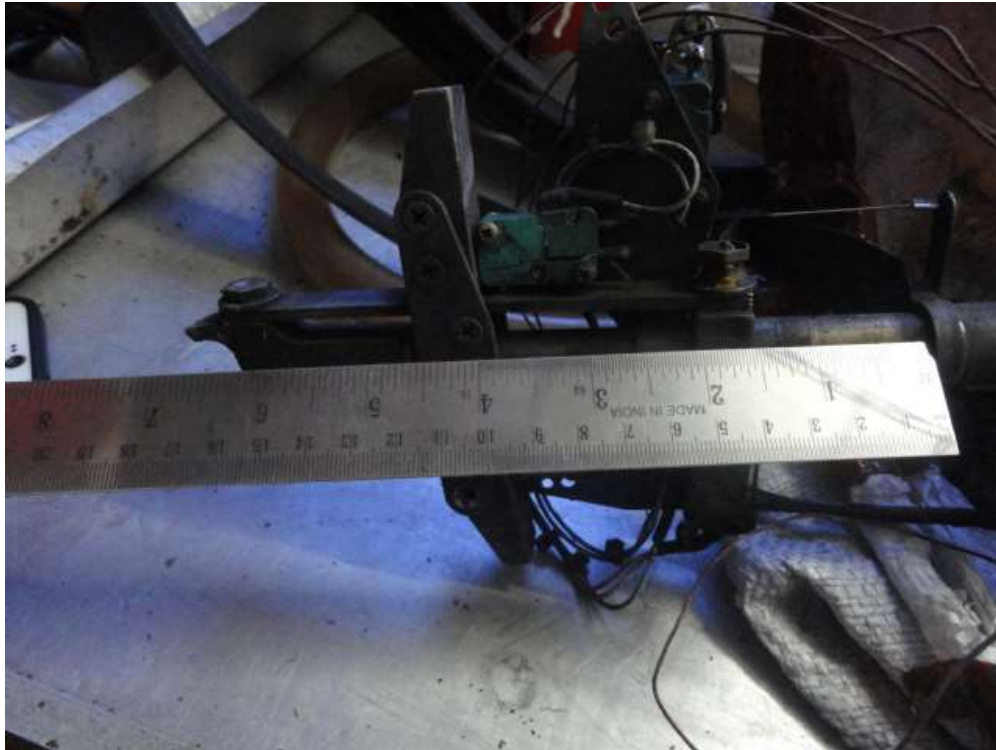
2.4.4 Clutch mechanism

The clutch unit (actuator mechanism) was found separated from the helicopter after the accident. The actuator was stuck at the last position before the impact which was measured and was found 1.60 inches which corresponds to the fully extended position which also indicates there might not have been any relative movement between the V-belts and the pulley.
