FINAL REPORT ON SERIOUS INCIDENT INVOLVING
M/S INDIGO AIRCRAFT VT-IFP (A320)
AND
M/S KUWAIT AIRWAYS AIRCRAFT 9K-APA (A330-200)
AT
MUMBAI
ON
30.11.2016

**FINAL REPORT ON SERIOUS INCIDENT INVOLVING M/S INDIGO
AIRCRAFT VT – IFP (A320) AND KUWAIT AIRWAYS AIRCRAFT
9K-APA (A330-200) AT MUMBAI ON 30.11.2016**

1. Aircraft :	Aircraft 1 M/s Indigo
	Type : Airbus
	Model : A320
	Nationality : INDIAN
	Registration : VT-IFP
	Aircraft 2 M/s Kuwait Airways
	Type : Airbus
	Model : A330-200
	Nationality : Kuwait
	Registration : 9K-APA
2. Date of occurrence :	30.11.2016
3. Time :	0001 UTC
4. Last point of Departure :	Aircraft 1 : Mumbai
	Aircraft 2 : Kuwait
5. Point of intended landing :	Aircraft 1 : Jaipur
	Aircraft 2 : Mumbai
6. Geographical location :	19° 05' 30" N & 072° 51' 58" E
7. Type of operation :	SCHEDULED
8. Phase of operation :	Taxi-In / Taxi out
9. Type of occurrence :	Ground Collision
10. Injury to persons :	NIL

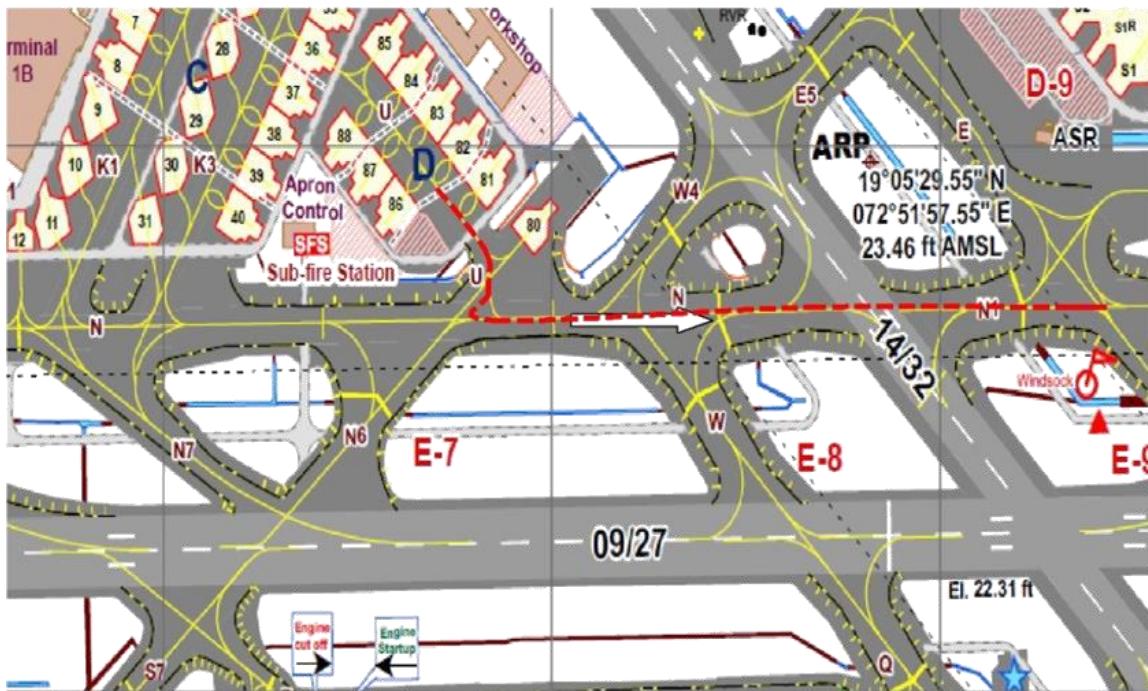
Taxi route followed by aircraft 1 for departure

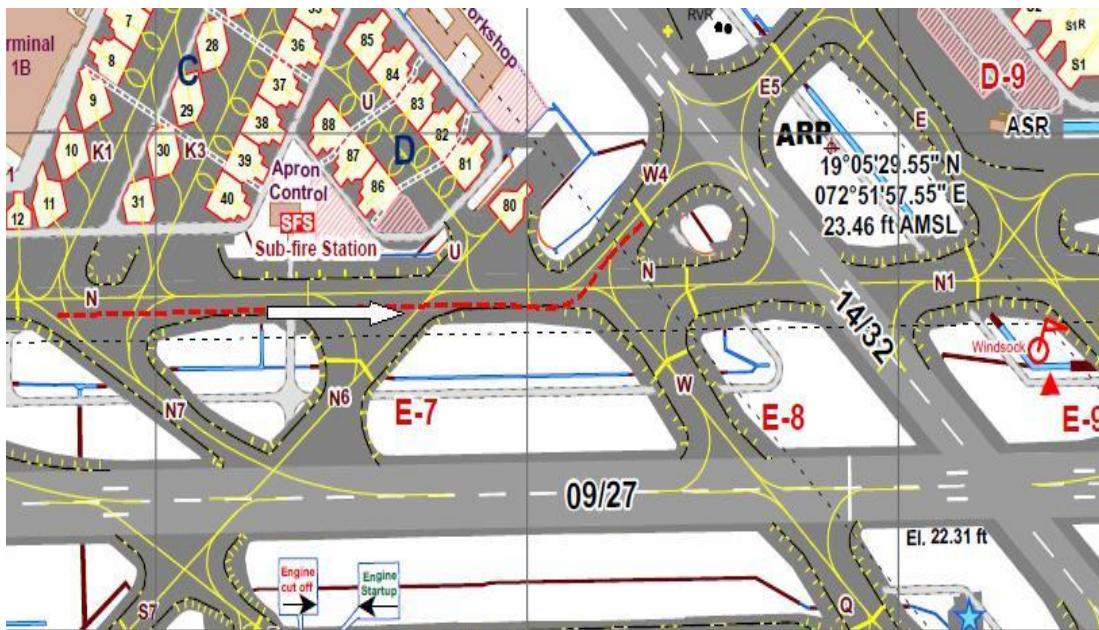
Taxi route followed by aircraft 2 after landing

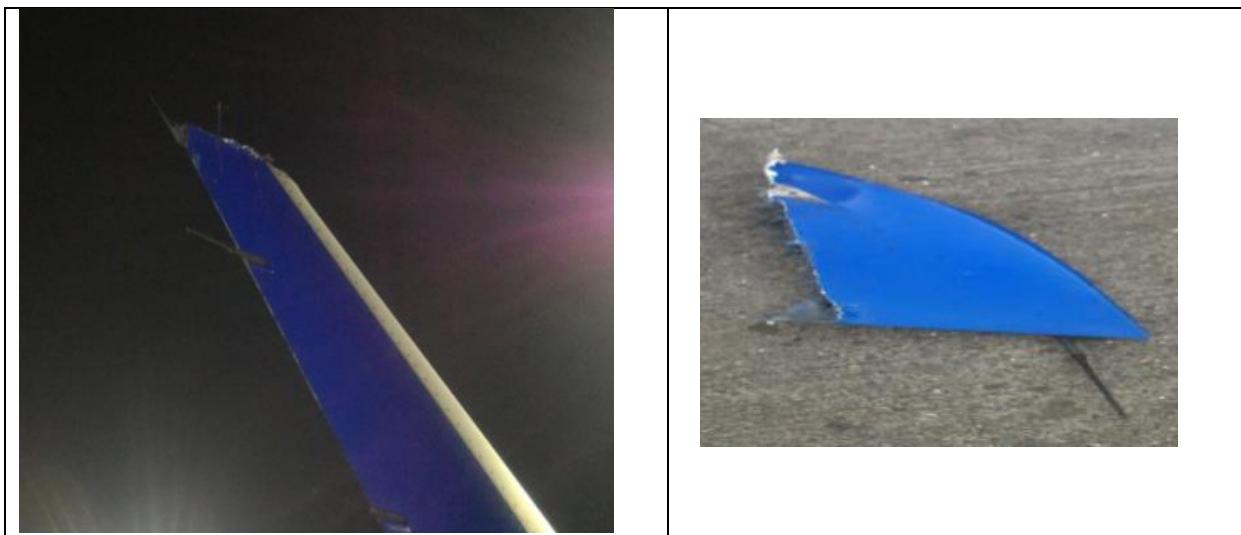
Aircraft 1

Upper section of LH Sharklet was found sheared off from the main wing structure. Leading Edge stainless steel cap of sharklet was damaged from the top edge. Both outer and inner skin of the sharklet was damaged.

The damaged LH Wing sharklet of aircraft 1 was removed and inspection was performed to ensure no other structure other than the sharklet has been affected by the impact. RIB 27 attachment region was inspected for damage or signs of pulled rivets and there were no damages. The aircraft 2 was also inspected and after maintenance action departed Mumbai CSIA.

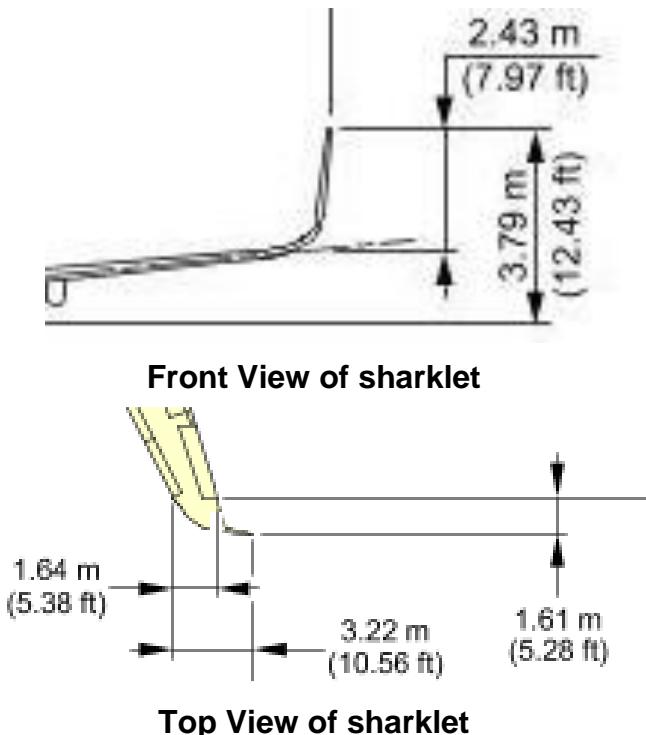
So, for aircraft such as the aircraft 1, the addition of sharklet / winglets does increase the wing dimensions of the aircraft. However, they do not extend upwards perpendicular to the horizontal plane, but rather extend upwards, backwards and outwards from the wing itself. Specific to the aircraft 1, the winglet extends the wing by 1.61 m from the wing joint and rises to a height of 2.43m above the wing.

In case of wings with sharklets, the increase in height of the wing tips is significant as it extends above the height of the aircraft's horizontal stabiliser. Prior to the introduction of sharklets / winglets, wingtips would have had sufficient vertical clearance to pass underneath the horizontal stabilizer of the same aircraft type.

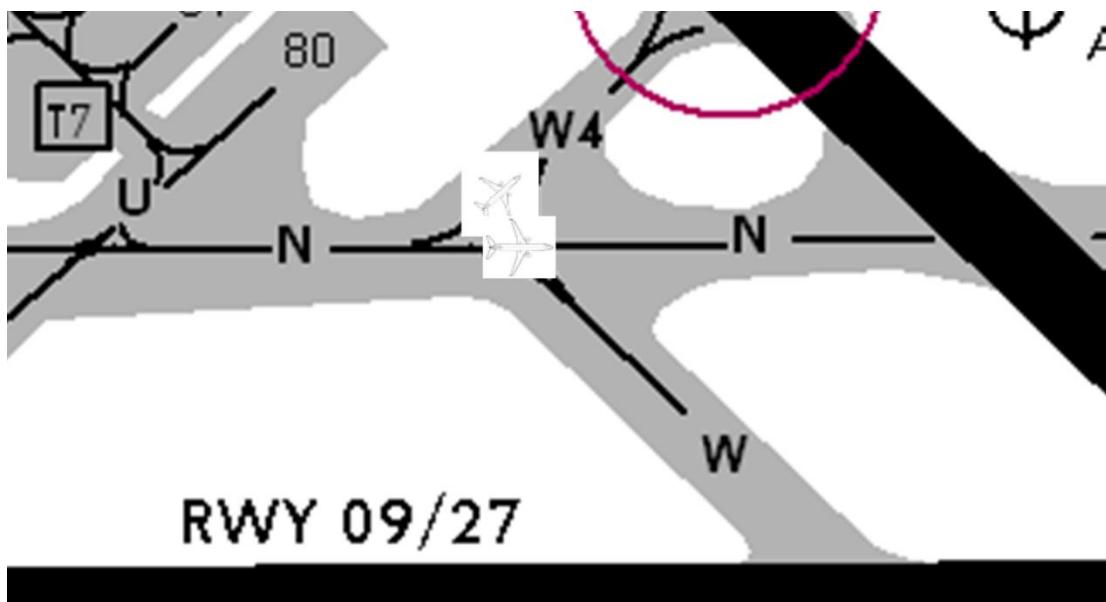
rear of any holding aircraft cannot be guaranteed. The position of the two aircraft at the time when the wings came in contact with each other is as shown in the following figure:

The taxiing restriction were in place as per the AIP(for VABB) dated 01 April 2012 AD 2.20 para 4.2. As per the restrictions "*Aircraft holding on TWY W4 at holding position RWY 14/32 will prohibit aircraft taxiing on TWY N.*"

As per the Aerodrome Manual MIAL/AO/DOC/01.01 Issue 06, Rev 00 dated 30.07.2016, "*Aircraft holding on TWY N11. N10, N6, W and W4 will prohibit aircraft to taxi on TWY N.*"

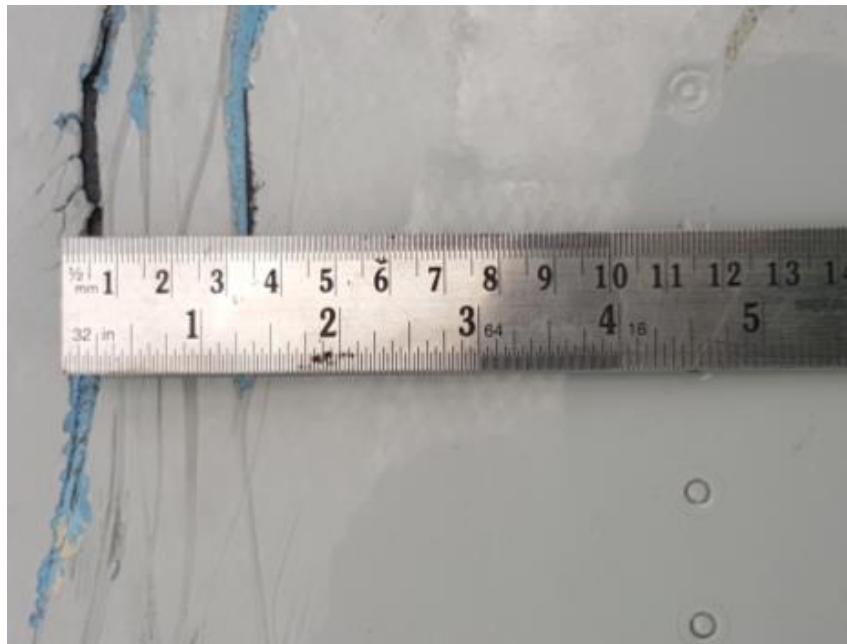
damaged. The scrapping of the wing sharklet with the wing of aircraft 2 has damaged outboard aileron lower skin, outboard aileron trailing edge wedge structure and lower wing surface/ wing trailing edge fairings. The main wing bottom surface had superficial paint scratches. Repairs and maintenance action was carried out on both the aircraft and were released after clearance by OEMs.

Scratch Marks on lower surface of wing of aircraft 2
