**FINAL INVESTIGATION REPORT ON RUNWAY
OVERSHOOT BY M/s. SPICEJET PRIVATE LIMITED
BOMBARDIER Q 400 AIRCRAFT VT-SUE ON 17.09.2016
AT TIRUPATI AIRPORT, TIRUPATI**

**FINAL INVESTIGATION REPORT ON RUNWAY EXCURSION BY M/S.
SPICEJET PRIVATE LIMITED BOMBARDIER Q 400 AIRCRAFT
VT-SUE ON 17.09.2016 AT TIRUPATI AIRPORT, TIRUPATI**

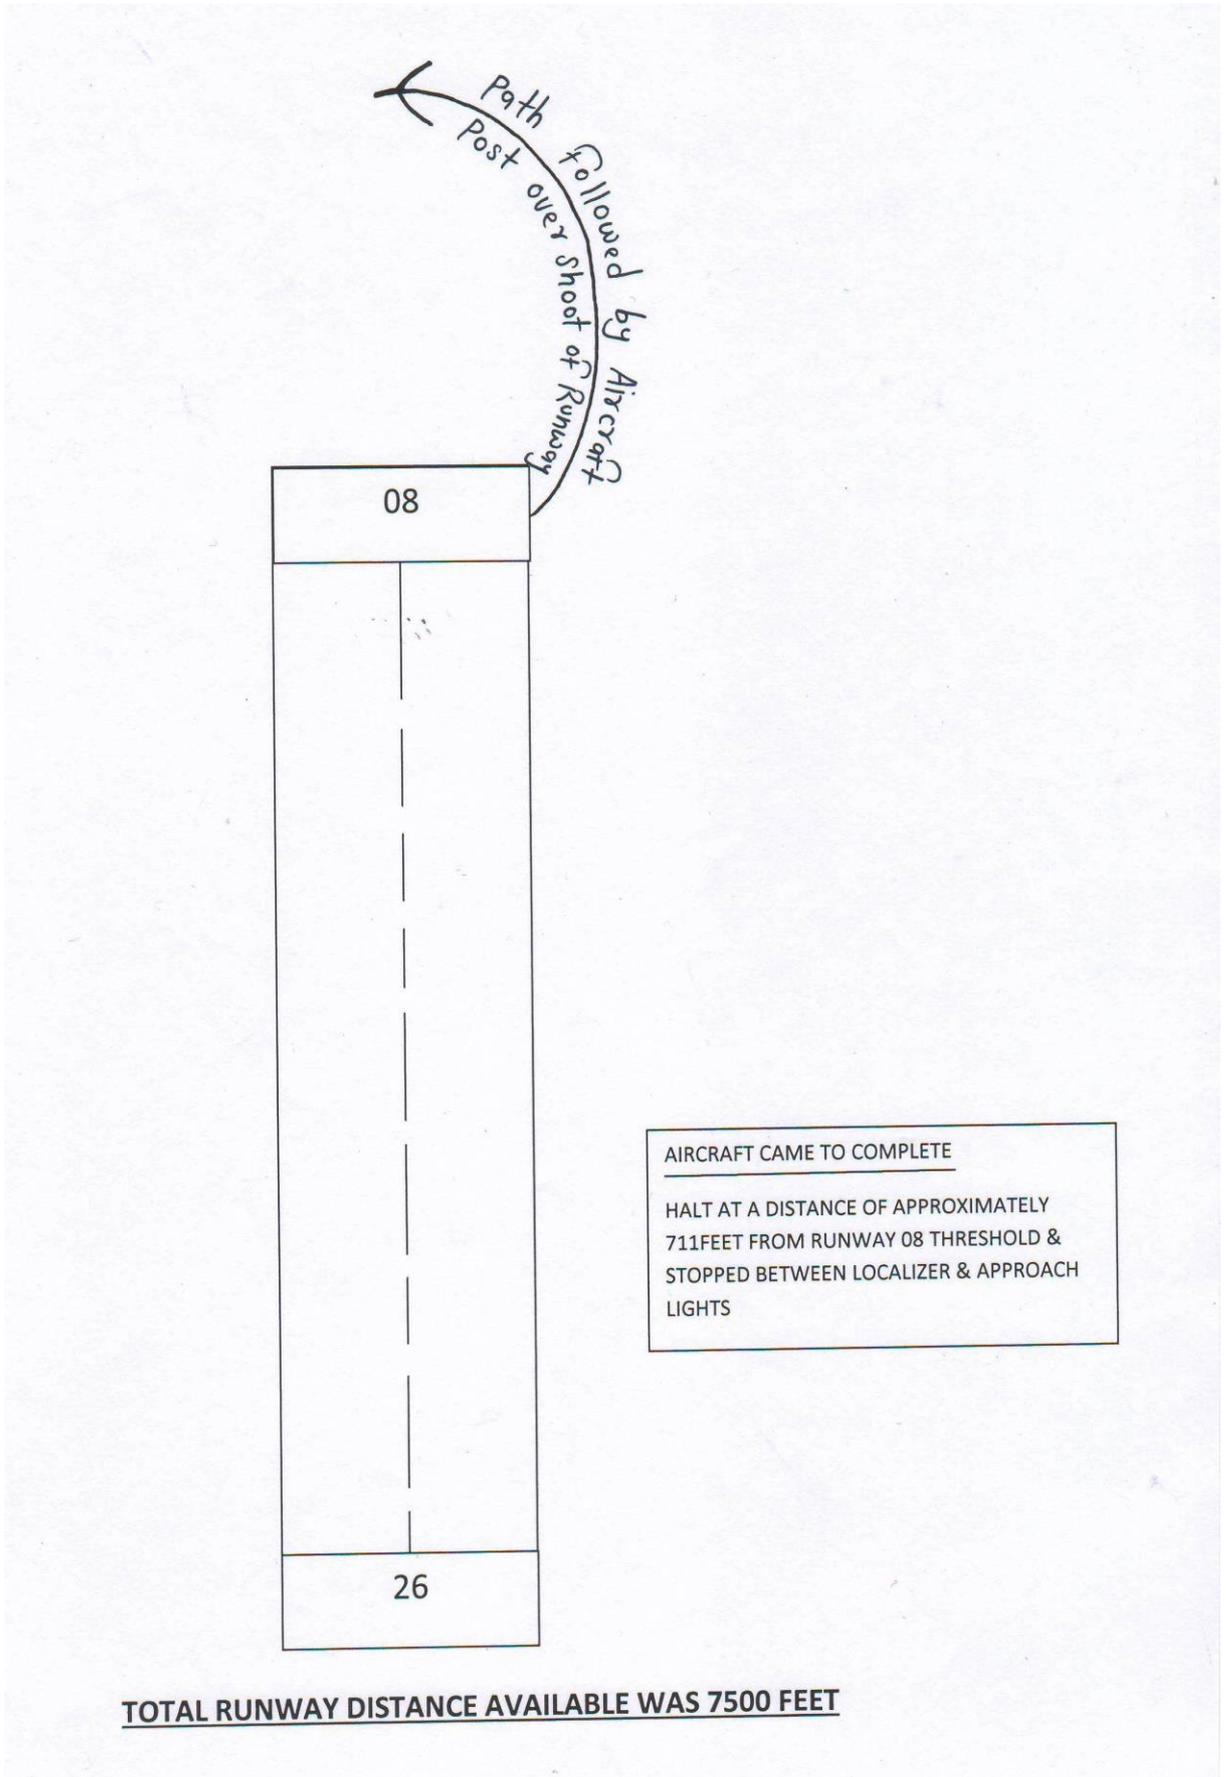
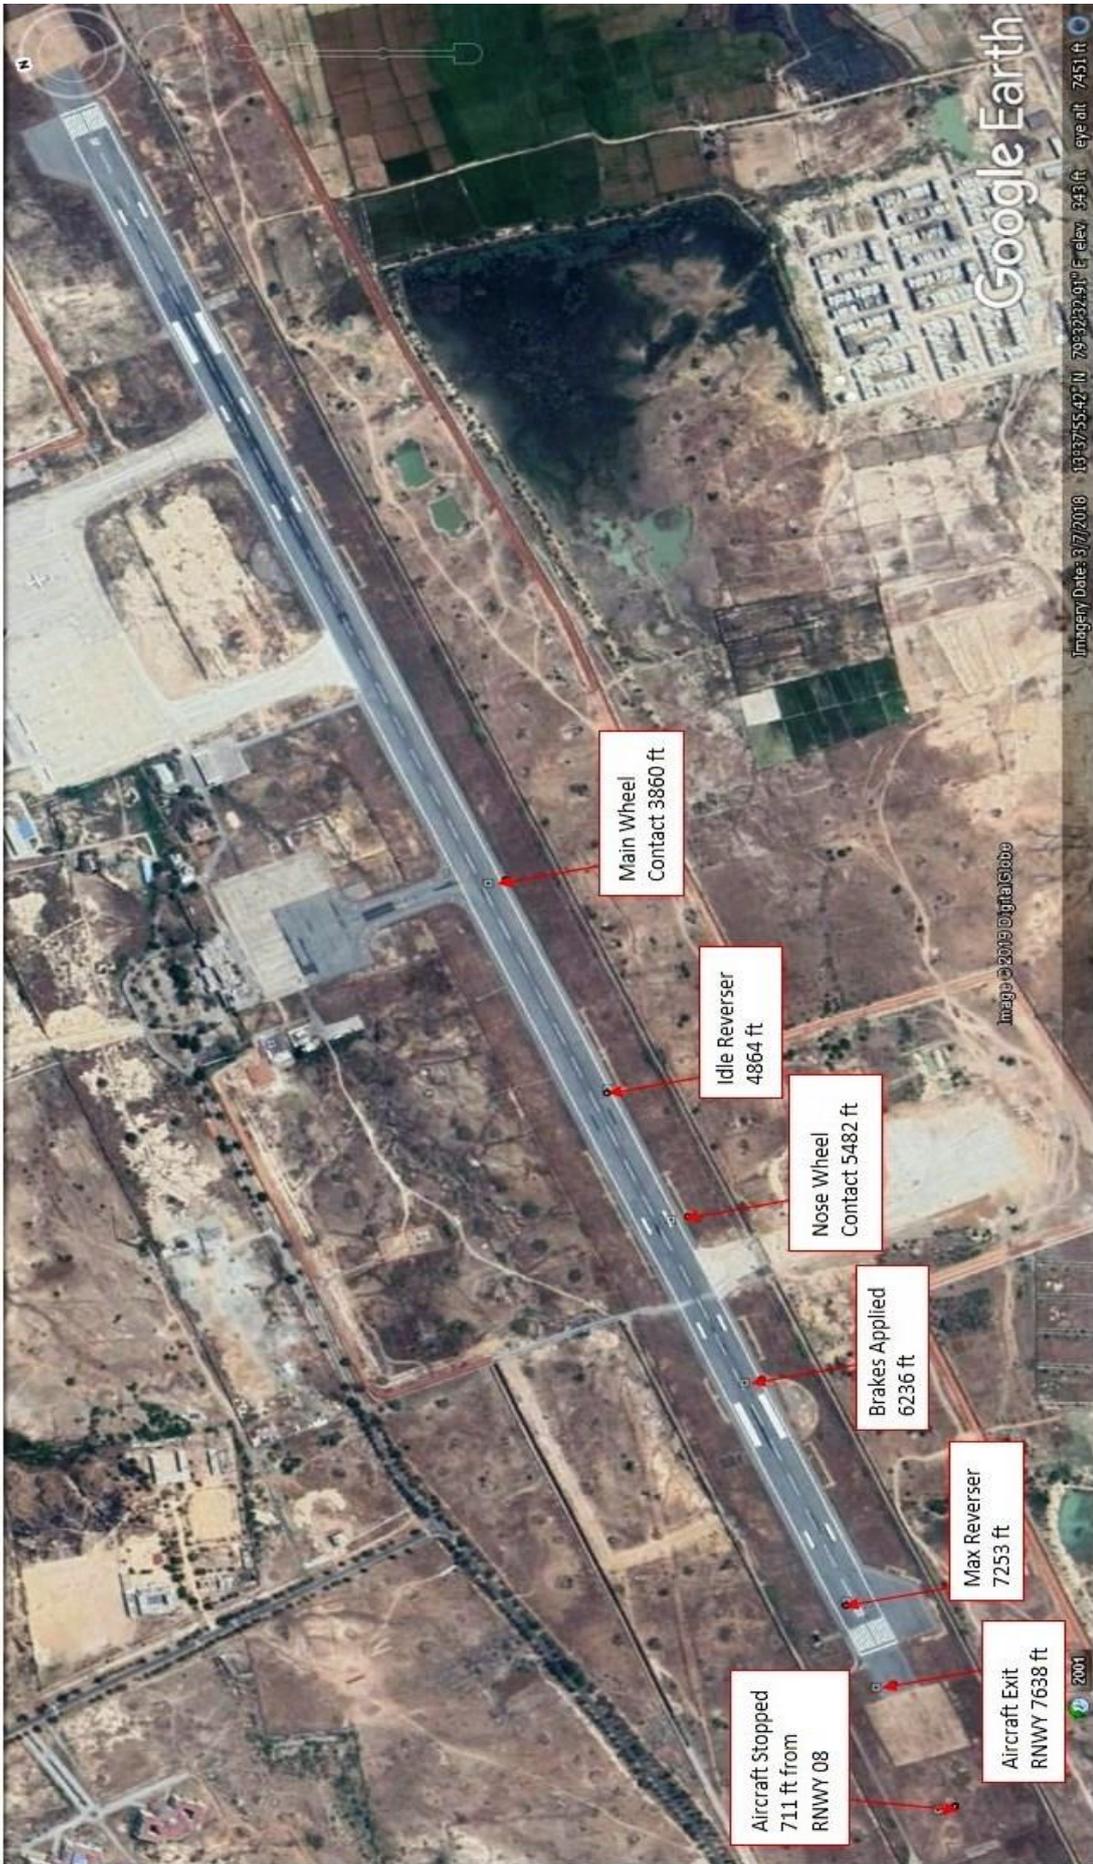
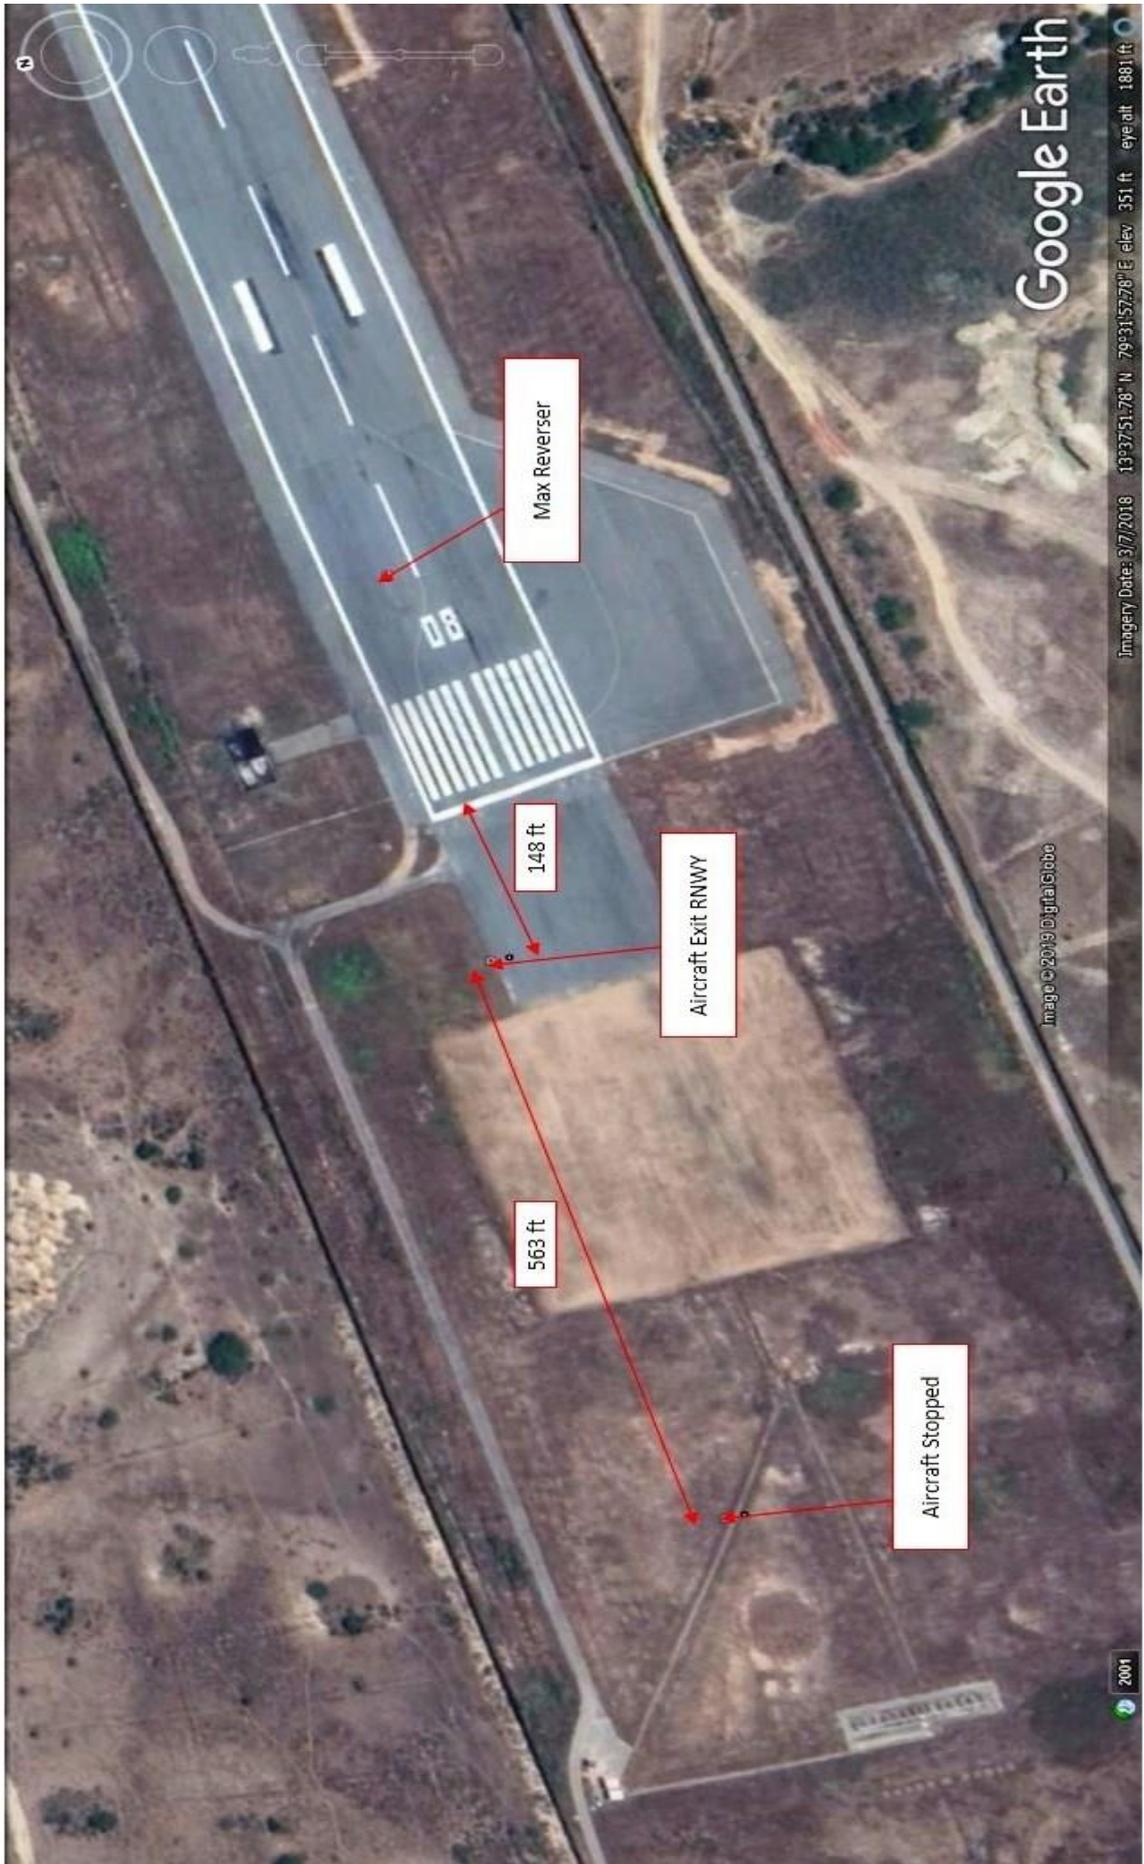
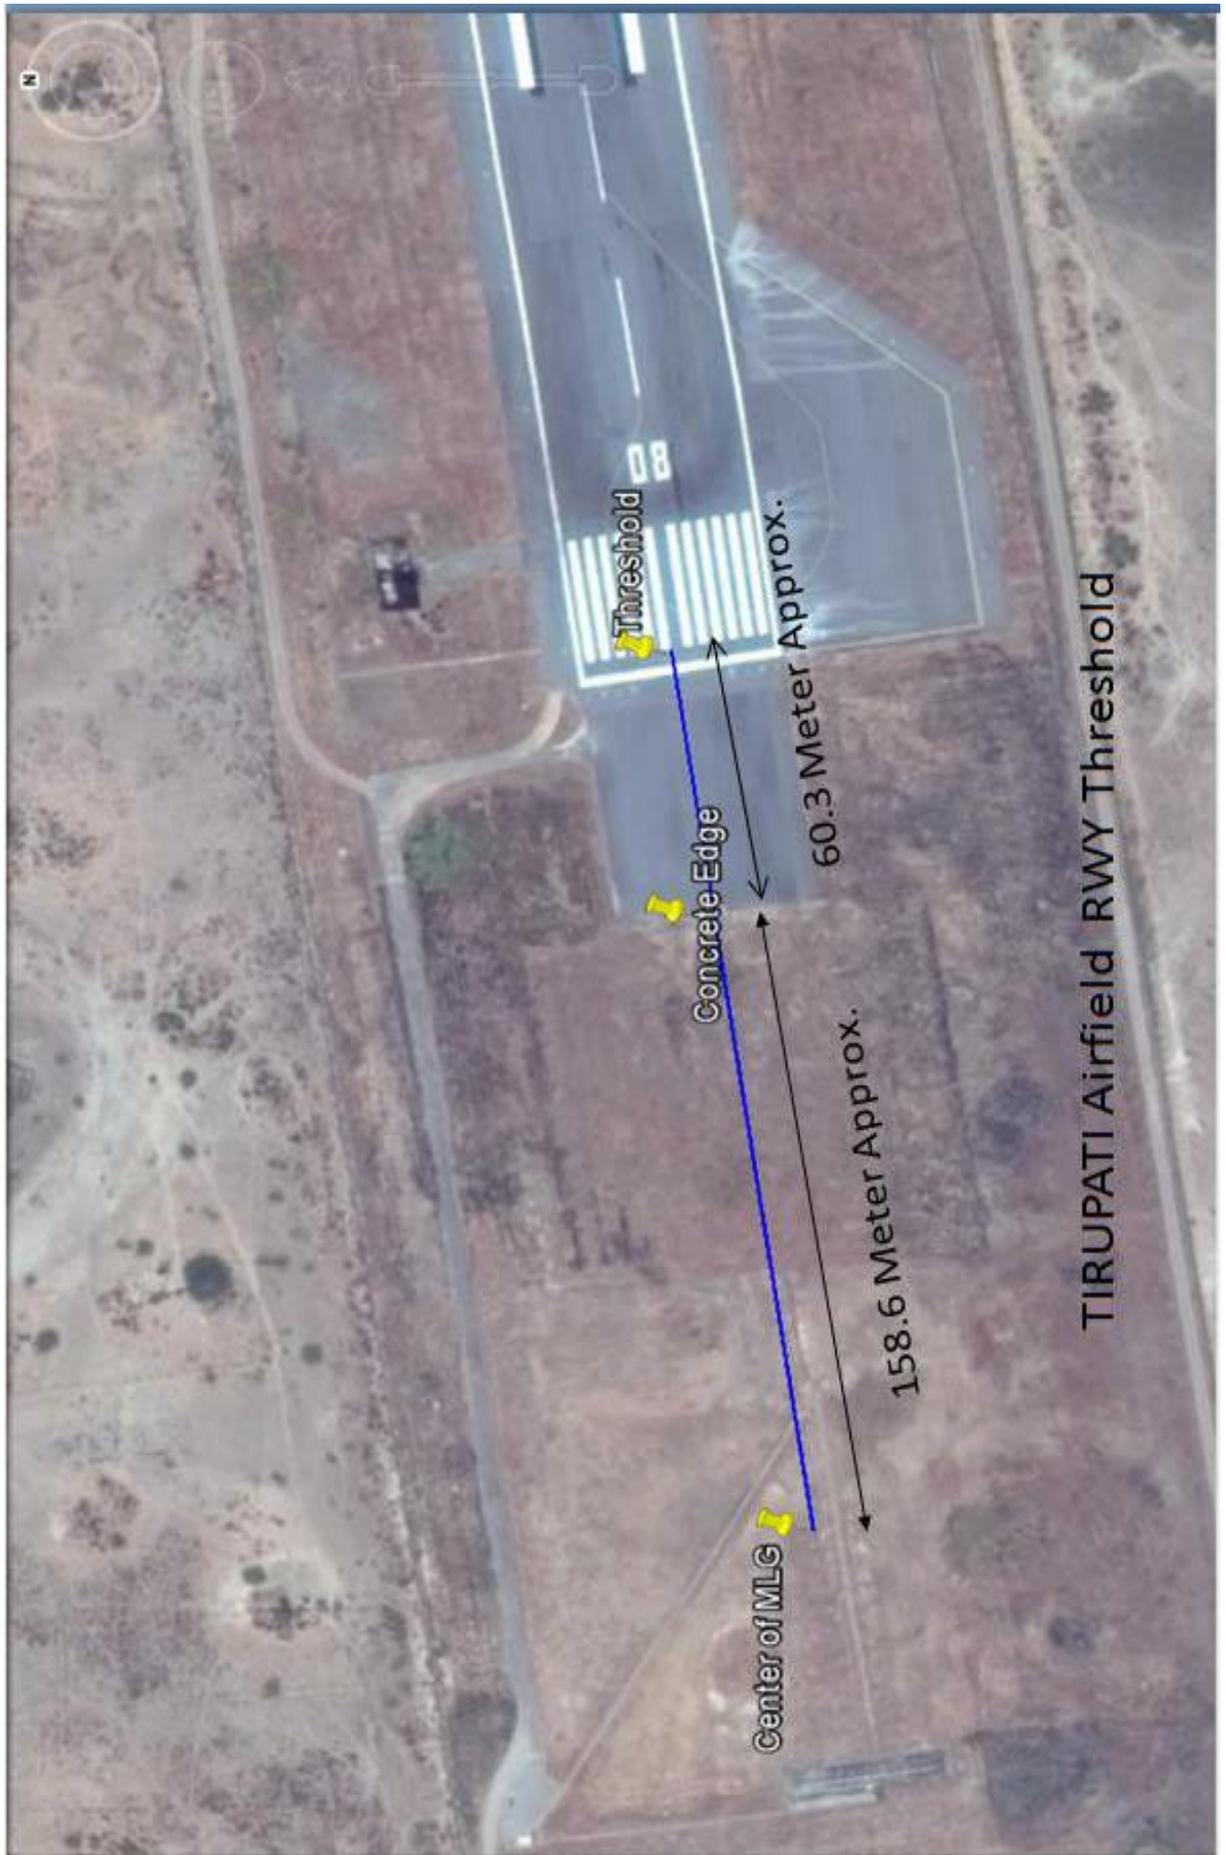
PHOTOGRAPHS

The aircraft crossed the runway 08 RESA and finally stopped in kuccha after completing an arc, with centre of MLG at 725 feet away from RWY08 threshold. The total length of Runway is 7500 feet. The approx. landing Distance required for Q 400 aircraft is 4000 feet.

The aircraft exited the runway and got stuck in the unpaved surface, approximately perpendicular to the Runway. There was no damage to the aircraft.
