**AIRCRAFT ACCIDENT INVESTIGATION BUREAU**

**FINAL INVESTIGATION REPORT  
ON SERIOUS INCIDENT INVOLVING  
M/S AIR INDIA'S BOEING 777-300 ER AIRCRAFT VT-ALJ  
AT MUMBAI ON 22.02.2016**

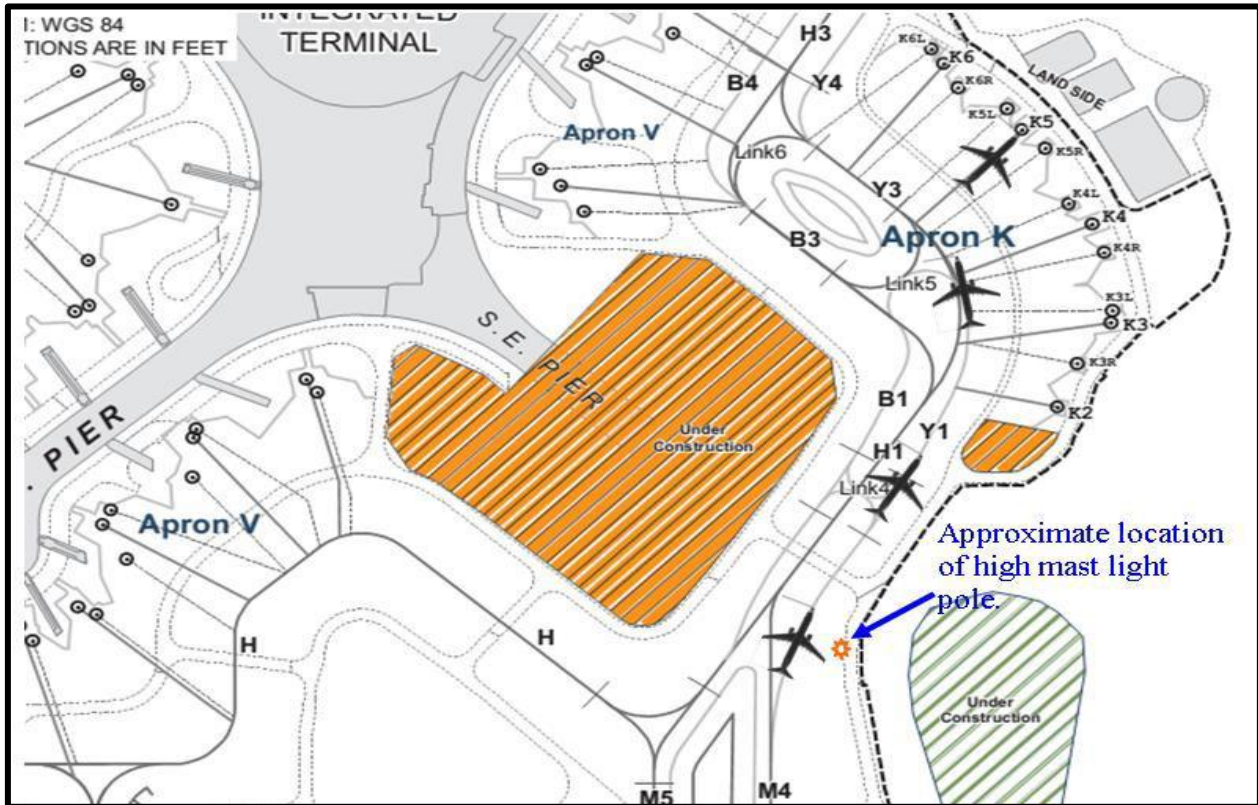
Figure : 2

The aircraft was given taxi clearance after landing at Mumbai for parking bay "K5" and instructed to taxi via "N - Cross Rwy 14 - N1 - Hold short of M6". Thereafter, AI191 was instructed to continue taxi via "M6 - M - M4 - Y1 - Y3" to parking bay K5 in South East Pier. The layout of South East Pier and track followed by the aircraft on its way to bay K5 is shown in the Figure 2 below: -

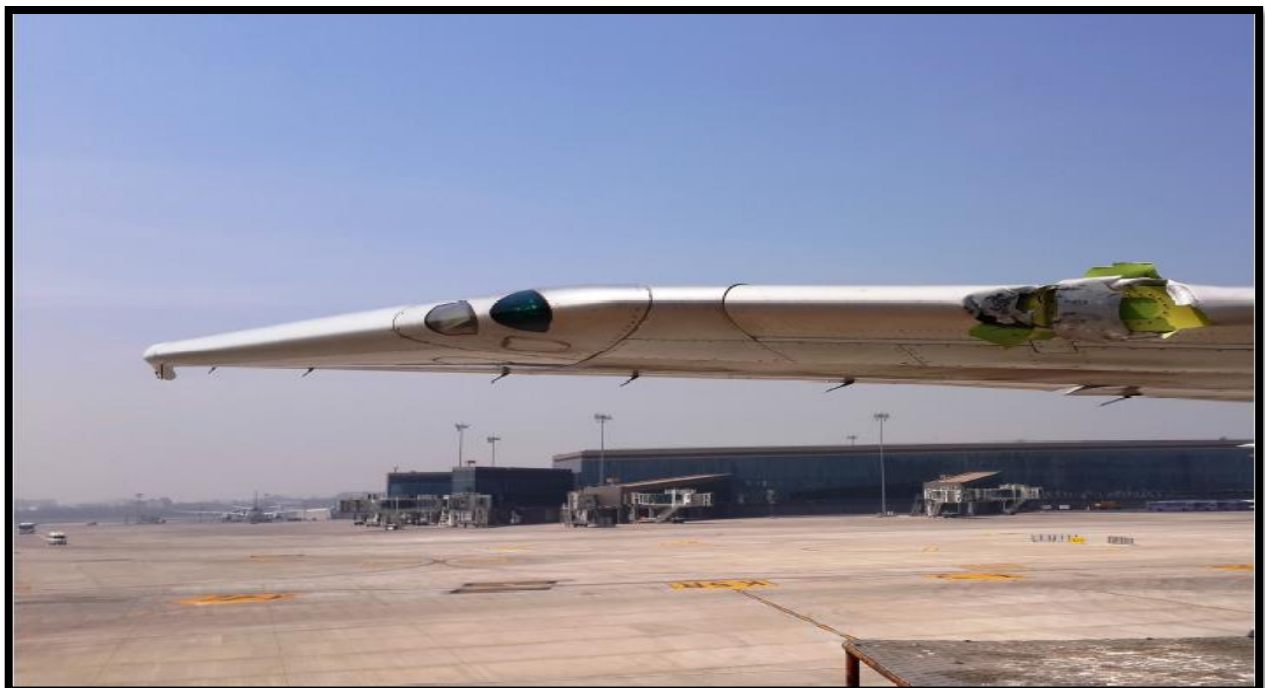
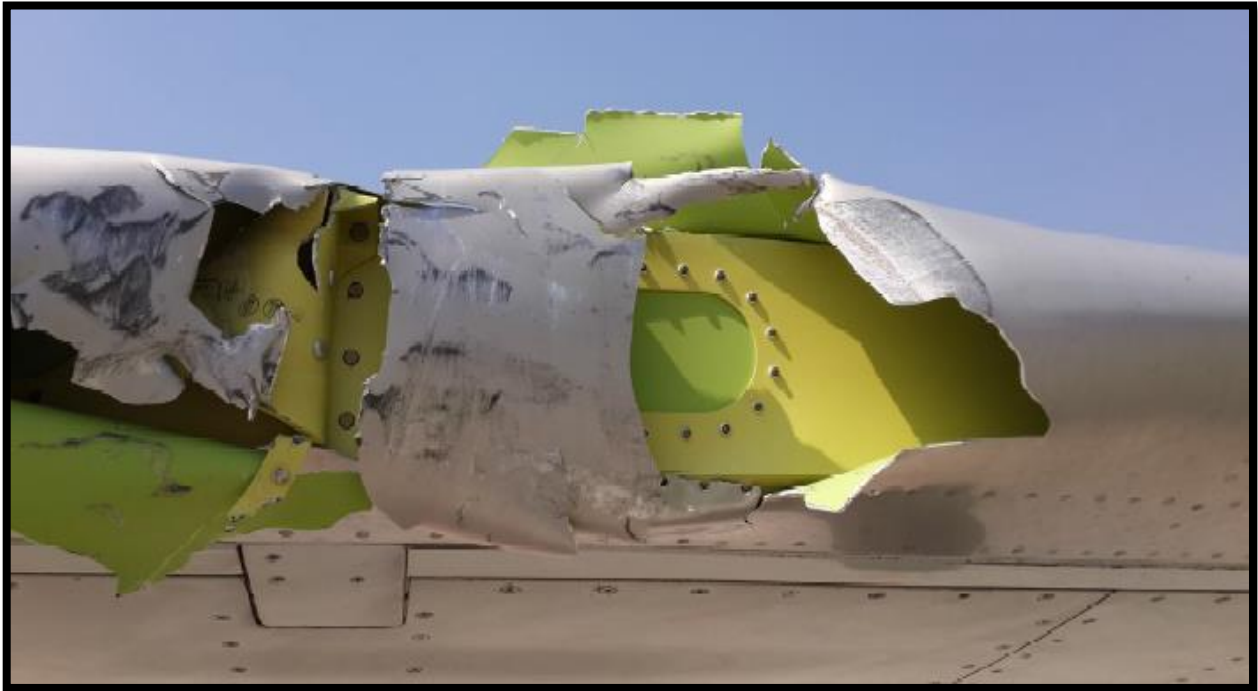
Figure : 3

The leading edge of the RH wing (Slat part no. 114W5110-6 and Leading Edge Bottom Panel 621AFB) suffered damaged at a distance of 29 inches from the wing tip due to impact with the High Mast Lighting Pole. The damages are shown in the Figure 3 and Figure 4 below: -

The Leading edge of the RH wing suffered damaged at a distance of 29 inches from the wing tip due to its impact with the High Mast Lighting Electric Pole. Dimension of LE Slat Damage was 24 inch X 19 inch. The damage was beyond the scope of Structural Repair Manual.

**3.1.5** The aircraft hit the High Mast Lighting Pole at a wing height and crew felt a shudder, but were unaware that aircraft had hit the pole. The damage to the wing was beyond the limits prescribed in the Structural Repair Manual.

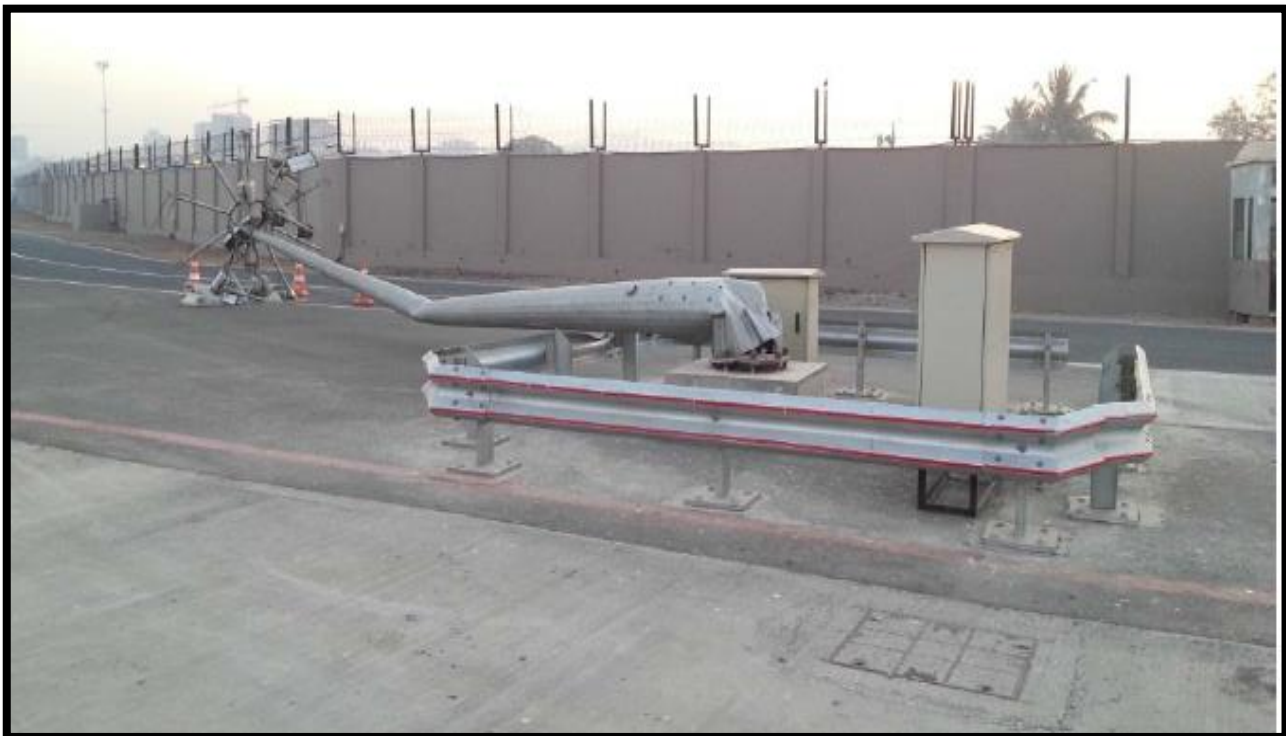
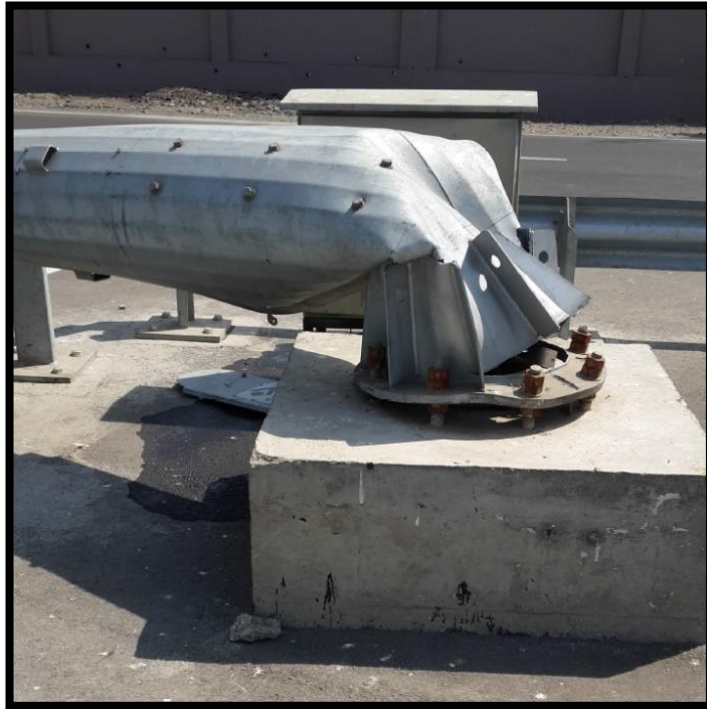
Figure : 5

The High Mast Lighting Pole was hit by the aircraft at a wing height. The resulting impact caused the lamp post to bend and tear partly at its bottom before falling down. The Lamp post fell onto area between taxiway Y1 and perimeter road.

The High Mast Lighting Electric Pole lamp post was hit by the aircraft at wing height and collapsed onto area between taxiway Y1 and perimeter road.

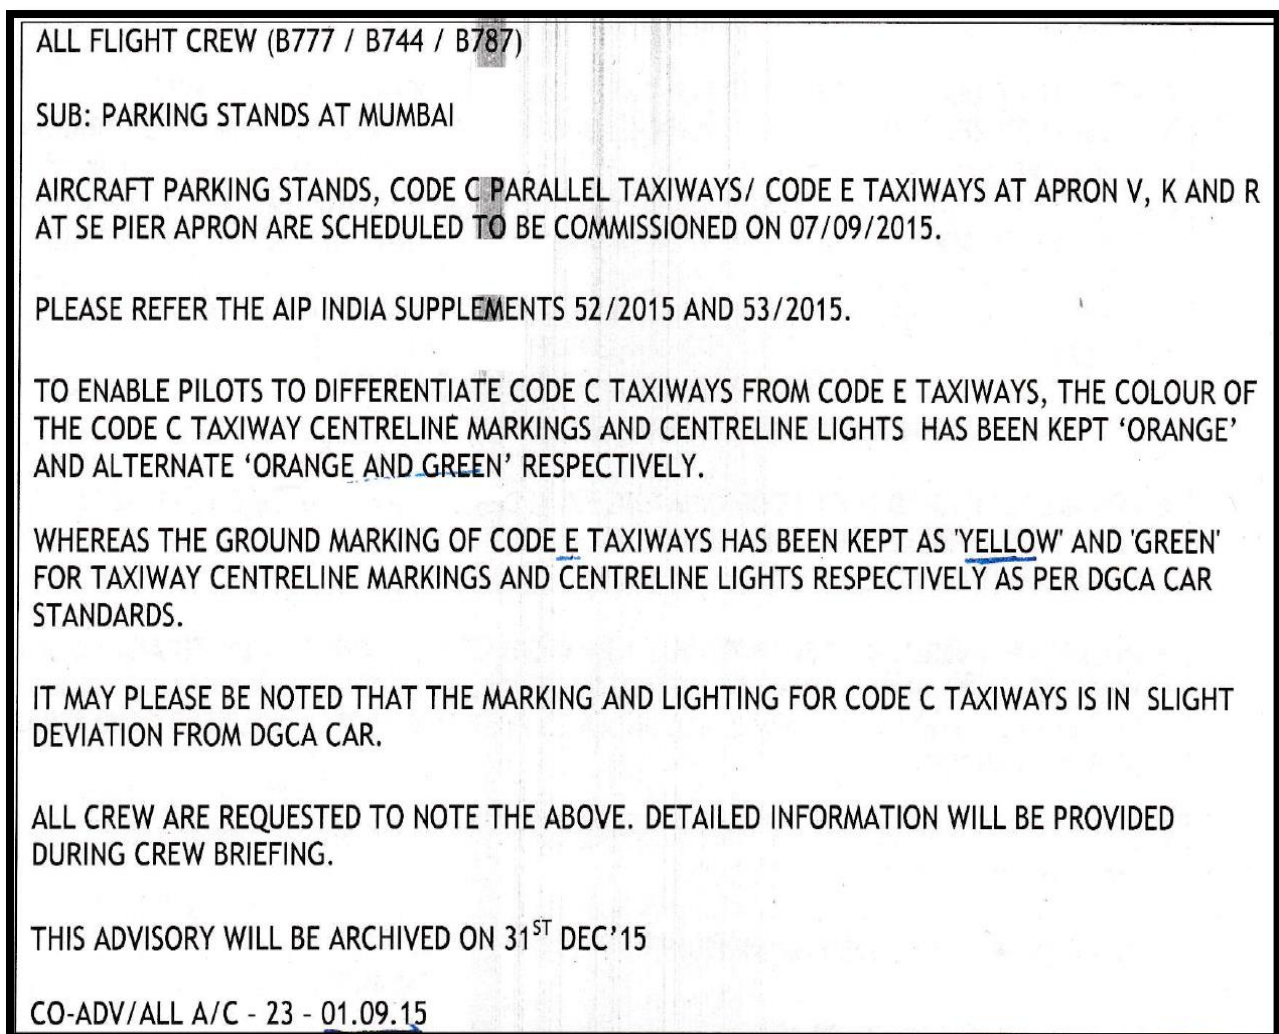
Figure : 8

Crew Advisory No. 23 dated 01.09.2015 was issued by Air India to all its crew regarding taxiing of aircraft in South East Pier. As per the advisory issued to the operating crew, South East Pier side facilities, markings and lighting for Code C taxiway, were in deviation from standards. Further, as per the advisory to the crew "the ground marking of Code E Taxiways has been kept as 'Yellow' and 'Green' for taxiway centerline markings and centerline lights respectively". Screenshot of the advisory is shown in the Figure 8 below: -

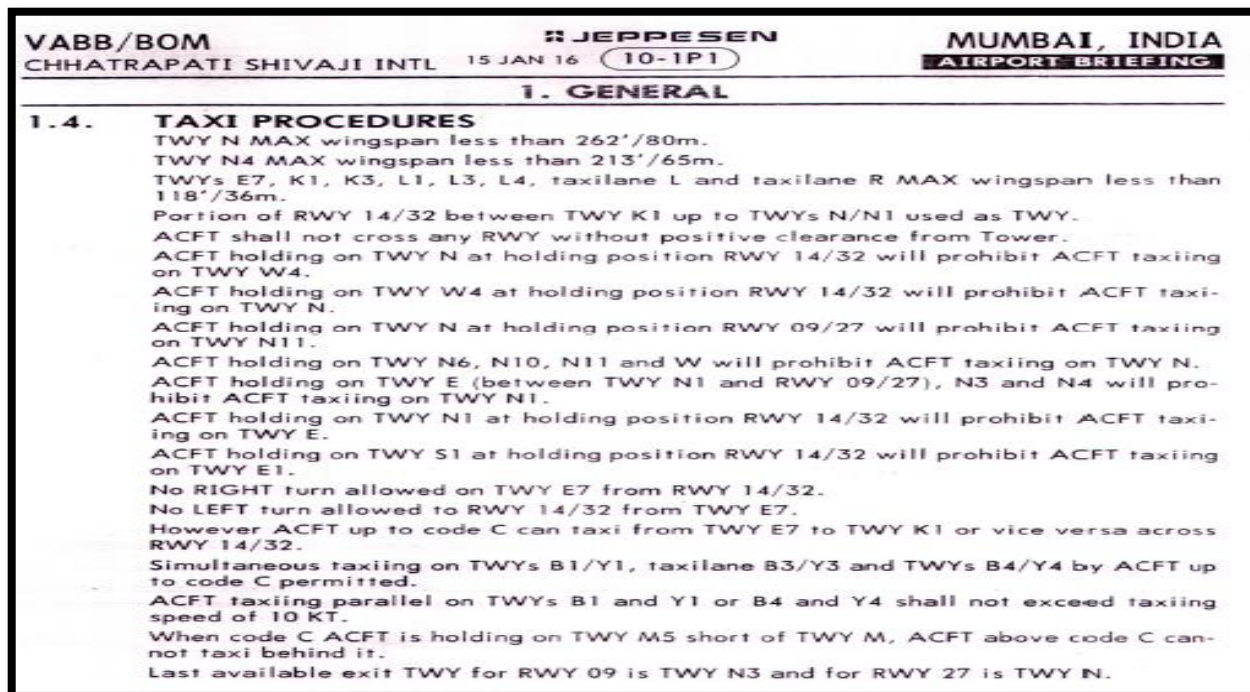
Figure : 9

The crew was using Jeppesen 10-1P1 dt 15 Jan 2016. The charts were not including/indicating that taxiway Y1 is restricted to Code C aircraft. The taxi procedures as per the Jeppesen is shown in the Figure 9 below: -

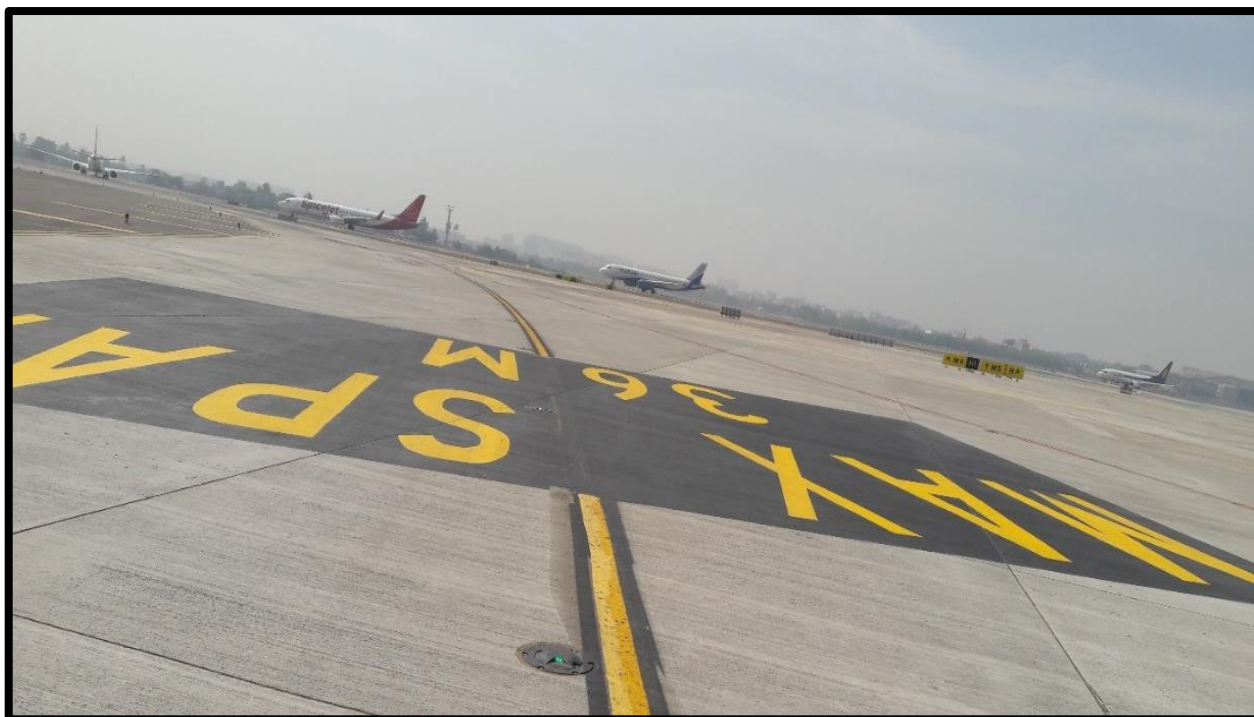
Figure : 11

Ground Marking "MAX SPAN 36 M" was available at entry point of taxiway Y1. Crew was able to notice the marking. The image of ground marking is shown in the Figure 11 below: -
