**Final Investigation Report on Serious Incident to M/s Jet Airways
aircraft VT-JEK at London Heathrow Airport on 30.08.2016**

Final Report on Serious Incident to M/s Jet Airways Ltd. B777-300, VT-JEK at London Heathrow Airport on 30.08.2016

| 13. Type of Occurrence | : Serious Incident (Late take-off) |

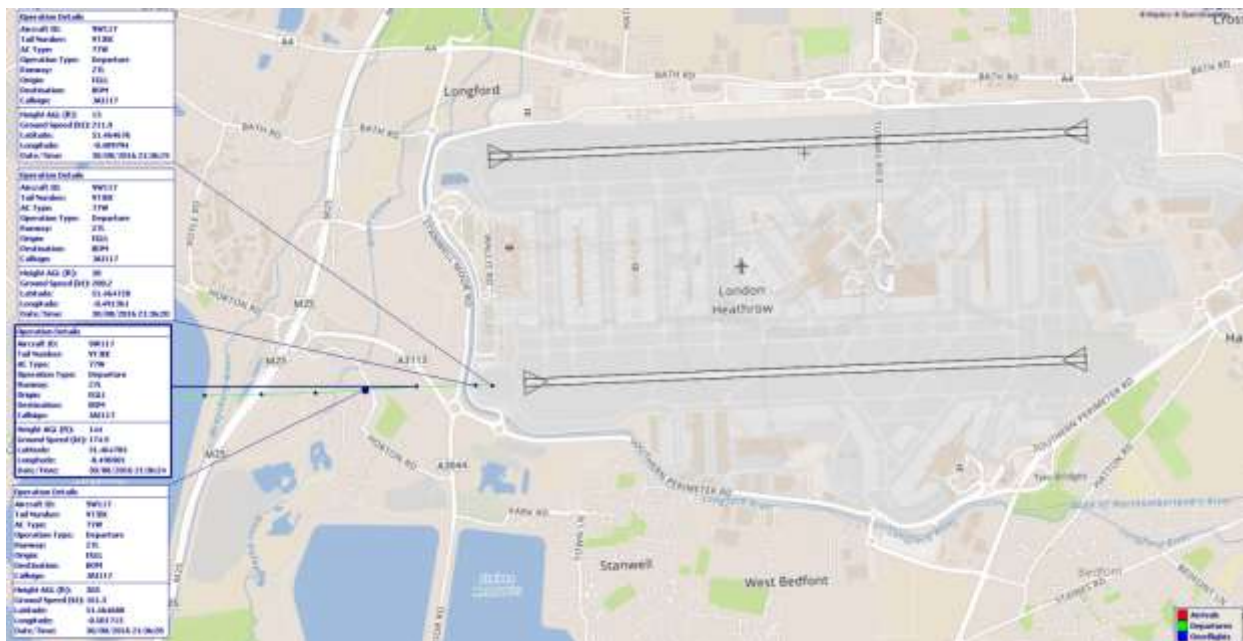
Figure 2 : ANMOS Plot of JAI 117

- III. The pilot of the B773 had clearly stated that they were able to accept a departure from the intersection S4E.
- IV. ATSI obtained a printout from the Heathrow Noise and Track Keeping System (ANOMS) which showed the B773 having just passed a height of 30ft approaching the western perimeter road. A review of the Aerodrome Chart and the AIP entries for Heathrow shows assessed aerodrome obstacles (trees) as high as 31ft. *[The ANMOS height data is not as accurate as the information supplied by Boeing. That is why the Boeing data was used in the AAIB final report and not the ANMOS data when showing the height at which the aircraft crossed the end of the runway.]*

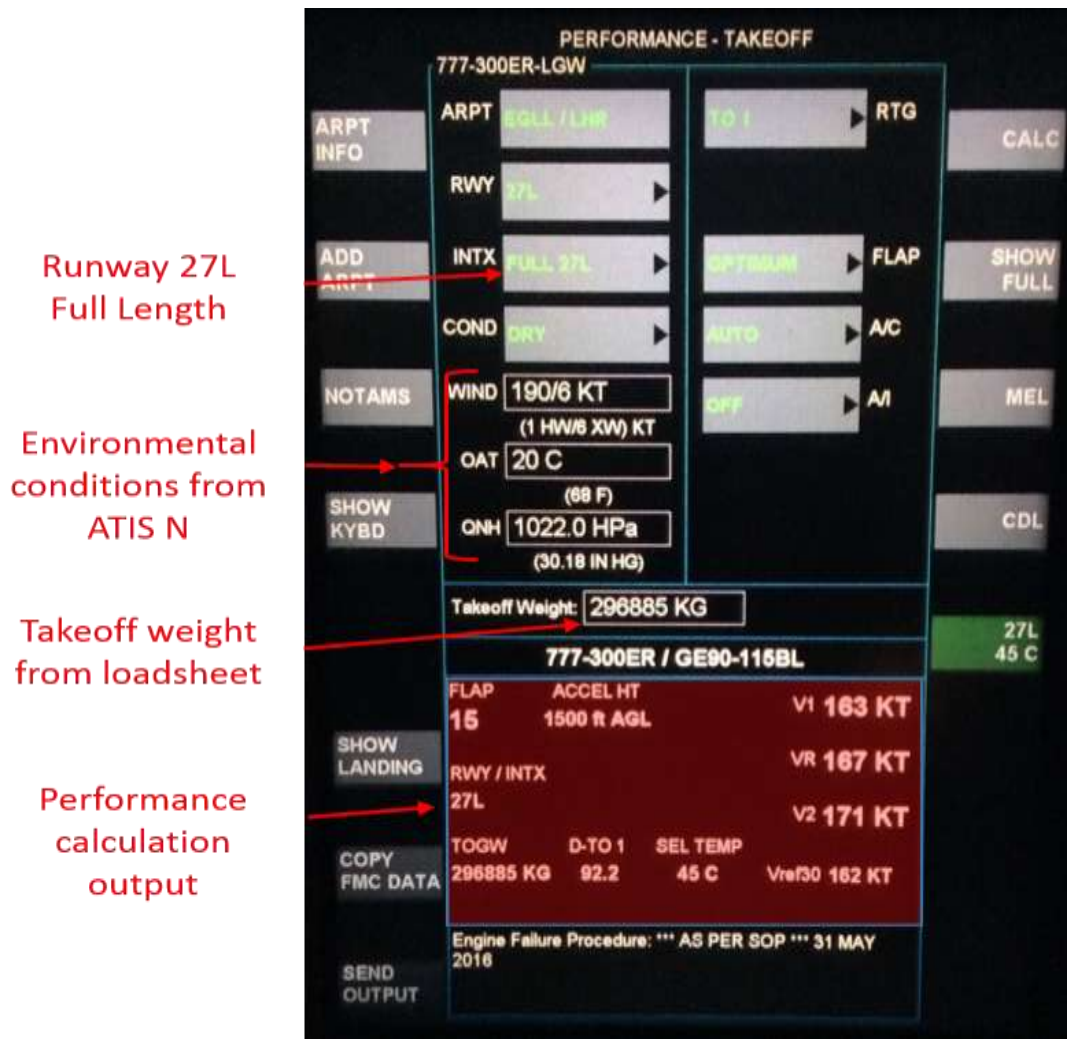
Figure 7: OPT output used for the takeoff

The calculation showed that, for a takeoff from the full length of Runway 27L, the takeoff power setting to be entered into the FMC was 'D-TO 1 SEL TEMP 45° C'. This corresponded to a reduction from rated power of 10% plus a further reduction entered into the FMC using an assumed temperature of 45°C.

The takeoff speeds were: $V_1 = 163$ kts, $V_R = 167$ kts and $V_2 = 171$ kts.

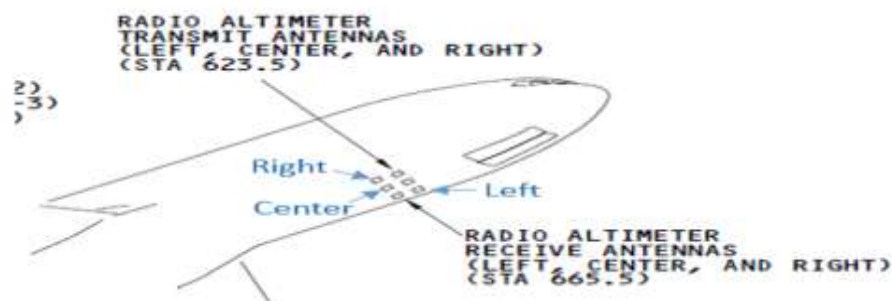
Figure: 9 showing Radio Altimeter Parameter

The ground track shows the airplane entering RWY 27L from Taxiway S4E. The analysis indicates that the takeoff was initiated at a distance of approximately 4286 feet beyond the runway threshold (7715 feet of runway remaining) at auto throttle engagement and the engines spooled up to the takeoff N1 of 92.2% at 4600 feet beyond the runway threshold. Rotation initiation occurred just prior to VR at 10,185 feet beyond the threshold and liftoff occurred at approximately 11,690 feet beyond the threshold. As the airplane climbed over the end of the runway, at 12,001 feet beyond the runway threshold, the center radio altitude parameter (shown on plot) was at 16.4 feet. The other two radio altimeter parameters, left and right (not shown), had values of approximately 16.6 feet and 17 feet, respectively. At the perimeter road, which was approximately 13,215 feet beyond the runway threshold, the center radio altitude parameter and left radio altitude were both at a value of approximately 112 feet and the right radio altitude value was 118 feet.

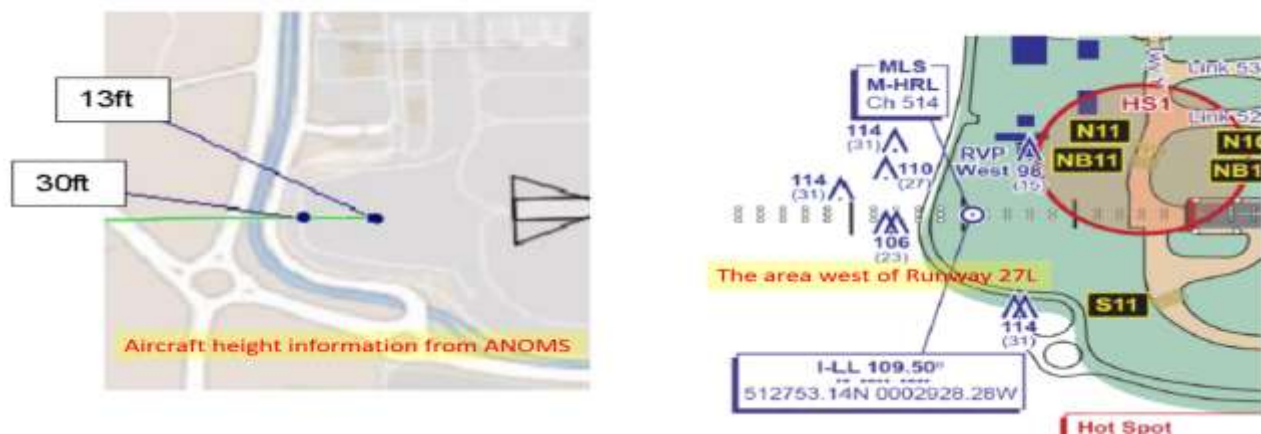
Figure 10: Aircraft height given by ANOMS and obstacles to the west of Runway 27L(UK AIP)
A comparison of ANOMS height information with aircraft-derived Mode S ADS-B data, taken from an earlier study, estimated the accuracy of ANOMS height information to be ‘*no worse than ± 55 ft*’. The ATSI report made the following recommendation:

‘A risk assessment [should] be considered jointly by both the Heathrow Aerodrome Authority and NATS ATC on the likelihood and impact of a similar incident reoccurring, with a view to revising the usage of intersection departures for aircraft above a certain size’.

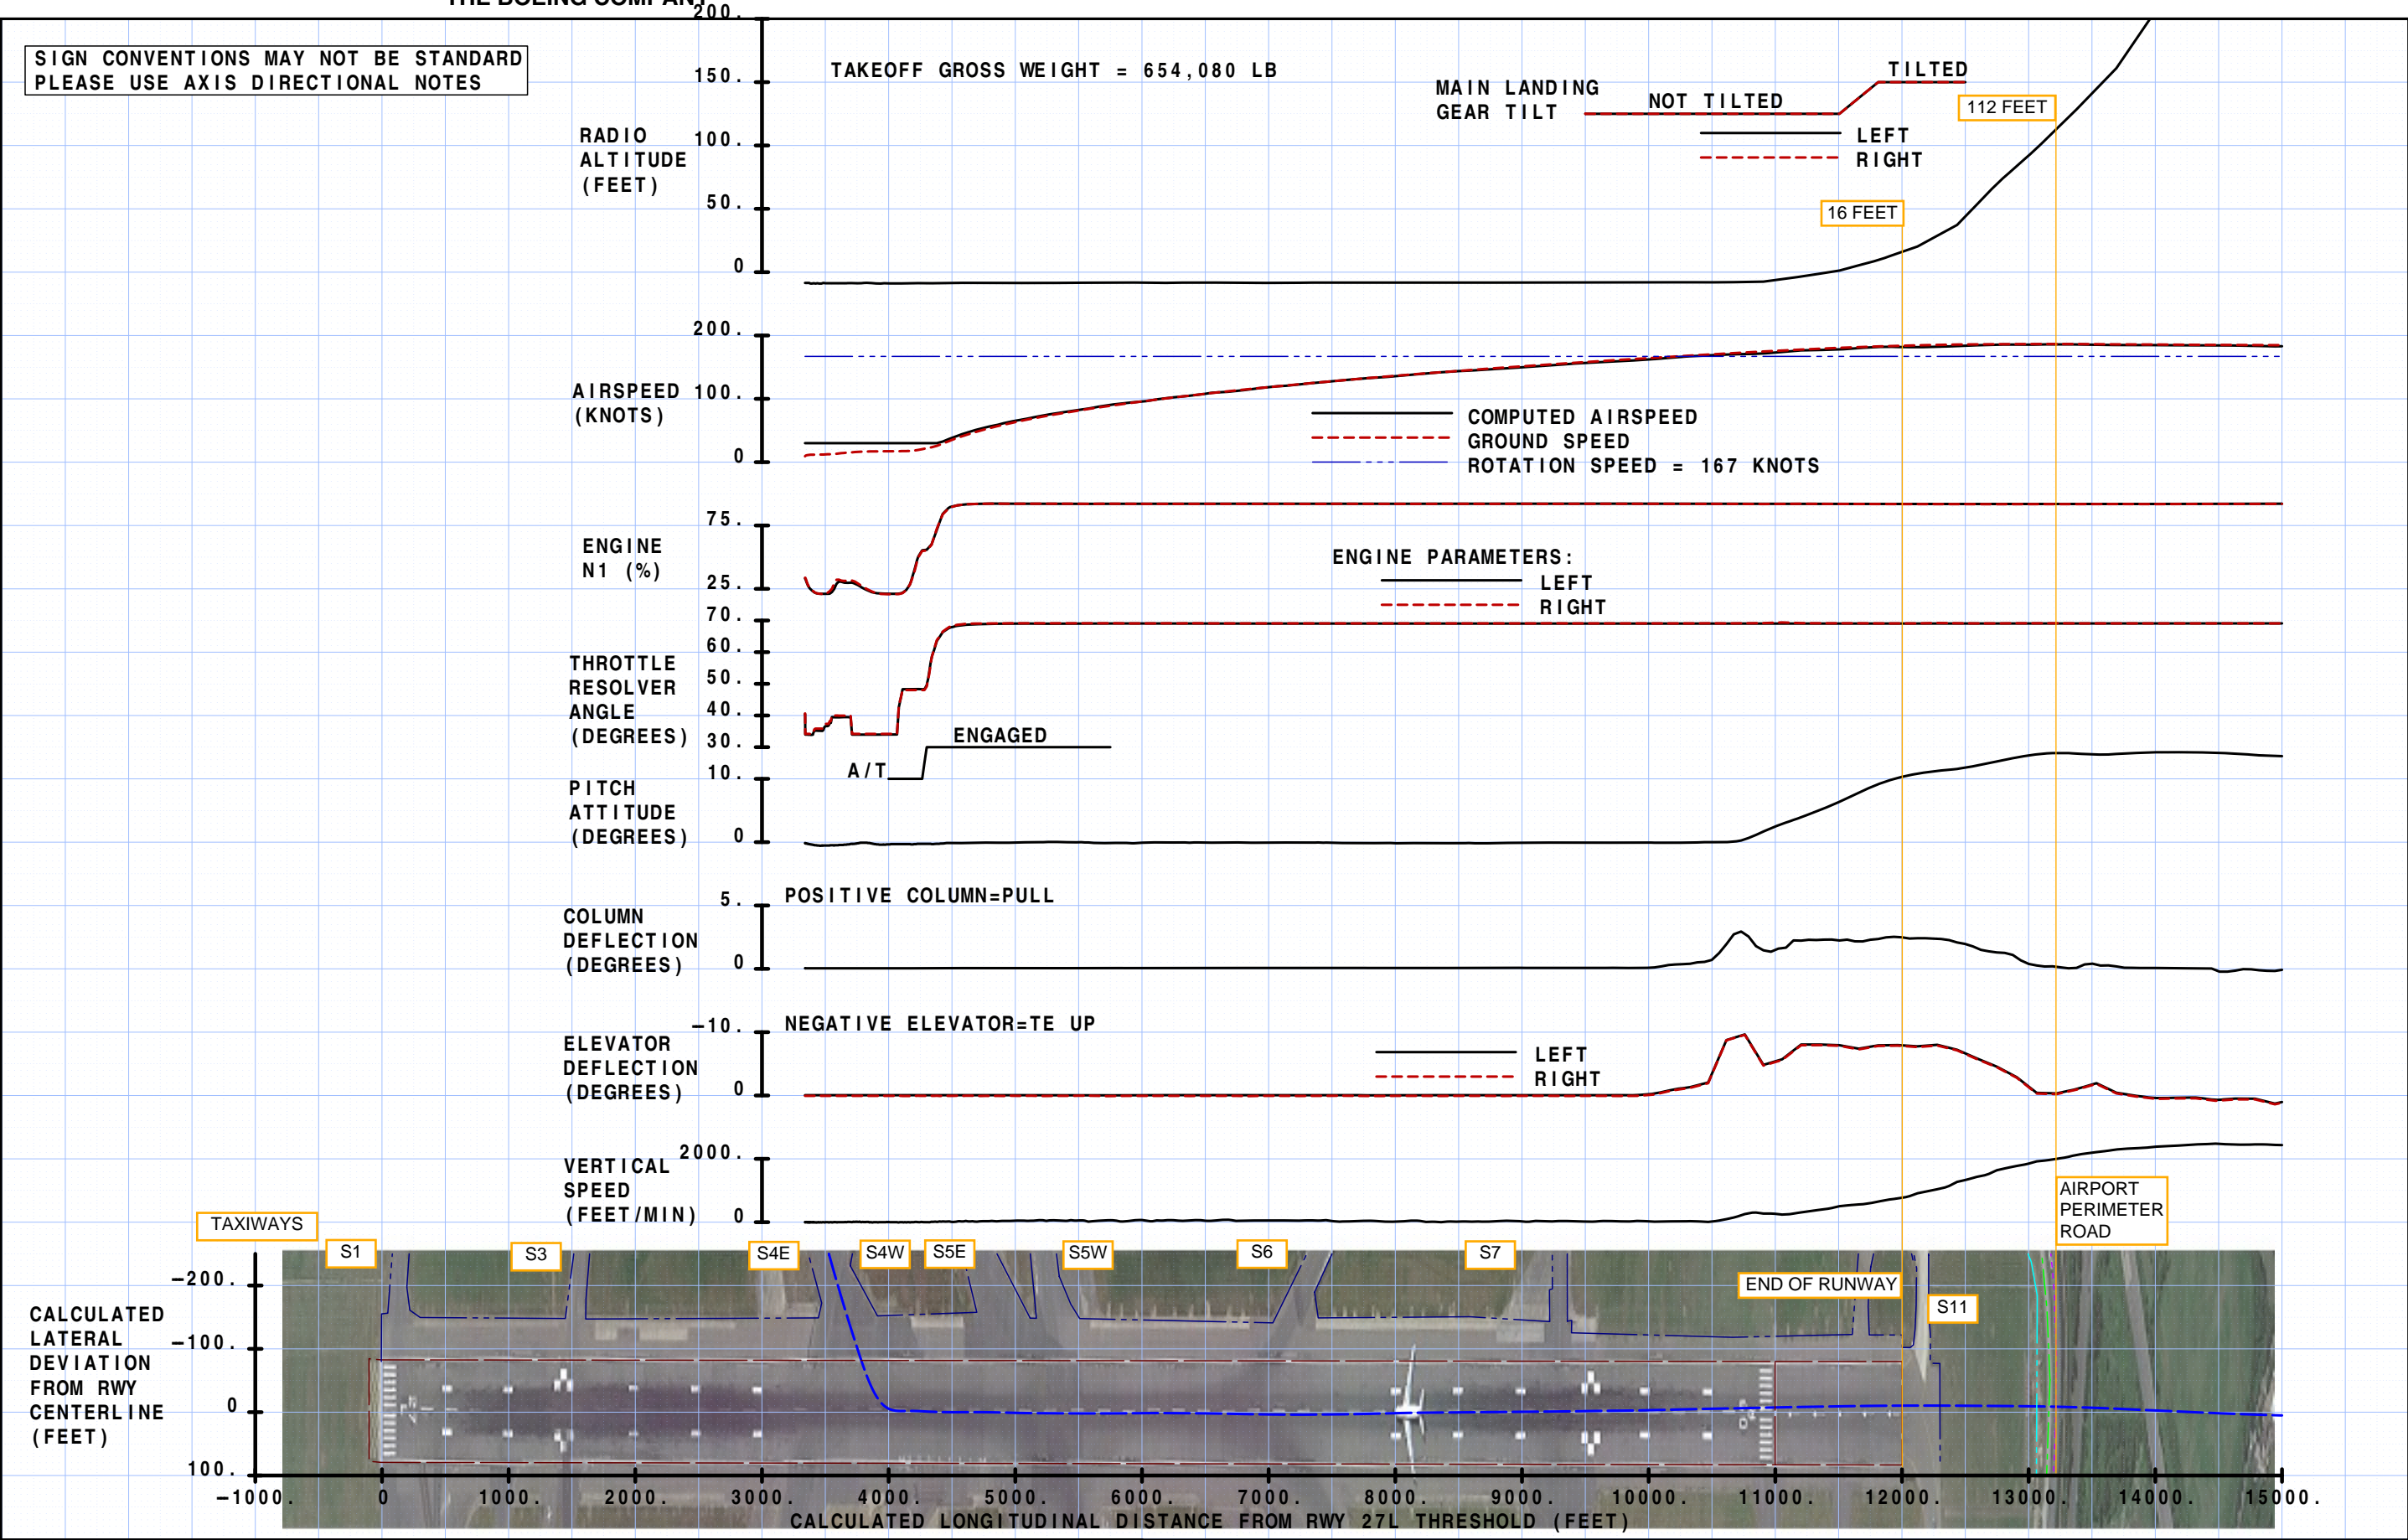
CALC	AERODYNAMICS	11AUG17	REVISED	DATE	JPL 777-300ER VERY LOW TAKEOFF	WD770/VT-JEK
CHECK					30AUG2016 -- NON-TIME-ALIGNED QAR DATA	
APPD					GROUND TRACK ANALYSIS	FIGURE
APPD					BOEING PROPRIETARY	5

A ground track was generated to show the airplane's path during the takeoff roll and initial climb out (Annexure II). RWY 27L has a length of 12,001 feet and a width of 164 feet. Longitudinal and lateral distances were calculated using the recorded inertial data: ground speed, drift angle, and heading. The distances were then referenced to the runway based on the airplane's turn onto the runway from Taxiway S4E. The airplane was estimated to have aligned with the runway centerline at 4000 feet beyond the runway threshold (8001 feet of runway remaining).

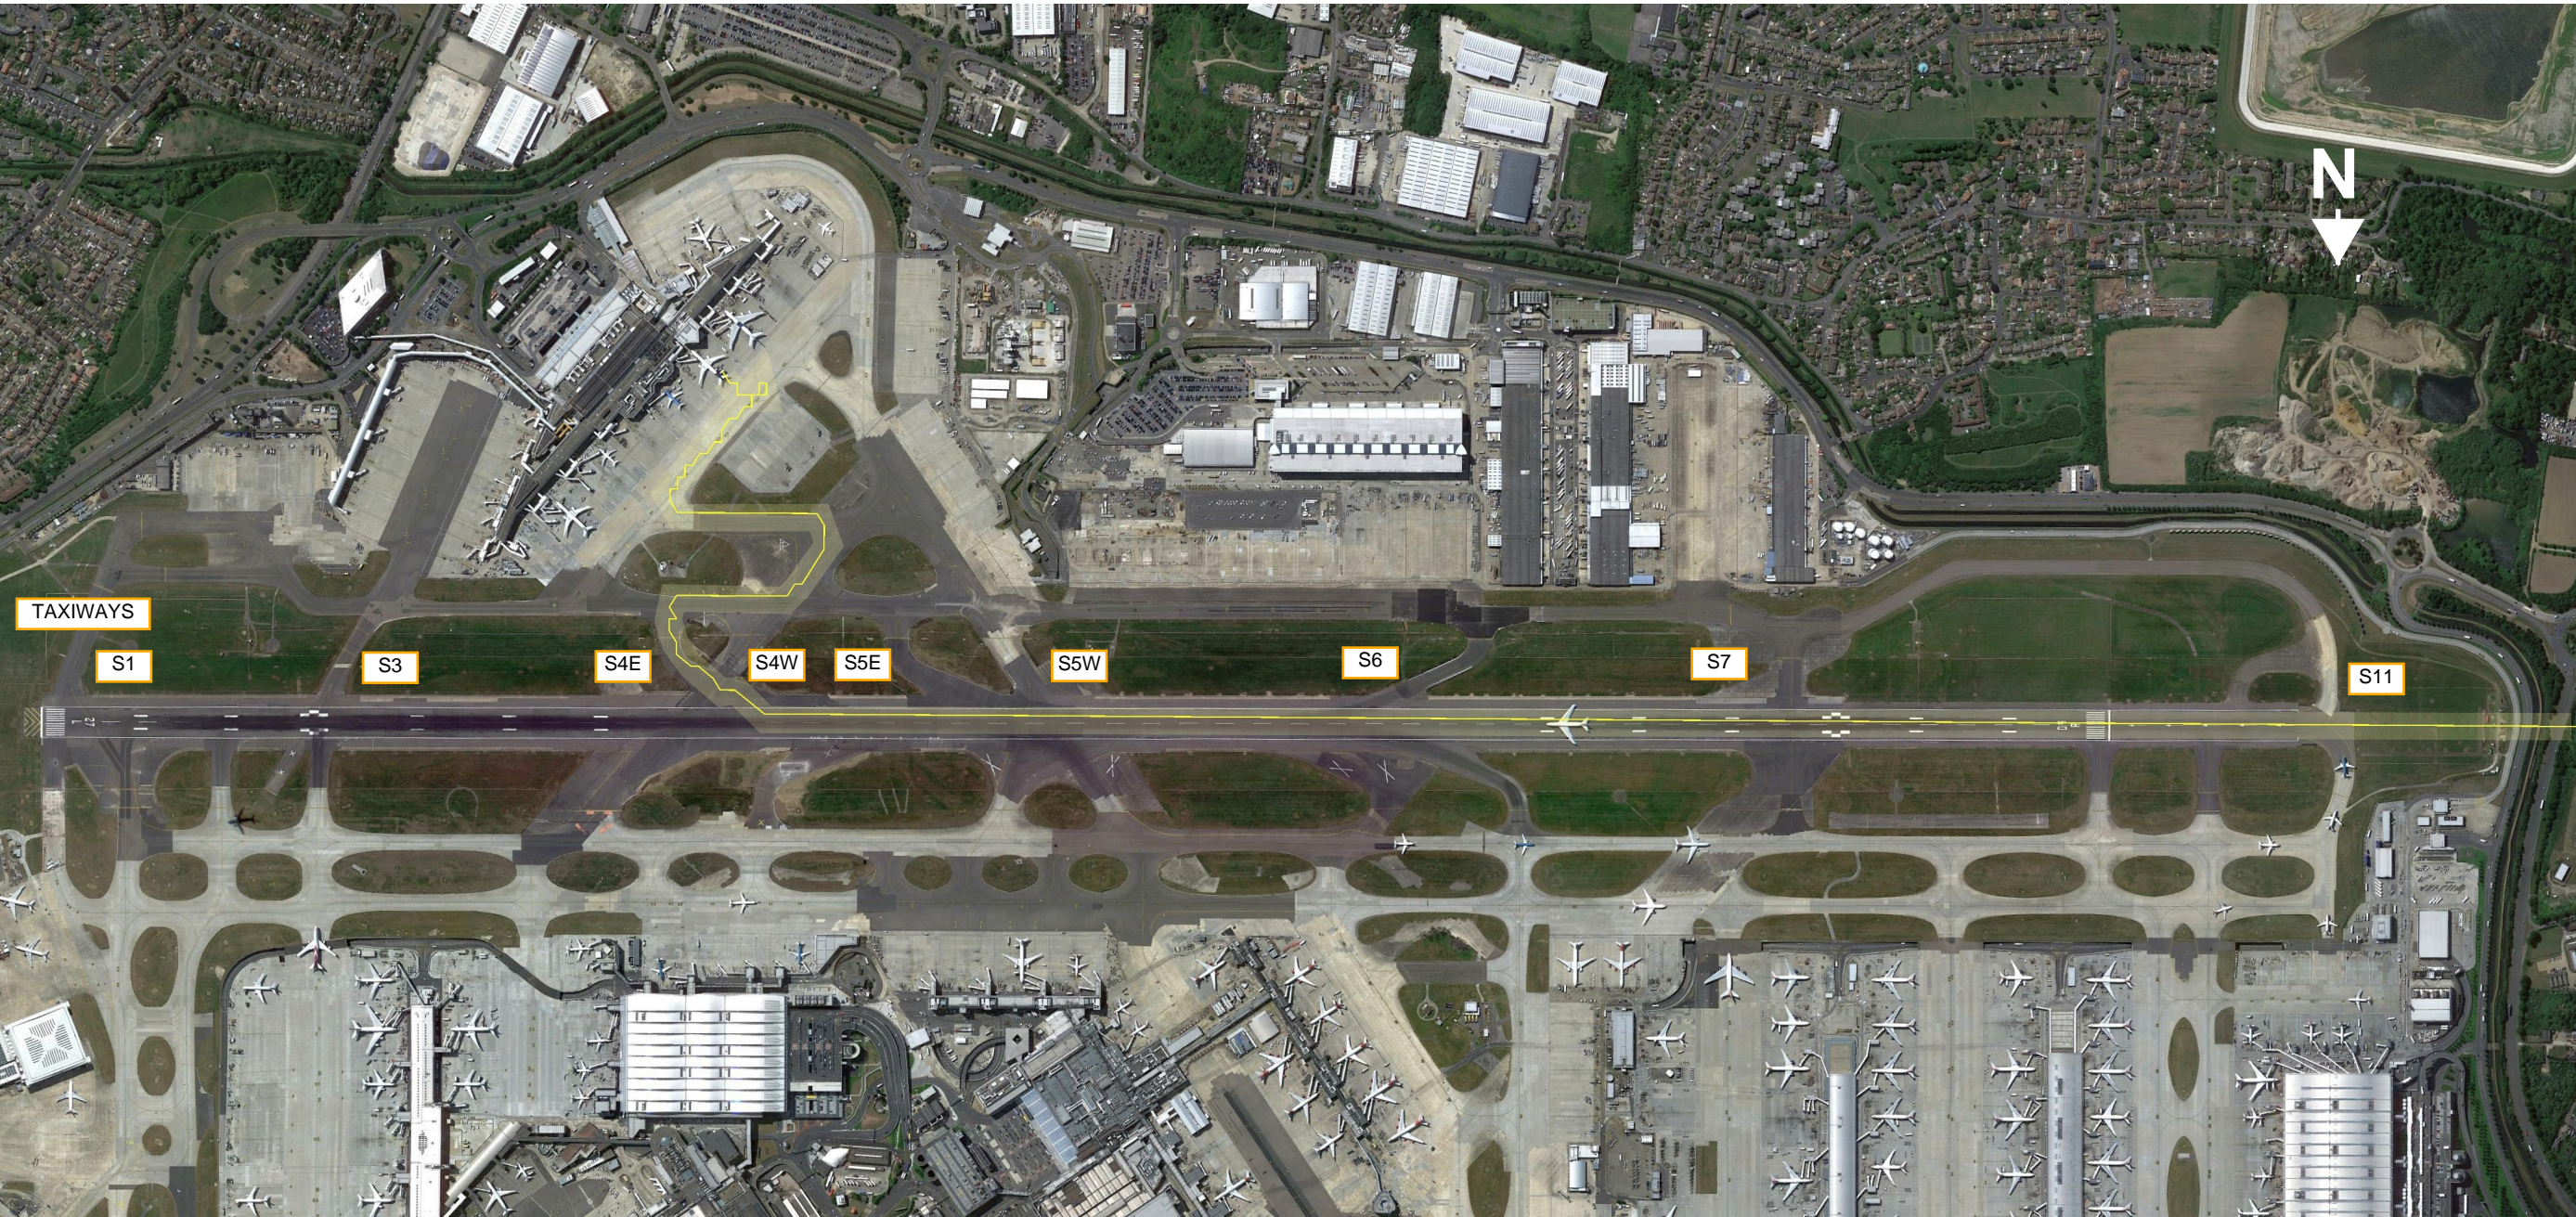
CALC	AERODYNAMICS	11AUG17	REVISED	DATE	JPL 777-300ER VERY LOW TAKEOFF 30AUG2016 -- NON-TIME-ALIGNED QAR DATA GOOGLE EARTH MAP - LATITUDE/LONGITUDE BOEING PROPRIETARY	WD770/VT-JEK
CHECK						FIGURE
APPD						6
APPD

Annexure II shows the QAR recorded latitude and longitude data (in yellow) on a Google Earth image of LHR starting at push back from the terminal through the takeoff roll and liftoff. The data confirmed that the airplane taxied onto RWY 27L using Taxiway S4E.
