**DRAFT FINAL REPORT ON SERIOUS  
INCIDENT (AIRPROX) BETWEEN  
BOEING 787-800 AIRCRAFT VT-AND &  
AIRCRAFT VT-ANI AT DELHI ON  
10.11.2016**

**AIRCRAFT ACCIDENT INVESTIGATION BUREAU**

**Final Report on Serious Incident (Airprox) between Boeing 787-800  
aircraft VT-AND & aircraft VT-ANI at Delhi on 10.11.2016.**

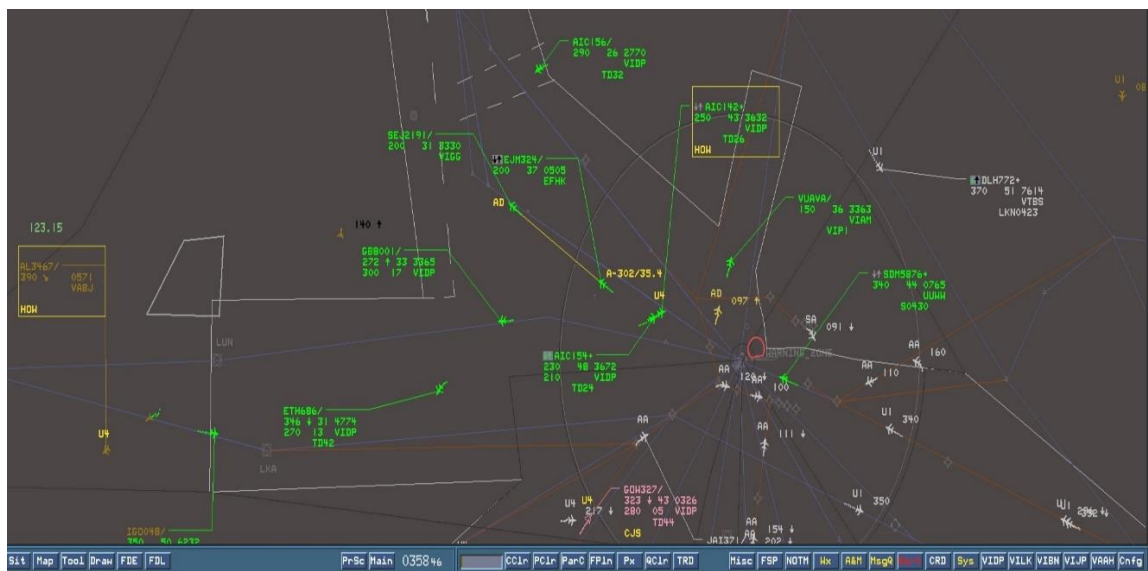
**Radar Snap Shot at 035846 UTC**

AIC154 and AIC142 were given descent to FL230 and FL250, respectively. At time 035835 UTC, AIC156 was given descend FL210. However, in the label the controller filled the cleared level for AIC154.

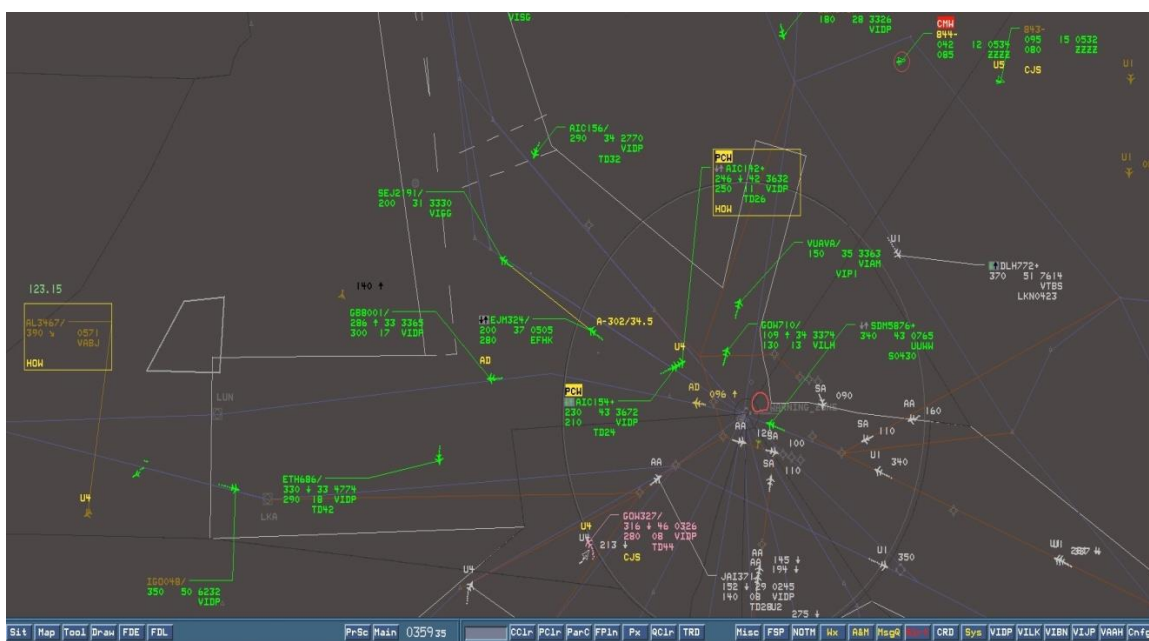
**Radar Snap Shot at 035935 UTC (Predicted Conflict Warning)**

At time 035855 UTC, AIC142 was given descend to FL210. The CFL (Cleared Flight Level) was not filled (In the data block) for AIC142. The transmission was not acknowledged by AIC142. (However, there was a blocked transmission/ garbled noise). Between 035933 UTC and 040020 UTC, PCW (Predicted Conflict Warning) was generated between AIC154 and AIC142, which was probably not acknowledged by the RSR Controller. At that time,

- ✚ AIC142 was descending passing FL246 with a descend rate of 1100' / minute & ground speed of 420 knots.
- ✚ AIC154 was maintaining FL230 with a ground speed of 430 knots.

It is recommended that, necessary action be taken by AAI to ensure that ATCOs give due cognizance to the PCW and take corrective actions immediately.

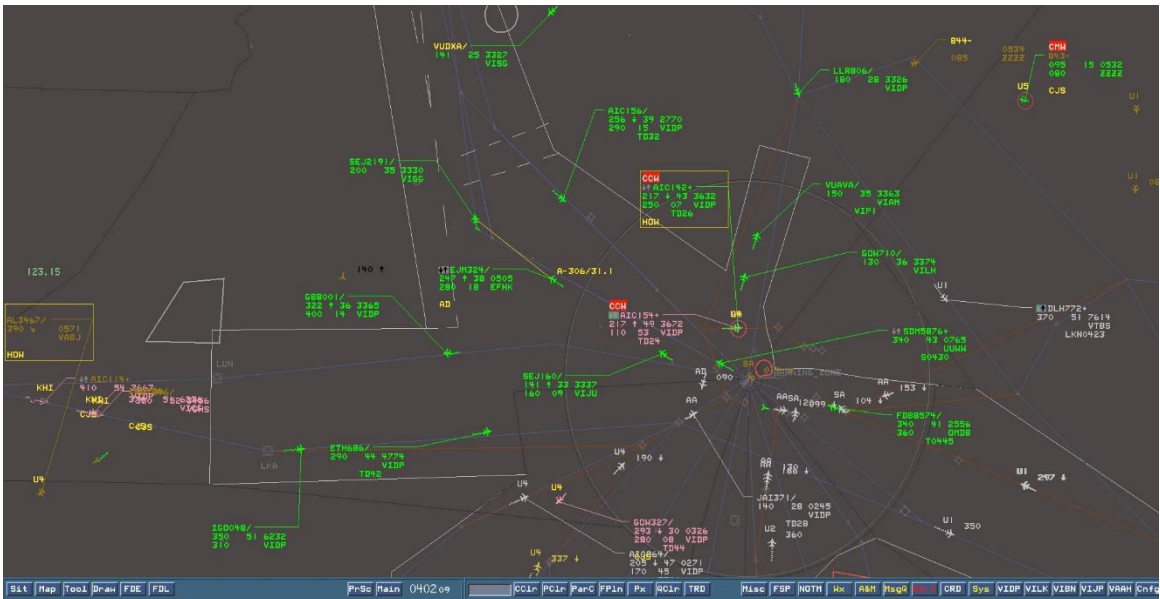
**Radar Snap Shot at 040209 UTC (Current Conflict Warning)**

At 040116 UTC, AIC154 was changed over to Approach Arrival (APAC). At 040138 UTC, APAC controller gave AIC154 to descent to FL110. At 040142 UTC, CCW (Current Conflict Warning) was generated in respect of AIC142 & AIC154, while AIC142 was descending passing FL220, the controller instructed it to maintain FL220. The CCW warning lasted till 040219 UTC. At 040230 UTC, AIC154 came in contact with ACC-West and informed that it is descending to FL110 and also informed that it received RA. Subsequently, AIC142 also informed that it has also received RA.

- **CCW was generated by the ATM system, in respect of AIC154 and AIC142 at 040142 UTC**, the controller immediately instructed AIC142, which was descending passing FL220, to maintain FL220. The CCW lasted till 040219 UTC (37 seconds).
