Final Investigation Report on Accident to
M/s Air India Express Ltd. B-737-800 Aircraft
VT-AYB on 04-09-2017 at Cochin Airport

**FINAL INVESTIGATION REPORT ON ACCIDENT TO M/s AIR INDIA EXPRESS LTD.,
BOEING B 737-800 AIRCRAFT VT-AYB AT COCHIN AIRPORT ON 04-09-2017**

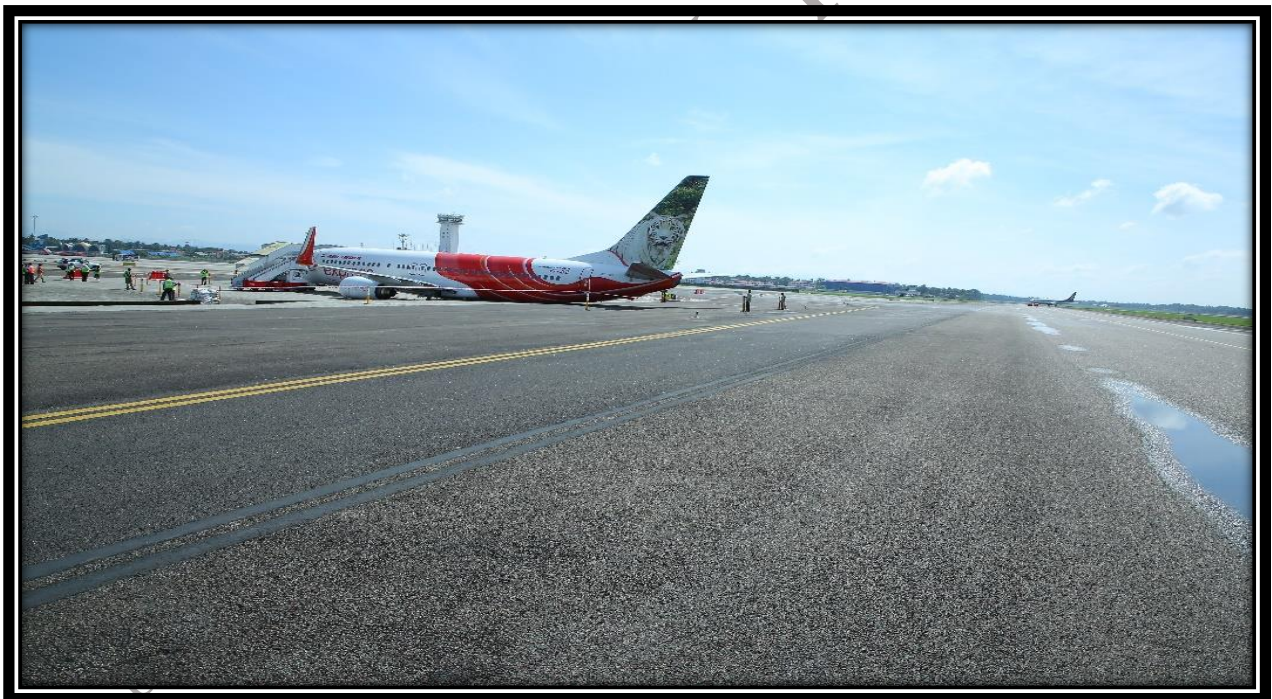
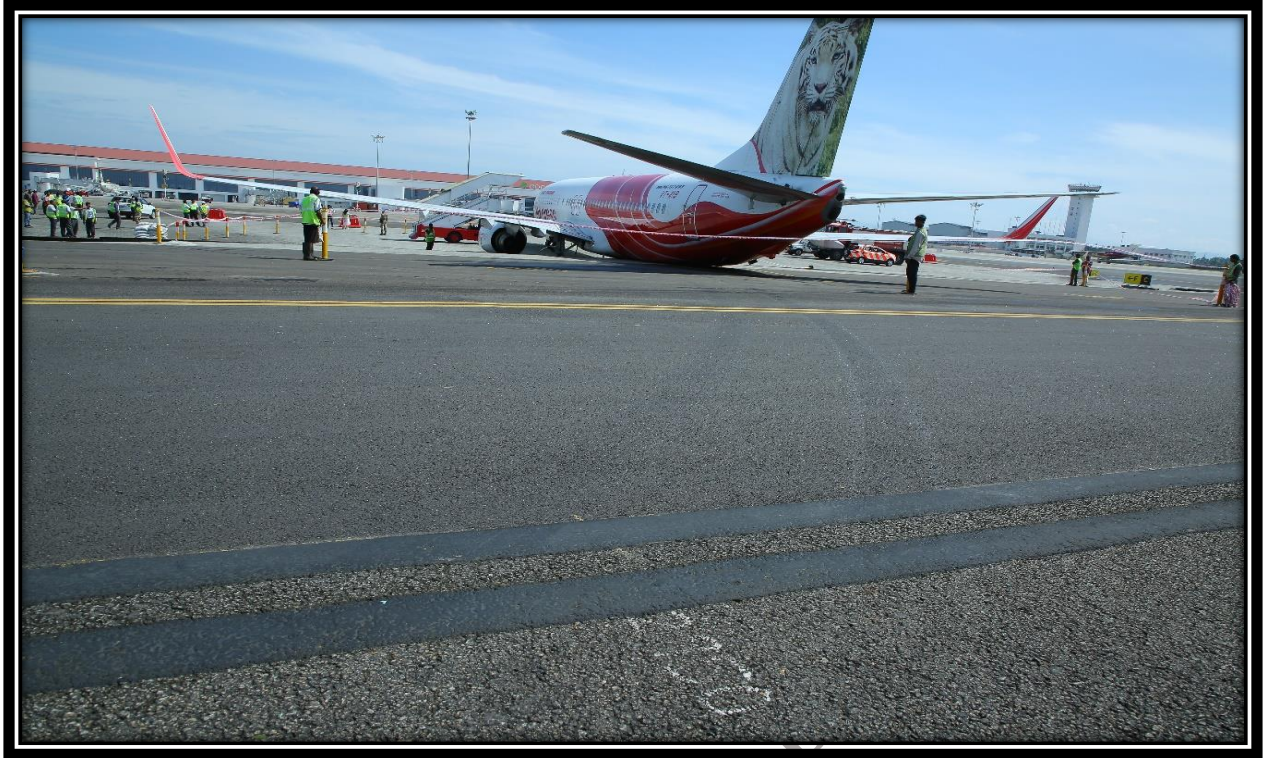
The taxiway markings at CIAL were carried out as per specifications in DGCA CAR Section 4 Series B Part 1-Aerodrome Design & Operations and ICAO Aerodrome Design Manual Part 4 .The markings at Taxiway C were repainted in March 2017 and Markings on Taxiway F were repainted in July 2017. However as per CVR tape transcript, the taxiway marking were was not visible. The DGCA team also found on 05-09-2017 that Taxiway C Centerline Marking was not visible. As per records submitted by ATC, a few other aircraft also reported that Taxiway Marking were barely visible during the month of April, May and June 2017.

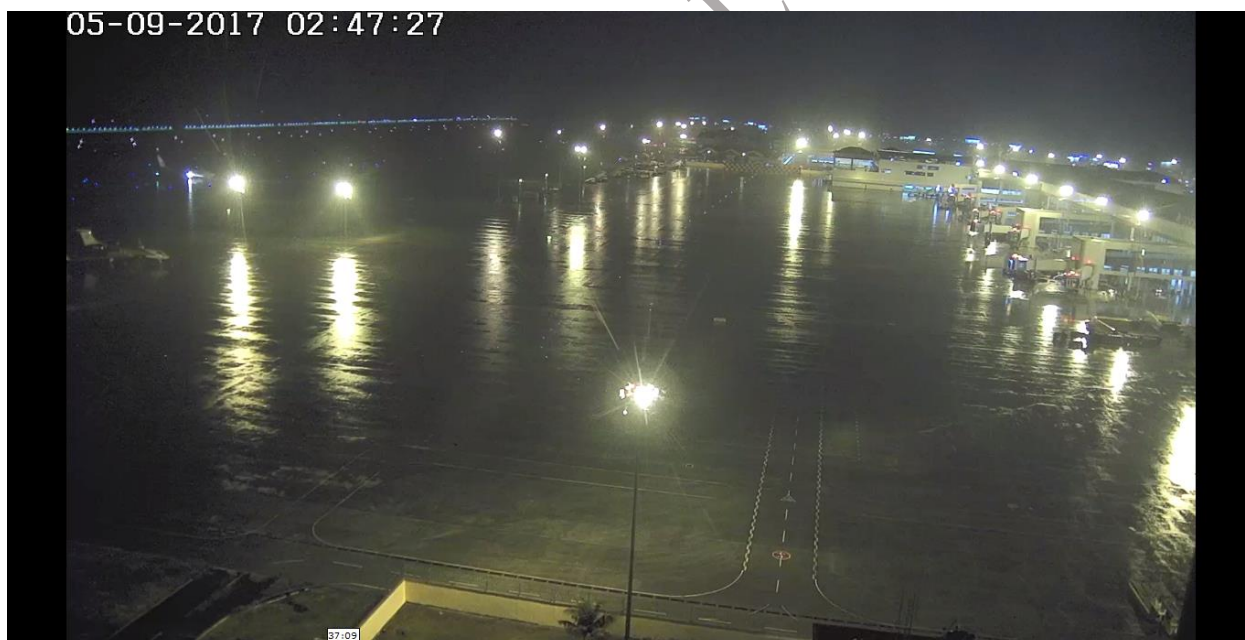
Apron Green taxi way center light glowing low before the accident.

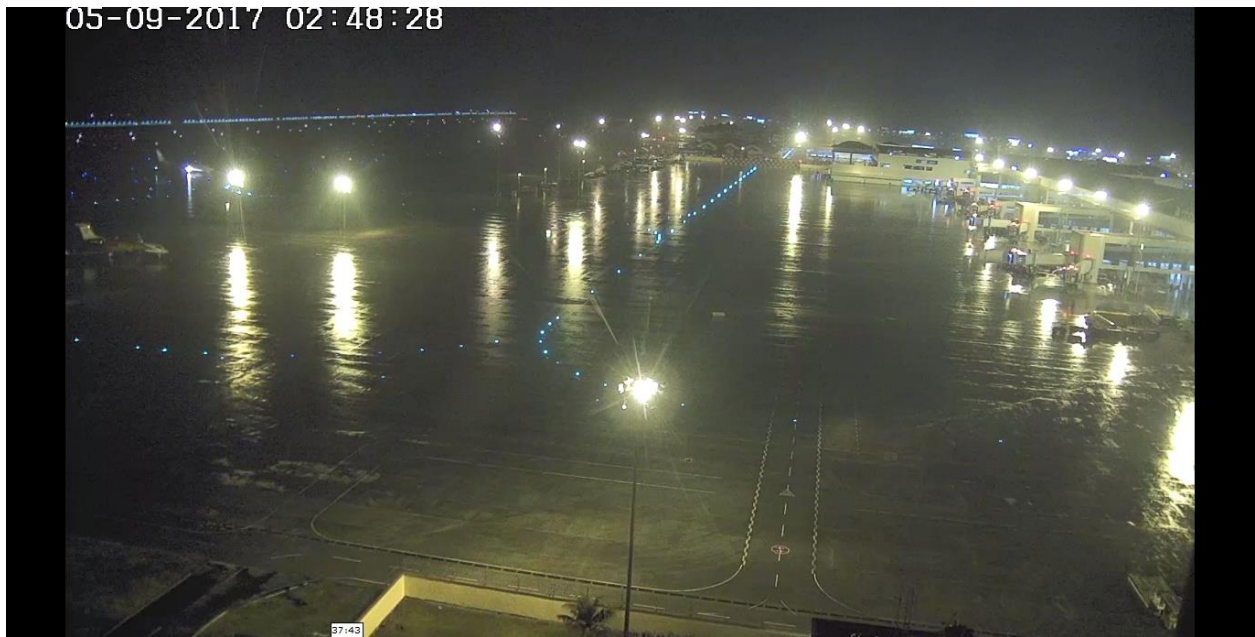
Apron Green taxi way center light intensity increased to high after accident (211327 UTC)

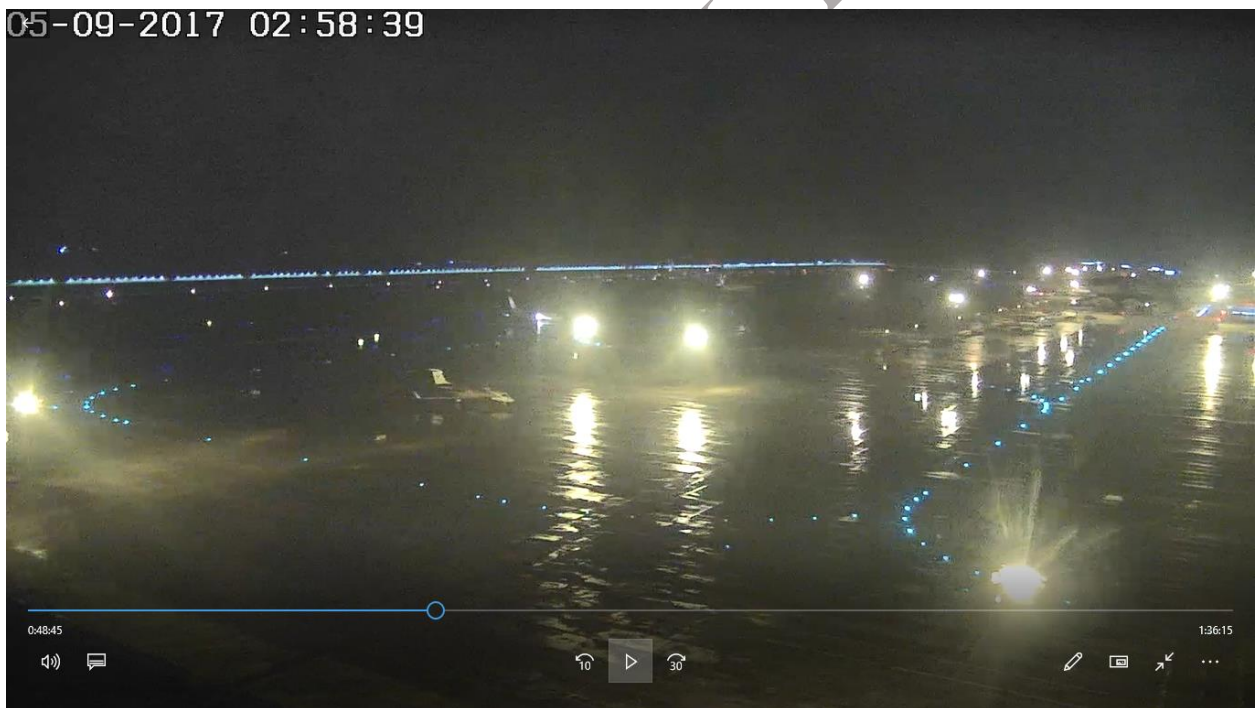
Green Centreline light extending upto the taxi track link Taxiway F.
Review of ATC tape reveals, no request was made by VT-AYB for increasing the intensity of lights
