FINAL INVESTIGATION REPORT ON ACCIDENT
TO PIPER SENECA PA-34 AIRCRAFT
VT-BCA OF M/s THE BOMBAY FLYING CLUB
AT DHULE ON 01/12/2017

**FINAL INVESTIGATION REPORT ON ACCIDENT TO M/s THE
BOMBAY FLYING CLUB PIPER SENECA PA-34 AIRCRAFT VT-
BCA AT DATARTI VILLAGE, NEAR DHULE,
MAHARASHTRA ON 01/12/2017**

SYNOPSIS

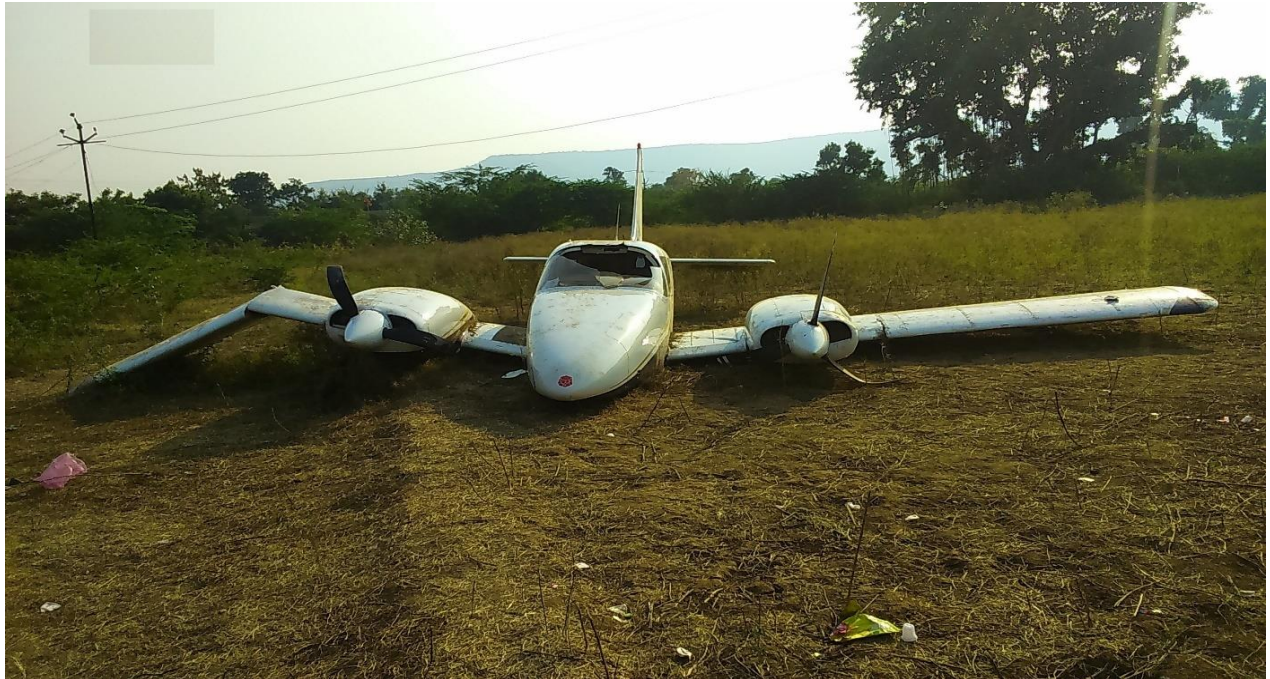
Fig: Aircraft final position at crash site

After force landing in an open field near Datarti village, the aircraft did not travel significantly. The aircraft touched levelled ground as evident by both wing tips, nose and tail of the aircraft remained unaffected. Both propellers contacted ground and were damaged.

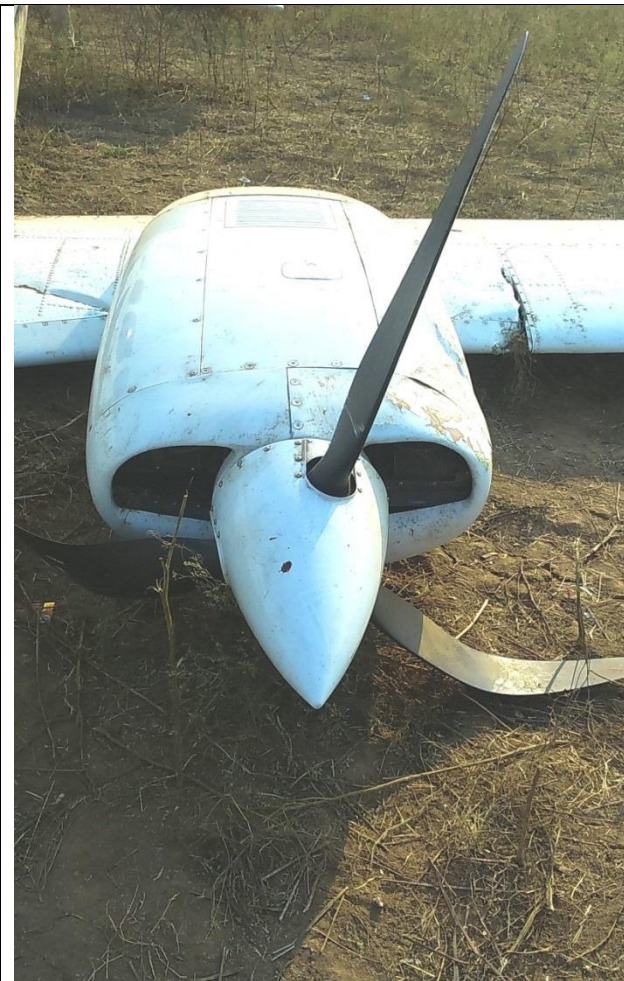
- a. LH propeller's two blades were found bent in the aft direction.
- b. LH engine cowling was found damaged.
- c. Deep cut on the leading edge of the wing near engine.
- d. Random wrinkles were found all along the wing.

Left Engine Propeller Blades

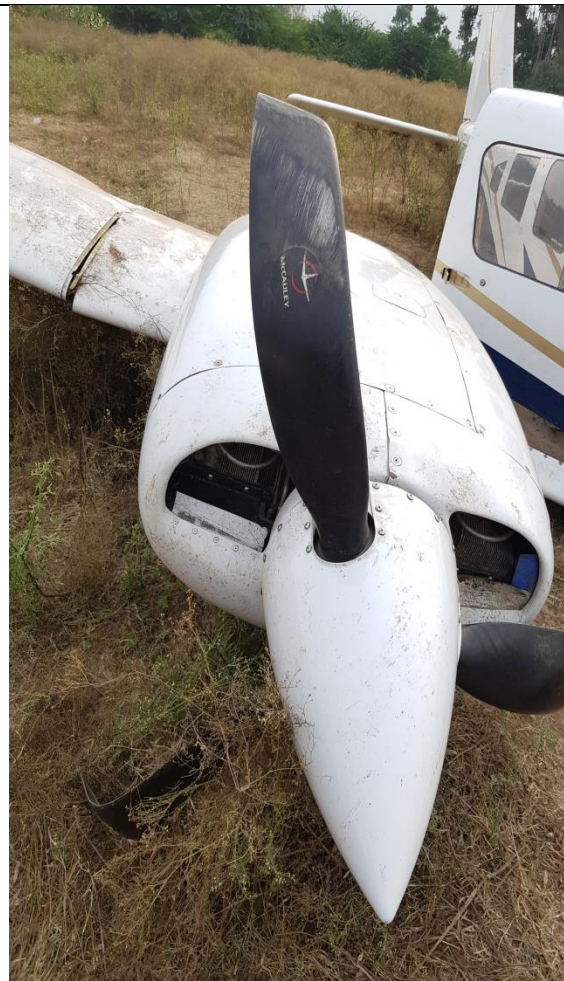
- a. Wing was found broken from the mid section.
- b. Wing surface had significant dents & wrinkles.
- c. All propeller blades were found bent.

Right Engine Propeller Blades

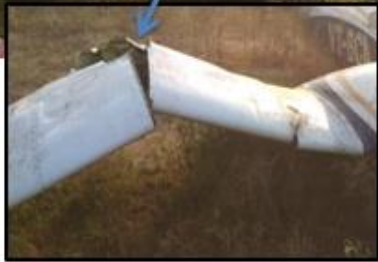
- Both wing surfaces were wrinkled and cracked. RH wing had suffered a deep cut. However, there were no signs of fuel leakage.

Cut Mark

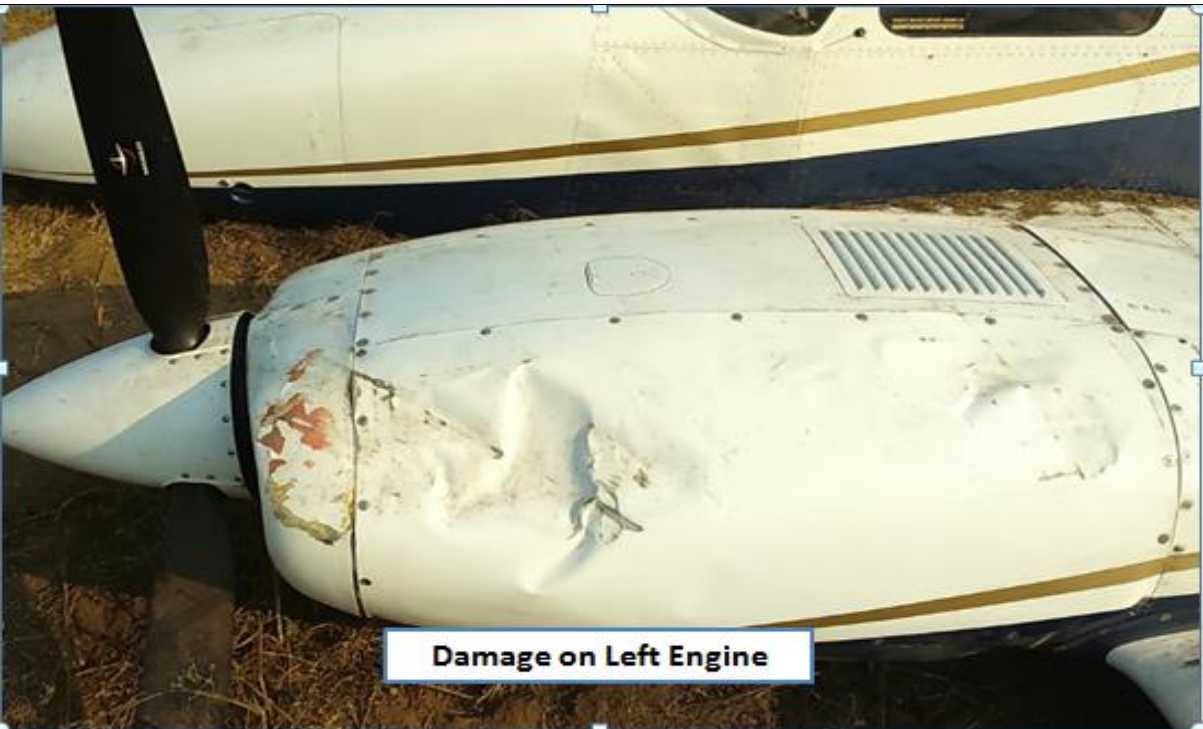
Damage on Left Engine
