**FINAL REPORT ON ACCIDENT TO
GOVT. OF MAHARASHTRA
SIKORSKY S-76C++ HELICOPTER
VT- CMM
AT NILANGA, LATUR
ON 25/05/2017**

**A X Joseph
Deputy Director, AAIB
Chairman, Committee of Inquiry**

1. Aircraft Type : Sikorsky S76 C++
Nationality : INDIAN
Registration : VT – CMM
2. Owner : Government of Maharashtra.
3. Operator : Government of Maharashtra.
4. Pilot – in –Command : CHPL holder on type
Extent of injuries : Nil
5. First Officer : CHPL Holder on type
Extent of injuries : Nil
6. Place of Incident : Nilanga, District Latur
7. Geographical Co-Ordinates : 18°07’34’’N, 76°44’57’’E
8. Date & Time of Incident : 25th May 2017, 0625 UTC
9. Last point of Departure : Nilanga, District Latur
10. Point of intended landing : Raj Bhawan, Mumbai
11. Type of operation : Non Schedule Operation
12. Crew on Board : 02
13. Passengers on Board : 04
14. Phase of operation : Take off
15. Type of accident : Crash landing after hitting Electrical
High Tension Cables

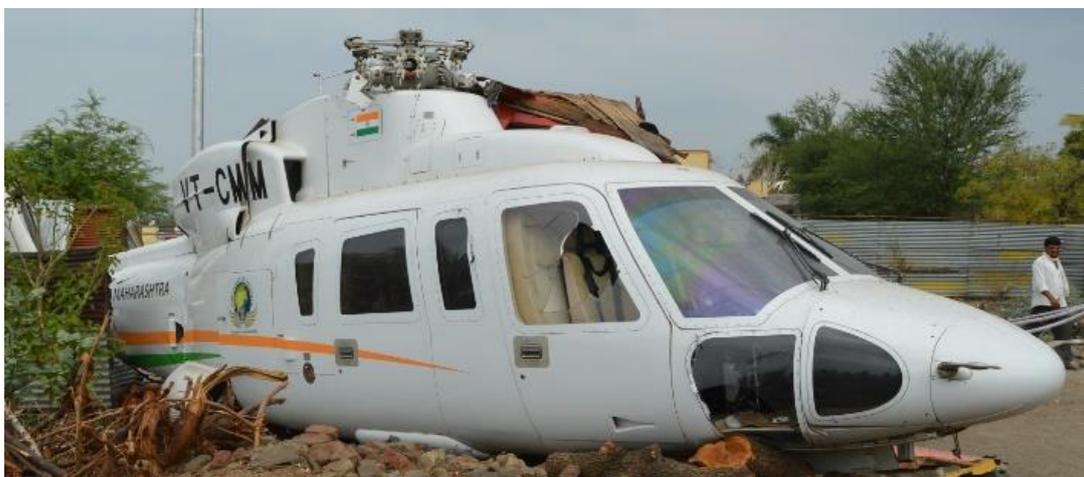
Fig:1- Main Fuselage

1. All the four main rotor blades had sheared off from its root attachment after the impact with the tree and roof of the parked truck.

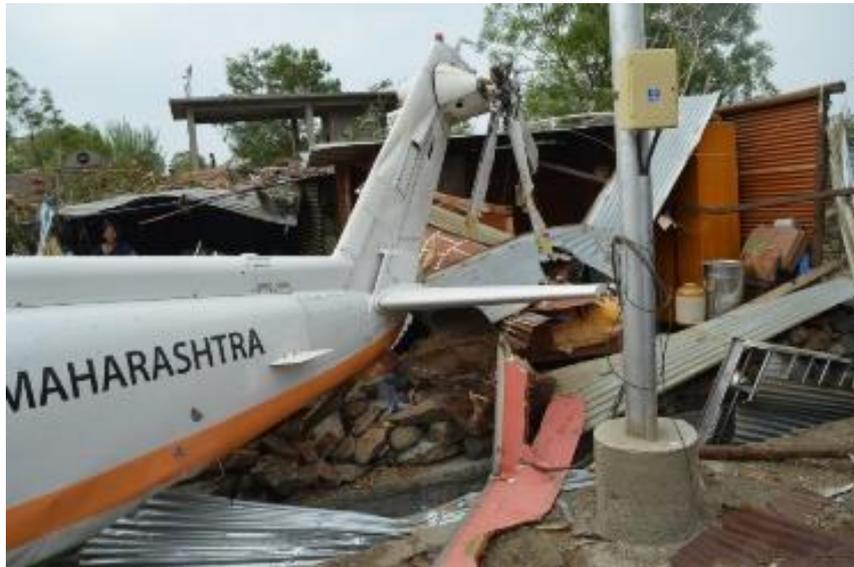
Fig:2 – Tail Portion

2. All pitch link rods for the main rotor blades were broken.
3. All the four tail rotor blades damaged after its impact with the house structure.

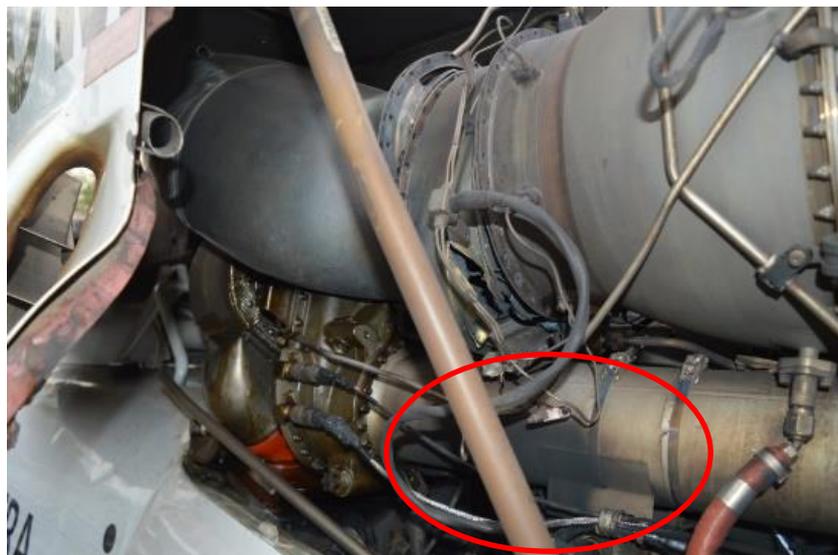
Fig:3 – Starboard Engine Power Turbine casing

7. The starboard engine Power turbine casing had burst open with local thermal damage in the surrounding area.

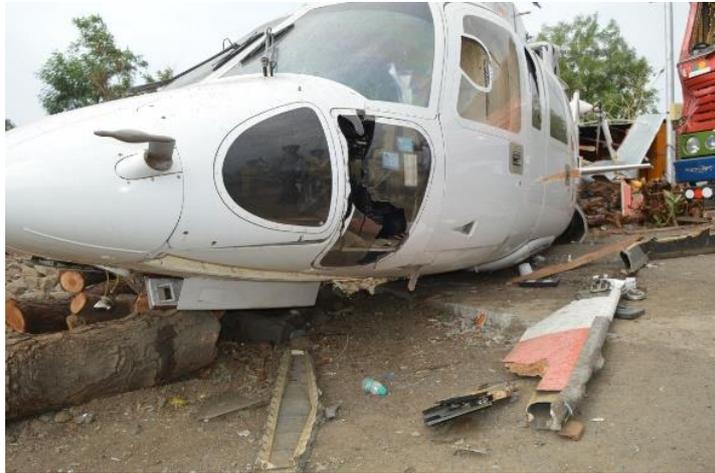
Fig:4 – Damaged Plexi window

8. Belly of tail boom had multiple dents
9. LH engine cowl was damaged
10. LH Passenger window was broken.
11. LH Cargo door was damaged.

12. Co-pilot window plexi was broken.
13. Pilot and Co-pilot wind shield were broken.

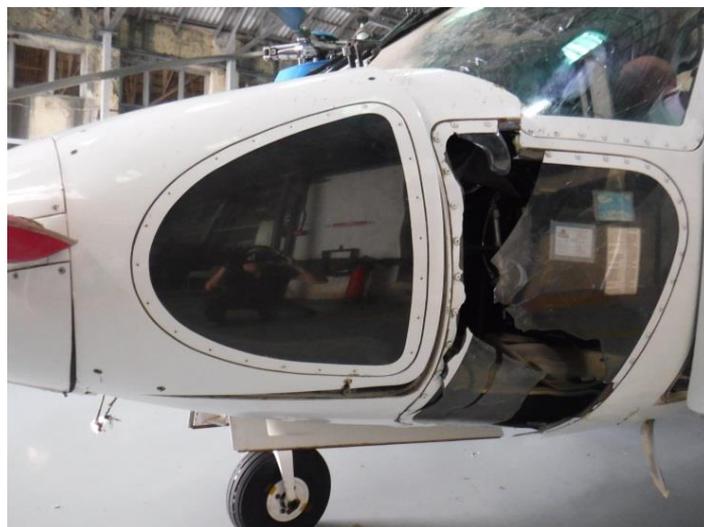
Fig:5 - Nose frame

The airframe was primarily intact. Nose frame was fractured and buckled just below the windshield on the left side, aft of the left electronics compartment access panel, through the second chin bubble at about fuselage station (STA) 60.

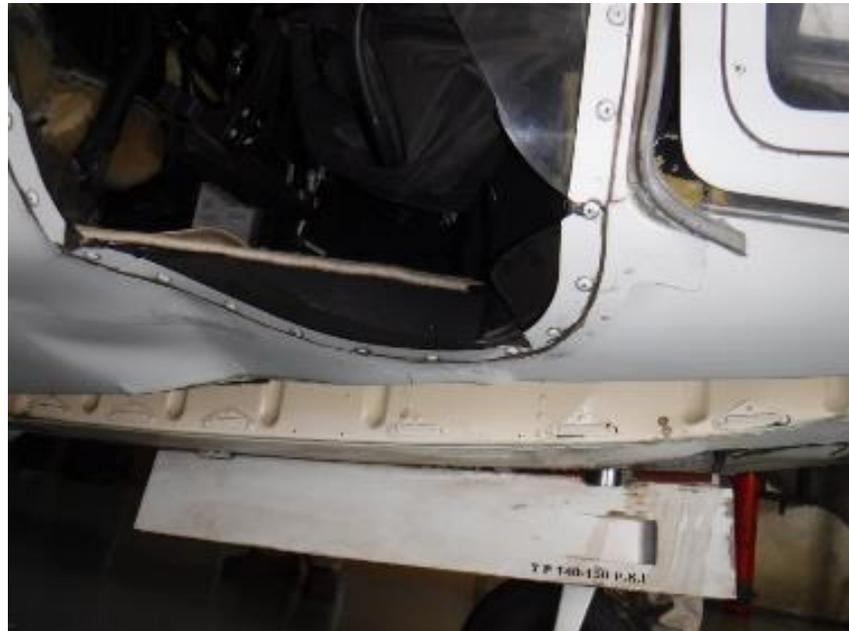
Fig:6 – RH side electronics access panel

Nose frame had damages on the right side aft of the right electronics access panel. The mounting brackets of the LRUs in the right side electronics bay were fractured.

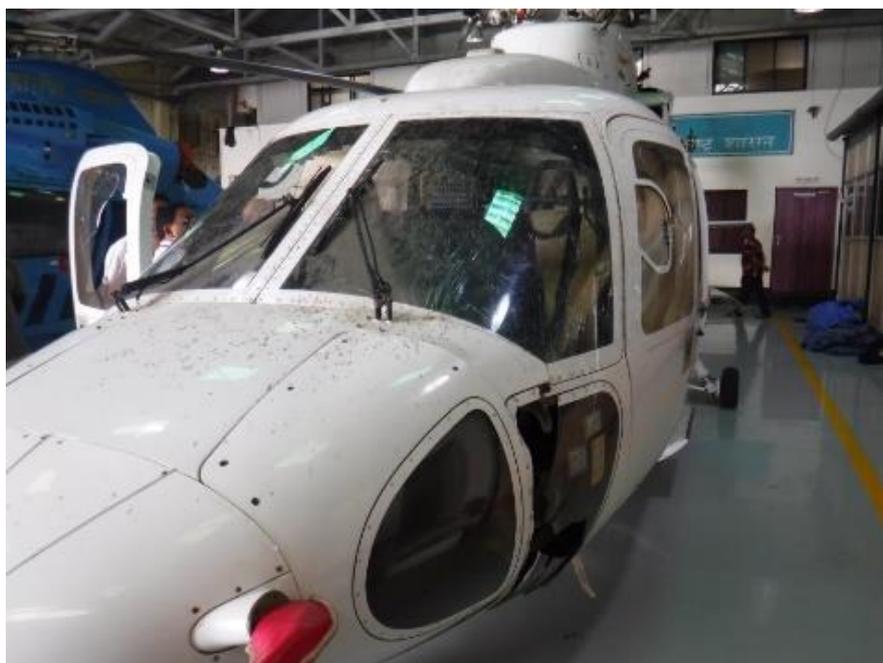
Fig:7 – LH Nose section

The left hand windshield was cracked but in place. The under-deck was buckled from STA 40 to 93. The aft right side pilot's second chin window was fractured at STA 70.

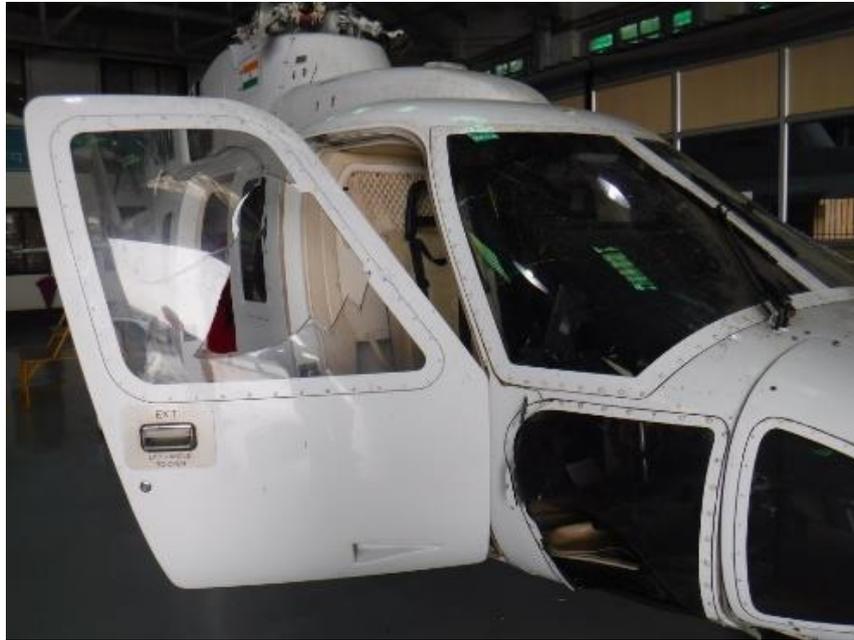
Fig:8 – RH Nose Section

The right side pilot's door and door frame were buckled near the hinge at about fuselage station (STA) 120 but the door still operated. The window in the right side door was cracked. The cockpit canopy and right windshield were intact.

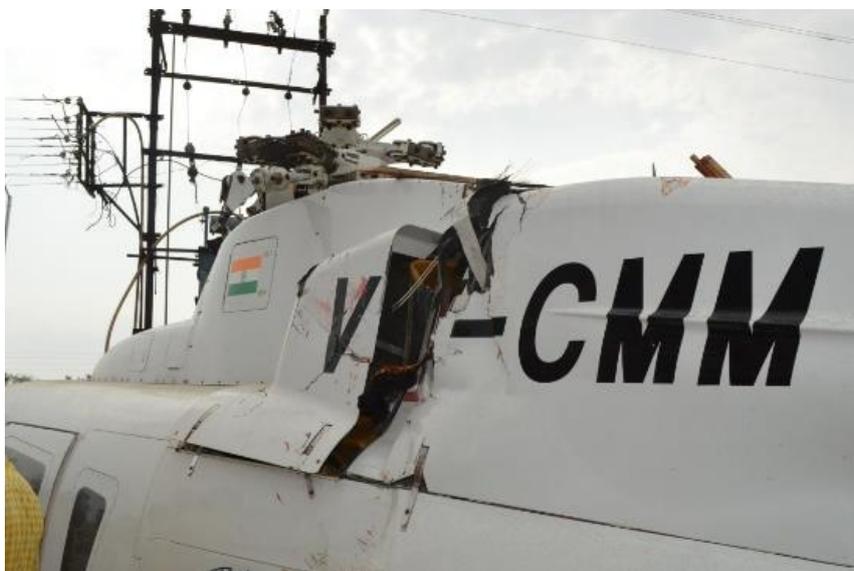
Fig:9 – LH Engine cowl

The number 1 engine inlet cowl and aft engine cowl showed impact damage and there was a vertical tear bisecting the registration number. A rod belonging to the lorry that was hit during the impact sequence pierced the left side.

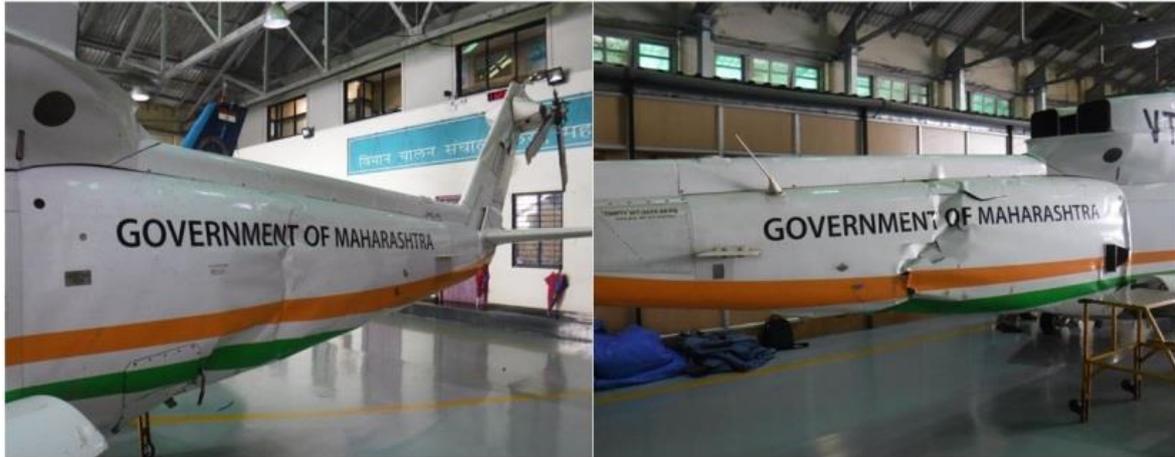
Fig:10 – Damaged Tail Section

Both the left and right sides of the tail cone were buckled just aft of the tail cone access panel and at STA 390. The horizontal stabilizer was still attached but fractured on the left attachment point. The left hand anti-collision light was broken. The vertical stabilizer fairing was fractured near the tail gearbox.

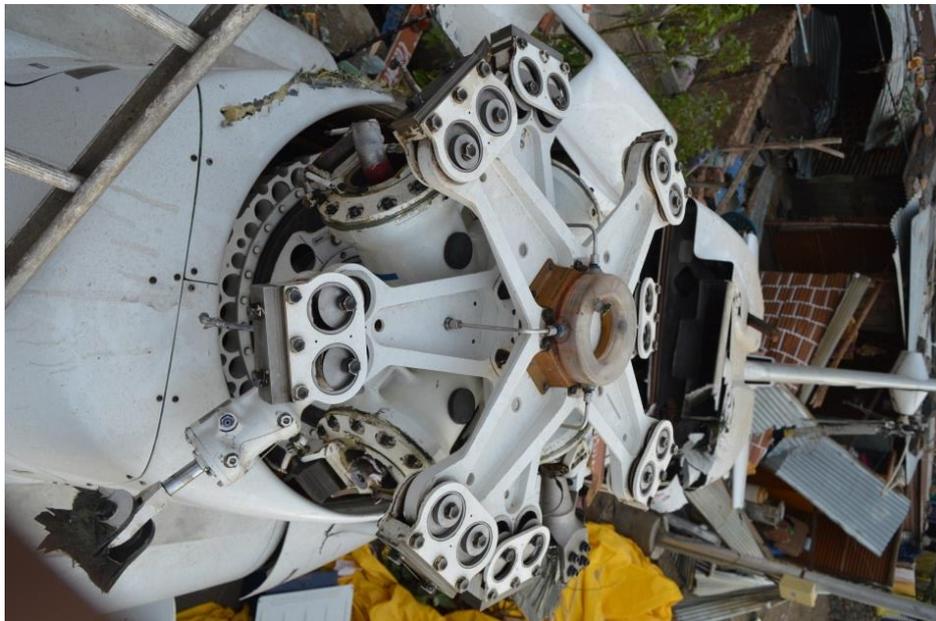
Fig:11 – Rotor Head

Three Main Rotor blades fractured at the spindle and one blade fractured at the blade cuff. The Red MRB was fractured at the spindle in the lag direction. The Blue MRB was fractured at the spindle in the lag direction about 45°. The

Yellow MRB was fractured at the spindle in the lag direction. The Black MRB was fractured at blade station BS 0 (cuff) in the lag direction.

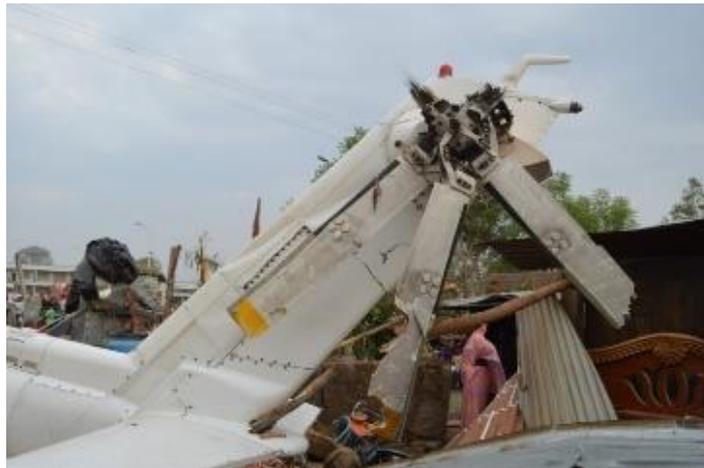
Fig:12 – Tail Rotor Head

All four tail rotor blades (TRB) were damaged during the mishap due to impact with the wires. Two blades separated at the blade root leaving only 4 inches of broom straw; A third blade was fractured just aft of the spar. The fourth blade remained attached from root to tip but was significantly damaged on the blade surface and trailing edge.

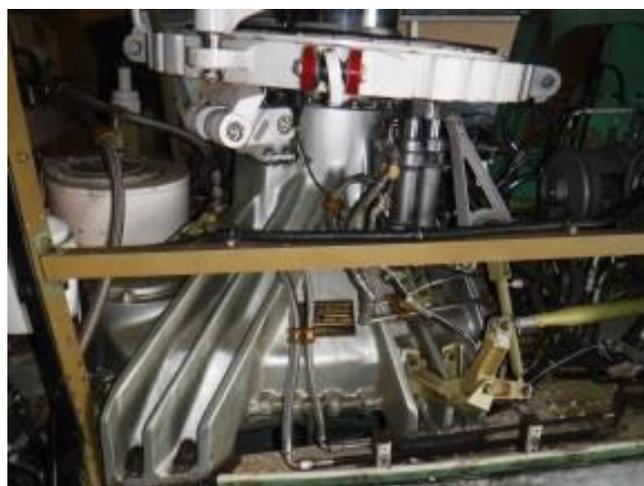
Fig:13 - Main gearbox attachment

The main gearbox remained attached to the airframe. All four mounting feet and all eight mounting bolts were intact. Mechanical continuity was confirmed by rotating the inputs and MRH and observing corresponding motions.

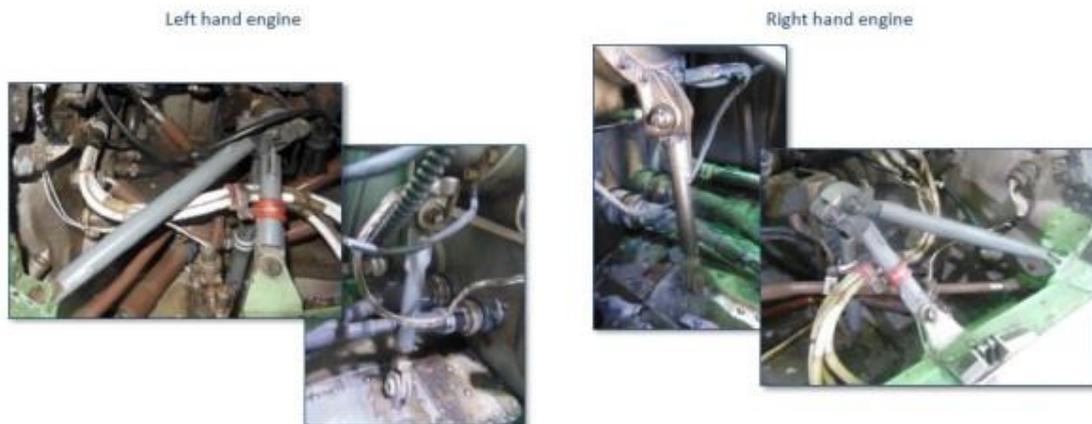
Fig:14 – Engine mountings

Engines: All engine mounting bolts were intact. Both engines were attached to the helicopter by the front and rear supports.

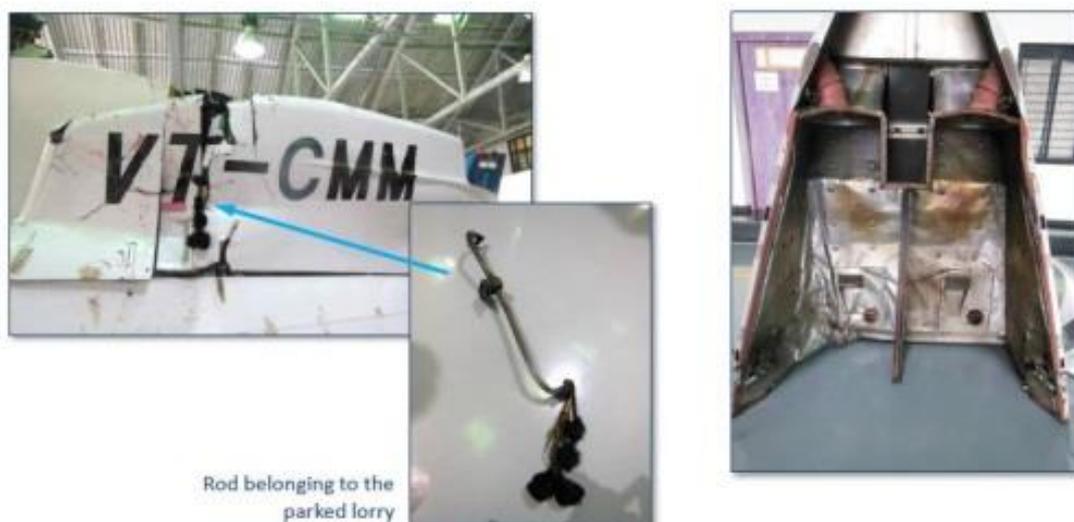
Fig:15 – Engine cowling

The engine cowling revealed impact damage to its left hand side. A rod belonging to the lorry that was hit during the crash had pierced and penetrated the cowling's left flank. The inside of the cowling was unremarkable with light heat stains (the RH one being slightly larger) in the vicinity of the engines' turbines.

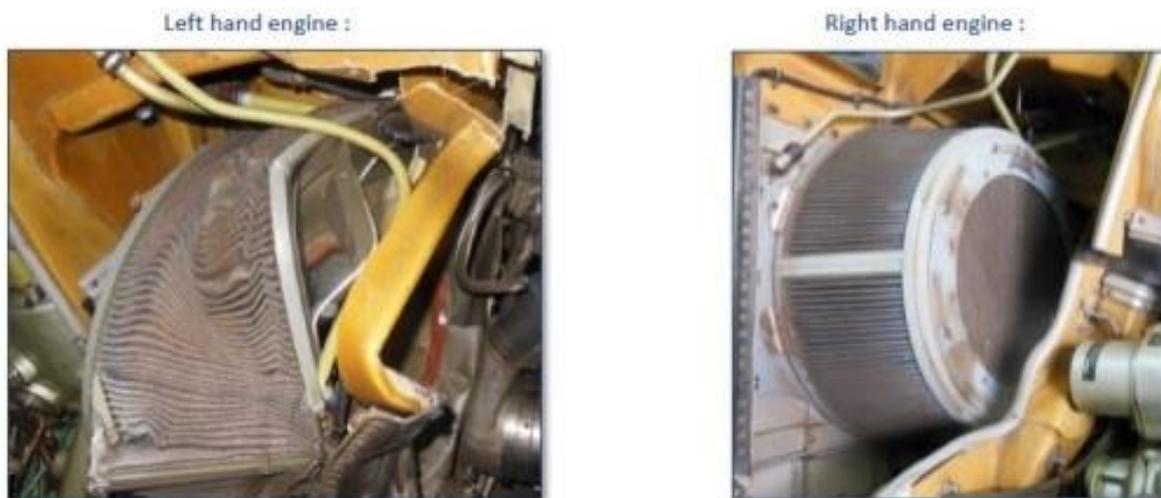
Fig:16 – Air Intake Filters

Both air intakes were fitted with sand filters which showed the presence of dust and small debris of vegetation. The RH filter was in good condition. The

LH filter was damaged during the sequence of the accident, leaving gaps that could allow debris to penetrate into the main air path.

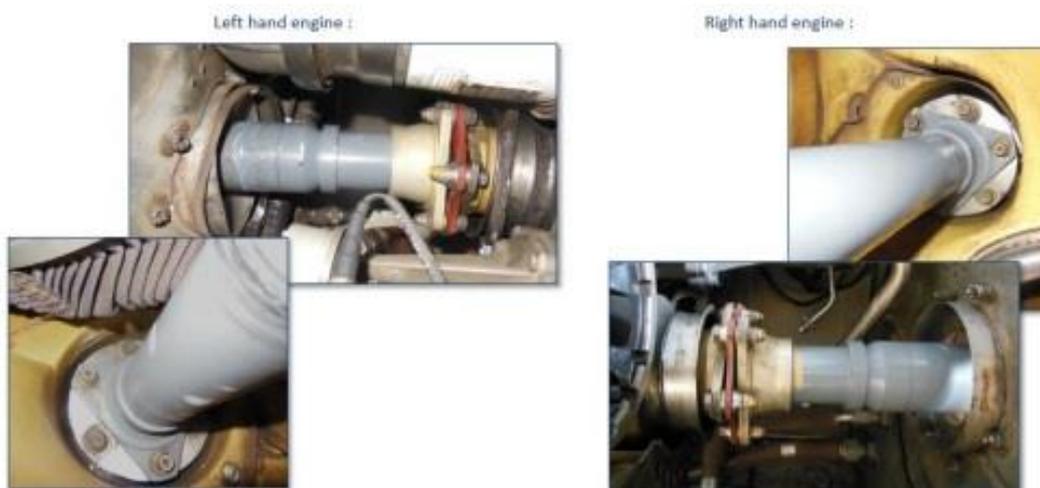
Fig:17 – Drive Shafts

The drive shafts were in place on both sides. The LH shaft showed circular traces of contact with static parts and a slightly warped flexible coupling indicative of light misalignment between the engine and the Main Gearbox as a consequence of the accident. The RH shaft did not exhibit any remarkable findings.

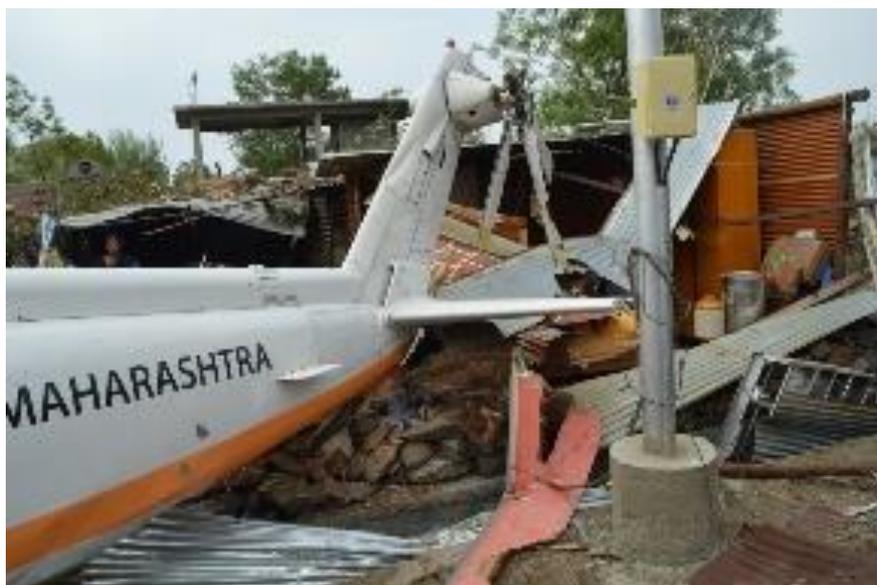
Fig:18 – Hut hit by tail boom

1.4 Other damage: The Helicopter tail boom hit a hut causing its roof and wall to collapse on the occupants.

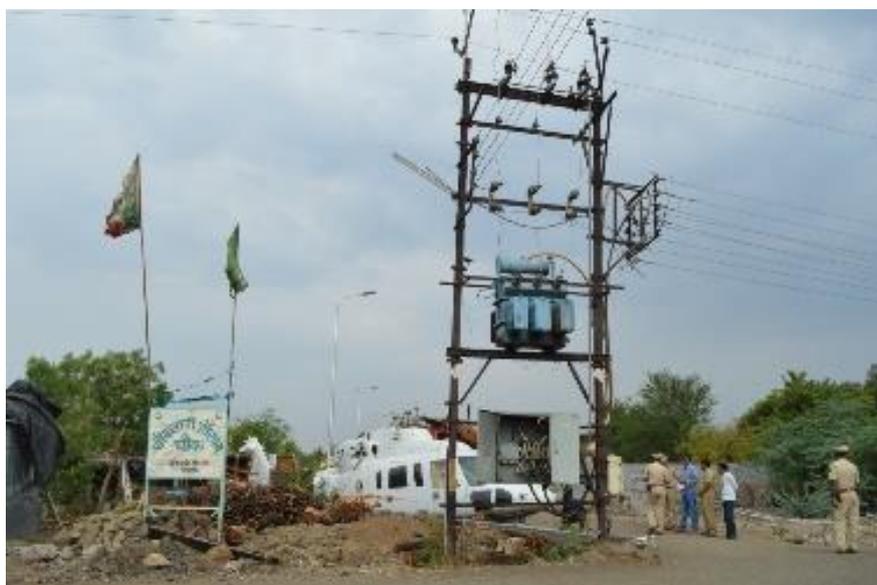
Fig:19 – 11 KV Electricity Transmission line

- The helicopter had hit a 11KV Electrical Cable, resulting in snapping of the cable. The cable had to be repaired to restore electricity supply.

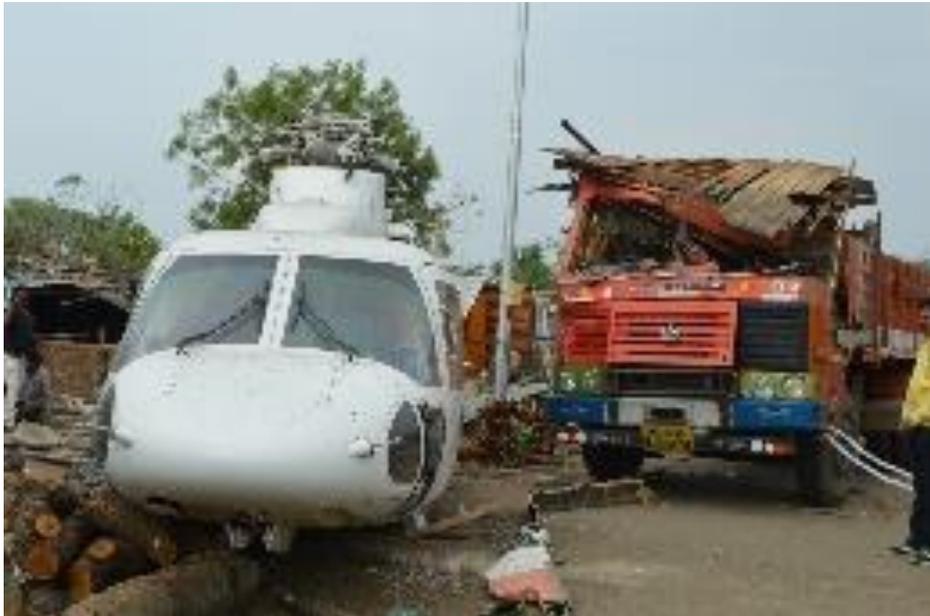
Fig:20 – Truck hit by Main Rotor

- The Main Rotor of the Helicopter had hit a tree and a truck parked nearby. The cabin of the truck was damaged by the impact of rotorblades and a steel railing from the truck got entangled in the main rotor blade.

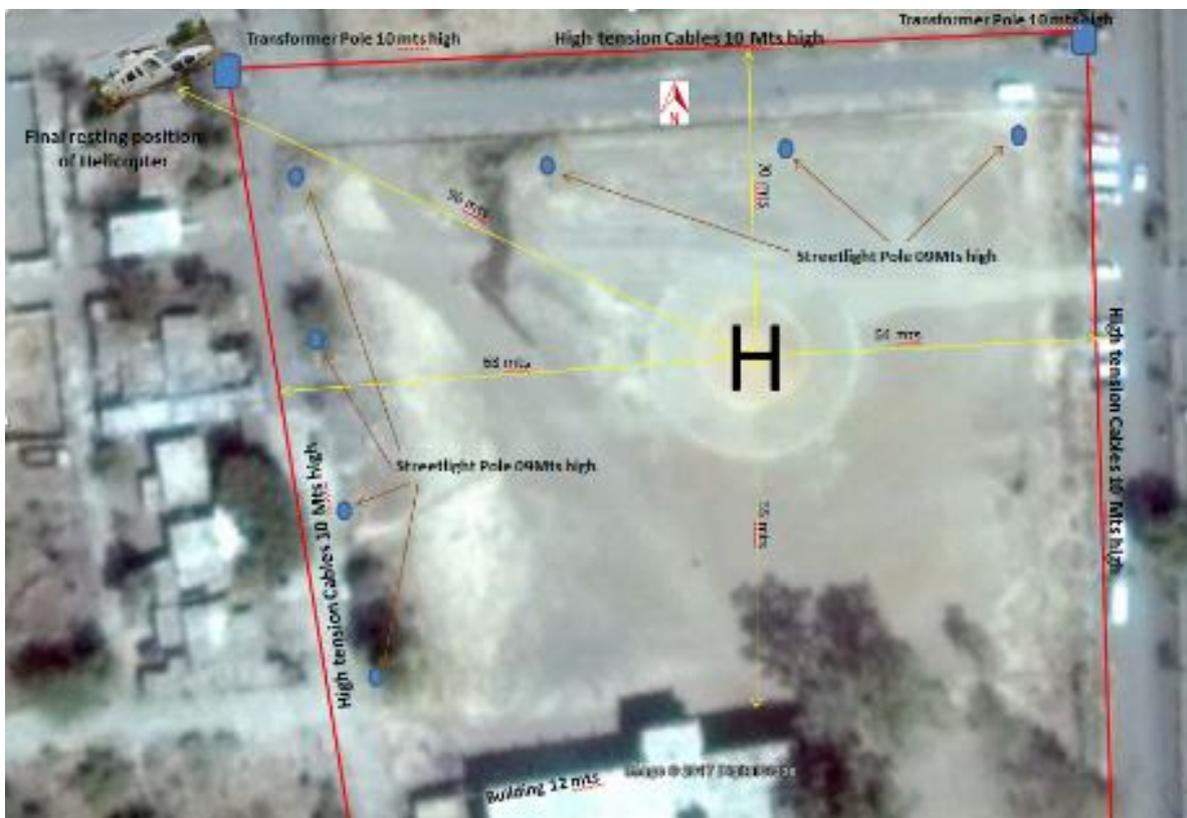
Fig:28 – Layout of the temporary landing ground.

The temporary landing ground is surrounded by high tension 11 KV electricity cables on three sides and high trees and building on one side. The electricity poles of 10m height (33 ft) carrying the 11 KV electricity cables are located at a distance of 64 mts from the centre of helipad in east direction and in the west direction electricity poles of 10m height carrying the 11 KV electricity cables are located at a distance of 68 mts from centre.

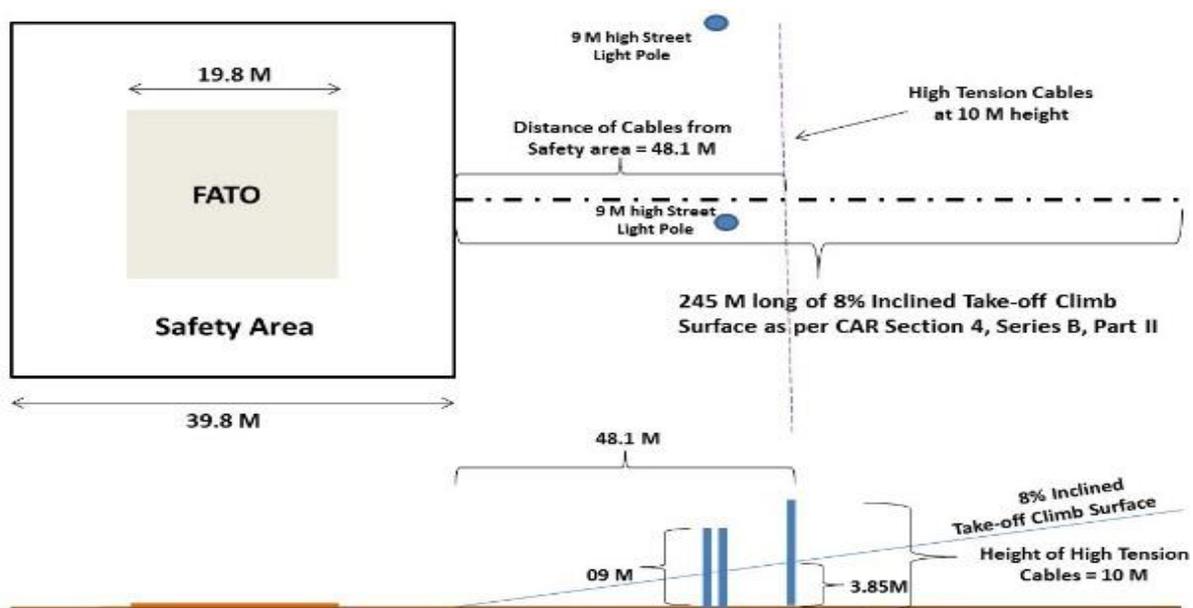
Fig:29 – Obstruction around the FATO

Further as per the para 4.6 of CAR Section 4, Series B, Part II, “An Approach and Take-off climb surface in an inclined plane sloping upwards (8%) from the end of the safety area and centered on a line passing through the centre of the FATO, should be available for a distance of at least 245 meters.”

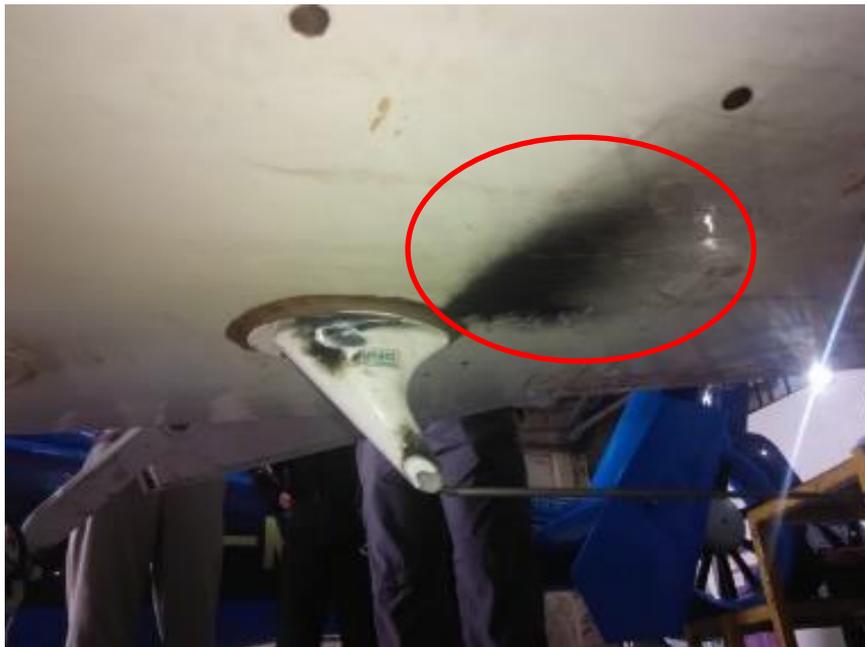
Fig:31 - Burn marks on belly

the belly of the helicopter hit the cables and caused it to snap, and the helicopter yawed to the right.

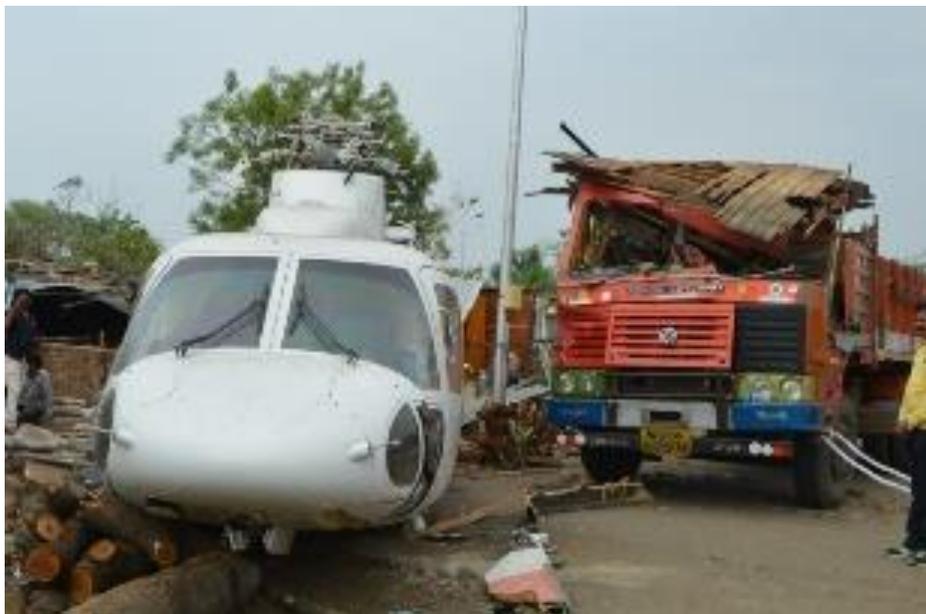
Fig:32 – Truck hit by main rotor

7. Subsequently, the main rotor blade hit the tree and blades disintegrated.
8. The helicopter there after crash landed and settled on the ground between truck and the hut.

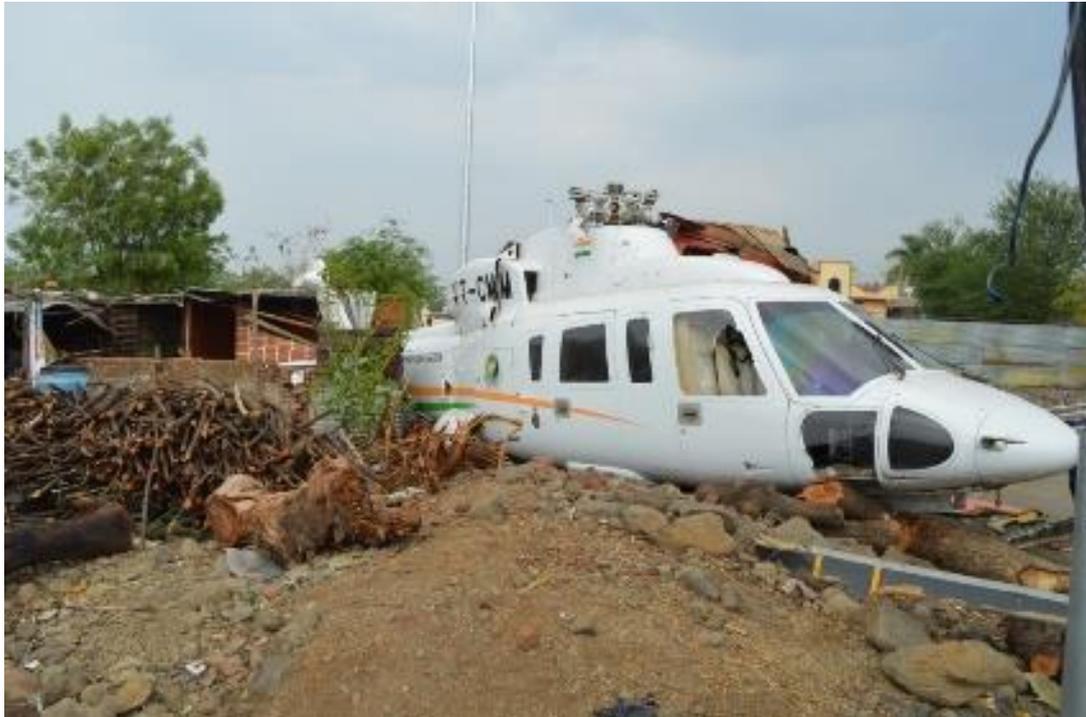
Fig:33 – Final resting position of helicopter

10. The tail boom of the helicopter hit a temporary house and damaged it and also injuring its occupants.
11. The one end of the snapped cable hit one of the person standing close to the accident side and injured him.
12. There was no fire after the helicopter impacted various obstacles before settling on the ground.

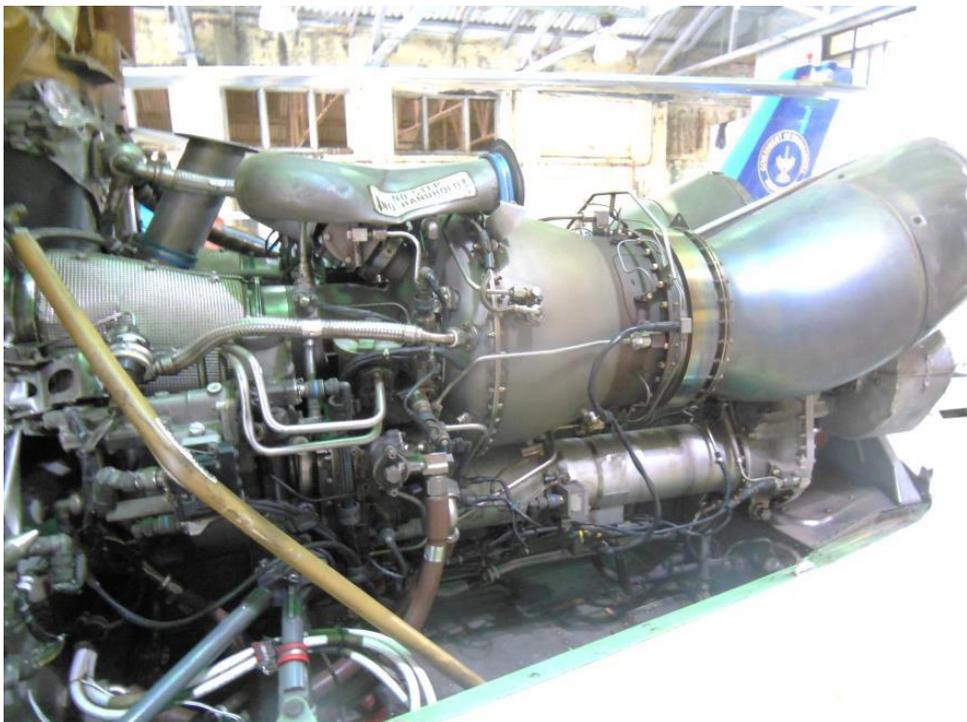
Fig:34 – LH Engine

The module 1 was in good condition. The output power drive rotated with the rotation of the Power Turbine thus confirming the continuity of the reduction gearbox gear chain.

The LH engine and cowling exhibited signs of impacts on the front LH side where the helicopter hit a parked lorry during the crash. Damage to the engine's front LH side occurred as a consequence of the accident and shortly before engine shut-down. The front support's fixings indicated excessive lateral or vertical load at the time of impact.

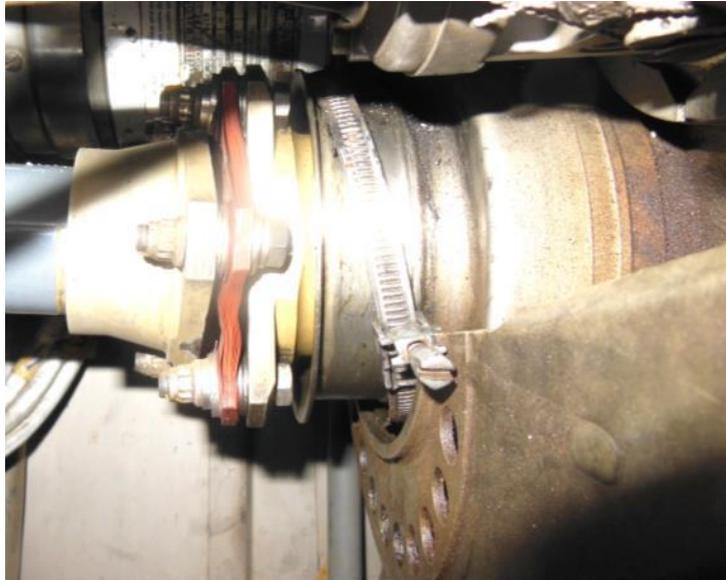
Fig:35 – LH Engine Module 1

Five fixing screws (out of 11) were sheared and were found on the engine bay floor along with their associated dowels indicating excessive lateral or vertical load at the time of impact.

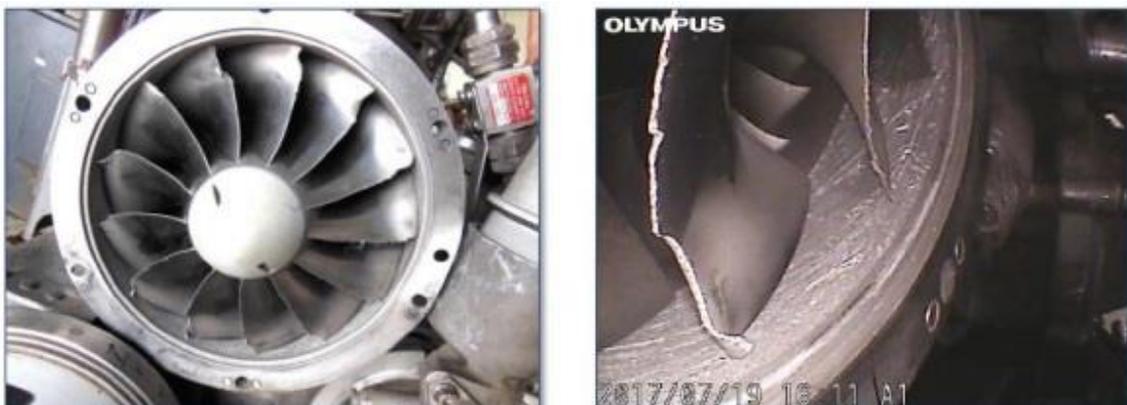
Fig:36 – LH Engine Module 2 – Axial Compressor

The casing of module 2 axial compressor was in good condition. The axial compressor exhibited significant FOD damage and deep scoring on the shroud indicating the ingestion of hard FOD. The numerous deep impacts affecting all the blades indicate that the engine was rotating at the time of the ingestion. The penetration of the FOD was made possible by the openings in the damaged LH barrier filter. As a consequence of the FOD ingestion, the Gas Generator could not be rotated by hand at the time of the examination.

The LH air intake barrier filter was damaged during the accident, leaving gaps that could allow debris to penetrate into the main air path. The compressor and the turbine exhibited significant damage consistent with the ingestion of hard metallic FOD. The findings in the HP turbine indicate that the engine was running at the moment of ingesting those FOD's made of metals with a fusion temperature close to that existing inside the combustion chamber with an established flame. Their solidification in the HP turbine and their absence in the Power Turbine indicate that the ingestion occurred shortly before the engine shut-down.

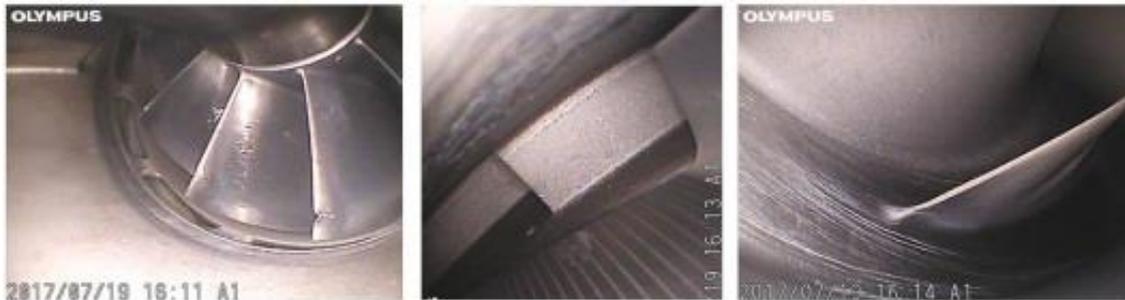
Fig:37 – LH engine Module 2 – Centrifugal Compressor

The boroscopic inspection showed FOD damage to the leading edges of the centrifugal impeller's blades. The base of the air path showed scoring marks left by hard FOD. The centrifugal diffuser's vanes were in good condition. The ingested FOD did not leave any splatter on the vanes.

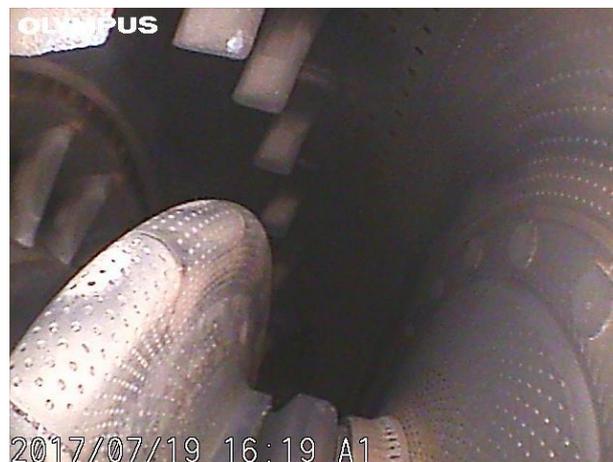
Fig:38 – LH Engine Module 3 – Combustion Chamber

The module 3 was in good condition. The boroscopic inspection of the combustion chamber showed no abnormality.

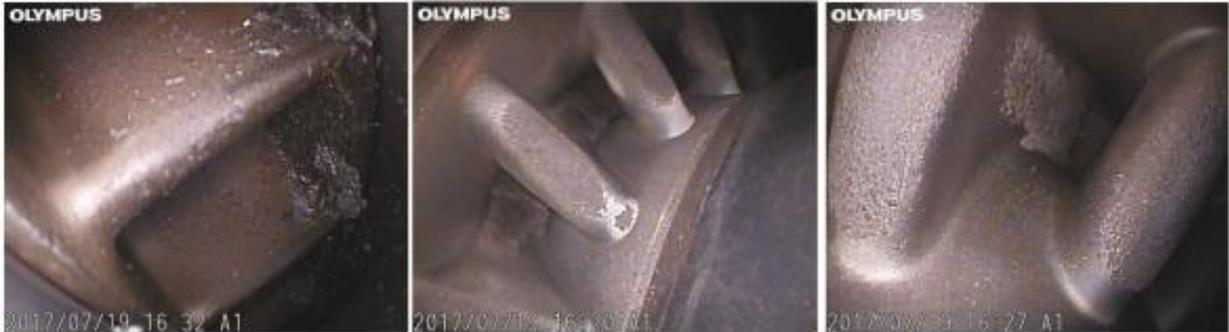
Fig:39 LH engine Module 3 – HP Turbine

The HP turbine blades too exhibited the presence of solidified metal around their tips with metal spread on the shroud. The blades' leading and top edges appeared in good condition without erosion nor corrosion.

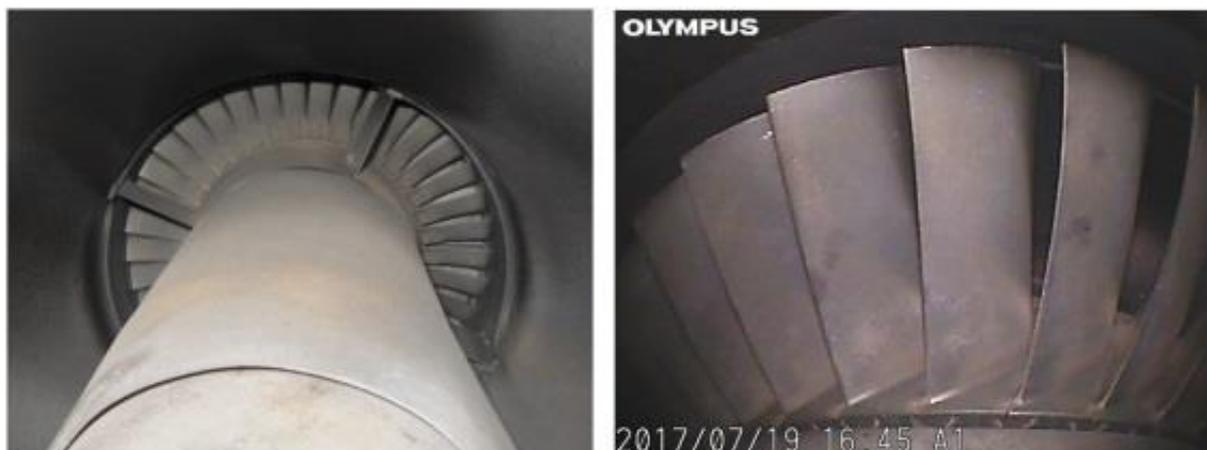
Fig:40- LH engine Module 4 – Power Turbine

The module 4 was in good condition. The examination of the Power Turbine wheel showed no abnormality or any visible impacts or traces of blade top rubbing.

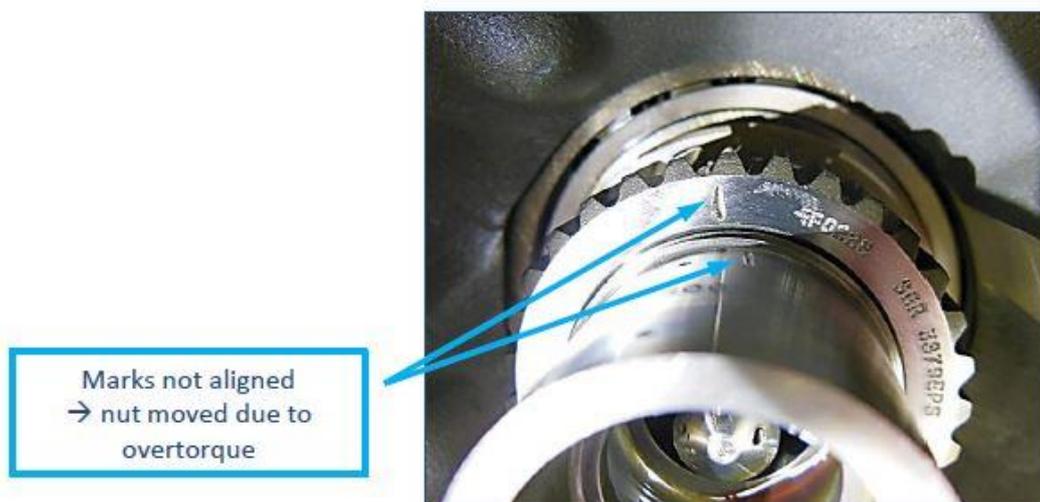
Fig:41 – Misalignment in drive nut

The module 5 was in good condition and rotated smoothly. It was separated from the Power Turbine module in order to reveal the splined drive nut on the drive gear's shaft. This nut transfers the torque delivered by the Power Turbine through the muff coupling to the reduction gearbox's gear train. Its position on the shaft is marked during the assembly process.

The drive nut's close examination revealed that the marks had moved by over 2mm indicating over torque caused by due to impediment to reduction gear box caused by rotor blades hitting obstacles during accident.

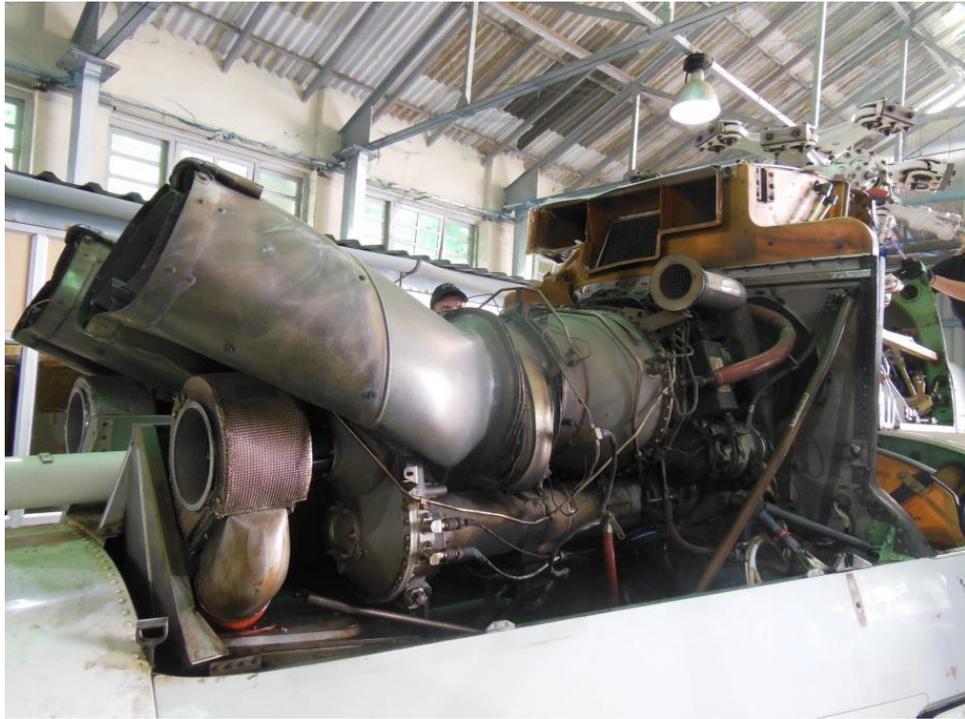
Fig:42 – RH Engine

The engine was attached to the helicopter and could be examined. The module 1 was in good condition with no particular findings to report. The output power drive shaft could be rotated smoothly manually when the engine was removed from the helicopter and separated from reduction gearbox.

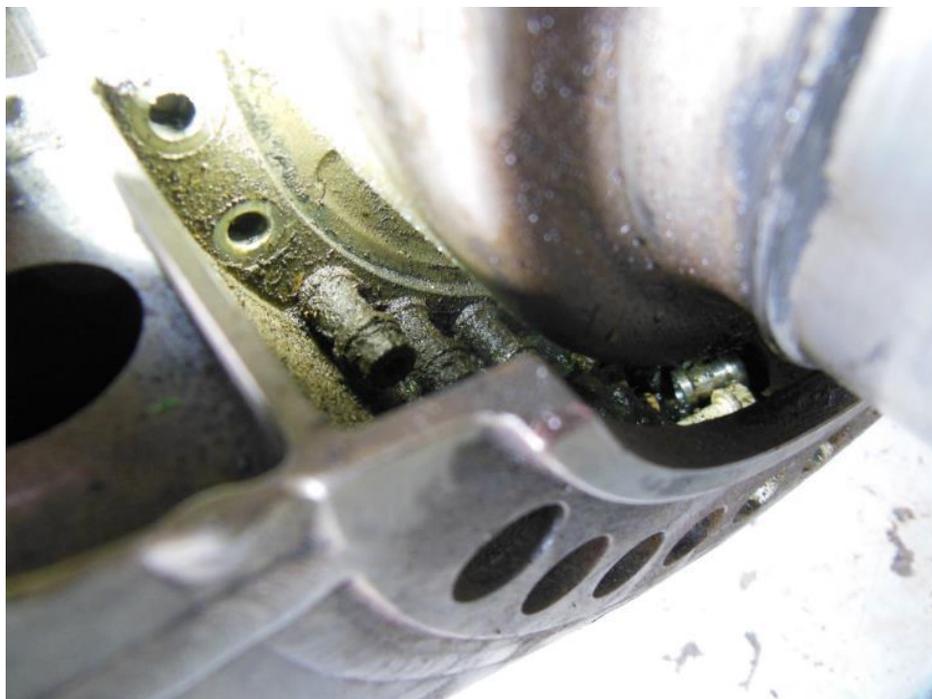
**Fig:43 - RH engine Module 1
- Module 2 (Axial Compressor)**

Two fixing screws (out of 11) were sheared and were found at the bottom of the front support along with their associated dowels thus indicating excessive lateral or vertical load at the time of impact.

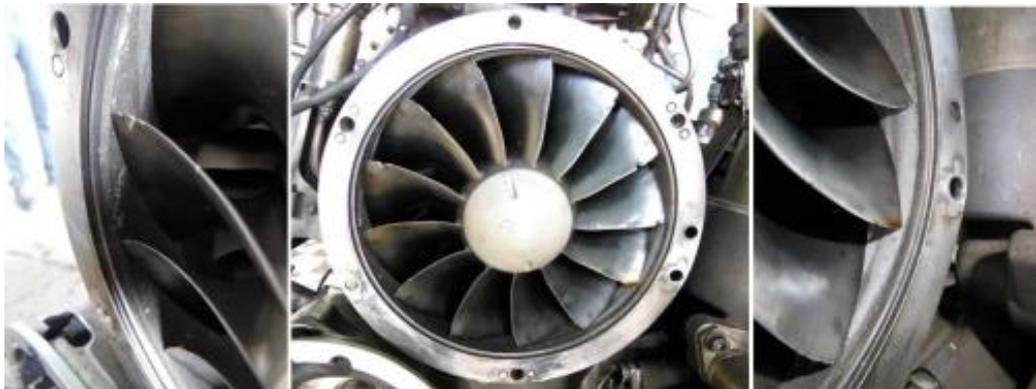
Fig:44 - RH engine Module 2 – Axial Compressor

The module 2 was in good condition with no particular findings to report. The Gas Generator was blocked initially. It could be unlocked manually and its rotation was smooth without noise although with some resistance.

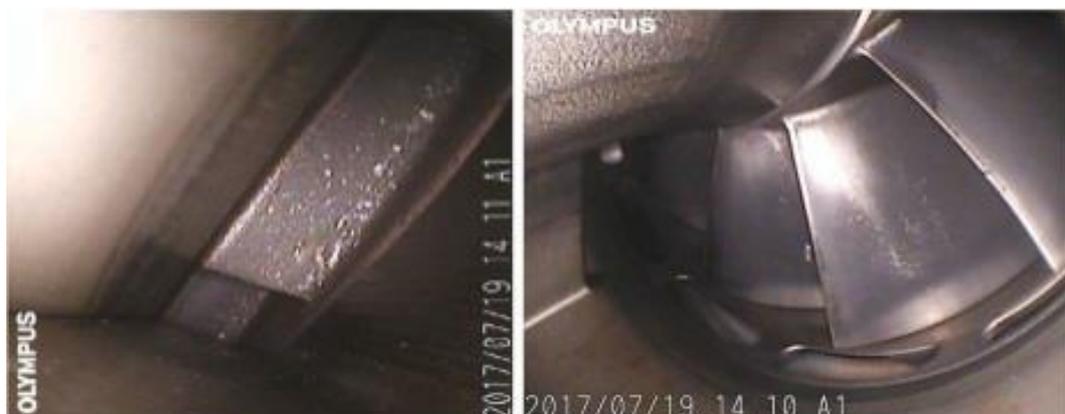
Fig:45 - RH engine Module – Centrifugal Compressor

The boroscopic inspection showed light FOD damage to the leading edges of some of the centrifugal impeller’s blades (bottom left photo). Both the impeller’s blades and the diffuser’s vanes showed sharp straight leading edges without any significant erosion.

The centrifugal diffuser’s vanes were in good condition and exhibited the presence of metallic splatter possibly caused by soft FOD and/or soft abrasable

coating being scrapped off the centrifugal impeller's cover whilst the engine was running during the accident and/or the Power Turbine blade-shedding.

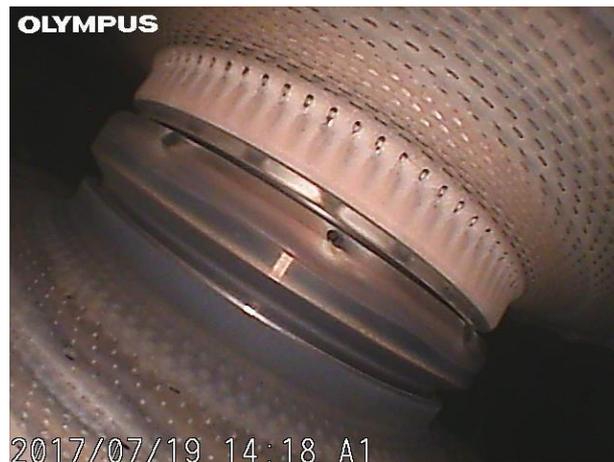
Fig:46 - RH engine Module 3 – Combustion Chamber

The module 3 was in good condition with no particular findings to report. The boroscopic inspection of the combustion chamber showed that it was in good condition with no findings to report.
