**FINAL REPORT ON ACCIDENT TO
GOVT. OF MAHARASHTRA
SIKORSKY S-76C++ HELICOPTER
VT- CMM
AT NILANGA, LATUR
ON 25/05/2017**

**A X Joseph
Deputy Director, AAIB
Chairman, Committee of Inquiry**

1. Aircraft Type : Sikorsky S76 C++
Nationality : INDIAN
Registration : VT – CMM
2. Owner : Government of Maharashtra.
3. Operator : Government of Maharashtra.
4. Pilot – in –Command : CHPL holder on type
Extent of injuries : Nil
5. First Officer : CHPL Holder on type
Extent of injuries : Nil
6. Place of Incident : Nilanga, District Latur
7. Geographical Co-Ordinates : 18°07’34’’N, 76°44’57’’E
8. Date & Time of Incident : 25th May 2017, 0625 UTC
9. Last point of Departure : Nilanga, District Latur
10. Point of intended landing : Raj Bhawan, Mumbai
11. Type of operation : Non Schedule Operation
12. Crew on Board : 02
13. Passengers on Board : 04
14. Phase of operation : Take off
15. Type of accident : Crash landing after hitting Electrical
High Tension Cables

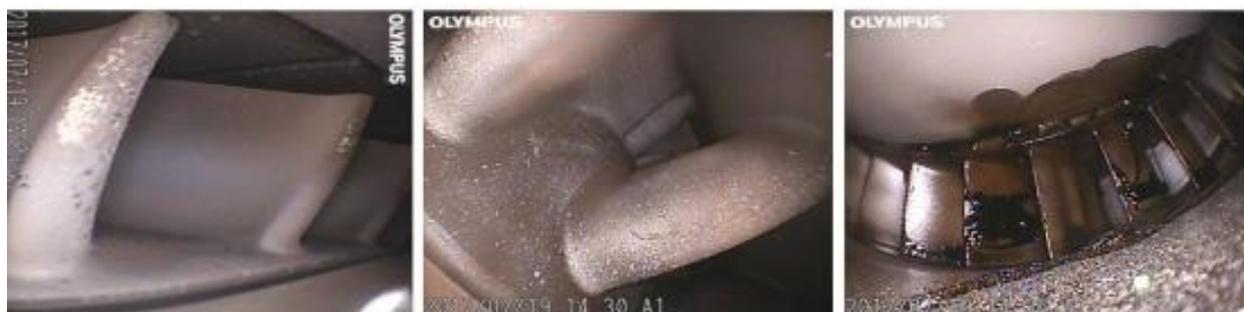
Fig:47 - RH engine Module 3 – HP Turbine

The boroscopic inspection of the Nozzle Guide Vane (NGV) showed that the vanes' leading edges were evenly covered with metallic splatter which are consistent with the compressor's condition. These deposits affected all the vanes similarly (bottom left photo).

The HP turbine blades' leading and top edges appeared in good condition without erosion nor corrosion (top right photo). The blades also exhibited the presence of metal splatter on their leading edges. All the blades were similarly

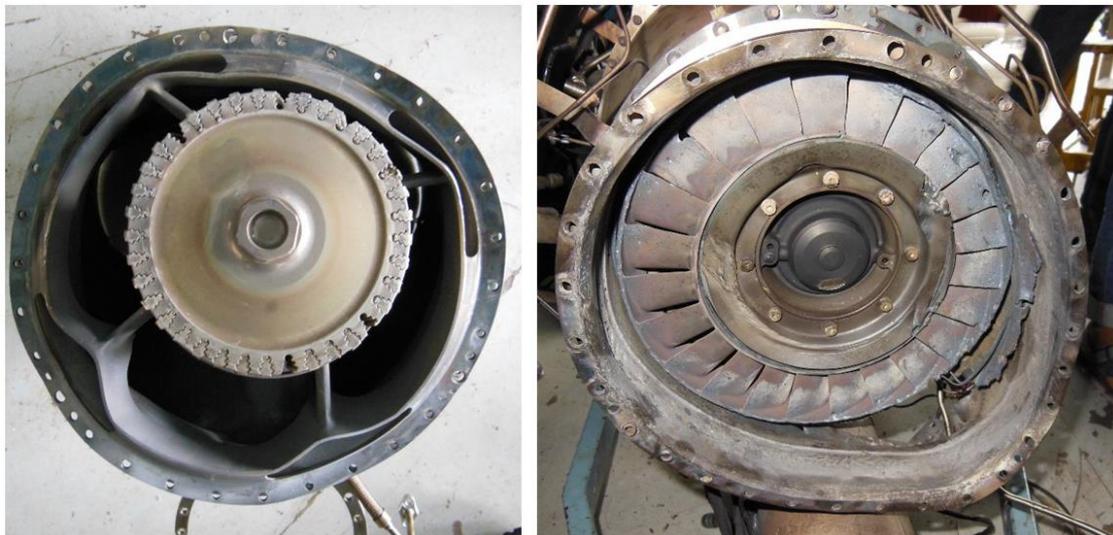
Fig:48 - RH engine Module – Power Turbine

The module 4 exhibited a deformed casing and several of the screws used to fix it to module 3 were ruptured and had fallen on the engine deck. The examination of the Power Turbine wheel revealed that all the blades had come off.

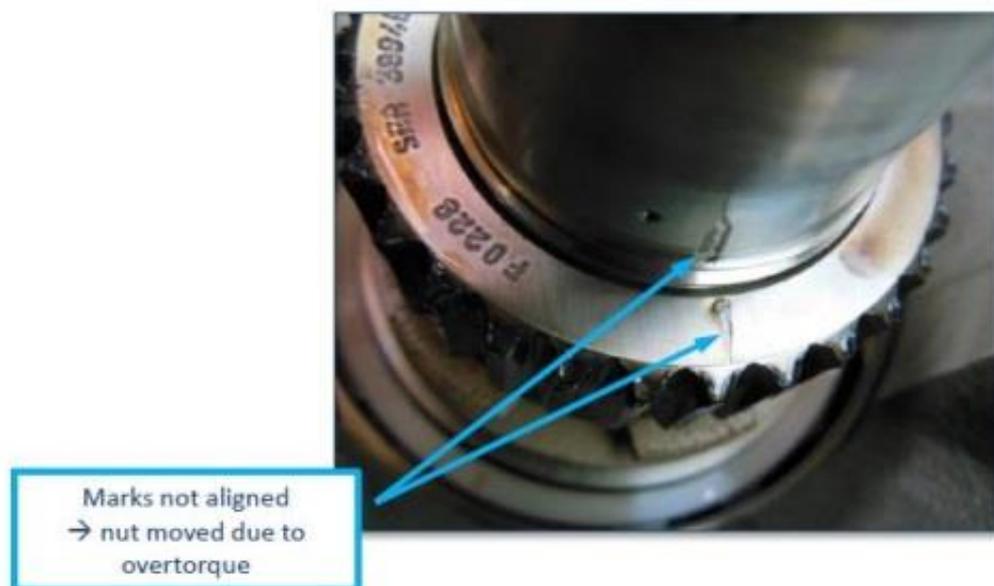
Fig:49 - RH engine Drive Nut

The module 5 was separated from the engine. A section of the casing used to centre it on the back of the module 4 was broken due to the forces released during the blade-shedding. The shafts could be rotated and a sticking point could be felt during the rotation.

Once the module was separated, the splined drive nut on the drive gear's shaft could be examined. This nut transfers the torque delivered by the Power Turbine through the muff coupling to the reduction gearbox's gear train. Its position on the shaft is marked during the assembly process. Should the rotation of the reduction gearbox's output shaft be impeded during engine operation, then the torque applied by the Power Turbine on the nut will increase. During an accident, this may lead to an over torque capable to rotate the nut on its shaft.
