**INVESTIGATION REPORT ON ACCIDENT TO  
AGUSTA AW 119 MK II HELICOPTER  
VT- NRK ON 10-06-2017  
AT  
BADRINATH JI HELIPAD, UTTARAKHAND.**

**GOVERNMENT OF INDIA  
MINISTRY OF CIVIL AVIATION  
AIRCRAFT ACCIDENT INVESTIGATION BUREAU**

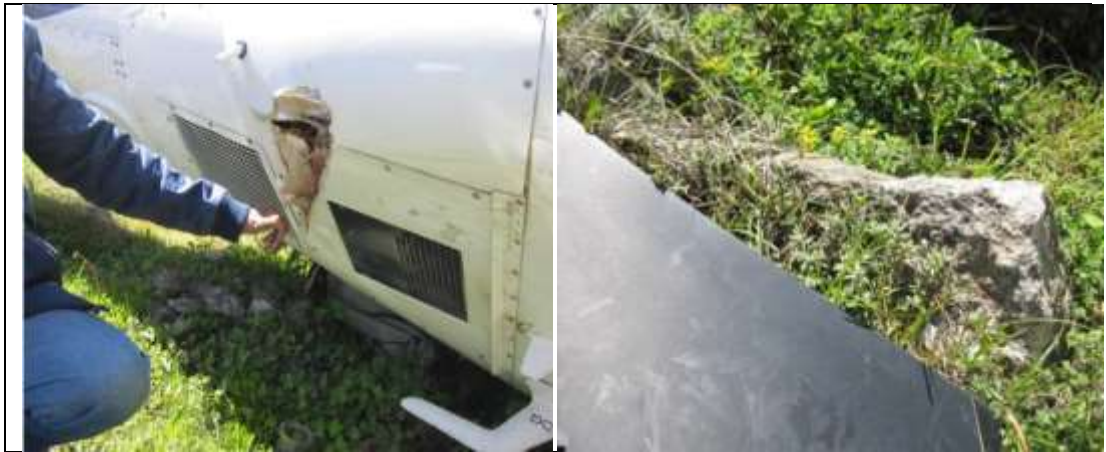
- The helicopter sank just after take-off during which it hit the ground/ terrain in nose up and a slight left bank condition. The helicopter first impacted a hard rock imbedded to the ground with the rear portion of right skid hitting the ground which got severed from the main structure. A significant impact mark was found on the rear part of the Fuselage, just below the Baggage Compartment due impact with a sharp rock.

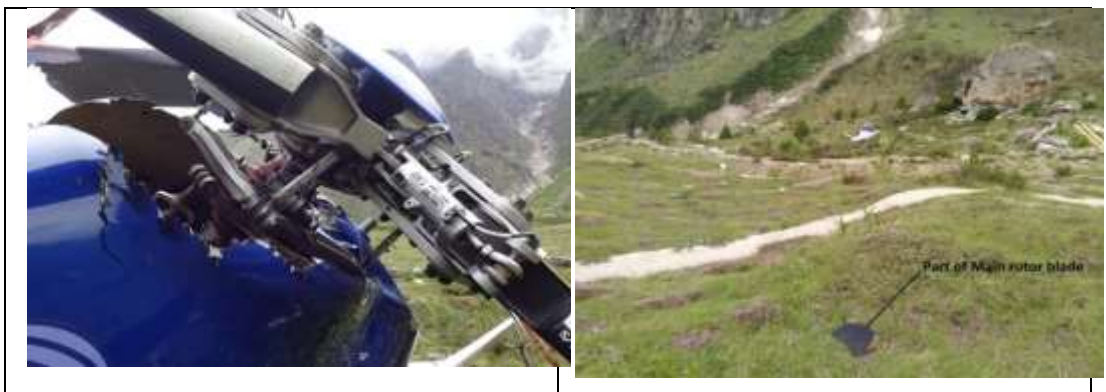
- Broken pieces of the main rotor blades were found scattered around the main wreckage. A piece was found at a distance of about 80 meters from the main wreckage. The roots of the blades were found attached to the hub. Marks of main rotor blades impacting the ground were observed.

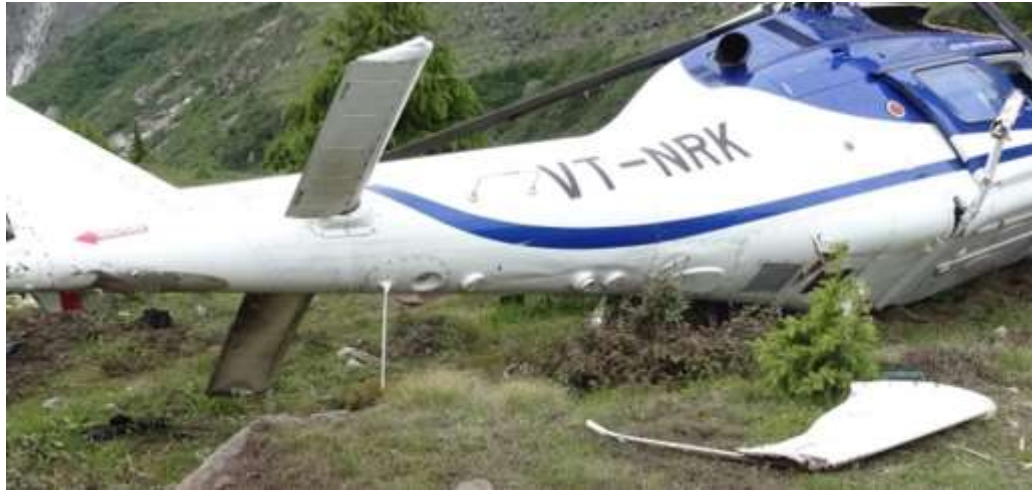
- The lower vertical fin/ tail rotor guard impacted the ground and was found separated from tail boom. The tail rotor blades were sheared off up to mid span due impact with hard rocks and trees.

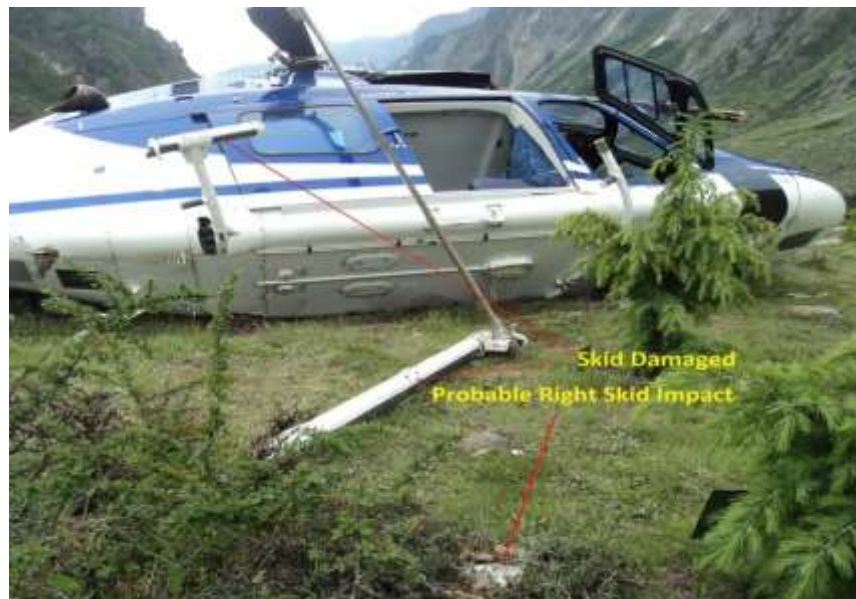
- As the ground had a downward slope towards left of the helicopter, the helicopter rolled towards left (though remained almost at the same point), resulting in left skid impacting the ground. The cross tubes of the skids were found tilted approximately 180 degrees upwards.

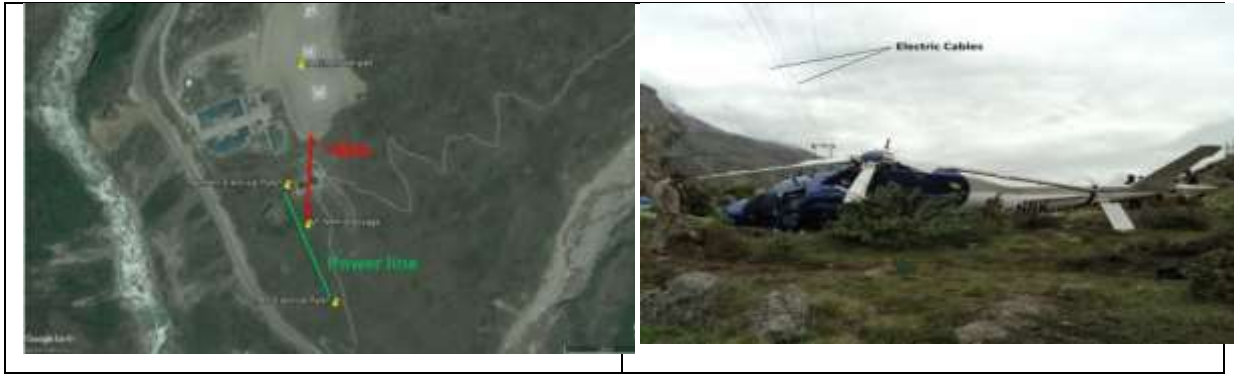
- The helicopter finally came to halt in a left bank attitude resting on the ground on its broken left skid and fuselage with the support of rocks & bunch of small trees. The final position of helicopter was approximately 150 m south of the take-off point and directly below the electric cables (power line) passing in the area.

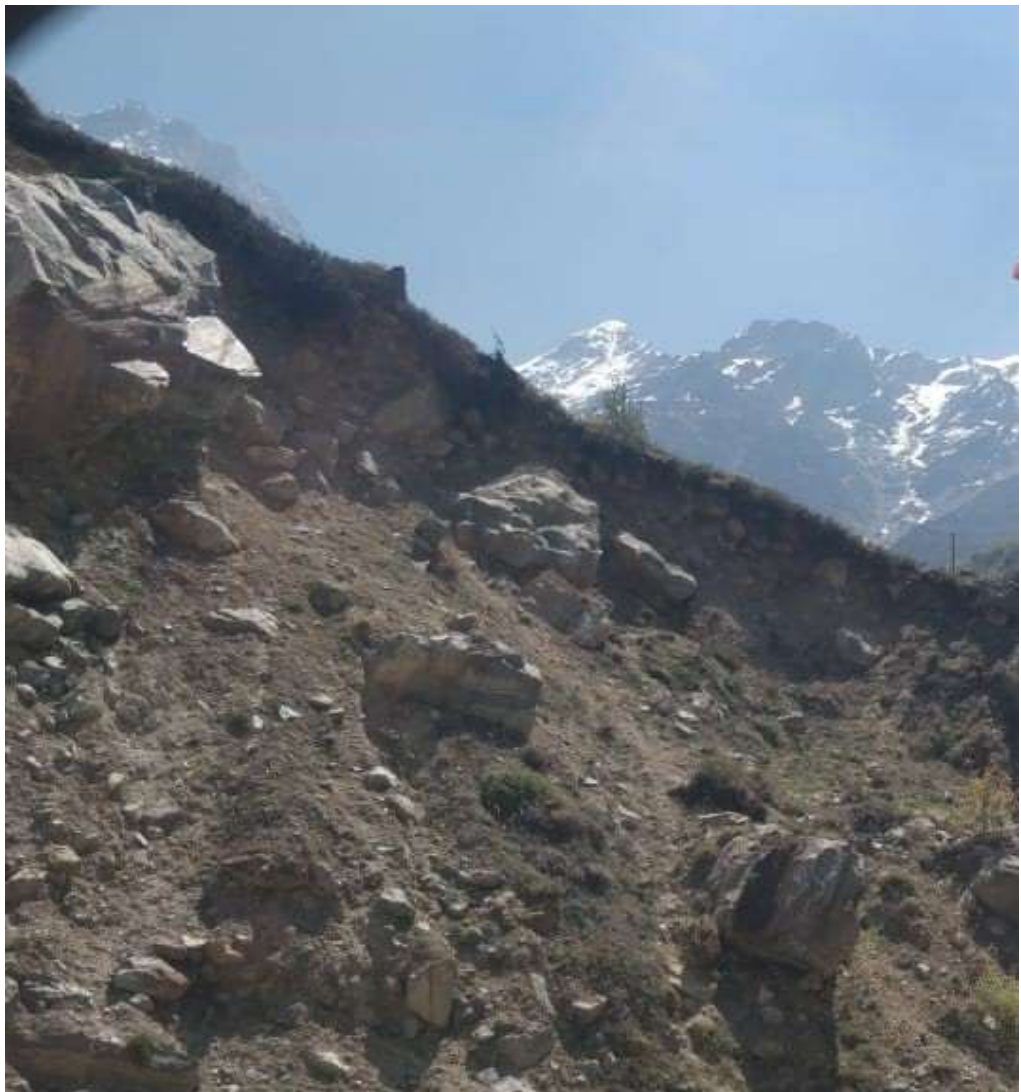
Ledge at the helipad end (towards take off direction)

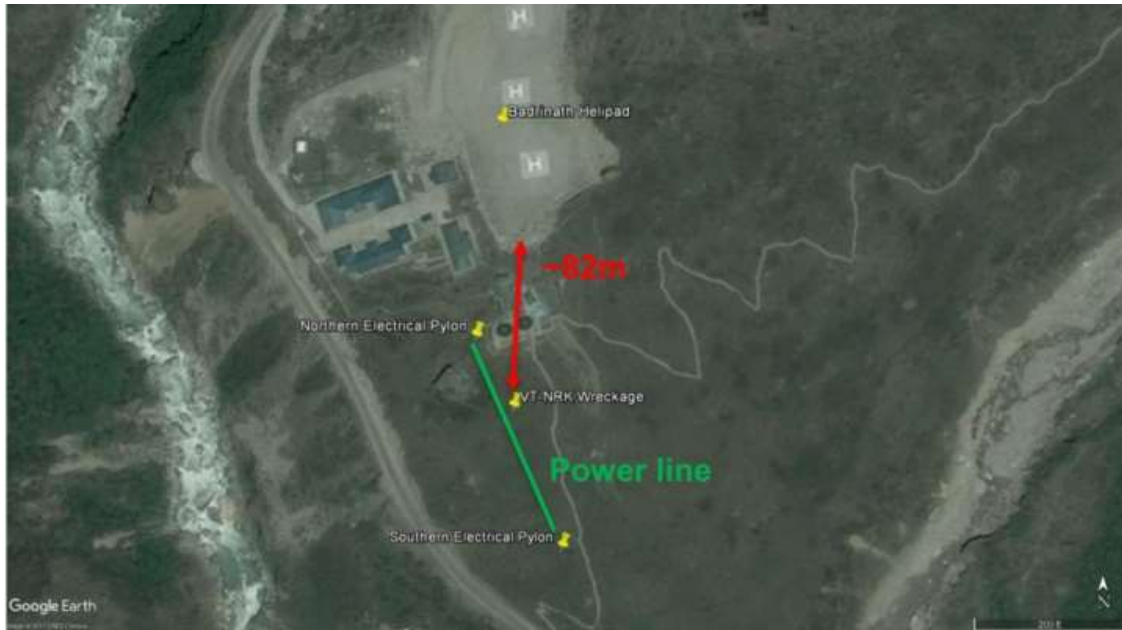
Power line (crossing flight path) above the wreckage

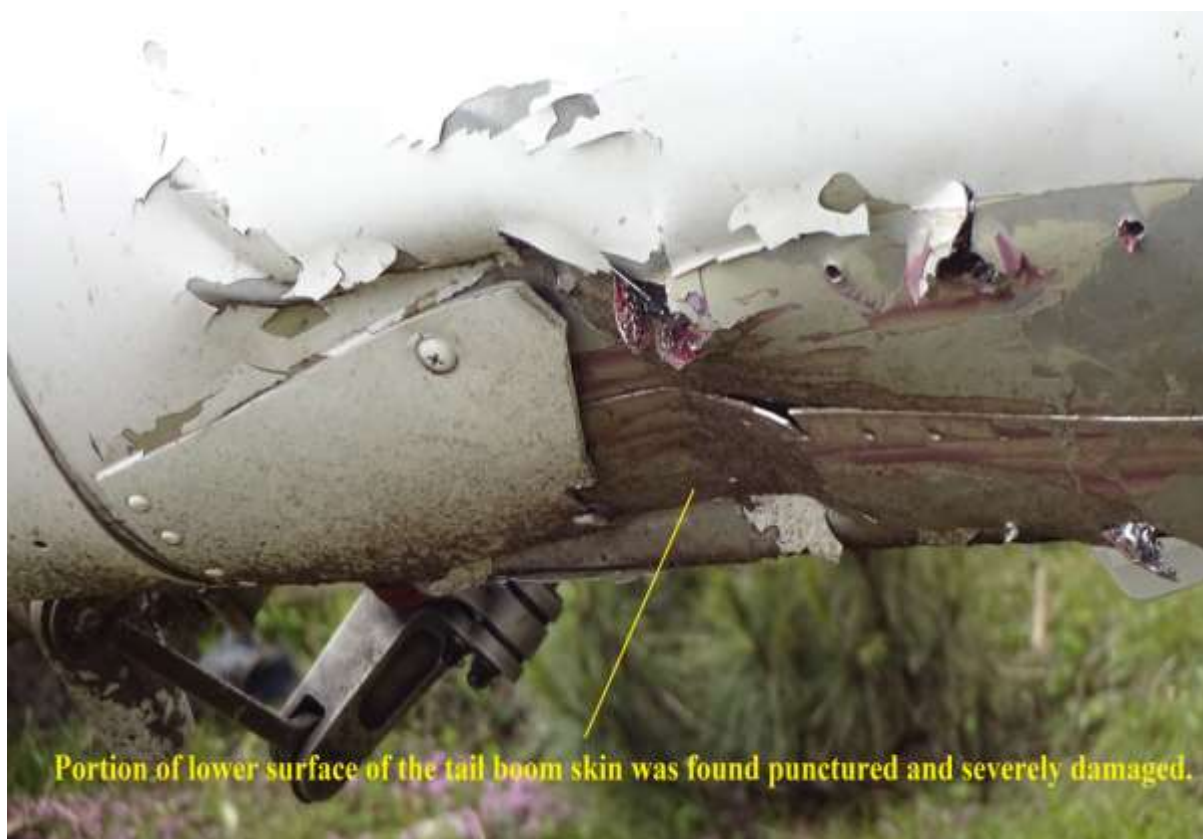
Portion of lower surface of the tail boom skin was found punctured and severely damaged.

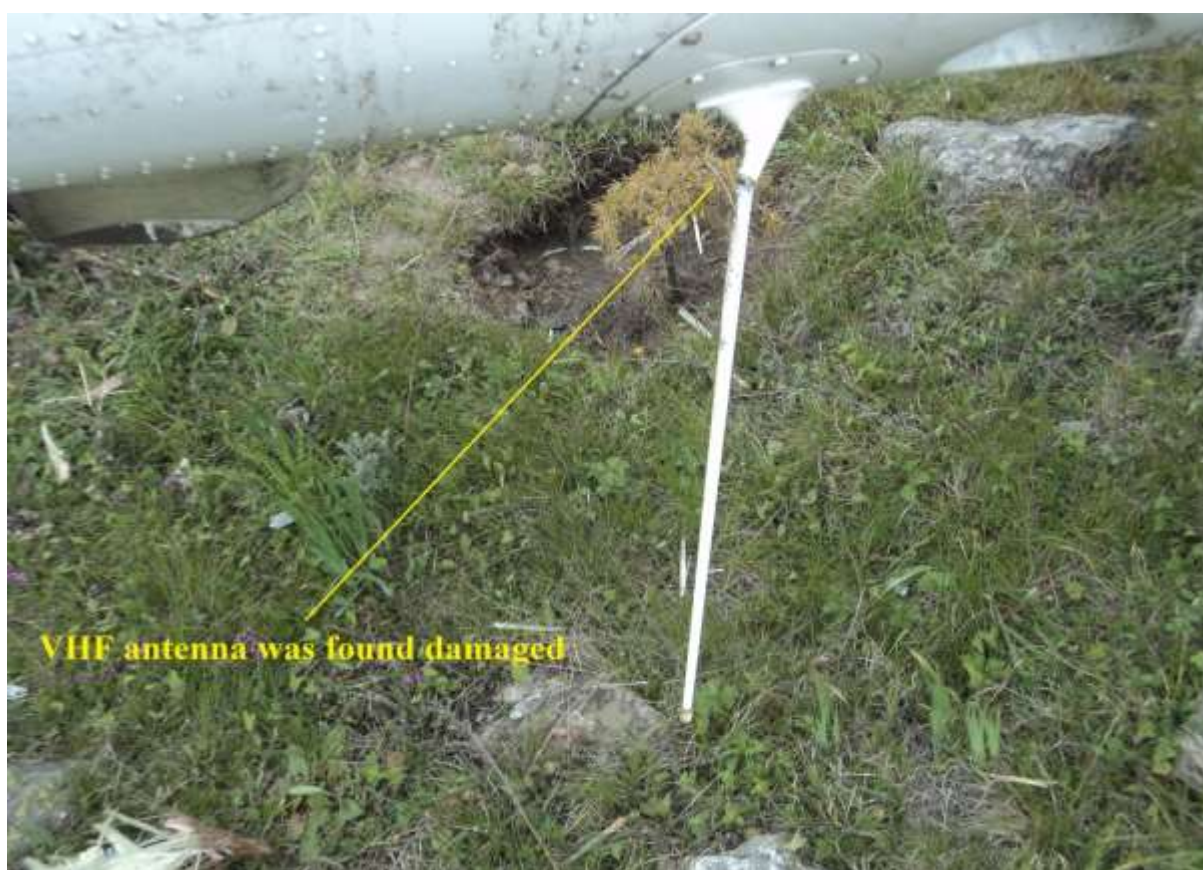
VHF antenna was found damaged

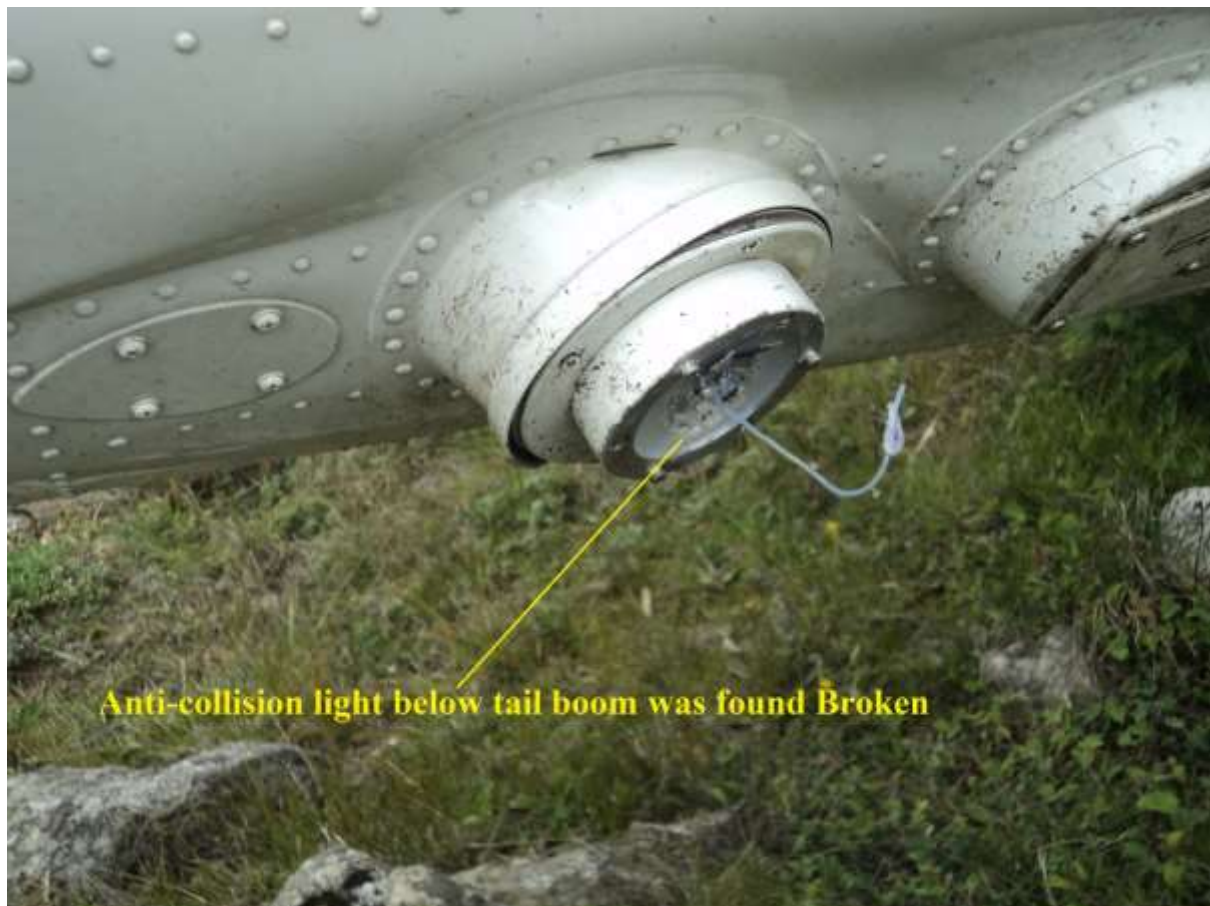
Anti-collision light below tail boom was found Broken

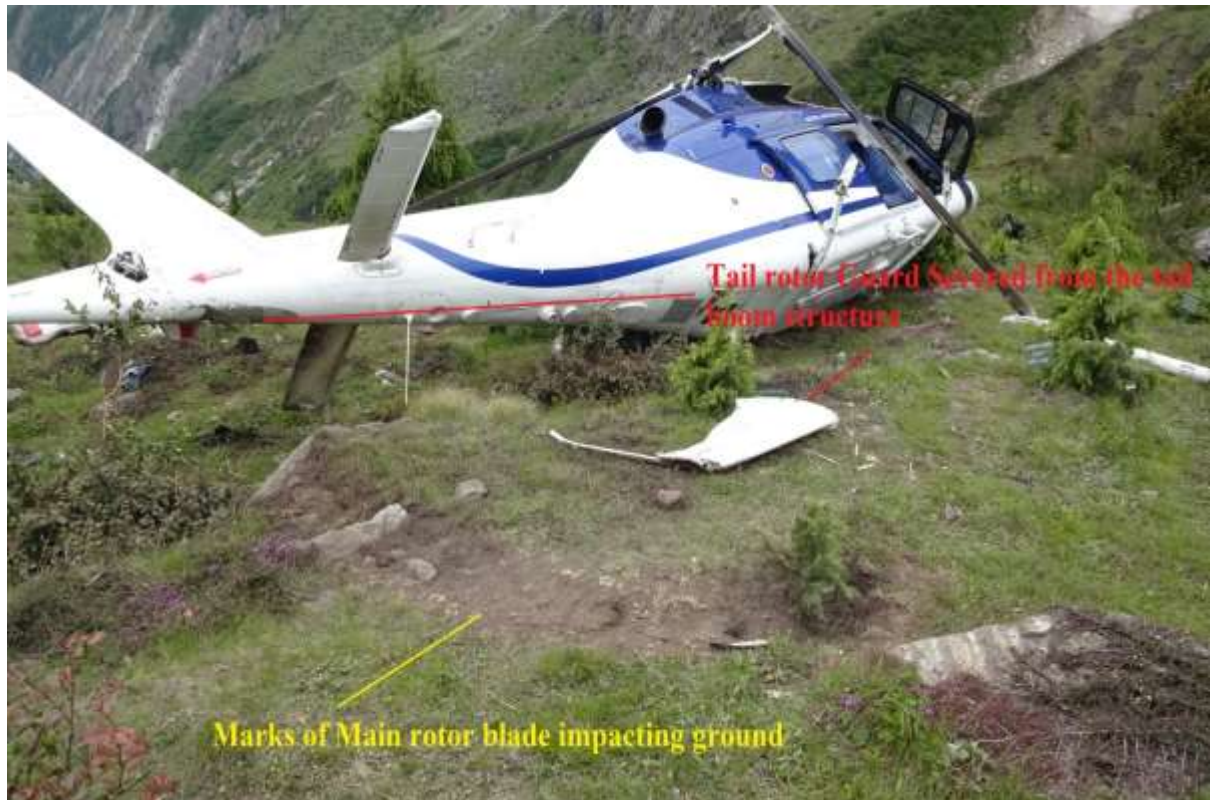
Tail rotor Guard Severed from the tail boom structure

Marks of Main rotor blade impacting ground

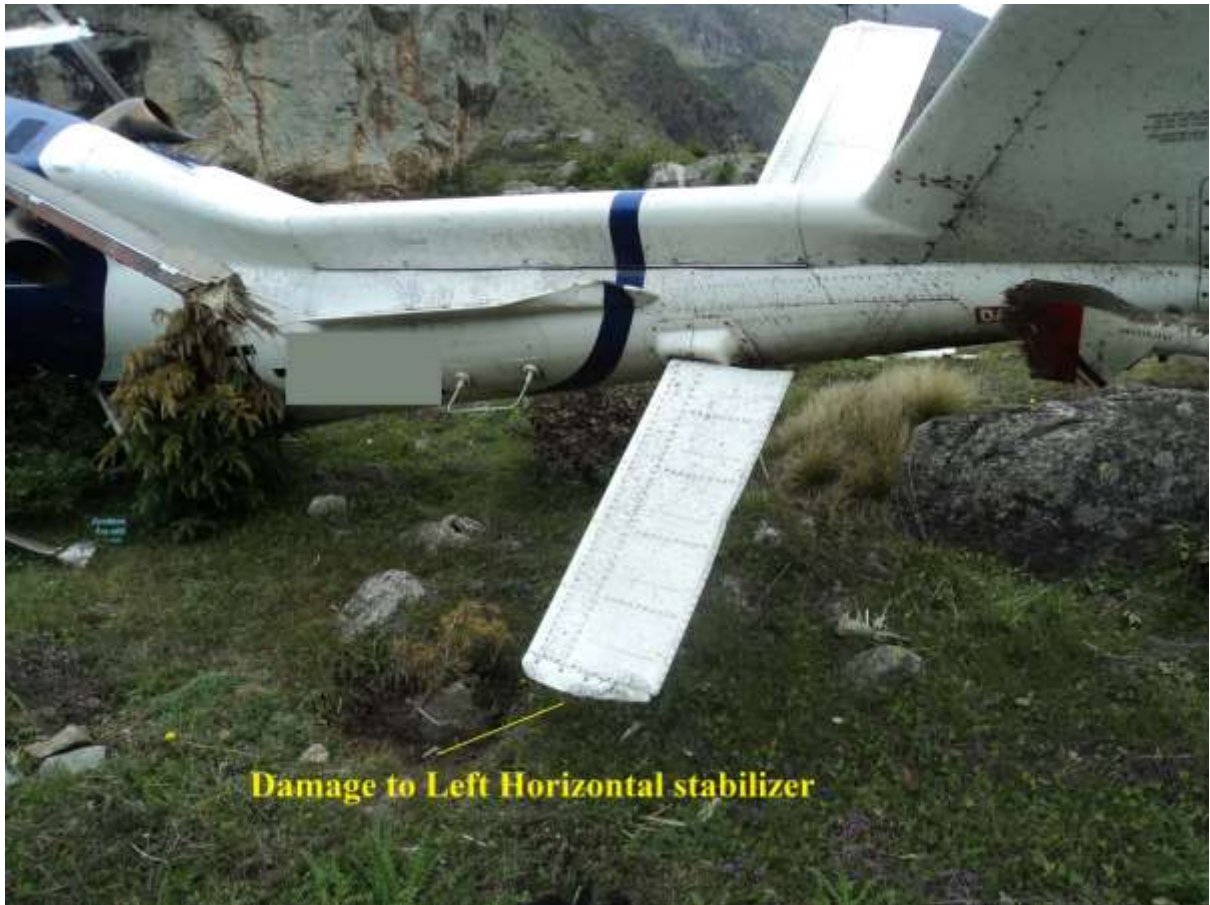
**Damage to Left Horizontal stabilizer**
