**GOVERNMENT OF INDIA
MINISTRY OF CIVIL AVIATION
AIRCRAFT ACCIDENT INVESTIGATION BUREAU**

**FINAL INVESTIGATION REPORT ON ACCIDENT TO
DHILLON AVIATION PVT. LTD.
BELL 206 B3 HELICOPTER VT- DDA ON 26-04-2017 AT
CHINTAGUFA HELIPAD, CHHATTISGARH.**

**Final Investigation Report on accident to M/s Dhillon Aviation Pvt. Ltd.
Bell 206 B3 Helicopter VT- DDA on 26-04-2017 at
Chintagufa Helipad, Near Sukma, Chhattisgarh.**

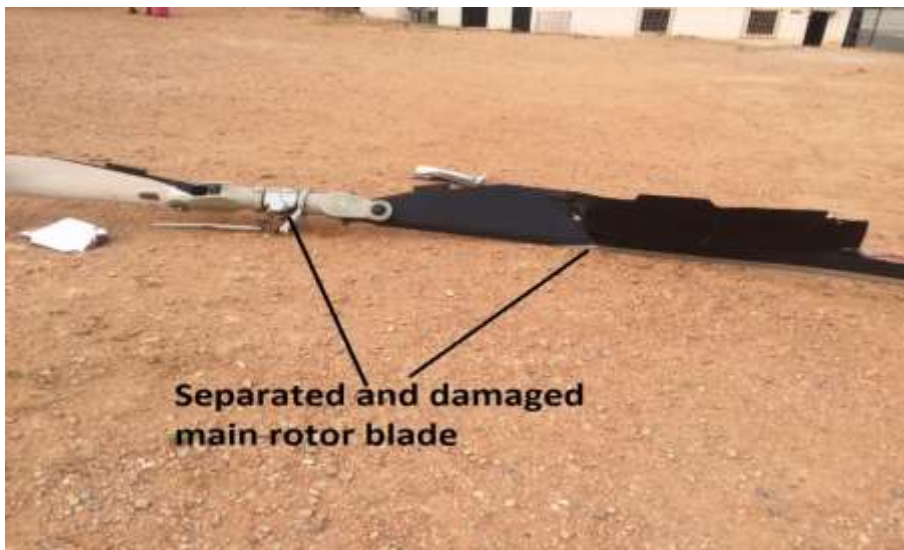
Engine Oil was found spilled on the helipad after impact. The main rotor head along with blades got separated and part of one of the blades from 3/4th

Separated and damaged main rotor blade

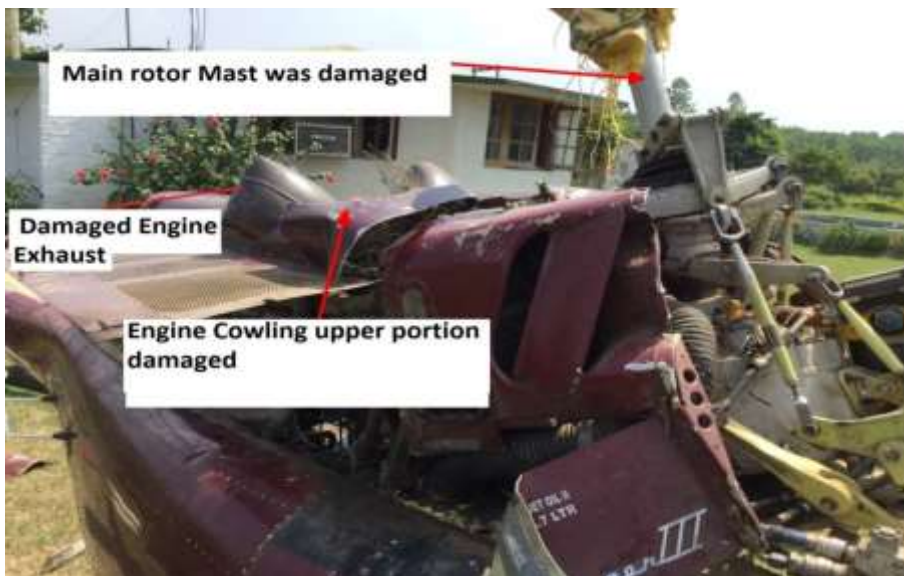
span of trailing edge (from tip) got sheared off. The main rotor mast, main gear box and its associated components were damaged due impact with ground. The upper portion of engine cowling and the engine exhaust was damaged.

Main rotor Mast was damaged

Damaged Engine Exhaust

Engine Cowling upper portion damaged

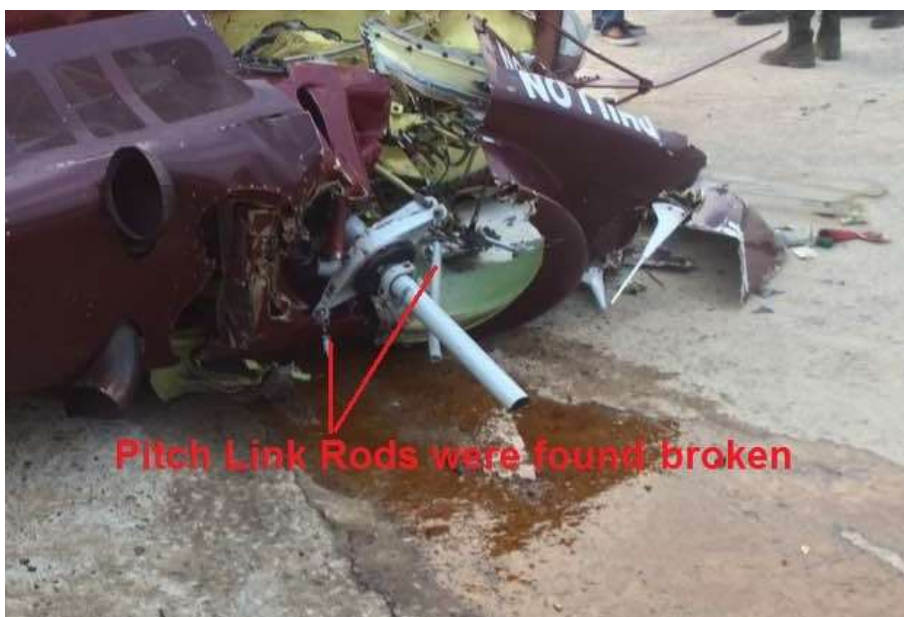
Pitch Link Rods were found broken

Tail Drive Shaft found broken and seperated from the tail boom

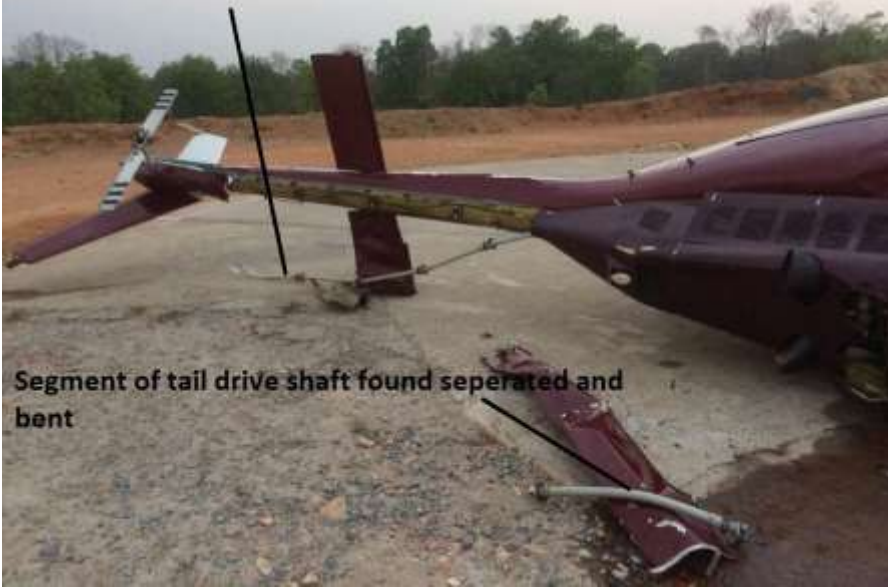
The main rotor drive shaft was found broken due to sudden stoppage of main rotor blades impacting with ground. A segment of tail rotor drive shaft was found bent & detached from the tail gear box adapter input and tail boom structure due to sudden stoppage of main rotor blades after impact.

Segment of tail drive shaft found seperated and bent

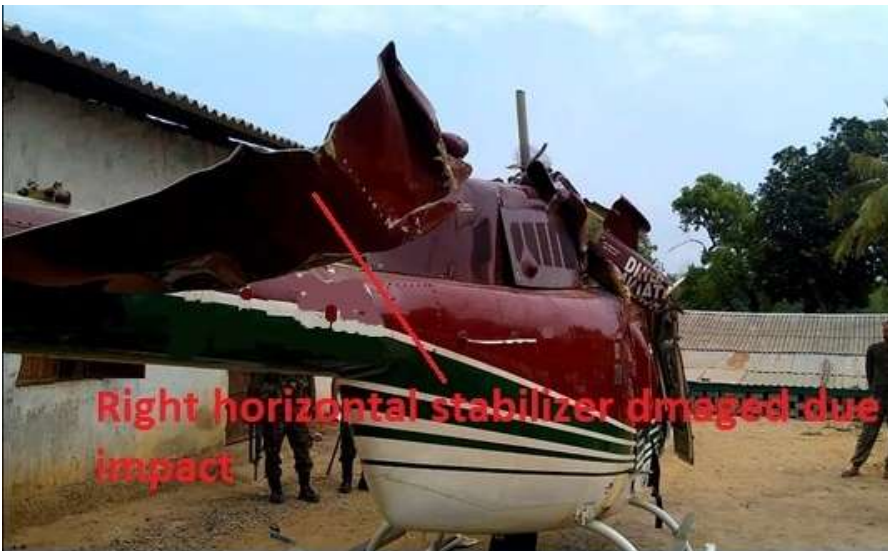
The tail rotor pitch change control rod was also found broken and bent. The right side horizontal stabilizer was crushed due impact with ground but found attached to the tail boom structure.

Right horizontal stabilizer damaged due impact

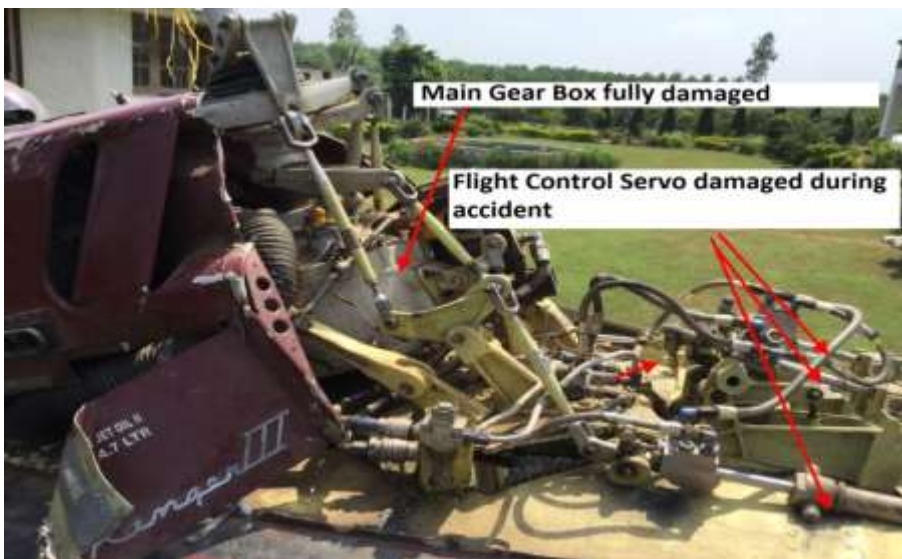
Main Gear Box fully damaged

Flight Control Servo damaged during accident
