**Final Report on Serious Incident between M/s Go Air Ltd. A320-214 &M/s
Jet Airways Ltd. B737-800 at Mumbai on 09.06.2017.**

COMMITTEE OF INQUIRY - VT-WAK

13. Type of Occurrence : Air Proximity

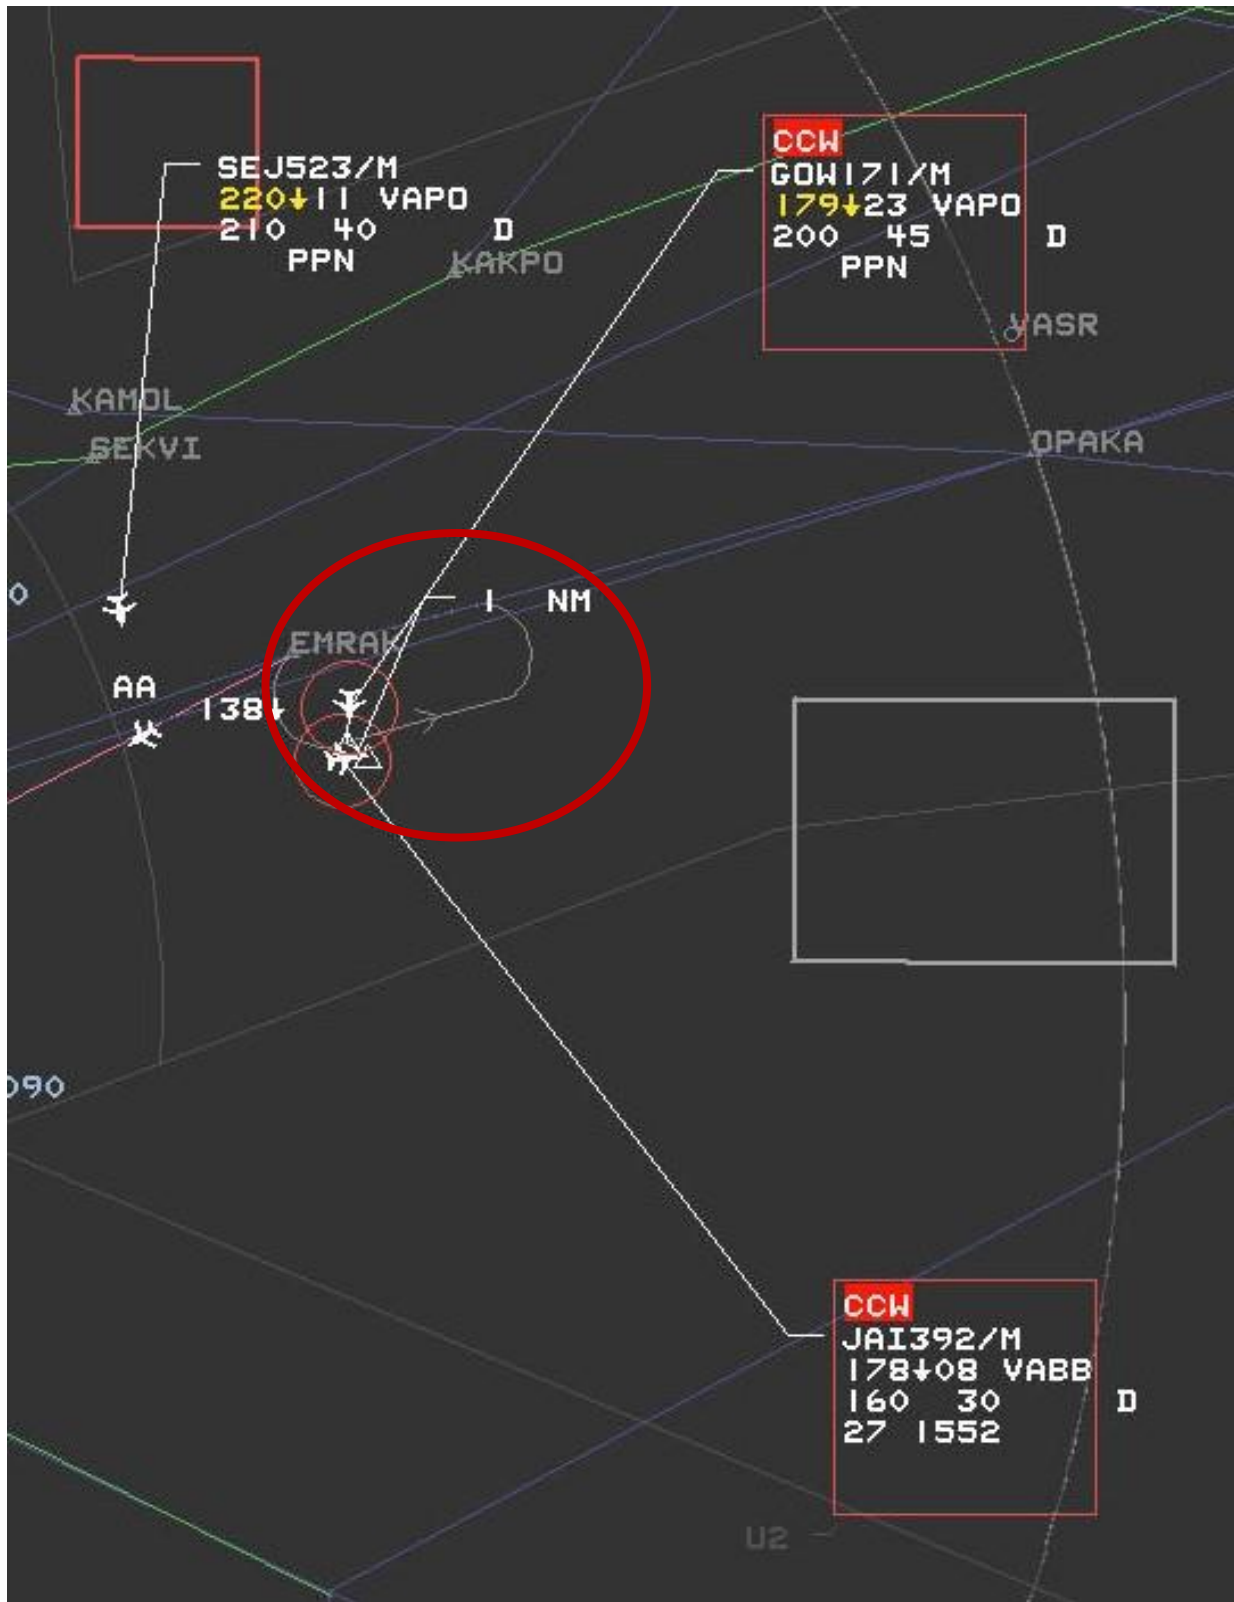
Both the aircrafts reported getting RA and followed the RA. *The lateral separation between GOW171 and JAI392 was reduced to 2.8 NM when the vertical separation was just 100 feet* as against the standard lateral separation of 10 Nm and standard vertical separation of 1000 feet.

Figure 1: Airprox between GOW171 and JAI392 with vertical and lateral separation as 100 feet and 2.8 NM

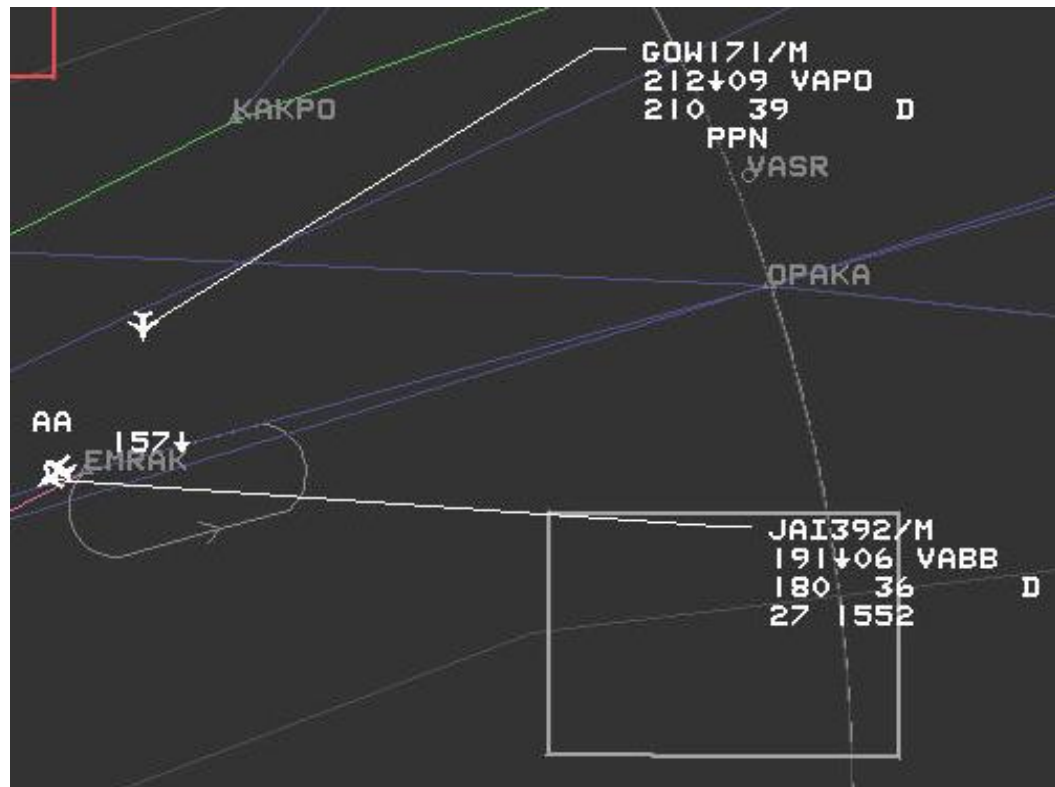
Figure 2: At 15:14:12, after GOW171 advised to maintain FL210 due Traffic

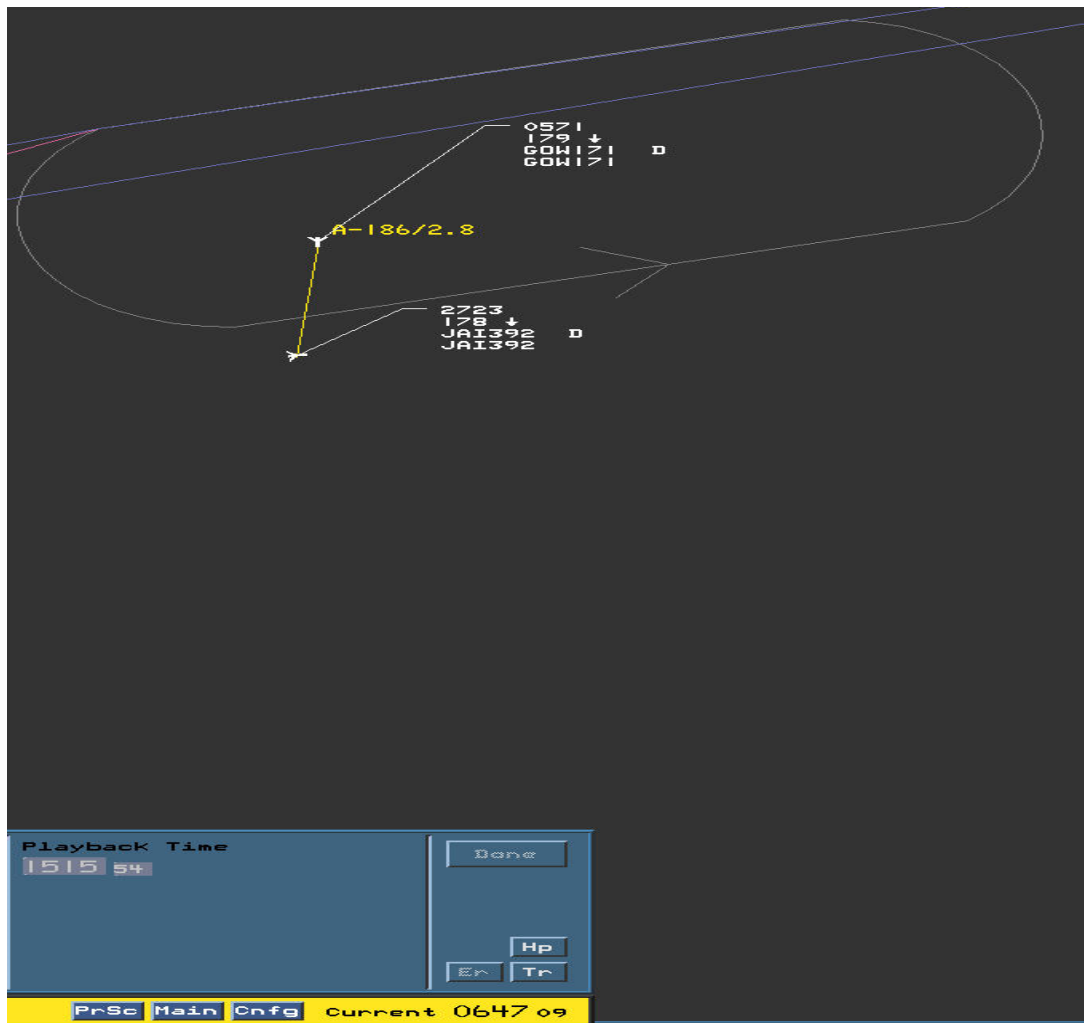
Figure 3: At time 15:15:54, Lateral/Vertical Separation 2.8NM and 100 feet

- 2.4 LAC Controller asked GOW171 to descend to FL100, when the traffic JAI392 was in the hold and descending to flight level FL 160.
- 2.5 The breach of separation leading to serious incident occurred at time 15:16 UTC where the ***lateral/Vertical separation reduced to 2.8 NM and 100 feet*** respectively.

- 3.1.9 The separation between the two aircrafts was reduced to 100 feet vertically and 2.8 Nm laterally.

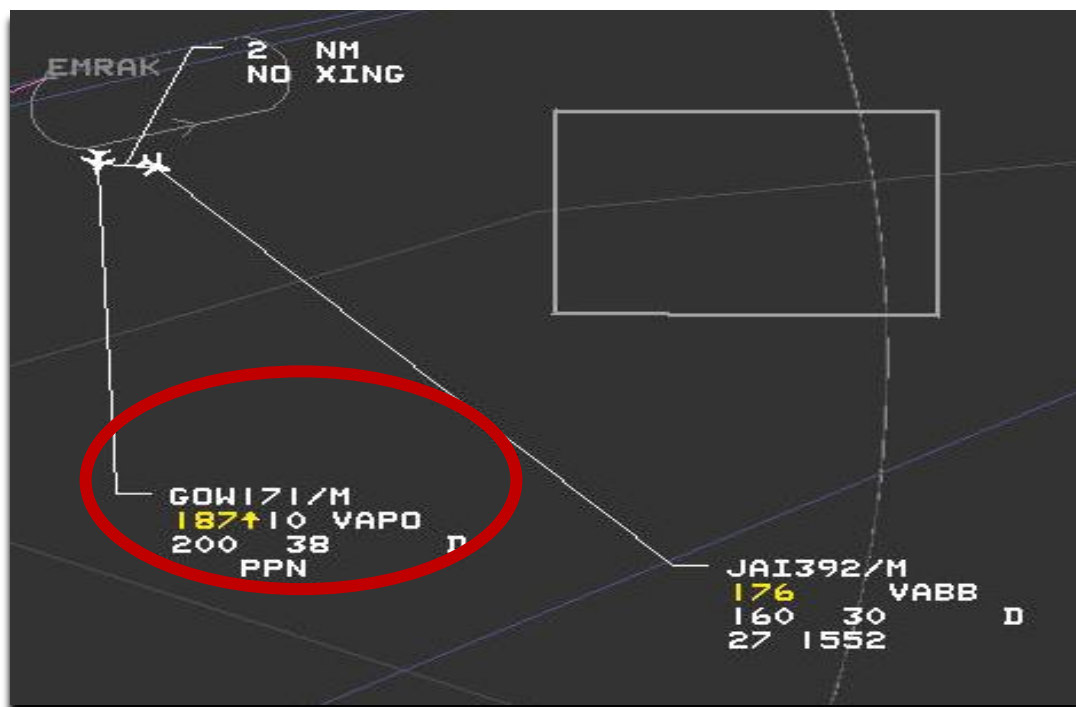
Figure 4: at time 15:16:28, after getting TCAS RA, both aircrafts following TCAS RA.

- 2.9 Both the aircraft reported getting TCAS-RA and were observed to follow TCAS-RA on situation display (SD).
- 2.10 GOW171 reported RA and was observed to follow RA (Climb). GOW171 was
