Draft Final Report on Serious Incident between
M/s Air Asia Ltd. VT-JRT, A320
and
M/s Interglobe Ltd (Indigo) VT-IEW, A320
in
Varanasi ACC
on
16.04.2017

Final Report on Serious Incident between M/s Air Asia Ltd. VT-JRT IAD768 A320 & M/s Interglobe Ltd (Indigo) VT-IEW IGO398, A320 in Varanasi ACC on 16.04.2017.

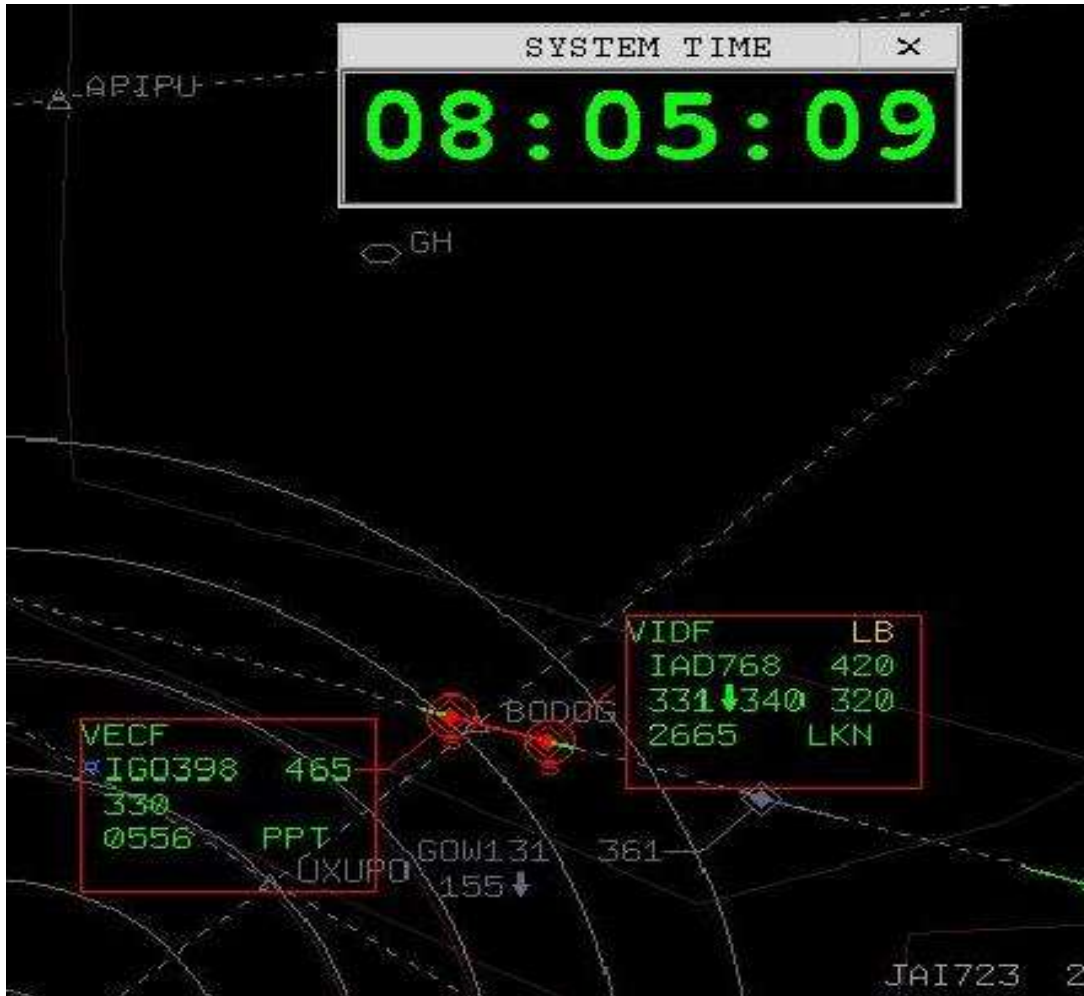
8. After this there was argument between the Radar Controller and Crew of IAD768 on R/T from 08:05:20 to 08:05:52 UTC.
9. IAD768 crossed the flight level of IGO398 i.e. FL330 at time 08:05:05 UTC with rate of descend 2300 feet per minute and the maximum rate of descend was observed to be 2820 feet per minute at time 08:05:10 with IAD768 passing FL327.

Figure: Showing IAD768 just before crossing the path of IGO398
