**FINAL INVESTIGATION REPORT ON SERIOUS  
INCIDENT TO M/s SPICEJET LTD. BOMBARDIER  
DHC – 8 – 402 (Q-400) AIRCRAFT VT-SUL AT IGI  
AIRPORT, DELHI ON 08.11.2017**

**AIRCRAFT ACCIDENT INVESTIGATION BUREAU**

On 08.11.2017, M/s Spice Jet Ltd. Bombardier DHC – 8 - 402 aircraft VT-SUL while operating a scheduled flight SG-2642, (Jabalpur-Delhi) was involved in a serious incident of hard landing and subsequent tail strike while landing at IGI airport, Delhi. The aircraft was under the command of pilot holding valid ATPL and duly qualified on type along with First Officer having a valid CPL holder and qualified on type. There were 02 cabin crew and 72 passengers on board the aircraft.

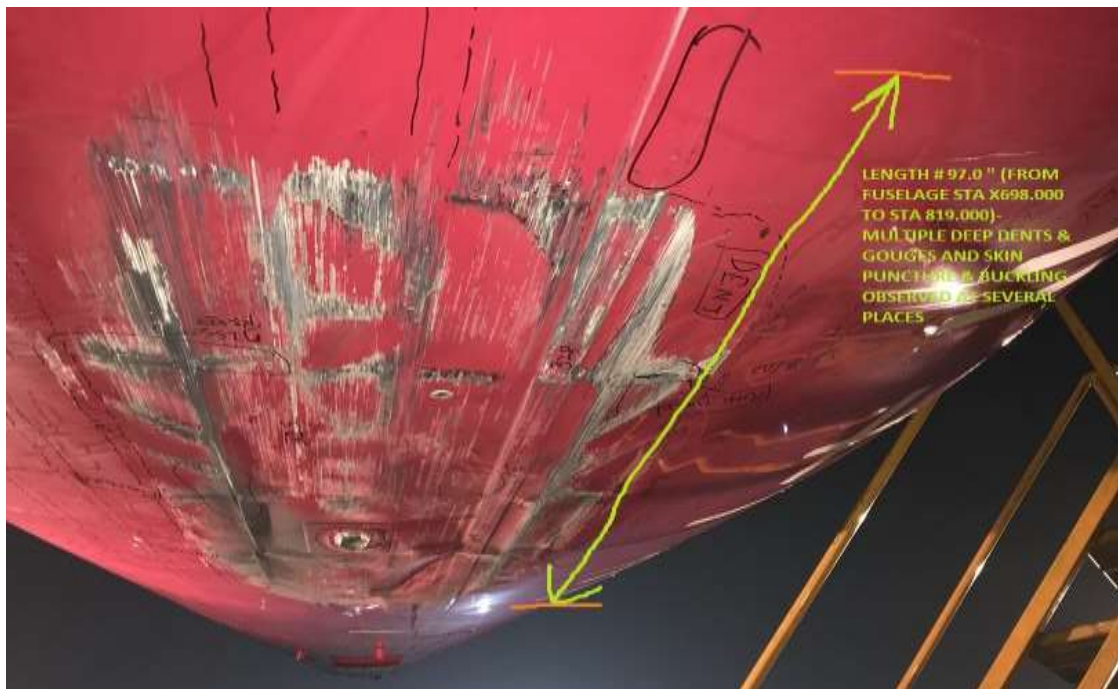
***Aft Centre Fuselage Section***

- Lower surface skin received heavy scrape marks, cracks, buckles, tears and crease damages between cross section 697.5 to 801 and between stringers 29P to 29S.

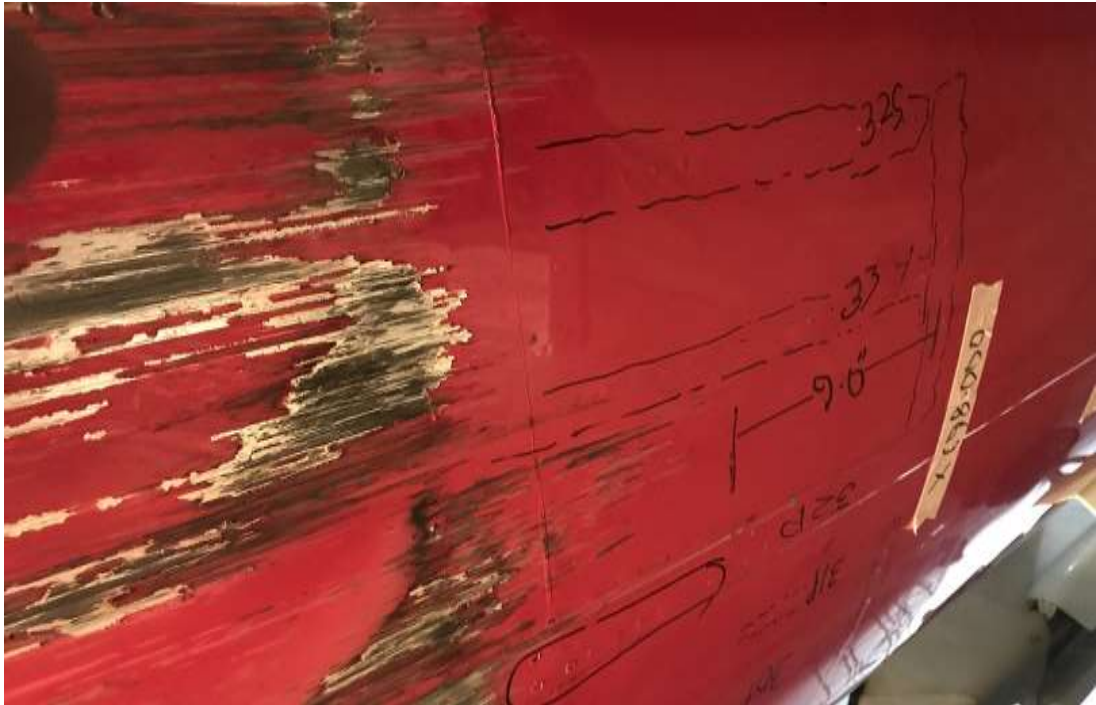
**Heavy Scrape marks on lower surface**

- The Frangible Switch Cover was found missing
- Fuselage Drain was found damaged.
- Few rivets were found missing between cross section 698 & 801

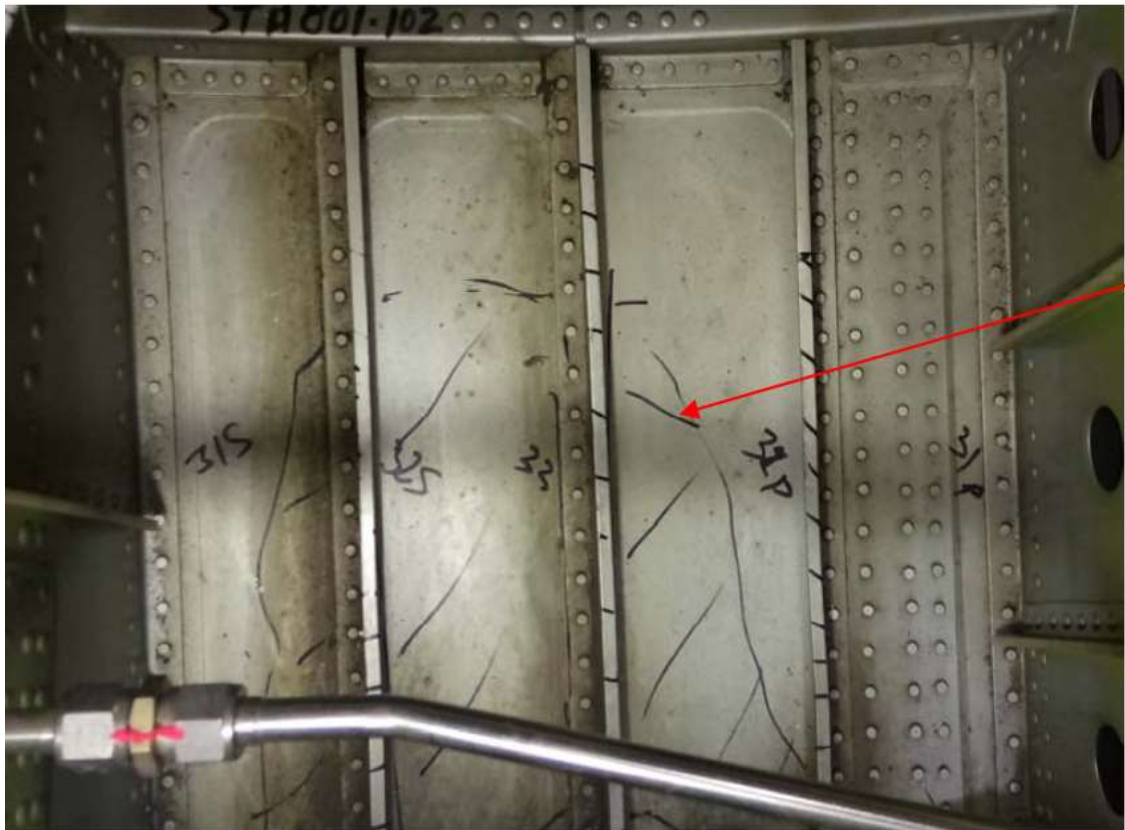
***Skin deflection and Stringer Buckling damage forward of Frame X801.102***

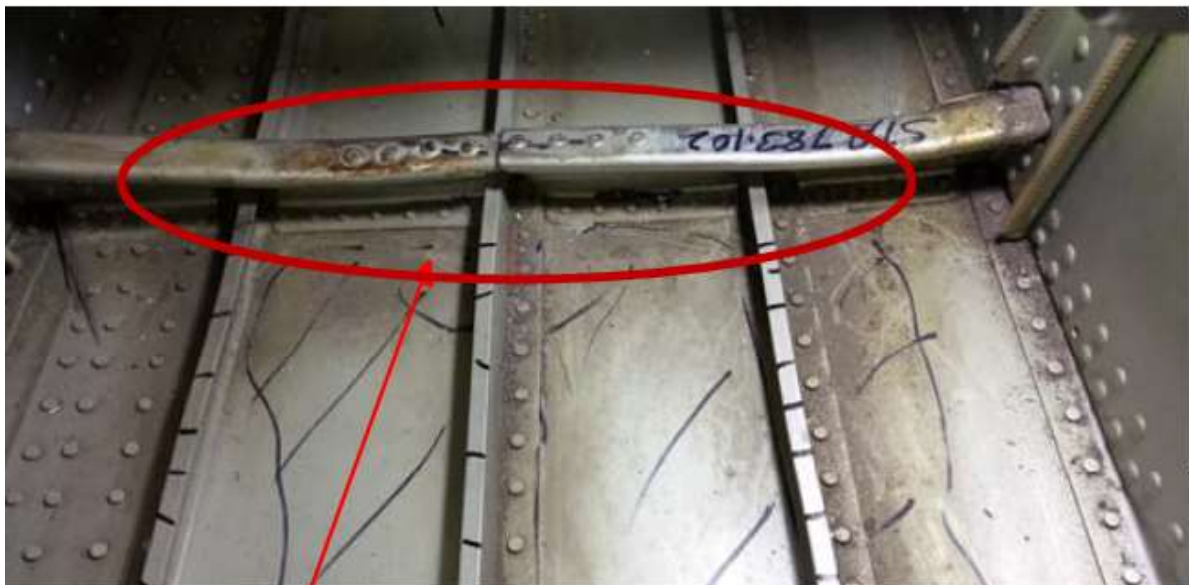
***Buckling damage at Frame X783.602***

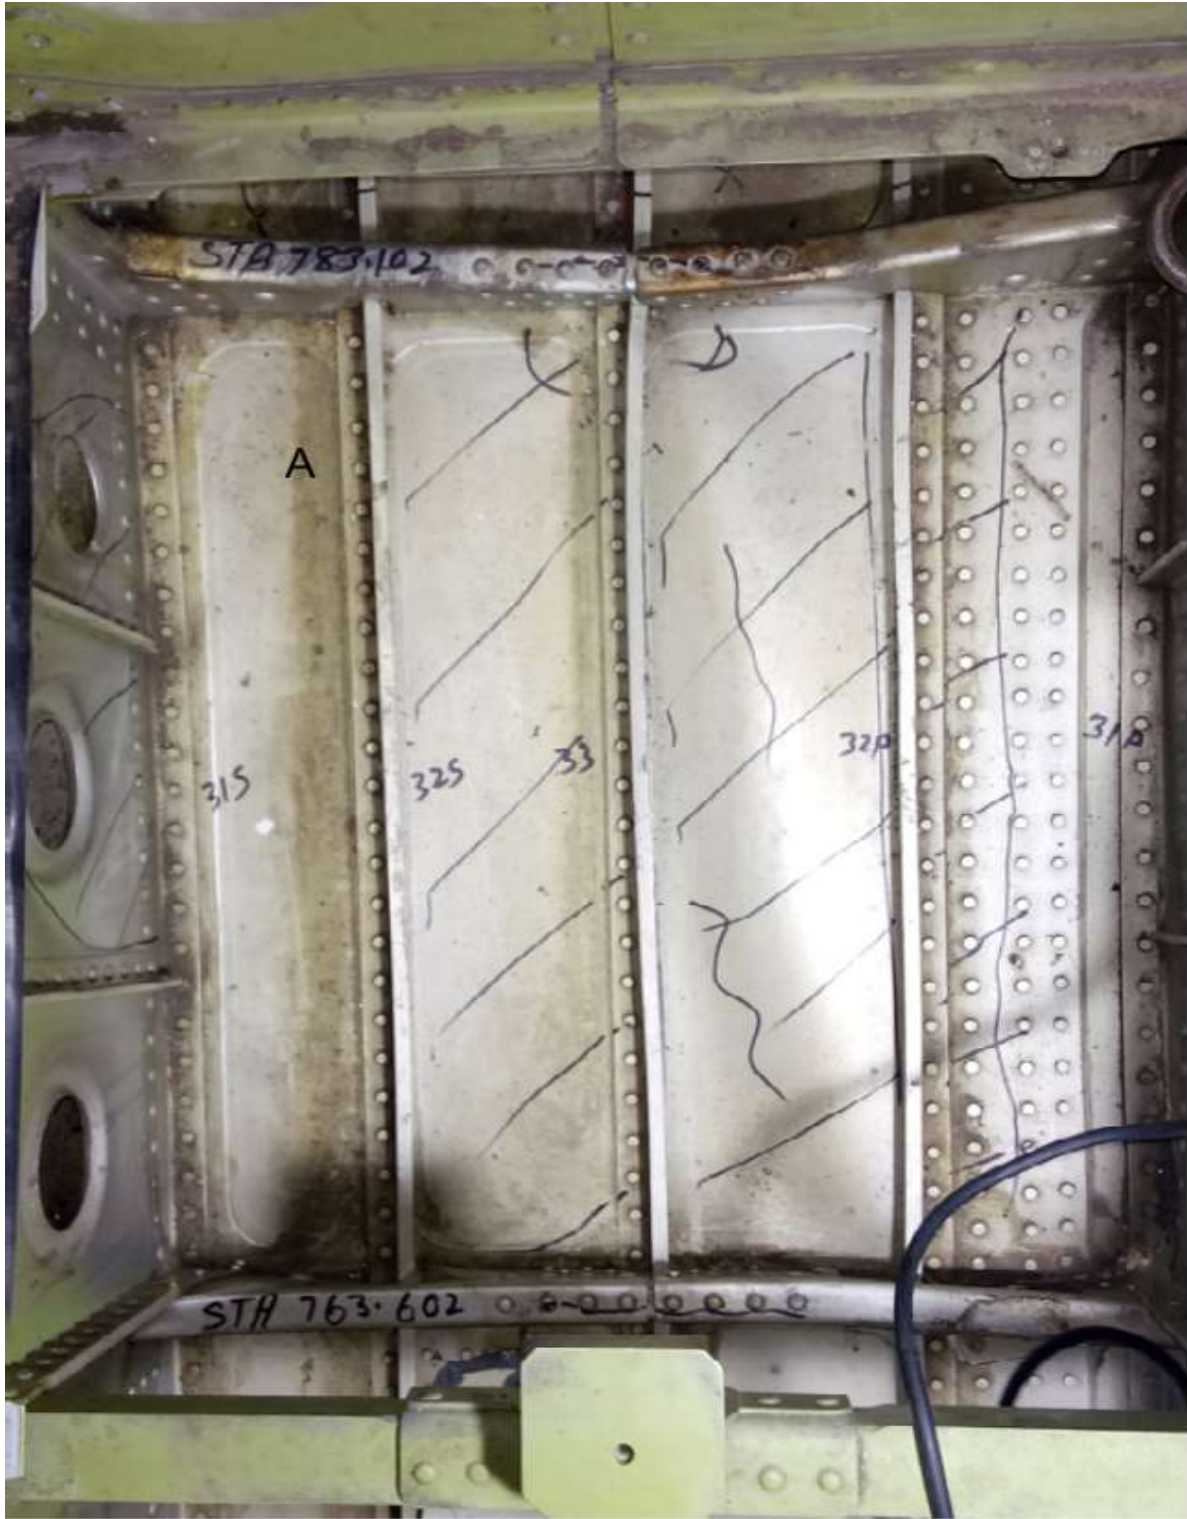
**Skin and Stringer damage between Station 783.602 & 763.602**

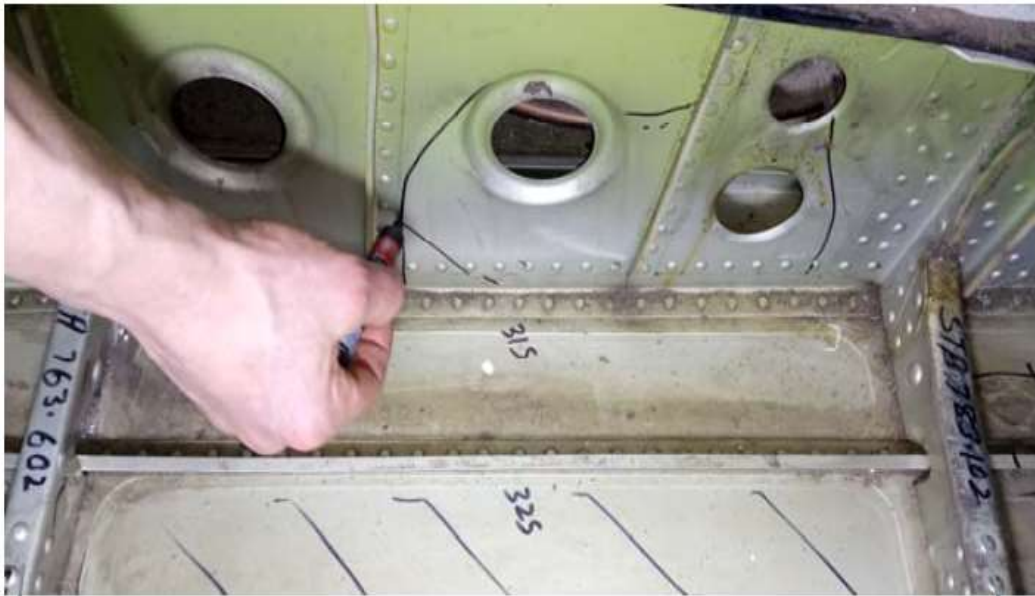
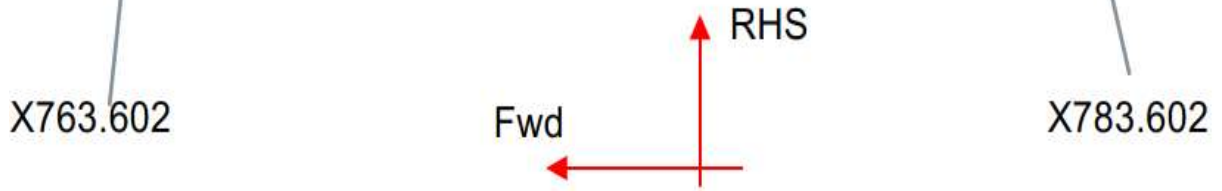
**RH Stringer 31S Keel Web Damage**

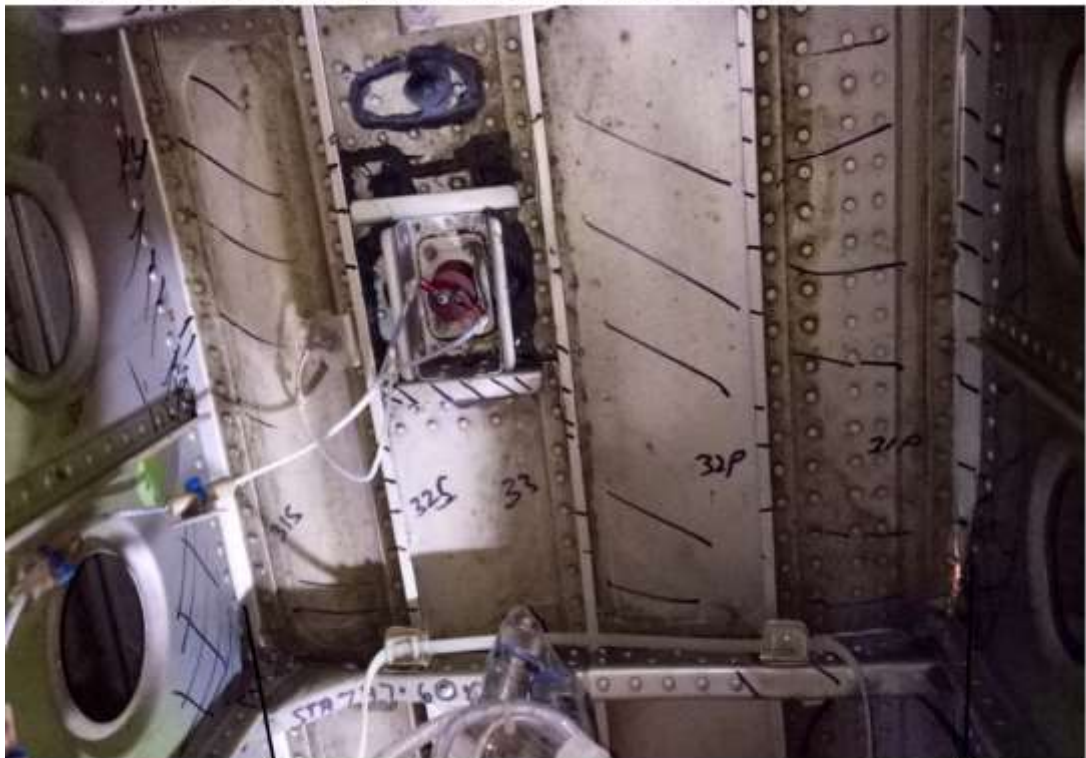
**Skin and Stringer damage between Station 747.602 & 763.602**

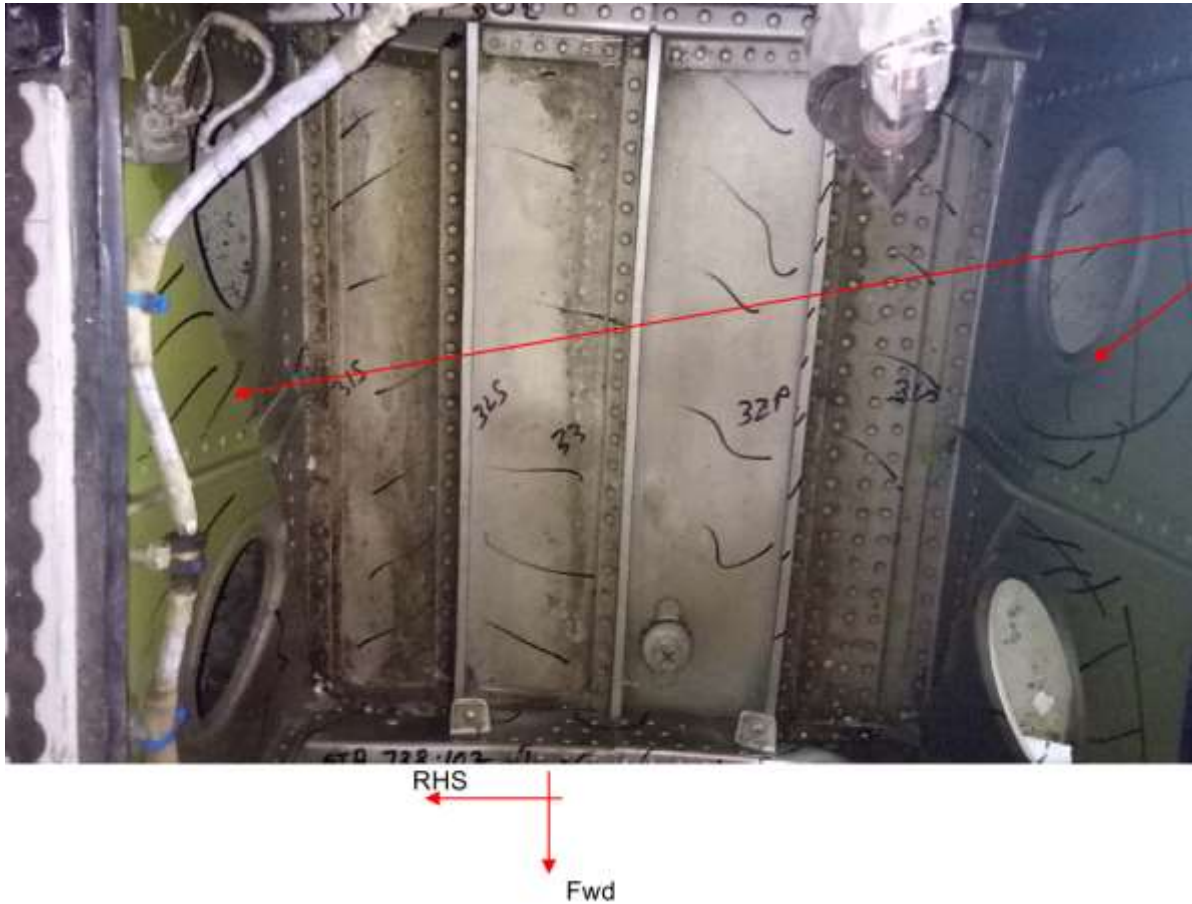
***RH (Stringer 31S) & LH (Stringer 31P) Keel Web Damage***
