**FINAL INVESTIGATION REPORT ON SERIOUS
INCIDENT TO M/S SPICEJET BOMBARDIER
DHC8-400 AIRCRAFT VT-SUM AT NAGPUR ON
24.11.2017**

**GOVERNMENT OF INDIA
MINISTRY OF CIVIL AVIATION
AIRCRAFT ACCIDENT INVESTIGATION BUREAU**

**INVESTIGATION REPORT ON SERIOUS INCIDENT TO M/S SPICEJET
BOMBARDIER DHC8-400 AIRCRAFT VT-SUM AT NAGPUR ON 24.11.2017.**

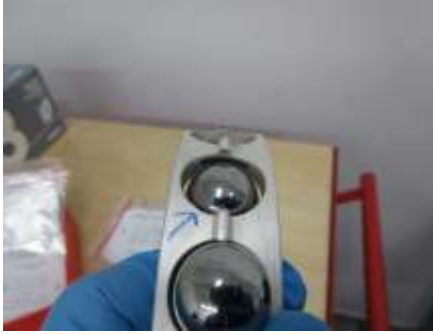
No. 1 Brg. - Flaking at cage

In the present case, the #1, #2.5, #3 and #4 bearings had all suffered some form of damage resulting in generation of metal chips. The damage could be attributed to a combination of lack of lubrication as well as vibrations due to imbalance seen in the LPC.

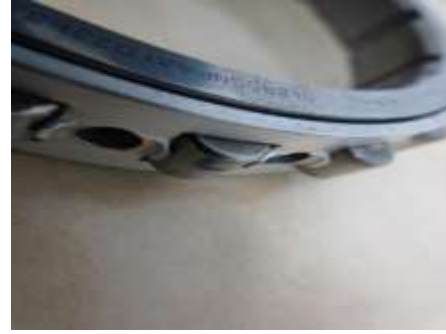
No.2.5 Brg. Dents on Roller Elements

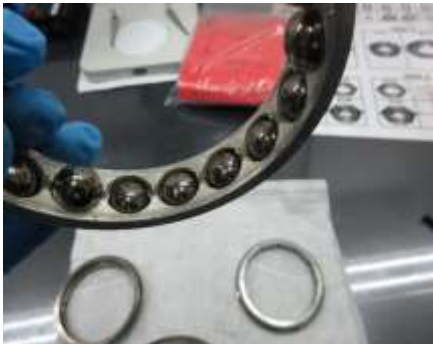
No.3 Brg. -Flaking of inner diameter of cage.

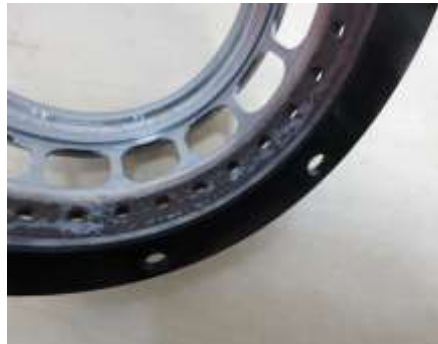
No.4 Brg: Corrosion on more than 30% of Area 1

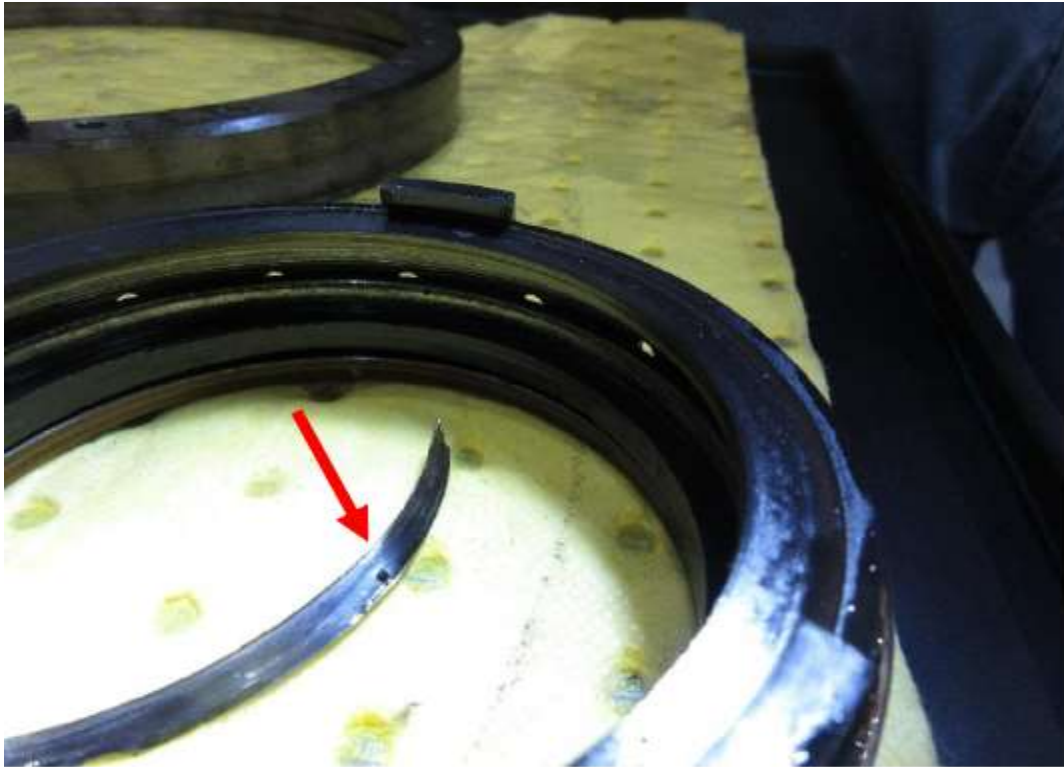
Wave spring of No. 3 bearing carbon seal assembly had broken

To conclude, the aircraft incident is attributed to the #3 Bearing Carbon Seal that had failed in service and caused oil to leak into the gas path. This

caused oil fumes to be released into the aircraft cabin through the Bleed Off Valves. Eventually enough oil was lost to cause the engine to lose oil pressure and trigger the Low Oil Pressure indication in the cockpit.

The incident occurred as No. 3 Bearing Carbon Seal failed in service resulting in oil leak into the gas path causing oil fumes getting into the aircraft cabin through the Bleed Off Valves.

Service Bulletin 35341 replaces the #3 Brg. carbon seal with one made from a carbon grade that is more resistant to high temperatures and humid environments. Similarly, the SB No. 35342R1 requires that No. 2.5 bearing seal be replaced with new one that has an increased minimum spring load to prevent potential spinning of the air/oil bearing seal ring.

Scrutiny of the engine records revealed that though the engine had a shop visit earlier, No. 3 bearing compartment Carbon Seal was of pre Service Bulletin 35341 configuration. The reason for the non-replacement of seal during that shop visit was that the area of the engine required for replacement could not be accessed which is in line with the SB No. 35341 issued by manufacturer on the subject.
