**GOVERNMENT OF INDIA  
MINISTRY OF CIVIL AVIATION  
AIRCRAFT ACCIDENT INVESTIGATION BUREAU**

**FINAL INVESTIGATION REPORT ON SERIOUS  
INCIDENT TO M/S SPICEJET LTD. BOEING B-737-800  
AIRCRAFT VT-SGZ AT MUMBAI ON 19.09.2017**

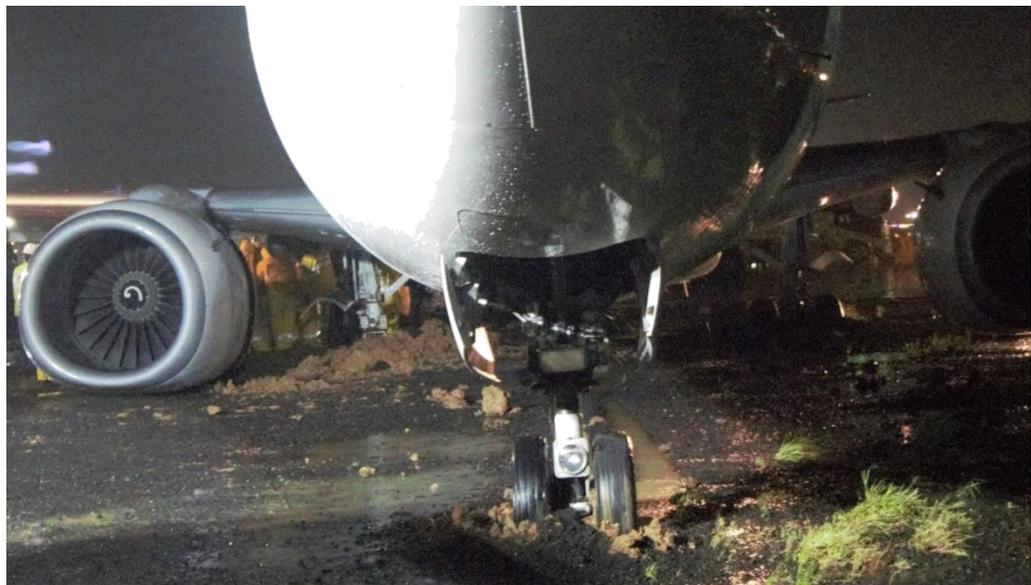
It was raining heavily at the time of landing. After landing on runway 27 the aircraft went 42 meters beyond runway 27 end and approximately 19 meters left of runway extended line.

Final position of the aircraft (nose wheels)

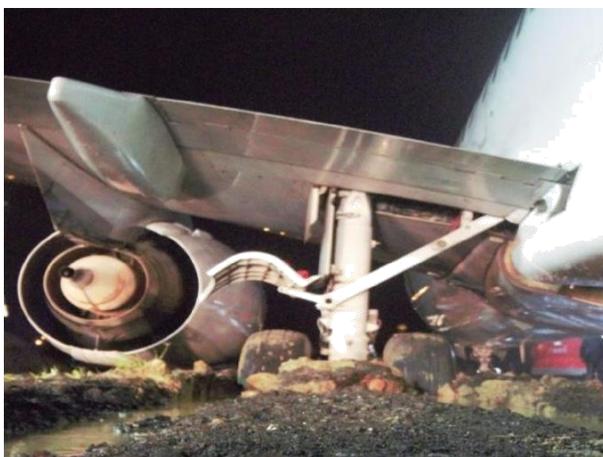
LH main wheels

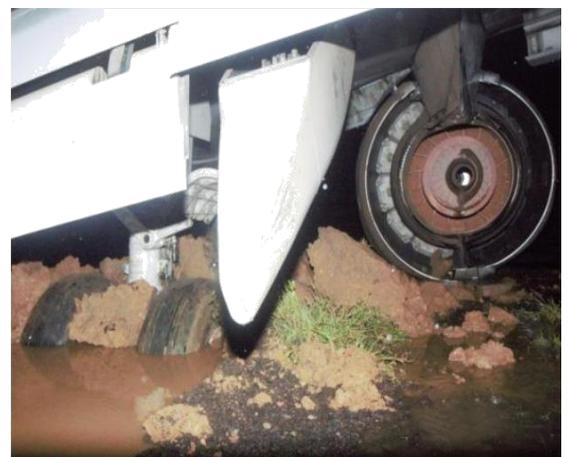
RH main wheels
