**FINAL INVESTIGATION REPORT ON
ACCIDENT TO M/s AHMEDABAD AVIATION &
AERONAUTICS LTD., CESSNA 172S AIRCRAFT,
VT-ABK ON 24-11-2018 AT MEHSANA
AIRFIELD, GUJRAT**

**GOVERNMENT OF INDIA
MINISTRY OF CIVIL AVIATION
AIRCRAFT ACCIDENT INVESTIGATION BUREAU**

FINAL INVESTIGATION REPORT ON ACCIDENT TO
M/s AHMEDABAD AVIATION & AERONAUTICS LTD., CESSNA 172S
AIRCRAFT, VT-ABK ON 24-11-2018 AT MEHSANA AIRFIELD, GUJRAT.

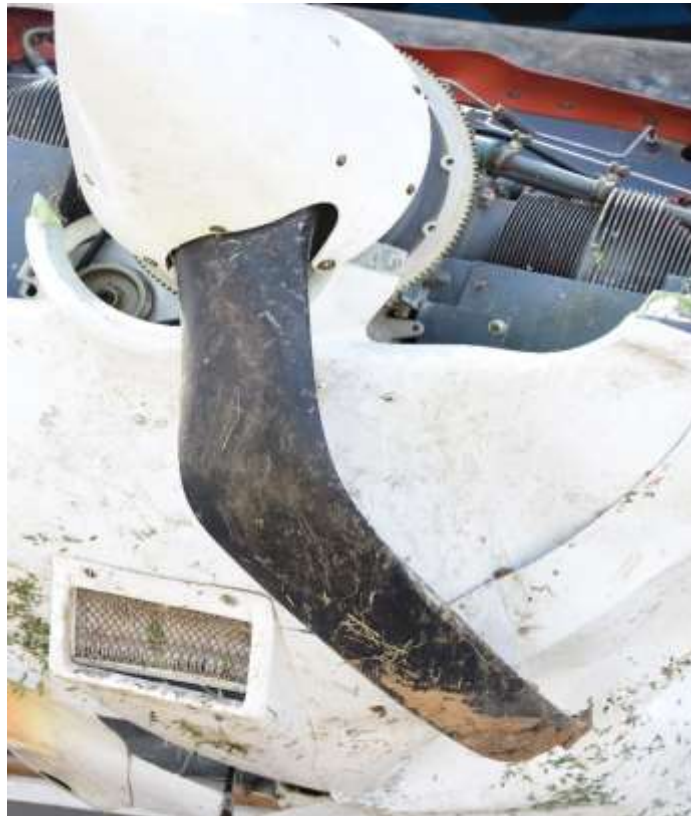
1. The propeller was found intact. However, one propeller blade was found bent backwards from 7-8 inch from root section upto tip.

Image 1. Propeller blade found bent backwards

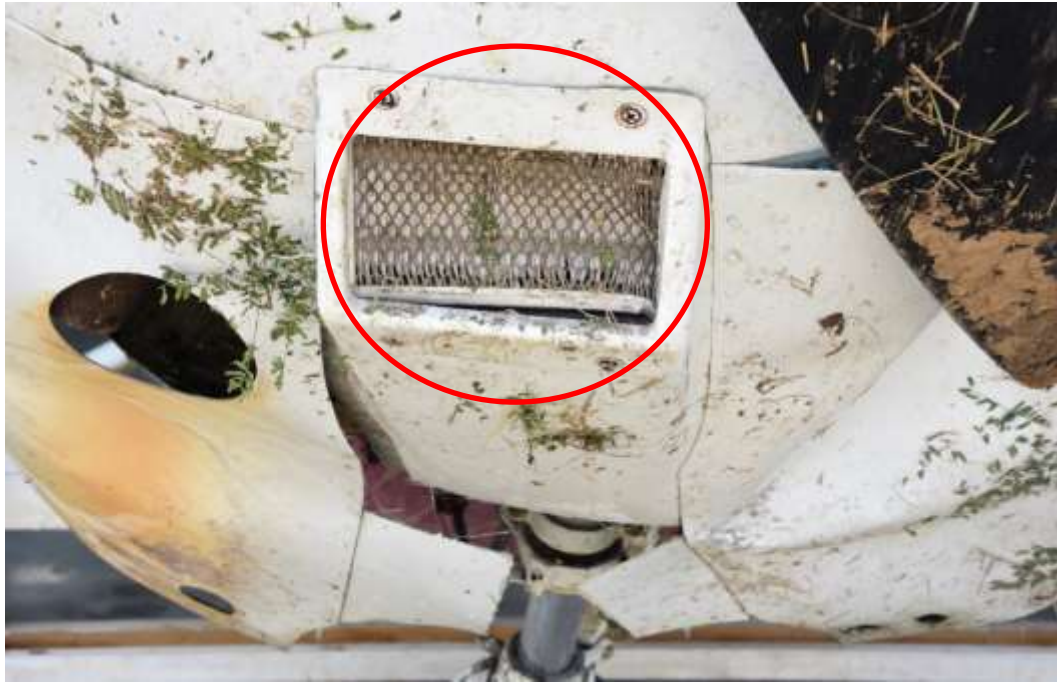
2. Top and Bottom engine cowling was found damaged.
3. Induction Air Filter was found damaged.

Image 2. Air Filter Found damaged

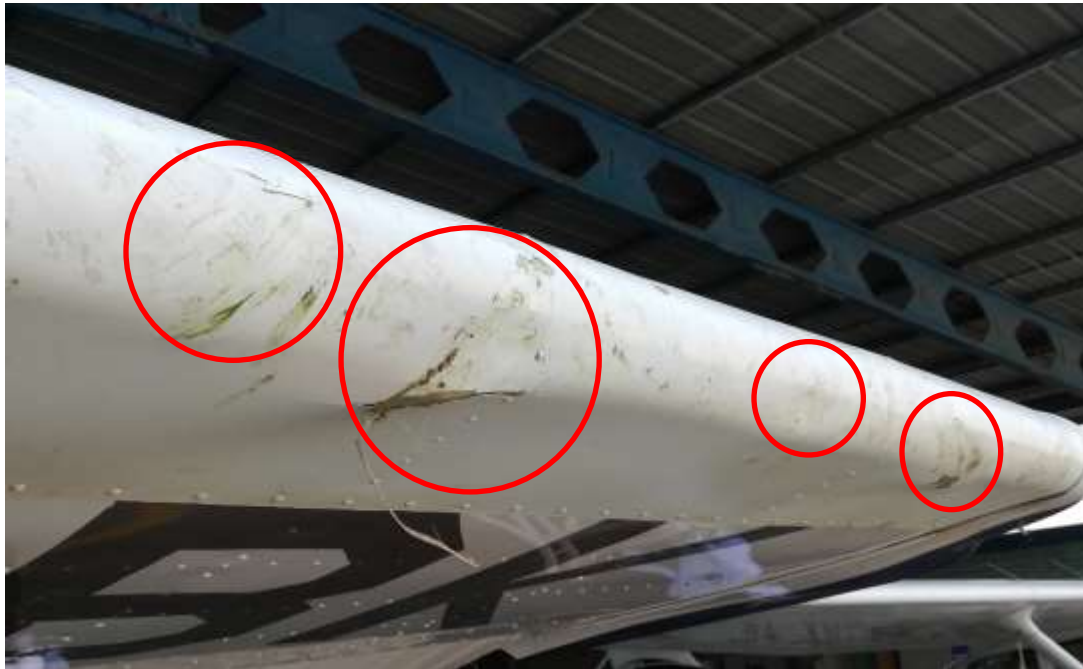
4. Dents were found at many wing stations along the leading edge of both the wings.

Image 3. Damages on Left Wing leading edge (Outboard)

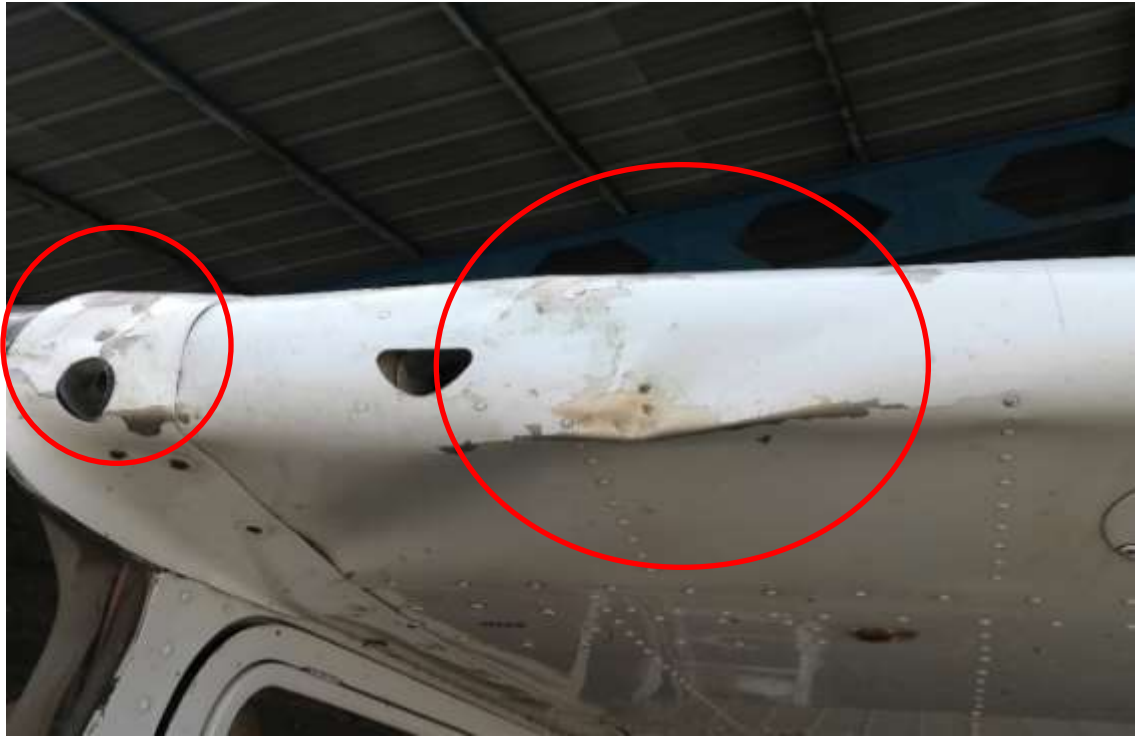
Image 4. Damages on Left Wing leading edge (Inboard)

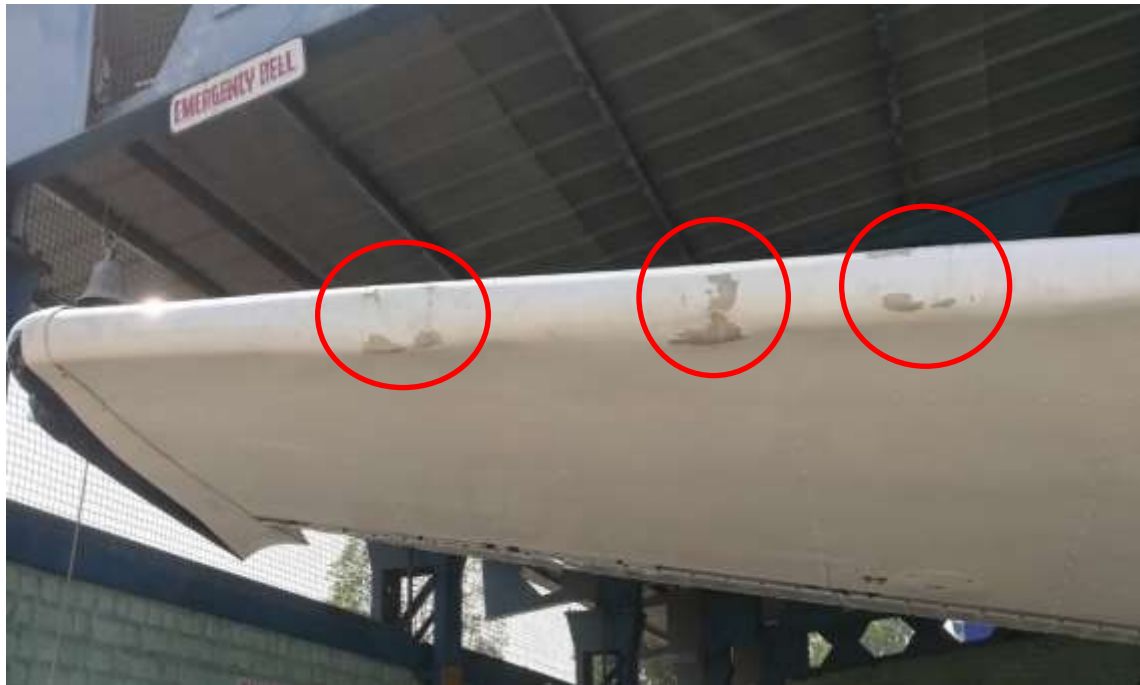
Image 5. Damages on Right Wing leading edge

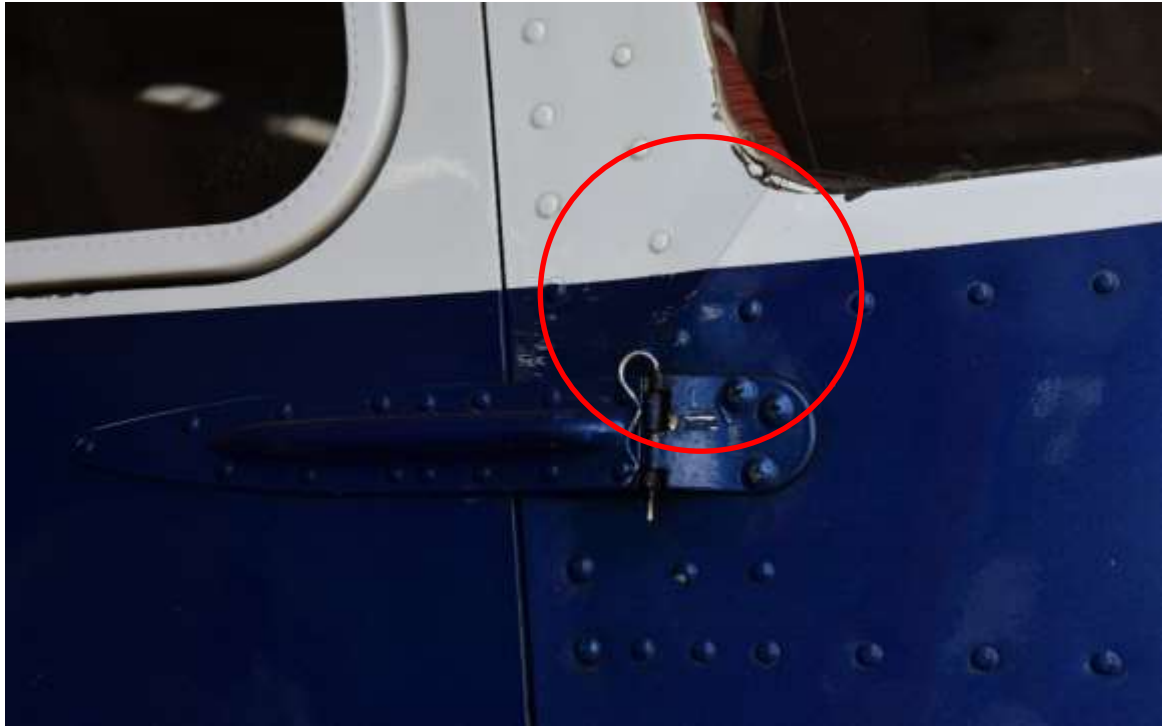
5. Skin at forward fuselage bulk head station above the upper hinge position of LH & RH door was found bent due to heavy impact.

Image 6. Skin found bent above the upper hinge RH door

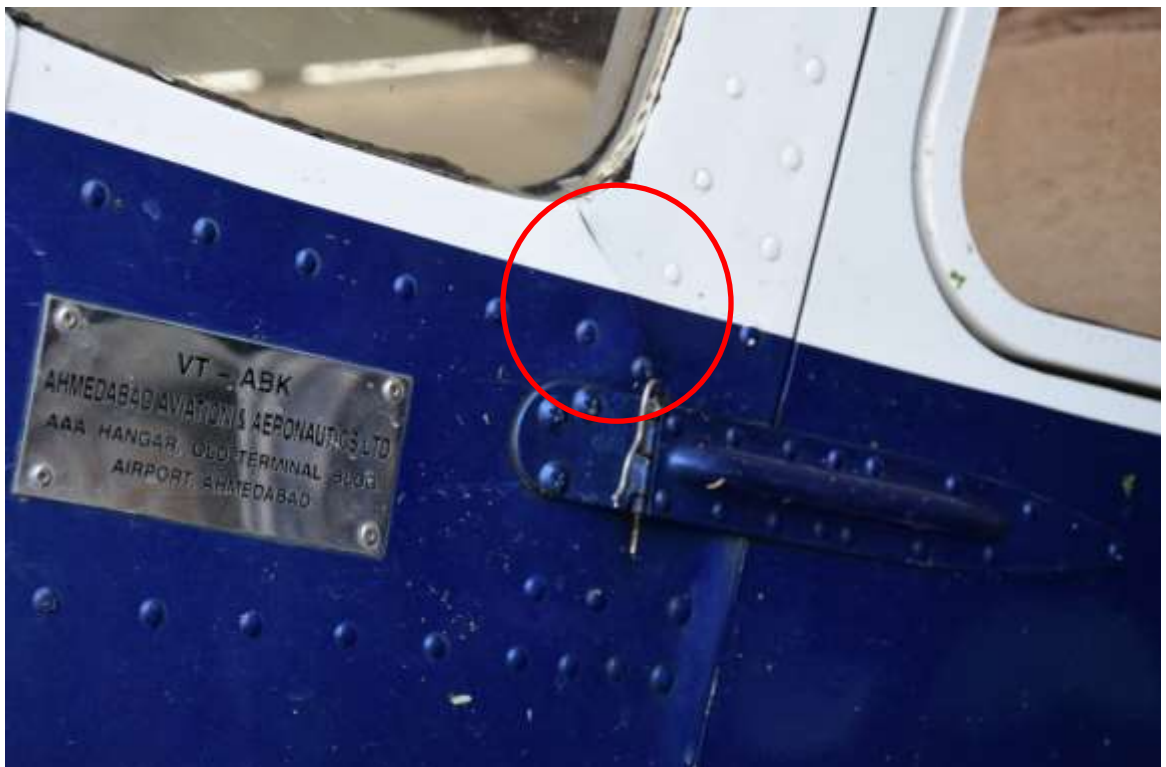
Image 7. Skin found bent above the upper hinge LH door

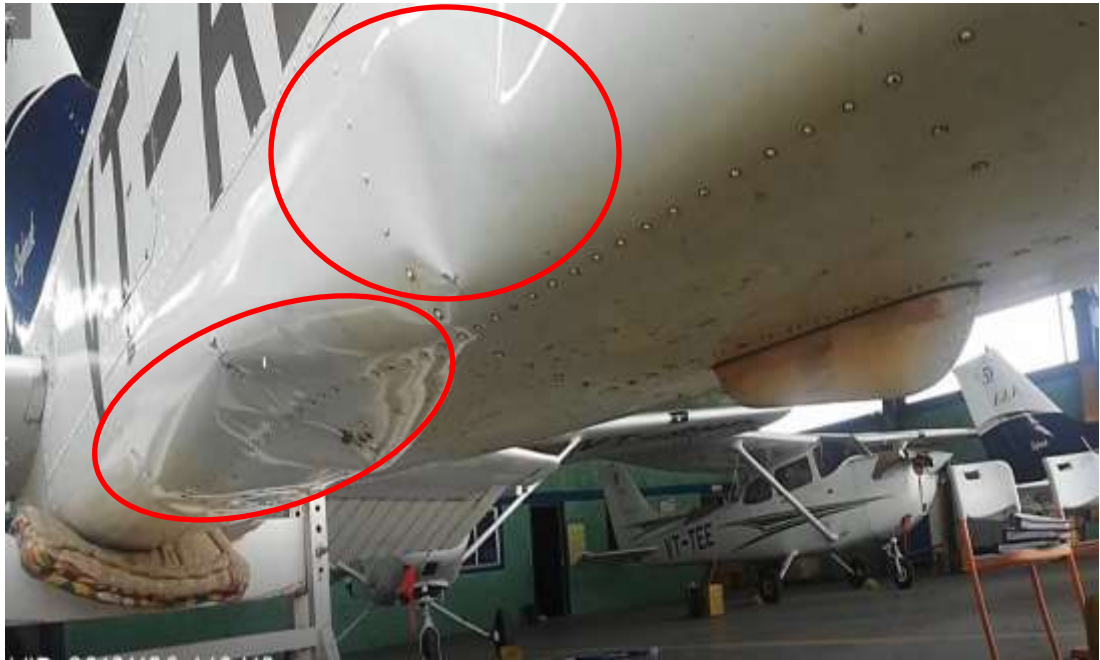
- Dent found at Fuselage Station (FS) No. 142 and between FS No. 124 & 178 on RH side.

Image 8. Dents in fuselage RH side

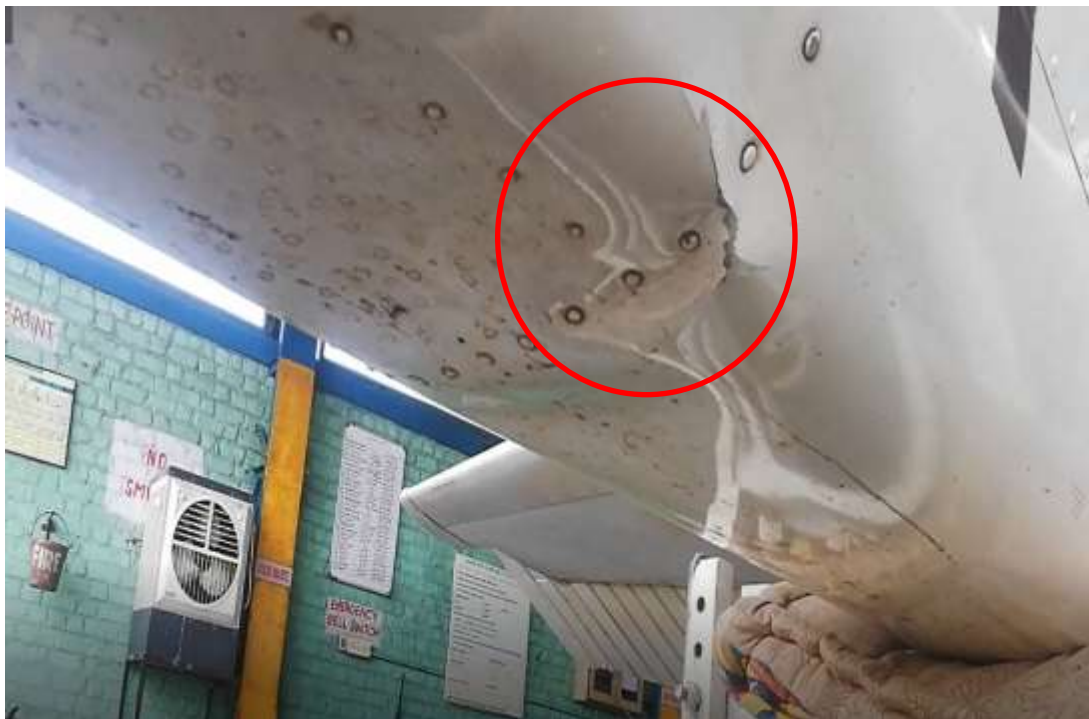
- Dent found at FS No. 142 on LH lower surface.

Image 9. Dent in Fuselage LH lower surface

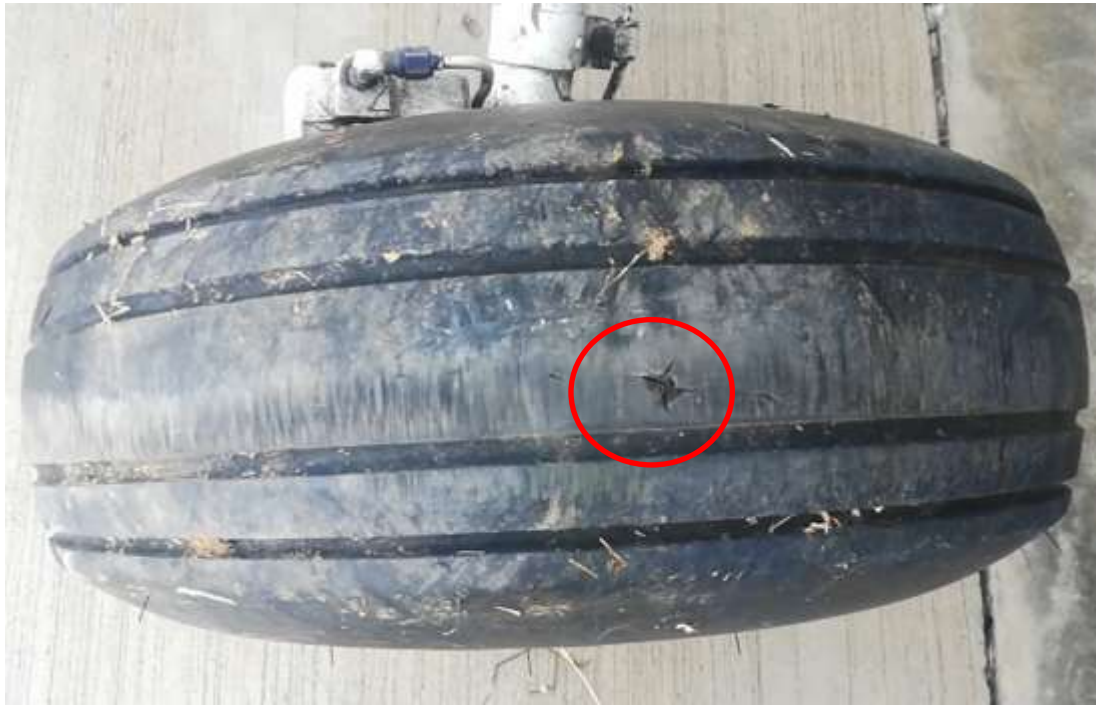
8. Cut mark on LH main wheel tire.

Image 10. Cut Mark on LH tyre

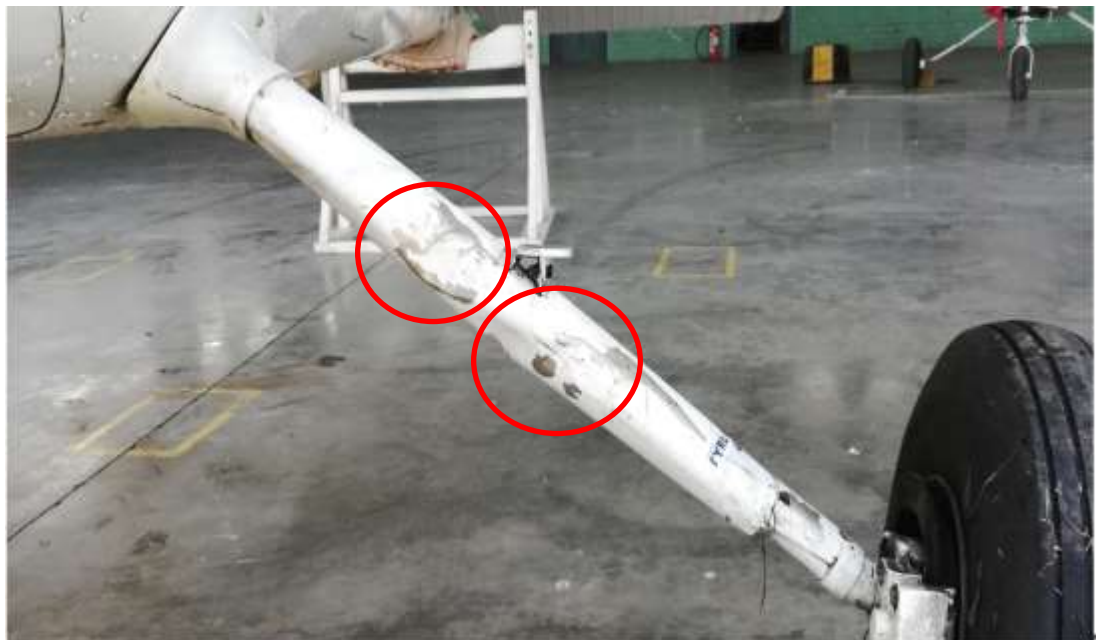
9. Dents found in LH main wheel strut fairing.

Image 11. Dents in LH main wheel strut fairing

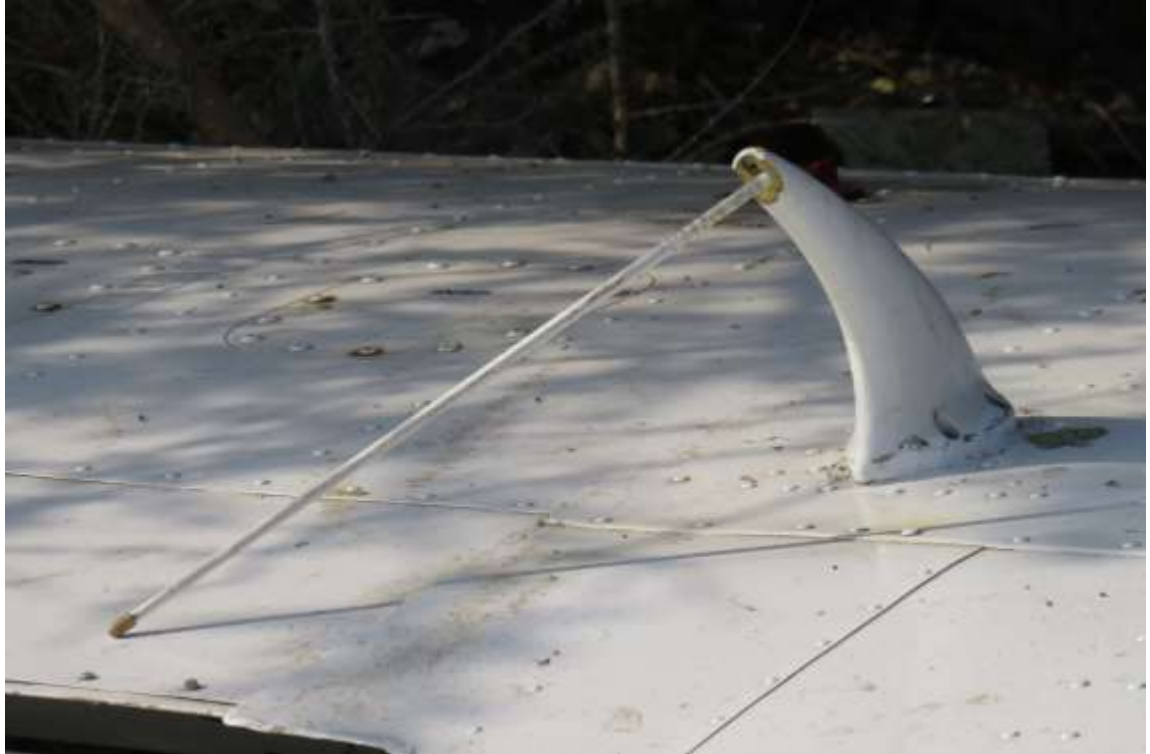
10. L.H. side VHF antenna mounted on upper surface of LH wing found broken.

Image 12. Broken LH VHF Antenna

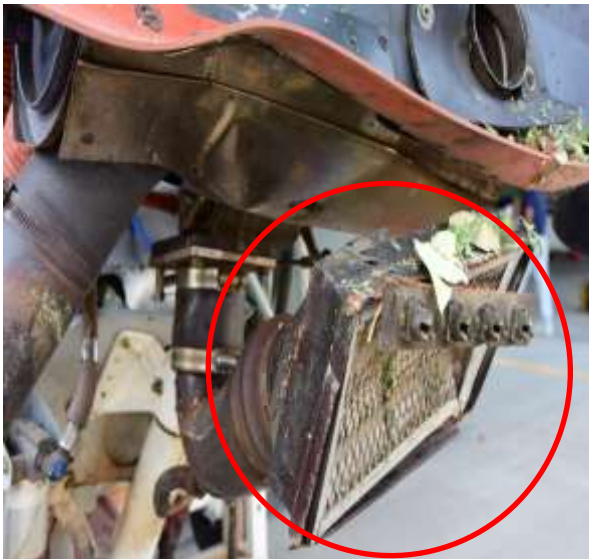
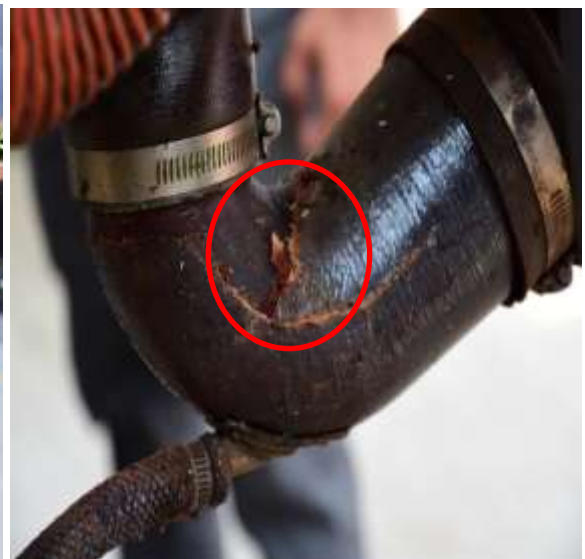
11. Air Intake was found broken.

Damaged Air Intake

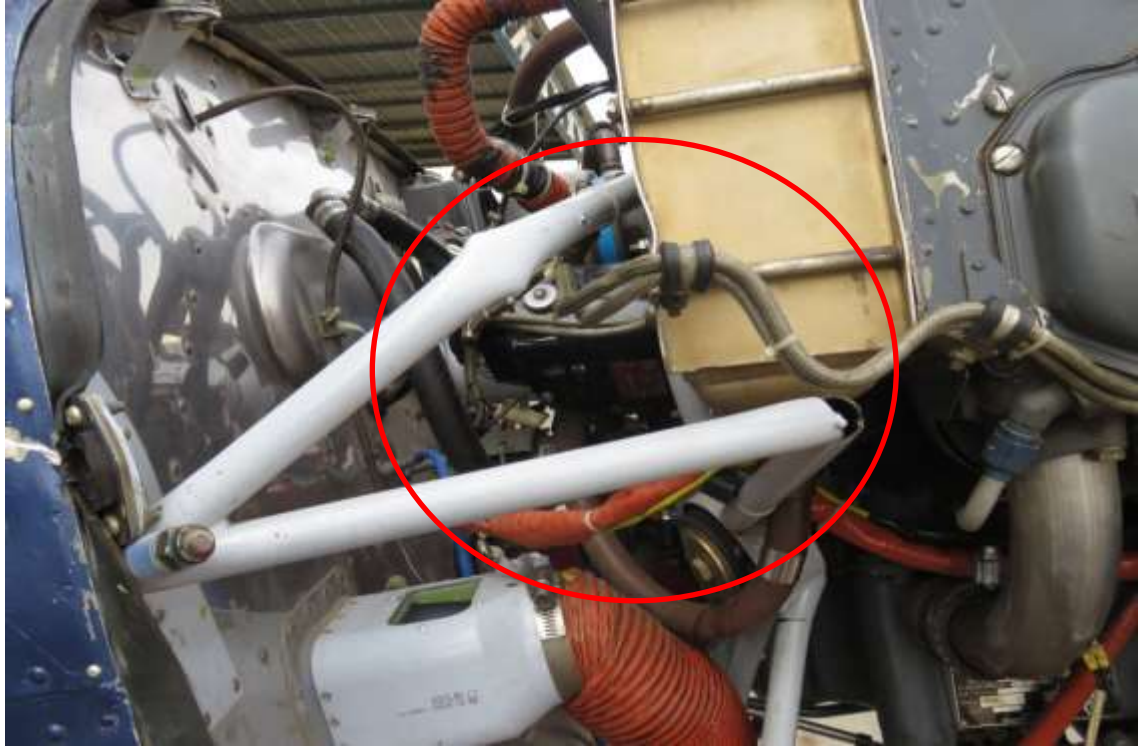
12. Engine mount found broken at upper RH side mount to engine attachment.

Image 15. Broken Engine Mount

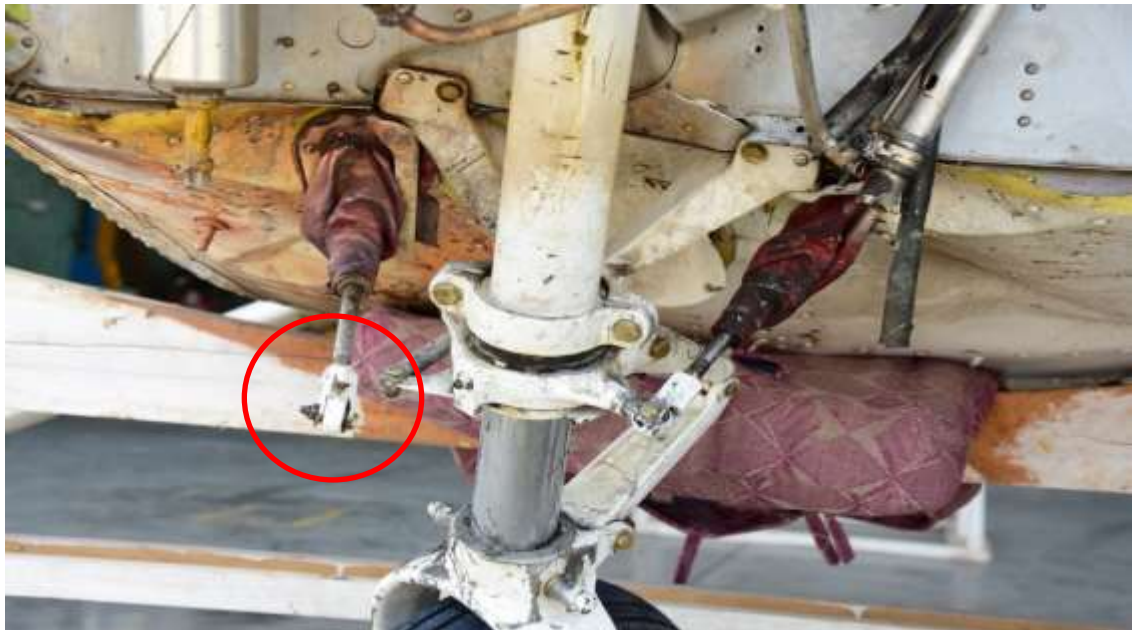
13. RH side steering rod eye end found broken from nose bearing.

Image 16. Broken RH side steering rod eye end

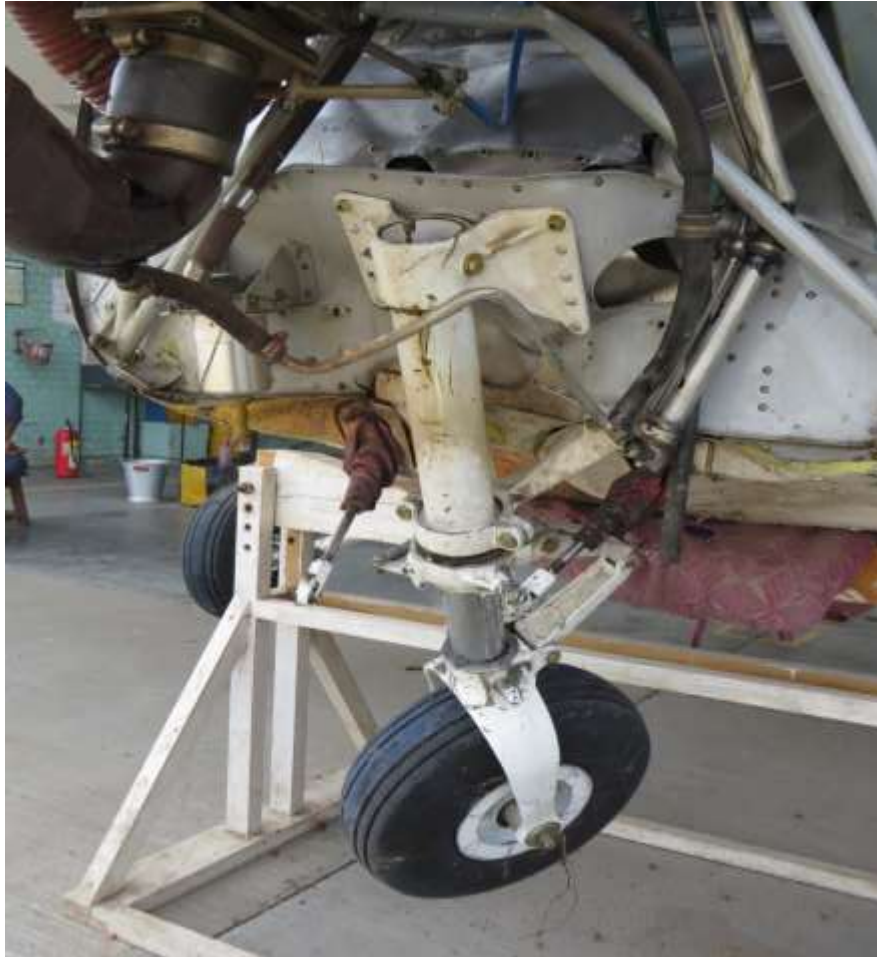
14. Nose wheel found bent backward along with lower firewall.

Image 17. Nose Wheel bent backwards

There was a small bump just before the drainage line, which probably arrested the speed of the aircraft. As the nose wheel of the aircraft ran over the bump, the nose section of the aircraft went up (pitched up) and due to its weight, it hit the ground on the other side of the sewage line with heavy impact. Due to the impact, the nose wheel along with lower firewall of the aircraft was found bent backwards (Image 18). The engine cowling along with the engine mountings were damaged. One of the propeller blade was found bent backwards due to impact with ground (Image 2).

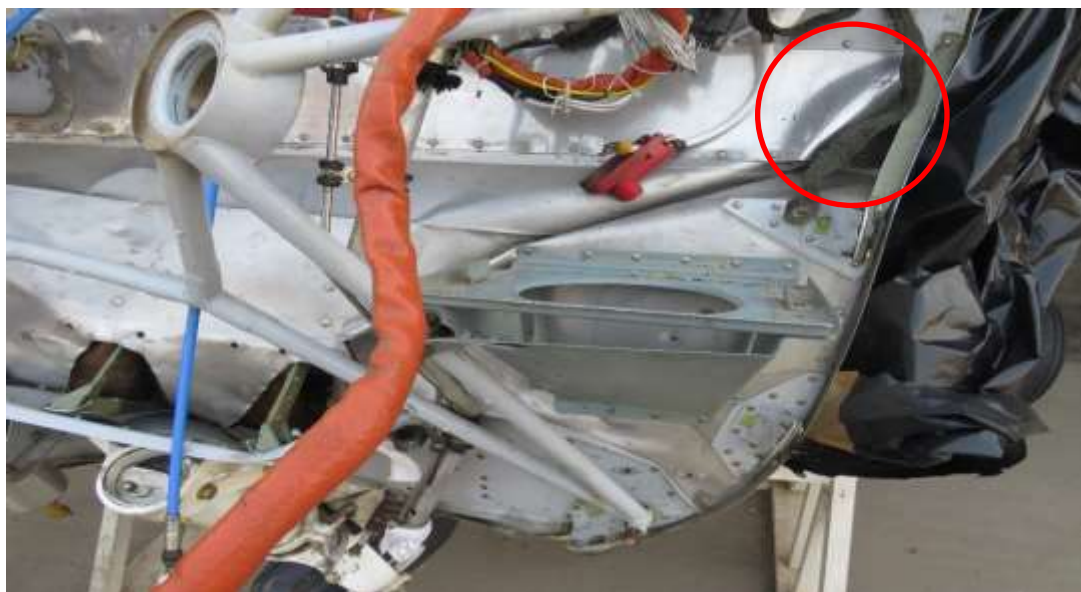
15. Upper firewall found damage above battery cradle.

Image 18. Damage to upper firewall

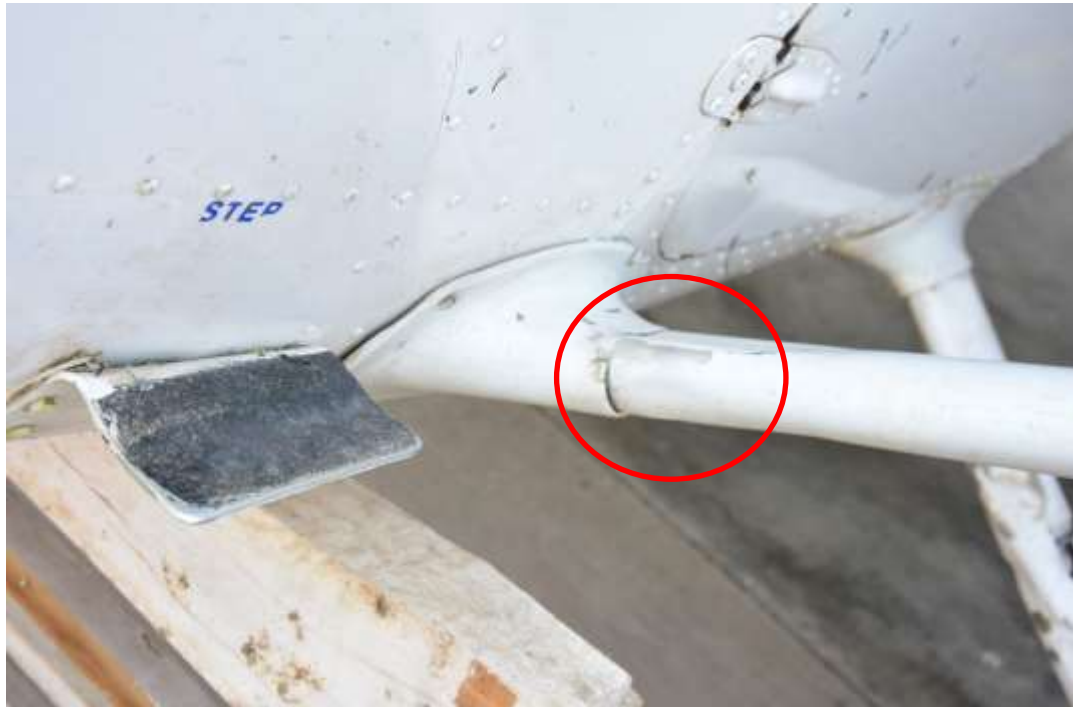
16. Dent found on LH wing strut near lower fairing attachment.

Image 19. Dent on LH wing strut

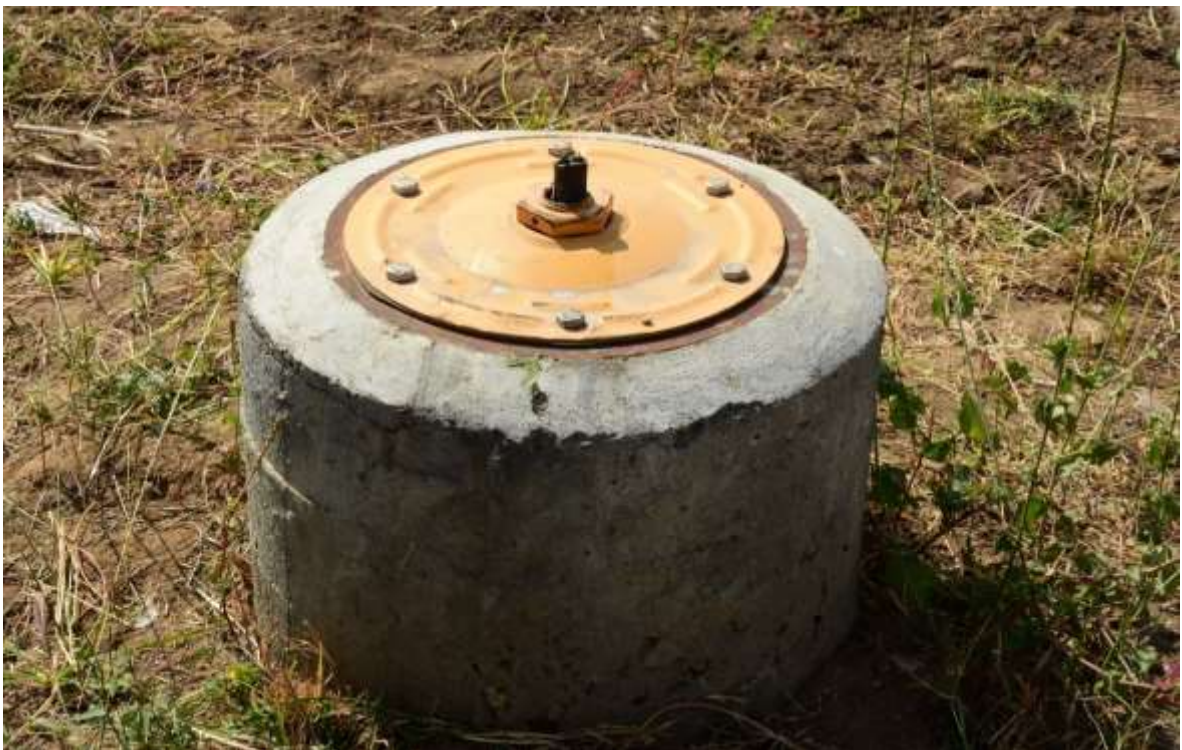
- The aircraft ran over one of the runway 05 end lights which was found broken.

Image 20. Broken runway end light

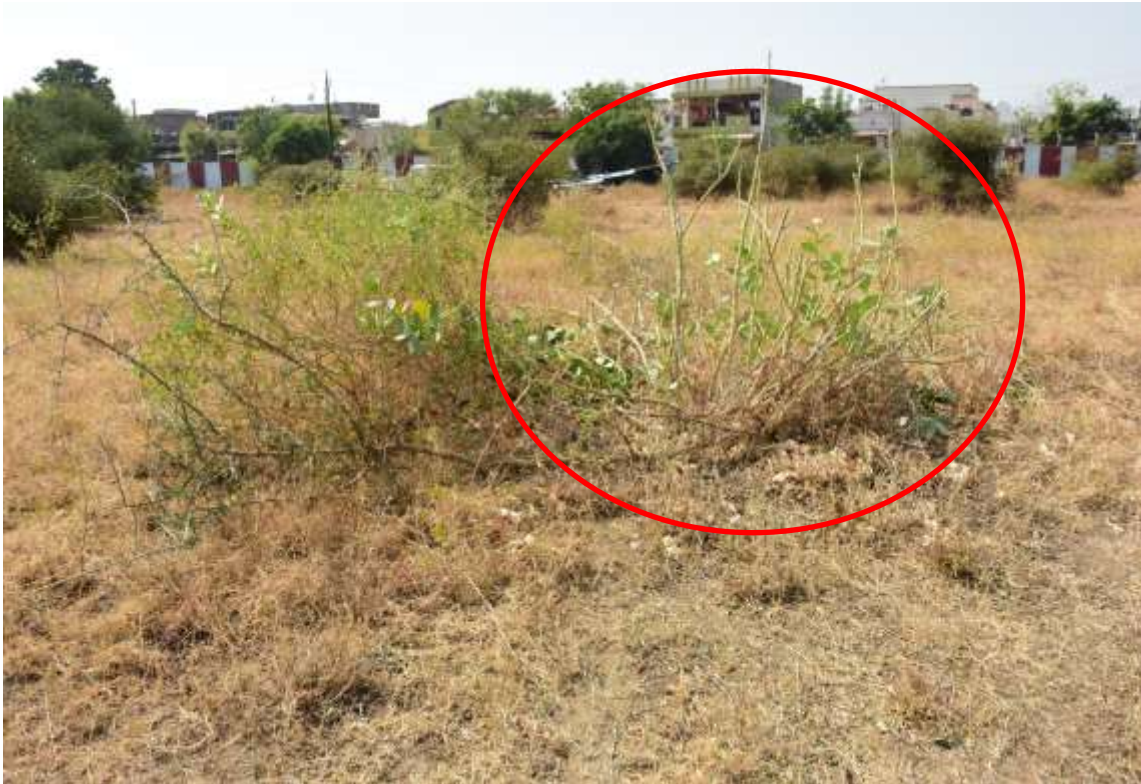
- Branches of some shrubs and bushes on the unpaved surface were found cut/broken by propeller & wings.

Image 21. Branches of shrubs & bushes found cut/broken

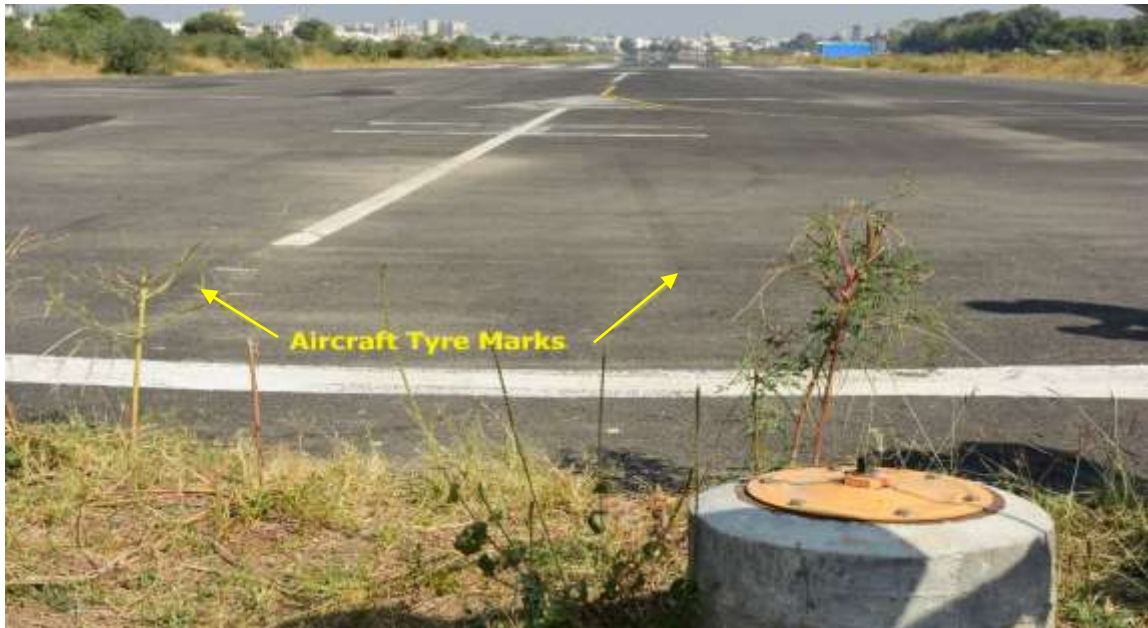
The aircraft was high on approach and made a delayed touchdown close to the runway 05 threshold. The exact touch down point could not be established as there was no prominent tyre marks of the aircraft found on the runway. Moreover, there were lot of tyre marks observed on the runway which probably were of other vehicles which went to the accident site after the accident. Based on the statements of the eyewitnesses and the student pilot, the touchdown point was identified to be after runway intersection B and close to runway 05 threshold. However, tyre marks of the aircraft were observed just before the runway 05 end.

Image 27. Aircraft Tyre marks close to runway 05 end

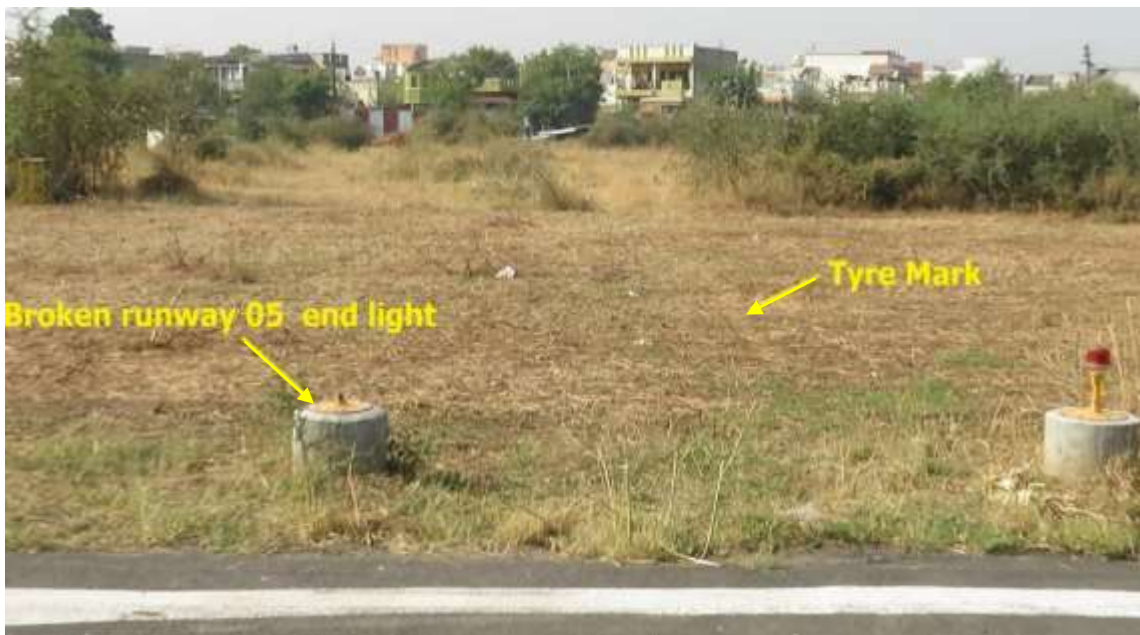
The landing was hard which resulted in aircraft bouncing twice before exiting the runway 05 end. While exiting the runway, the left wheel of the aircraft ran over one of the runway end lights which was evident from the cut marks found on the LH tyre of the aircraft and damaged it (Refer Image 11). The damaged part of the light was found on the unpaved surface at around 36 meters from the runway 05 end.

Image 28. LH wheel of aircraft ran over runway end light

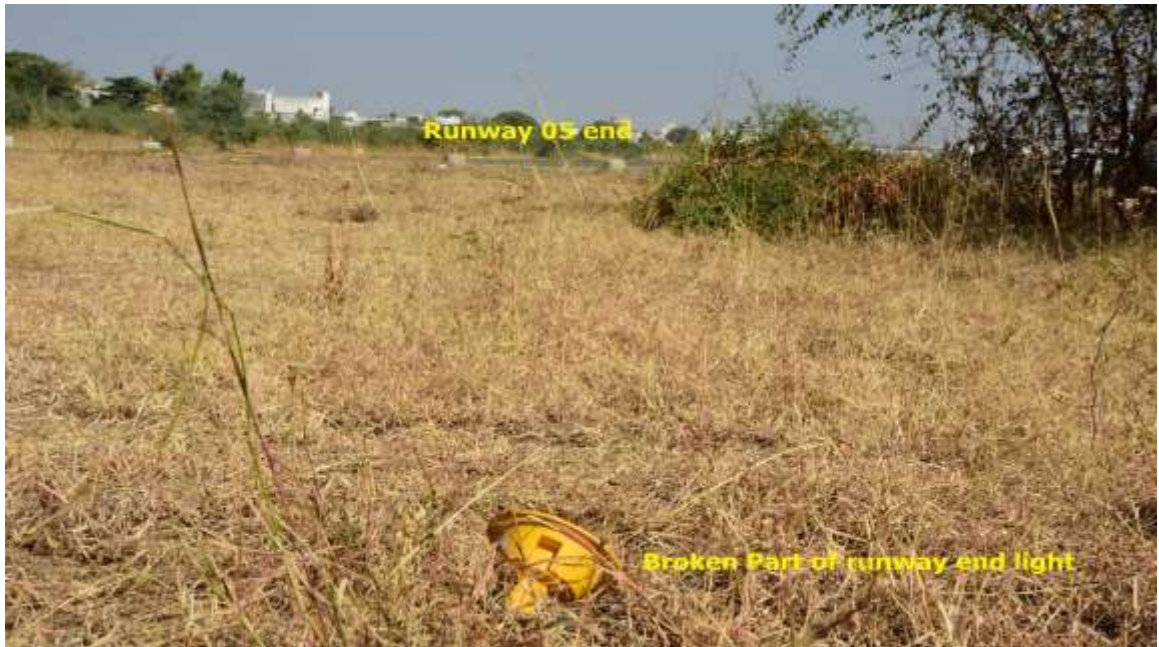
Image 29. Broken part of runway end light found on unpaved surface

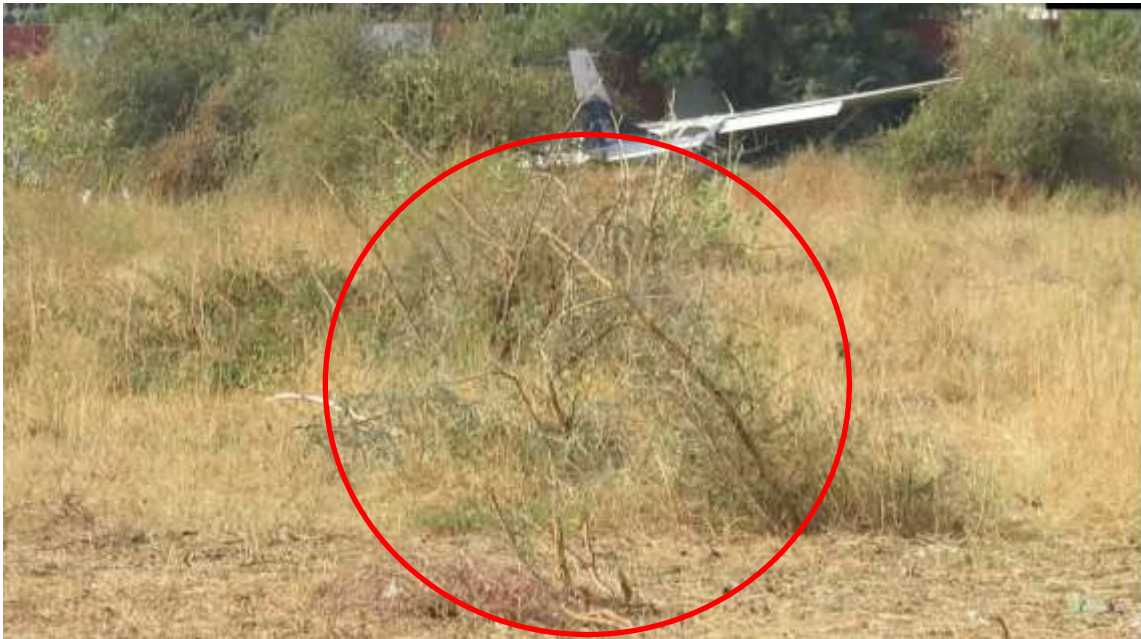
The aircraft continued to travel on the unpaved surface after exiting the runway, running over the bushes and the wings impacting the shrubs on the way. This was evident from the damages observed on the leading edge of the wings (Image 4 to 6). Some branches of shrubs and bushes were found cut probably by the propeller blades and wings.

Image 30. Shrubs & Bushes cut by aircraft

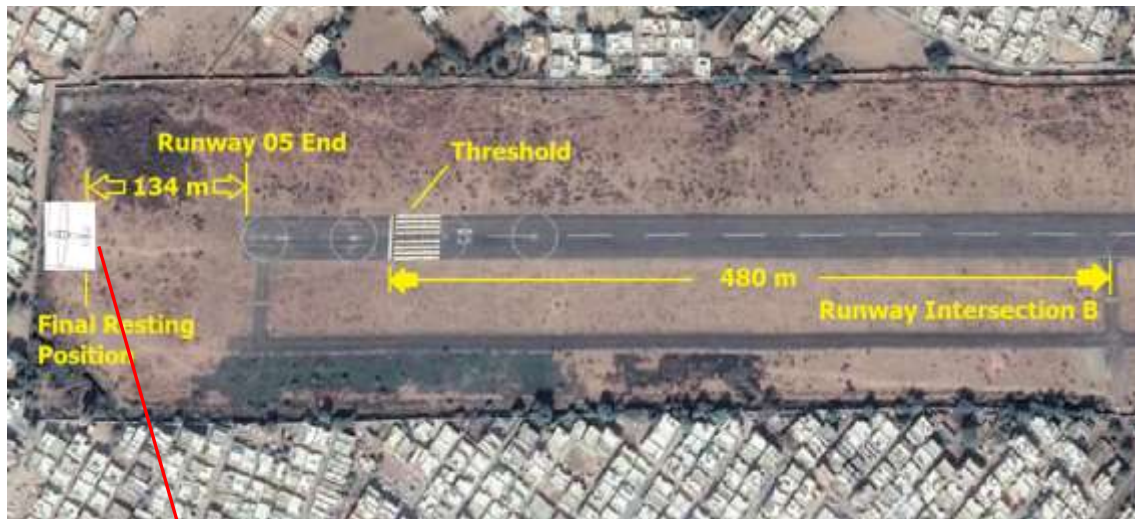
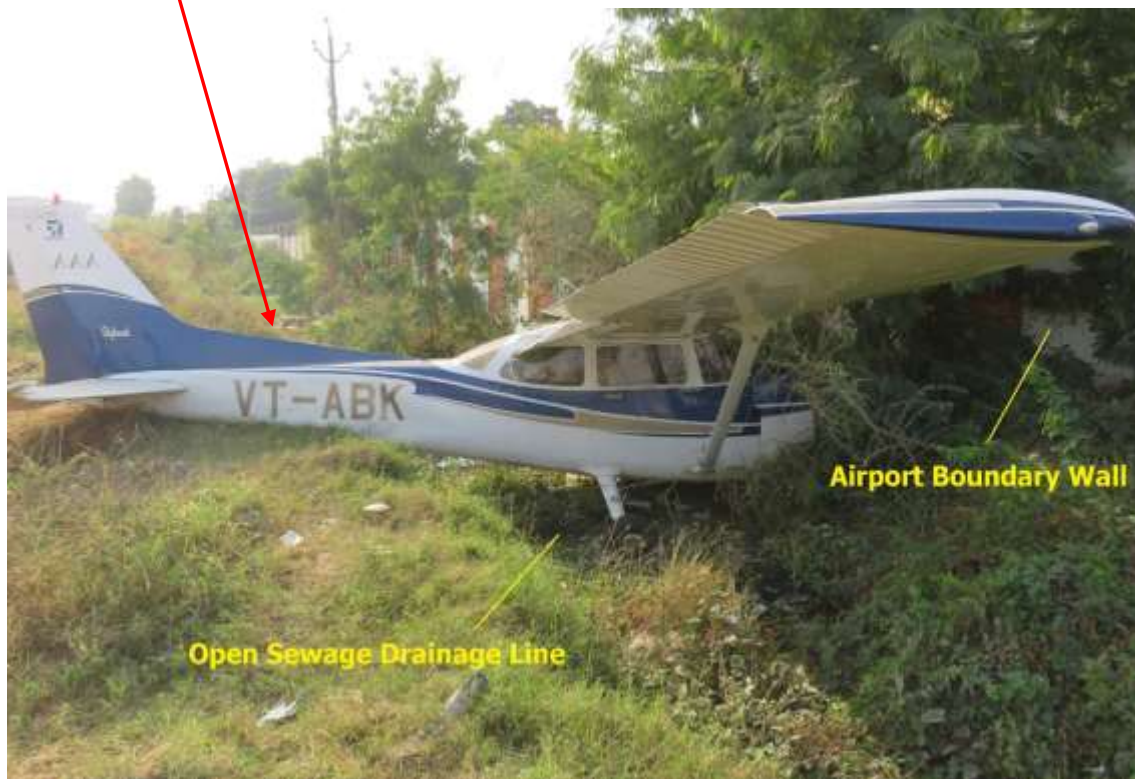
The aircraft travelled for about 134 meters on the unpaved surface before coming to final halt just before the airport boundary wall. The aircraft was found lying over an open sewage drainage line (adjacent to the airport boundary wall). The nose section of the aircraft was resting on ground on the other side of the drainage line (close to the boundary wall). The fuselage mid-section along with cabin was hanging over drainage line and the main wheels in the sewage.

Image 31 & 32. Final resting position of the aircraft

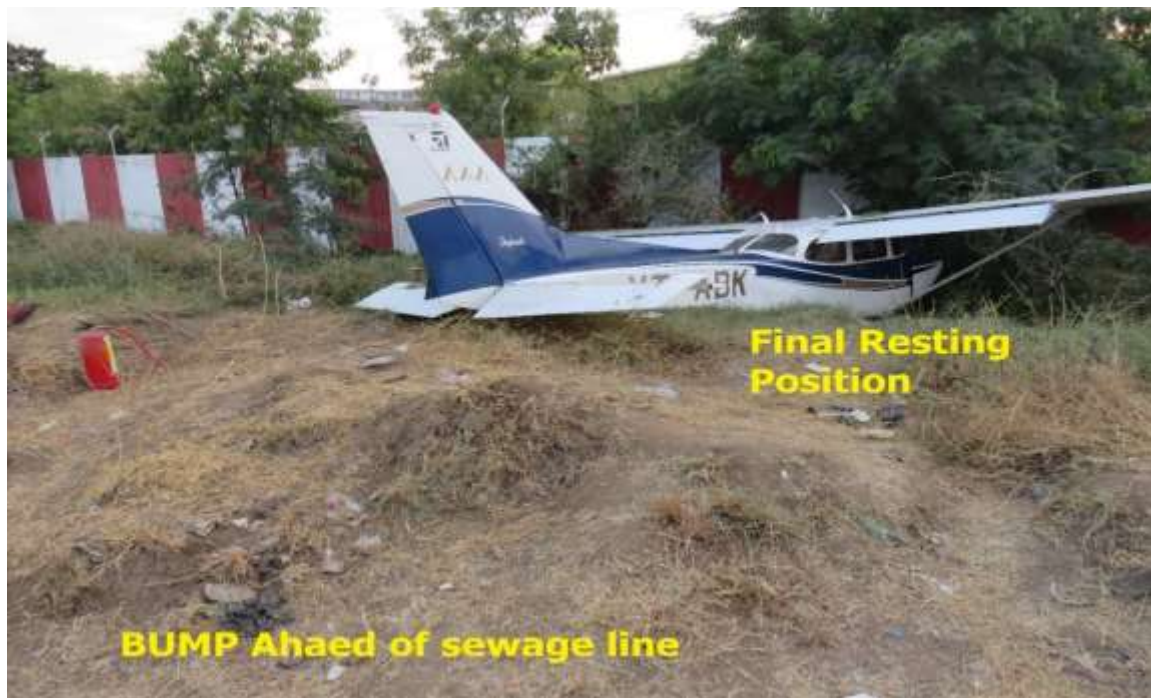
Image 33. Aircraft ran over the bump before coming to final halt

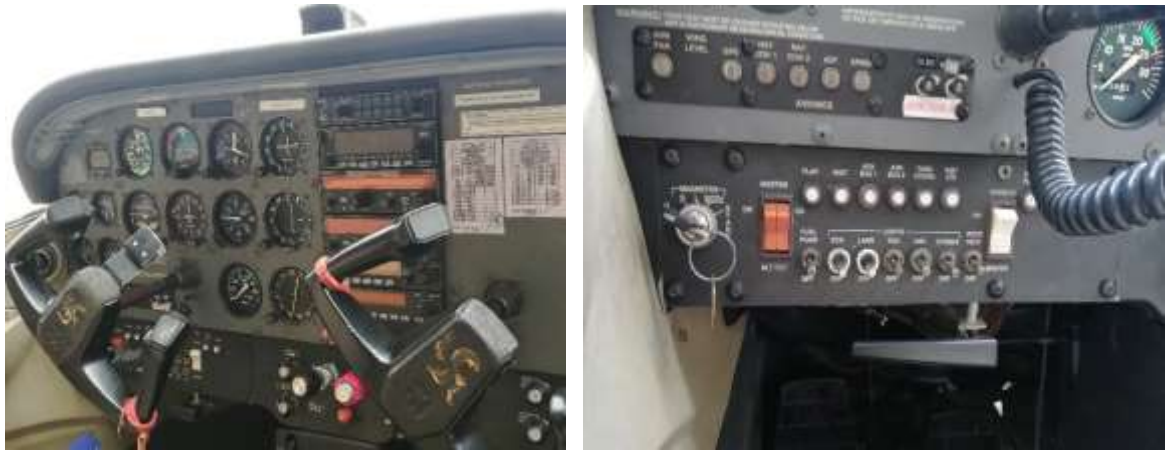
All the switches/CB's in the cockpit were found in OFF position. The ELT started transmitting signals after the impact, which was later switched off by the engineering personnel. The wing training edge flaps were found deflected in flaps 20 (20°) position. The rudder was found deflected towards the port side which was in line with the position of rudder pedals in cockpit, as left rudder pedal was found pushed in.

Image 34. All the switches in cockpit were in OFF/Pushed IN position.
