**FINAL INVESTIGATION REPORT ON
ACCIDENT TO M/s AHMEDABAD AVIATION &
AERONAUTICS LTD., CESSNA 172S AIRCRAFT,
VT-ABK ON 24-11-2018 AT MEHSANA
AIRFIELD, GUJRAT**

**GOVERNMENT OF INDIA
MINISTRY OF CIVIL AVIATION
AIRCRAFT ACCIDENT INVESTIGATION BUREAU**

FINAL INVESTIGATION REPORT ON ACCIDENT TO
M/s AHMEDABAD AVIATION & AERONAUTICS LTD., CESSNA 172S
AIRCRAFT, VT-ABK ON 24-11-2018 AT MEHSANA AIRFIELD, GUJRAT.

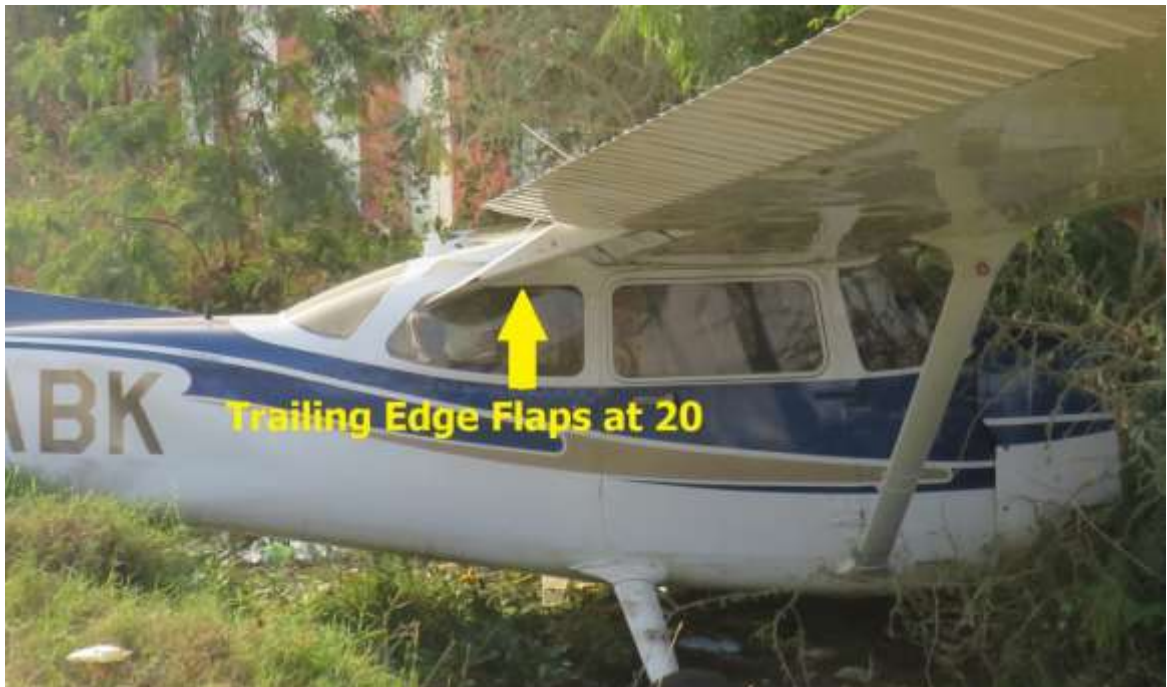
Image 35. Trailing Edge Flaps at 20° Position

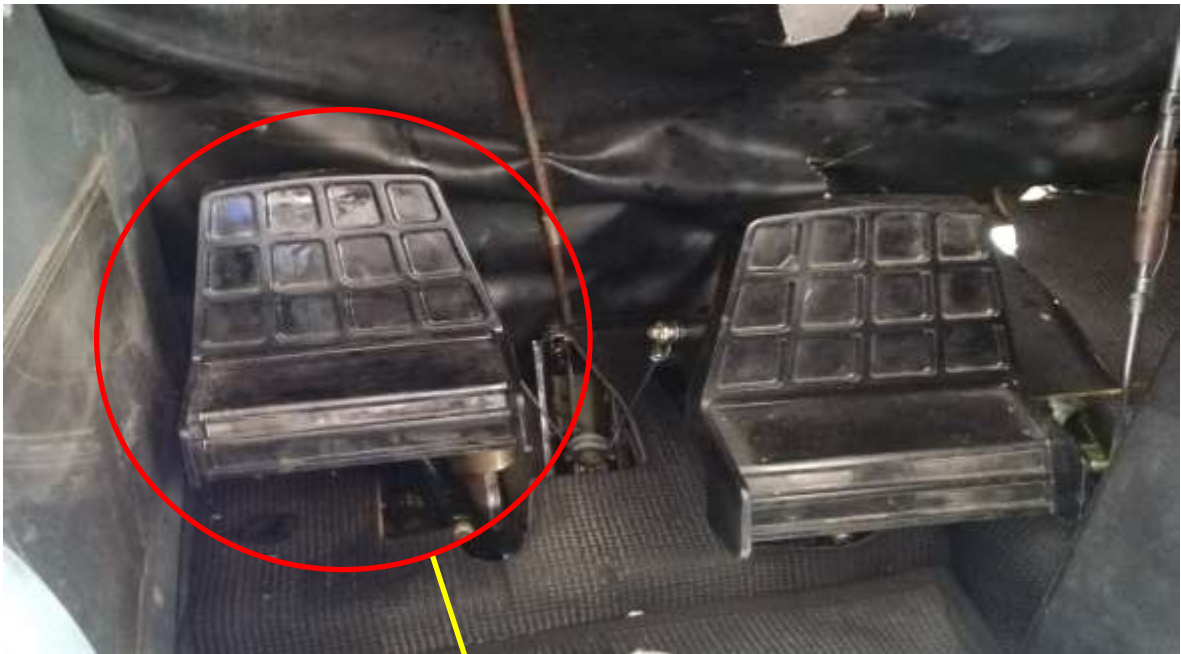
Image 36. Rudder pedal Position in cockpit (Left pedal pushed in)

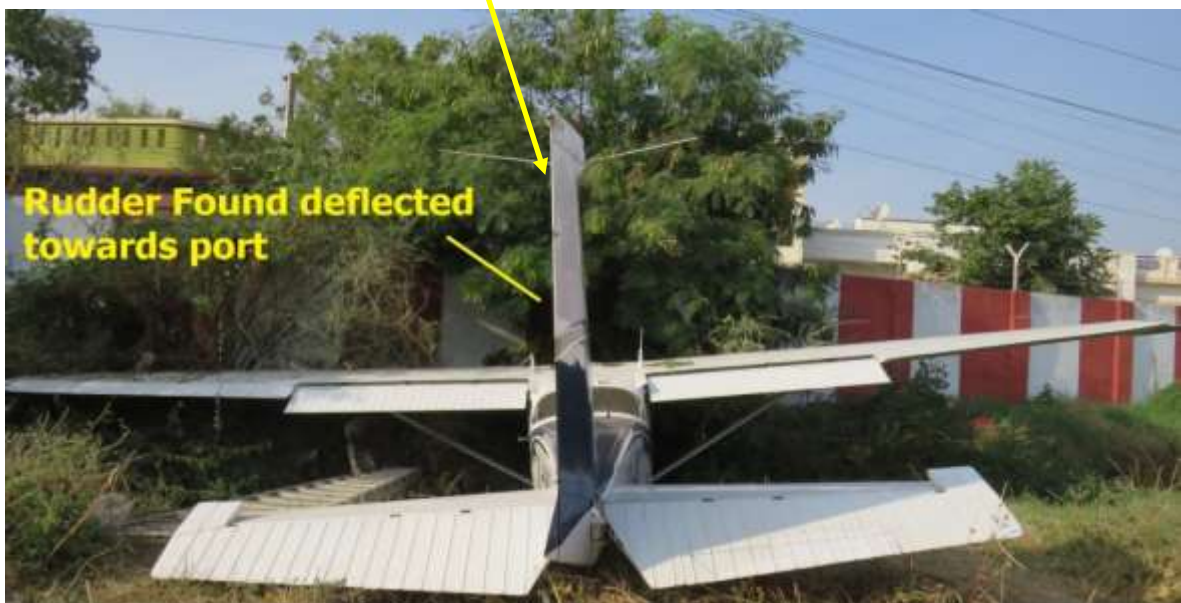
Image 37. Rudder found deflected towards port side

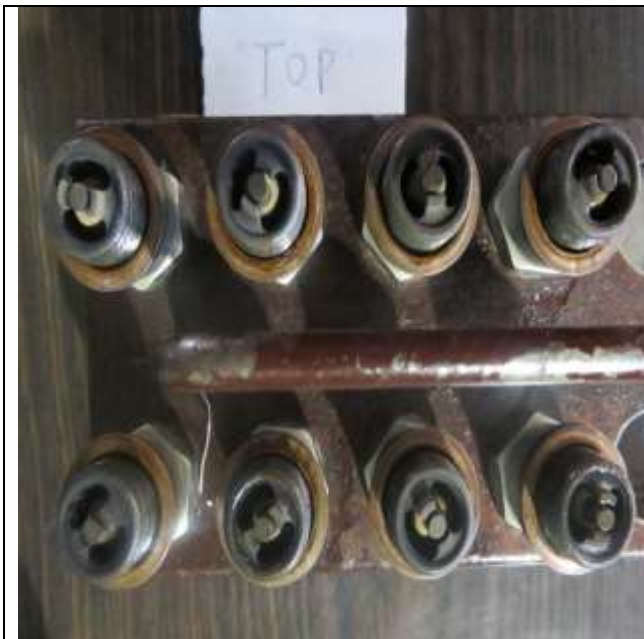
All the 08 Spark Plugs were checked for any carbon deposit and No such deposits were observed. The condition of the all the spark plugs were found satisfactory. All the plugs were subjected to rig test and found satisfactory.

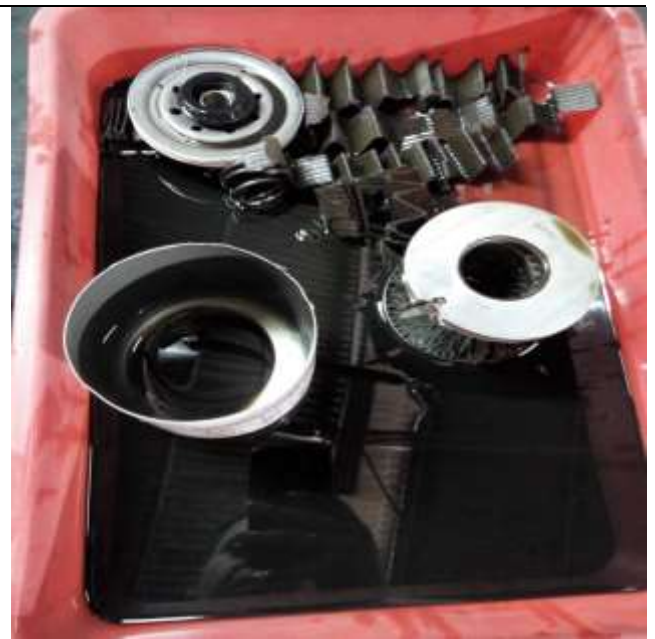
Oil Filter

Oil filter was checked for any deposit like metal particles etc. There were no abnormalities observed. The filter was also cut open but no particles seen.

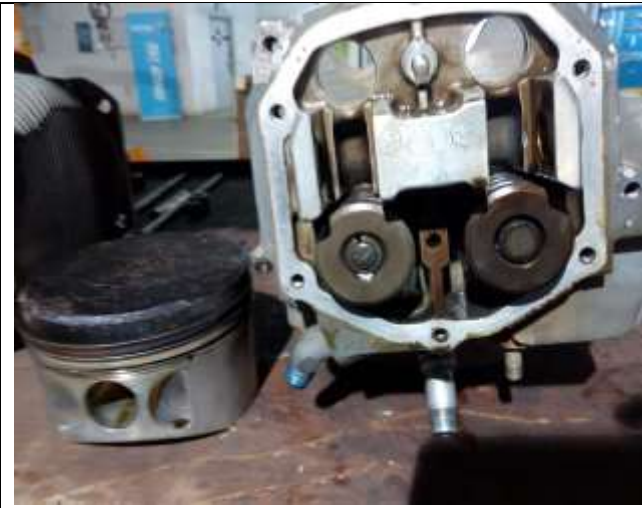
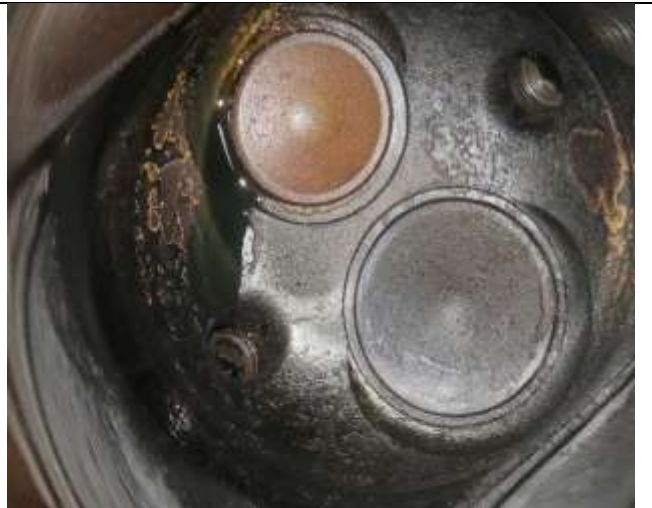
Cylinder # 2

- Traces of oil were observed in cylinder # 2 & # 4 which were fresh and may be due to the engine impacting with ground.
- The condition of the piston heads & the bore was found satisfactory in all the cylinders.
- The condition of the piston rings was found satisfactory on all the pistons.

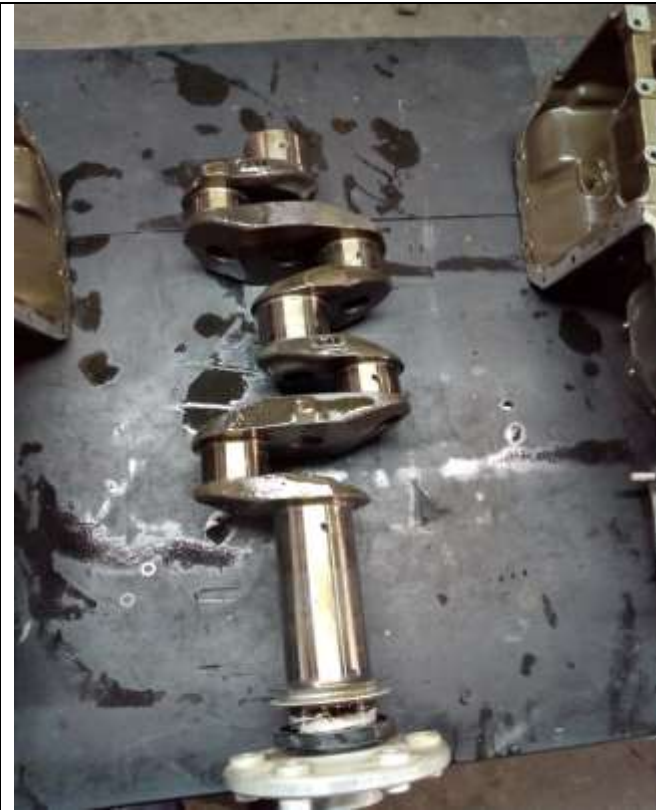
Crank Shaft

- The condition of internal parts were found satisfactory. No abnormalities noticed on the crank shaft. All the metal bearings were in position & in good condition. The journal diameters of crank shaft were in good condition.
- There was no sign of oil starvation noticed in the engine, i.e. all the moving parts were well lubricated.
- The cam shaft was found in good condition.
- Sufficient amount of oil was present in oil sump and the condition of oil sump was found satisfactory.
- The condition of gears were found satisfactory.

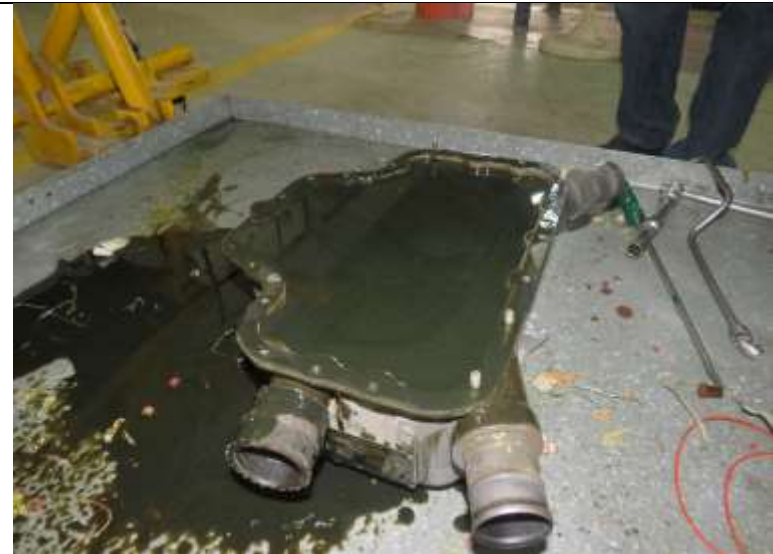
Oil Sump

There was no sign of oil starvation noticed in the engine, i.e. all the moving parts were well lubricated. Also, sufficient amount of oil was present in the oil sump thereby indicating that whatever external oil leak was observed, it was consequential to the impact.
