**FINAL INVESTIGATION REPORT OF
ACCIDENT TO M/S PHL
DAUPHIN SA 365 N3 HELICOPTER VT-PWA
AT BOMBAY HIGH ON 13th JANUARY 2018**

**AIRCRAFT ACCIDENT INVESTIGATION BUREAU
MINISTRY OF CIVIL AVIATION
GOVERNMENT OF INDIA**

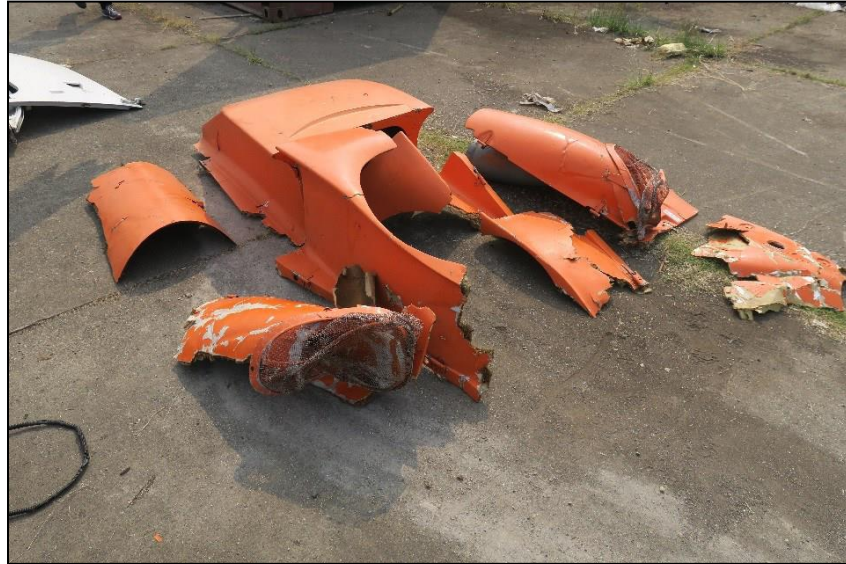
Damage to the front and right side part of the MGB cowling

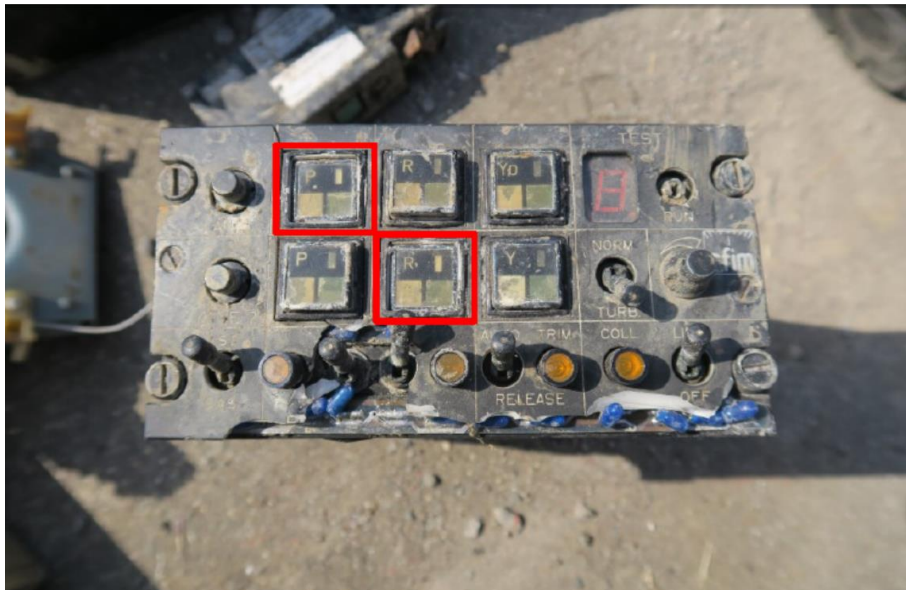
AUTOPILOT CONTROL PANEL

The cockpit was destroyed. Most of the control and indication units were severely damaged. The position of the pushbuttons of the Autopilot Control Panel was as shown below.

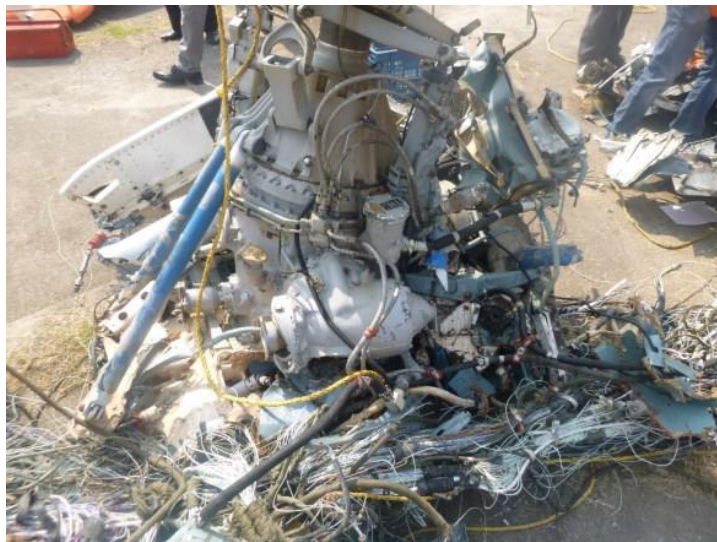
Main Gearbox (MGB)

The main gearbox was complete without any external mechanical damages or evidence of overheating. Some external corrosion evidences were observed which could be because of salty water immersion. It was not possible to turn the MGB by hand, due to the internal corrosion (magnesium casing).

No metallic particle was found on chip detector. Magnesium corrosion powder (nonmagnetic) was found on detector confirming high level of corrosion inside.

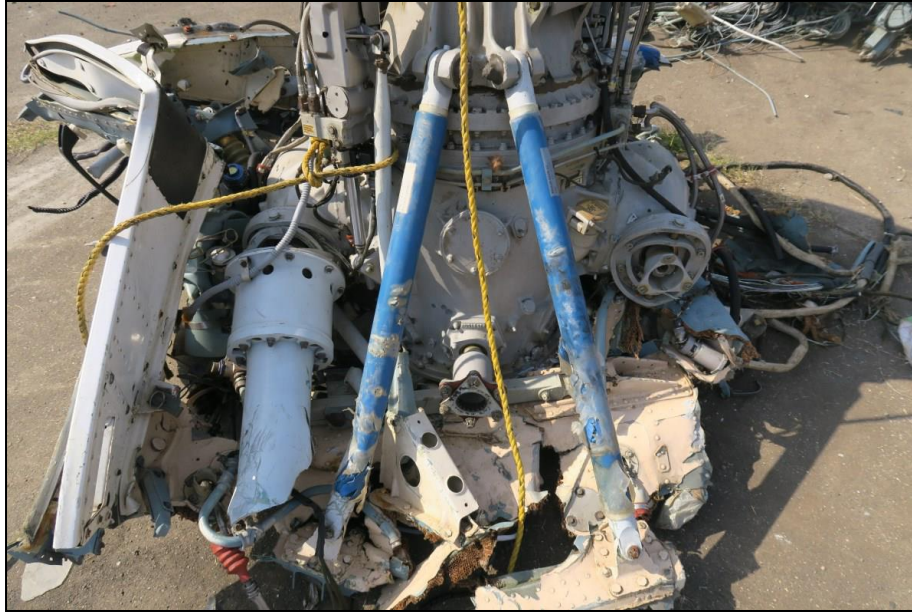
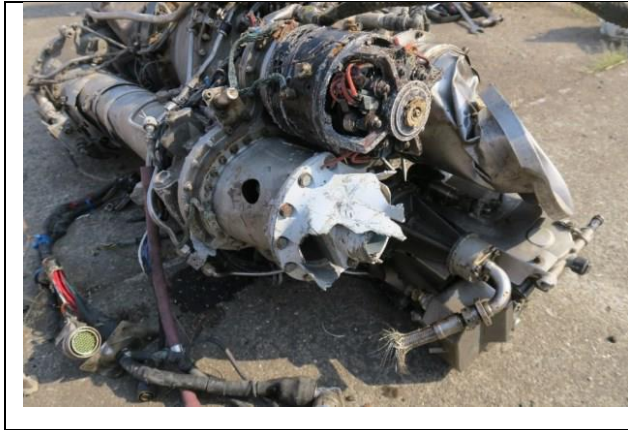
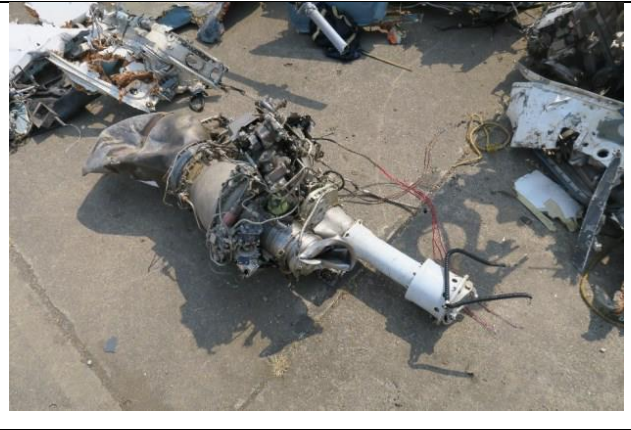
The left coupling was found broken at two locations i.e. at the MGB input (flexible coupling and universal joint), and at rear housing (coupling shaft and housing). Rupture of some flexible coupling bolts and evidence of traction loads were observed on the flexible coupling. The ruptures and deformations were due to overload, with no pre-impact damage.

Tearing due to torsional load was observed on the coupling shaft. This observation shows that the left engine was running during the fracture sequence.

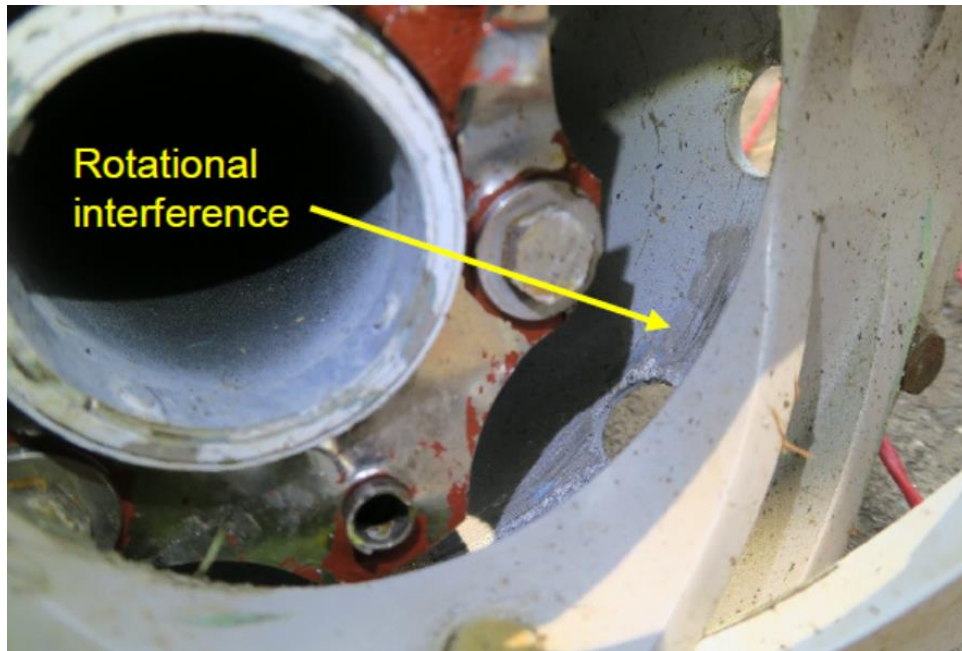
The right coupling was found broken at the MGB input (flexible coupling and universal joint). The ruptures and deformations are due to overload, with no pre-impact damage. Rotational interference was observed on the inner surface of the

front housing indicating that the right engine was running during the fracture sequence.

Rotational interference between flexible coupling and front housing

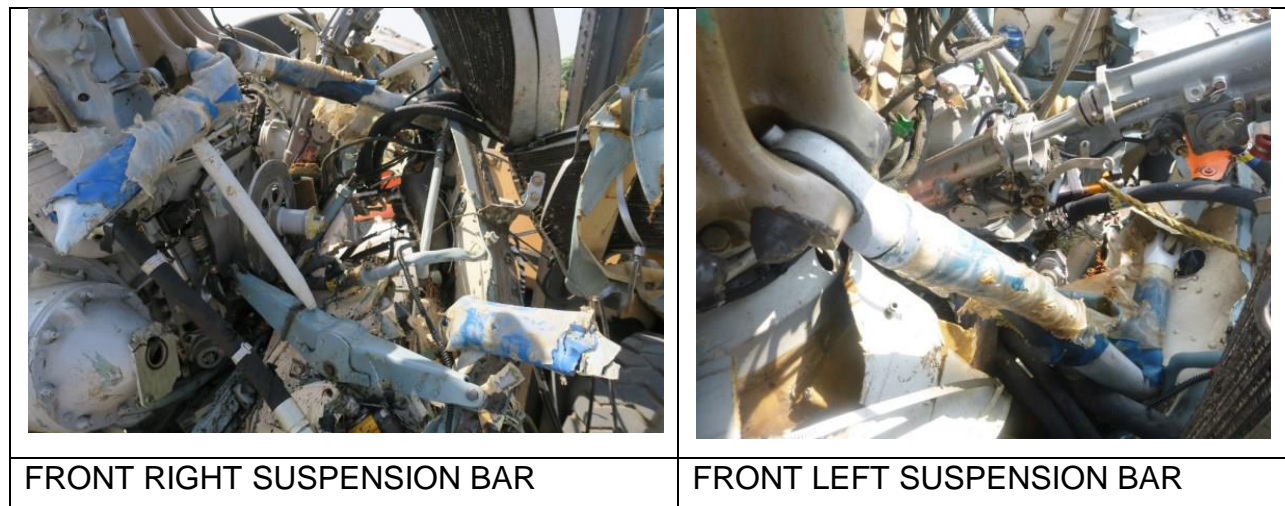
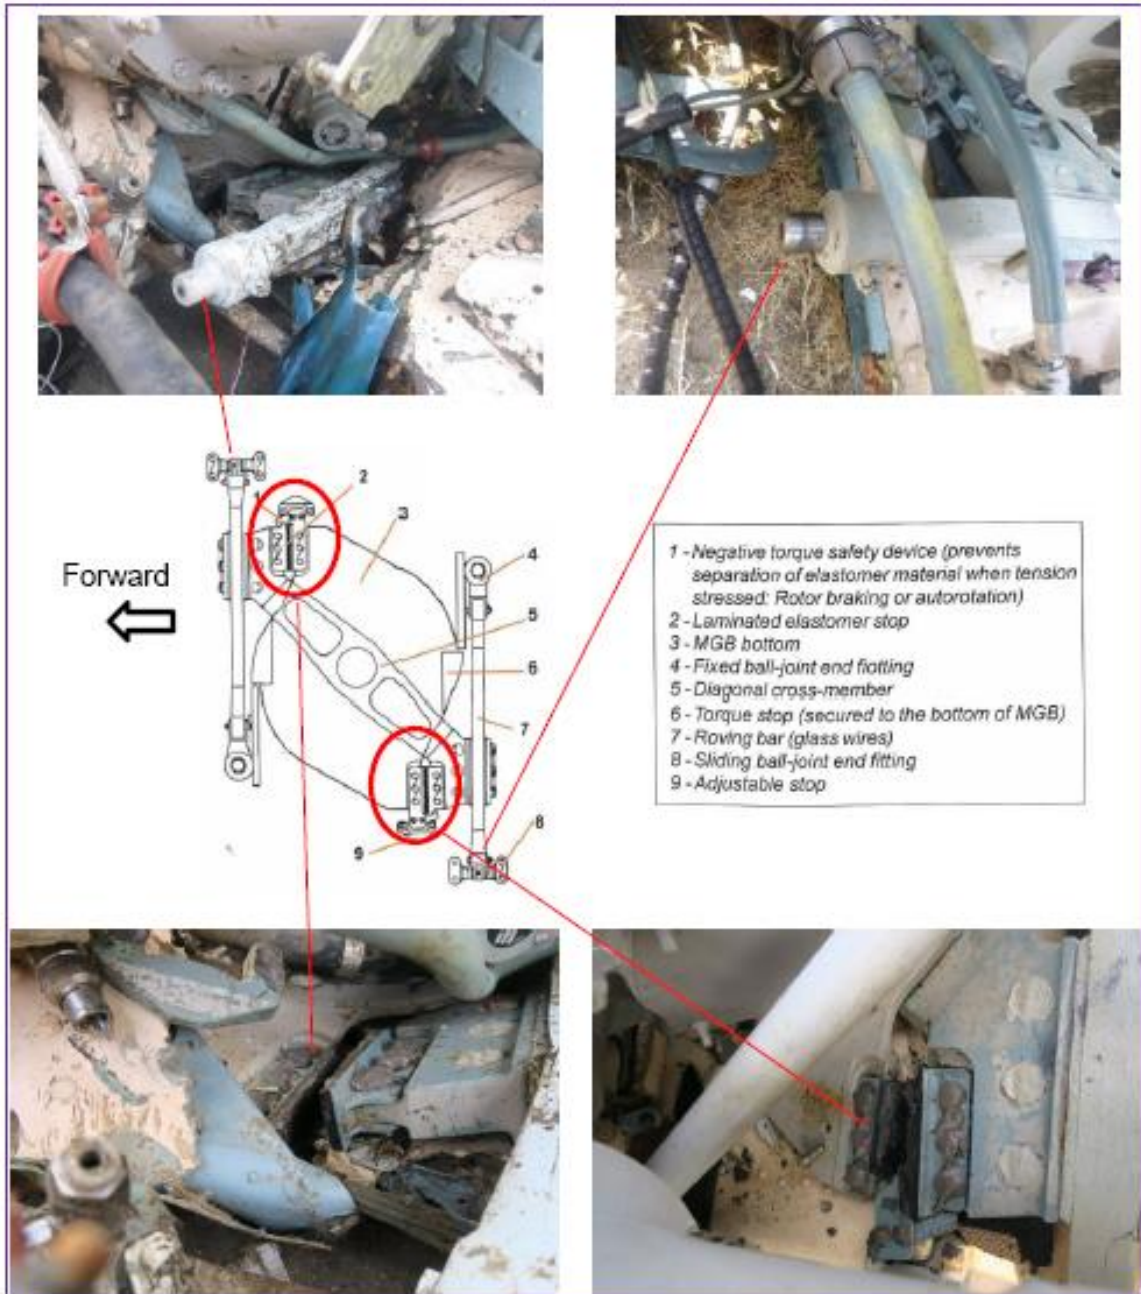
The four suspension bars were still attached to the conical housing and to the ferrule on the mechanical deck. The front right suspension bar was distorted and broken in the middle. The rupture was static. The front left suspension bar was complete with substantial distortion. Both front bars experienced compression loads due impact, with no damage prior to accident. The two aft suspension bars were complete with little distortion.

The two laminated elastomer stops were fractured and the two roving bars slid out of their ball-joint end fittings. The main gearbox had turned clockwise in relation to the structure. The damage was because of sudden stoppage of rotating powered main rotor due to impact with water.

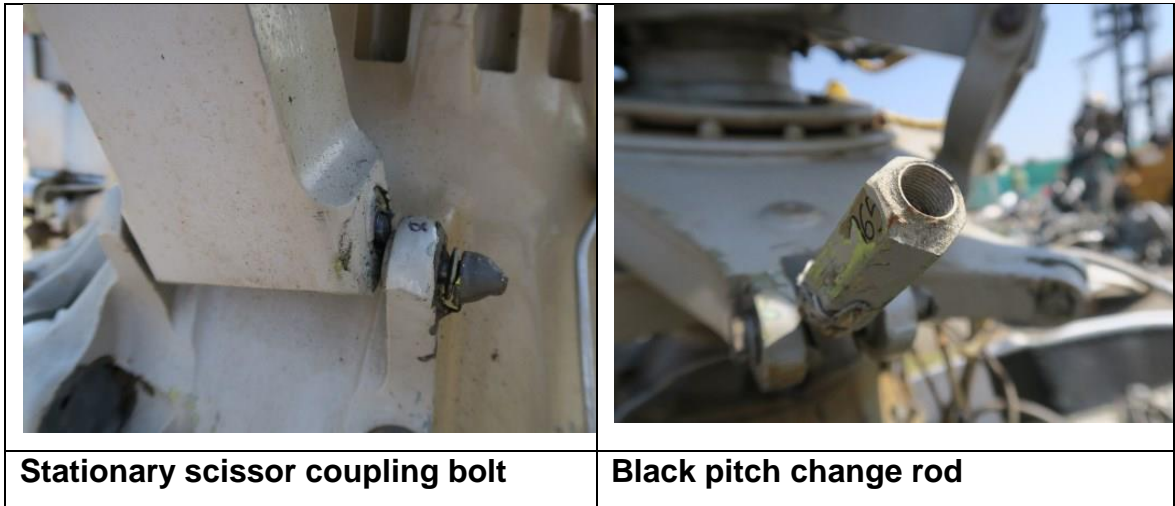
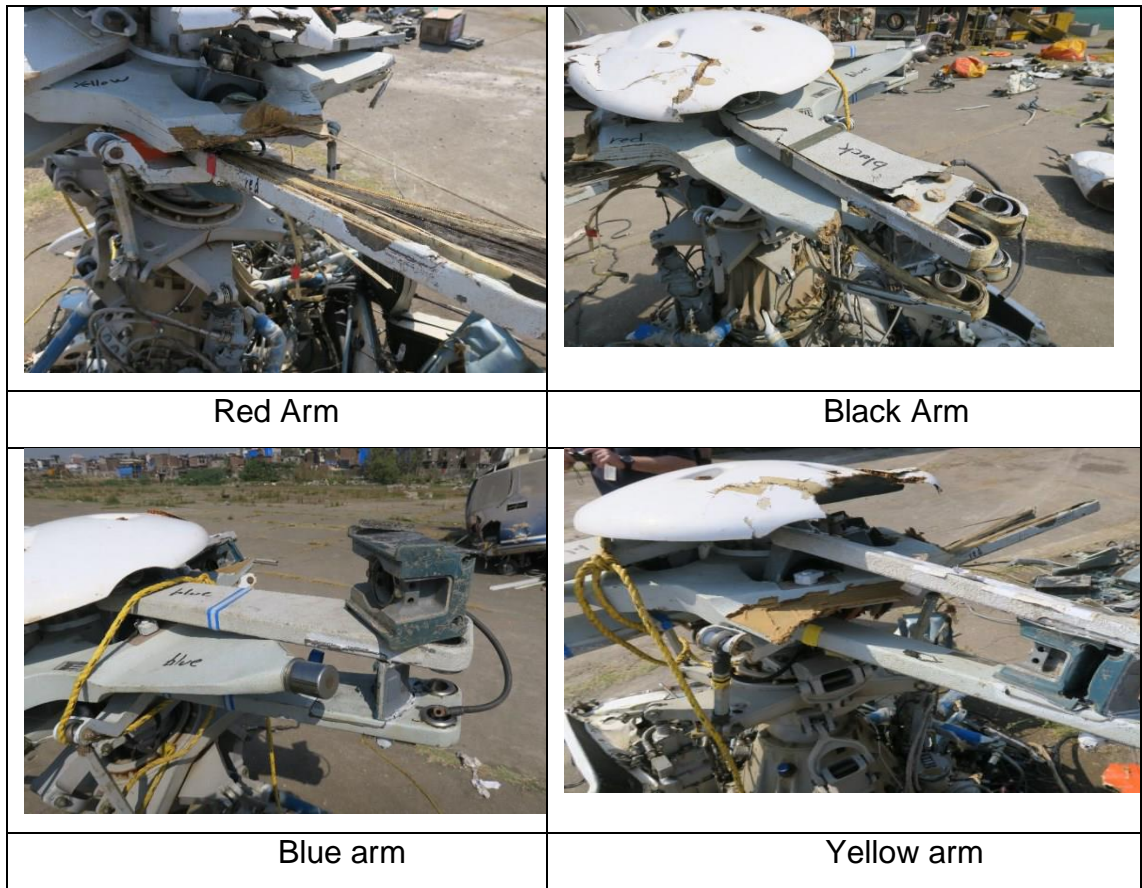
Rotating and non-rotating swash-plates were in a high position with a tilt to the left and forward. Both rotating scissors were in position and undamaged. Stationary scissor coupling bolt was found broken due to overload.

- Red Arm -** The star arm had broken due to overload in flapping (delamination at the root). The blade attach beams were destroyed. The laminated spherical thrust bearing moved into a pitch up position.
- Black Arm** The tip of the star arm had broken due to overload in drag. The star had moved clockwise in relation to the blade attach beams, which stopped suddenly when the blades struck water.
- Blue Arm -** The star arm was complete. The star had moved clockwise in relation to the blade attach beams, which stopped suddenly when the blades struck water. The frequency adapter was struck out of its fitting by the star arm.
- Yellow Arm** The star arm was broken due to overload in drag and flapping. The blade attachment beams moved into a pitch up position. The star had moved clockwise in relation to the blade attach beams, which stopped suddenly when the blades struck water.

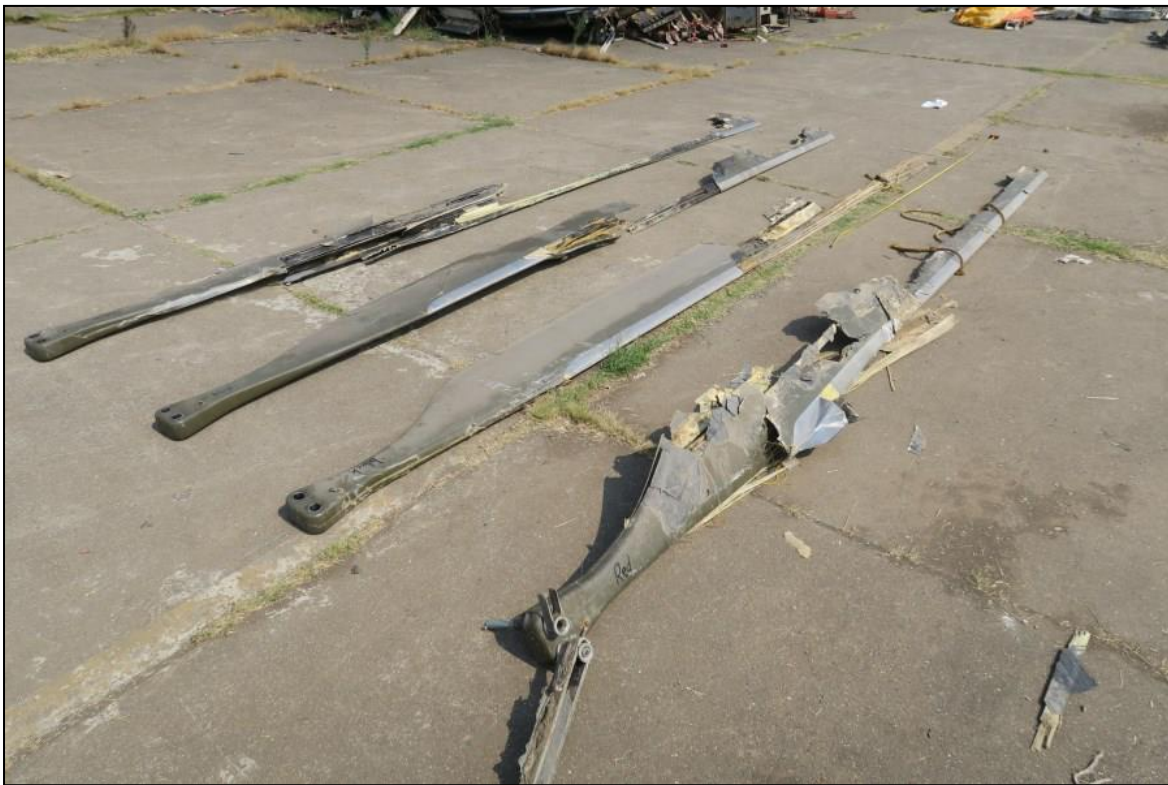
Main Rotor Blades

All four blades showed significant damage and had broken at about half of their respective lengths. The tip of the black blade was missing. All damages were because of the impact with a very high momentum.

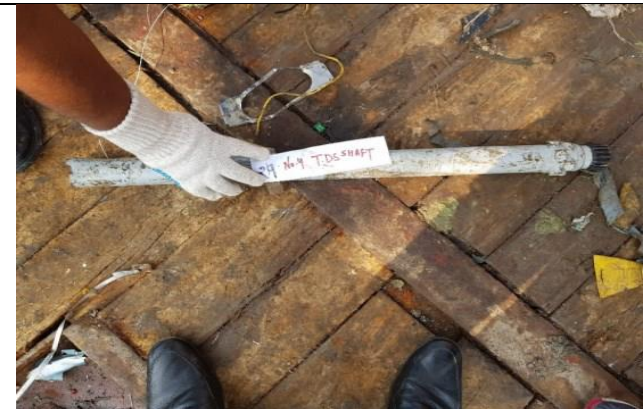
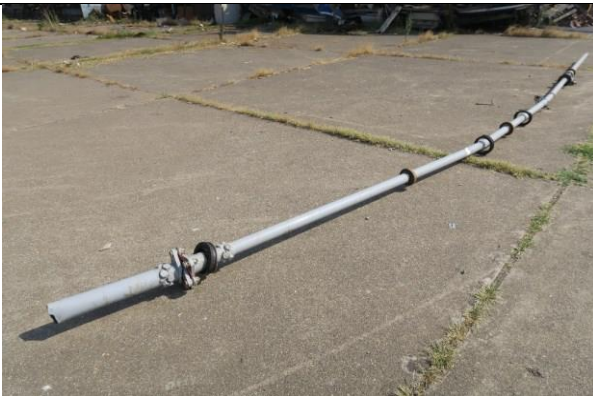
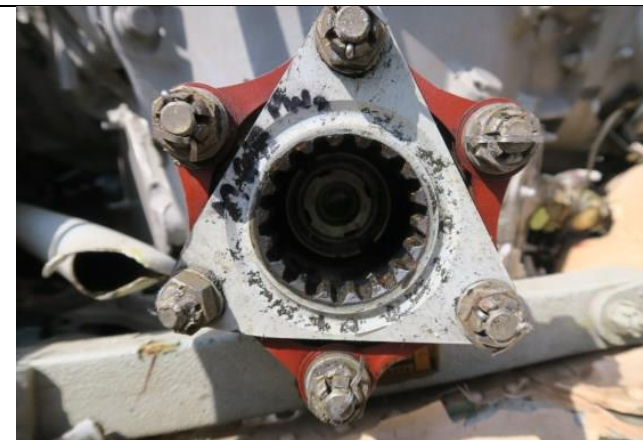
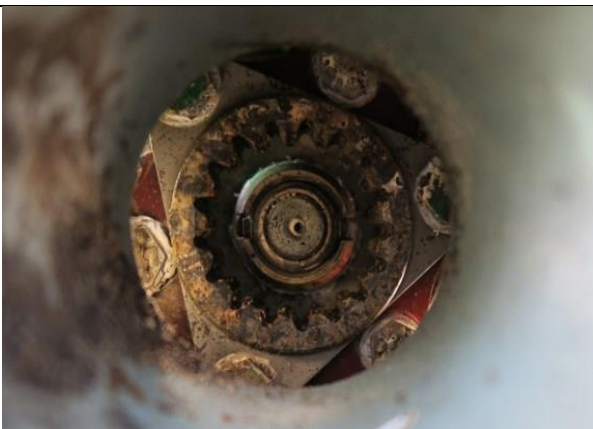
<p>Forward shaft</p>	<p>Aft of tail rotor drive shaft</p>

<p>Flexible coupling at MGB output</p>	<p>Flexible coupling at TGB input</p>

The forward shaft was found broken by overload. No damage was observed on the two splined-end fittings and flexible couplings were in good condition. All bearings were corroded due to contact with salt water, and did not show evidence of mechanical damage prior to the accident.

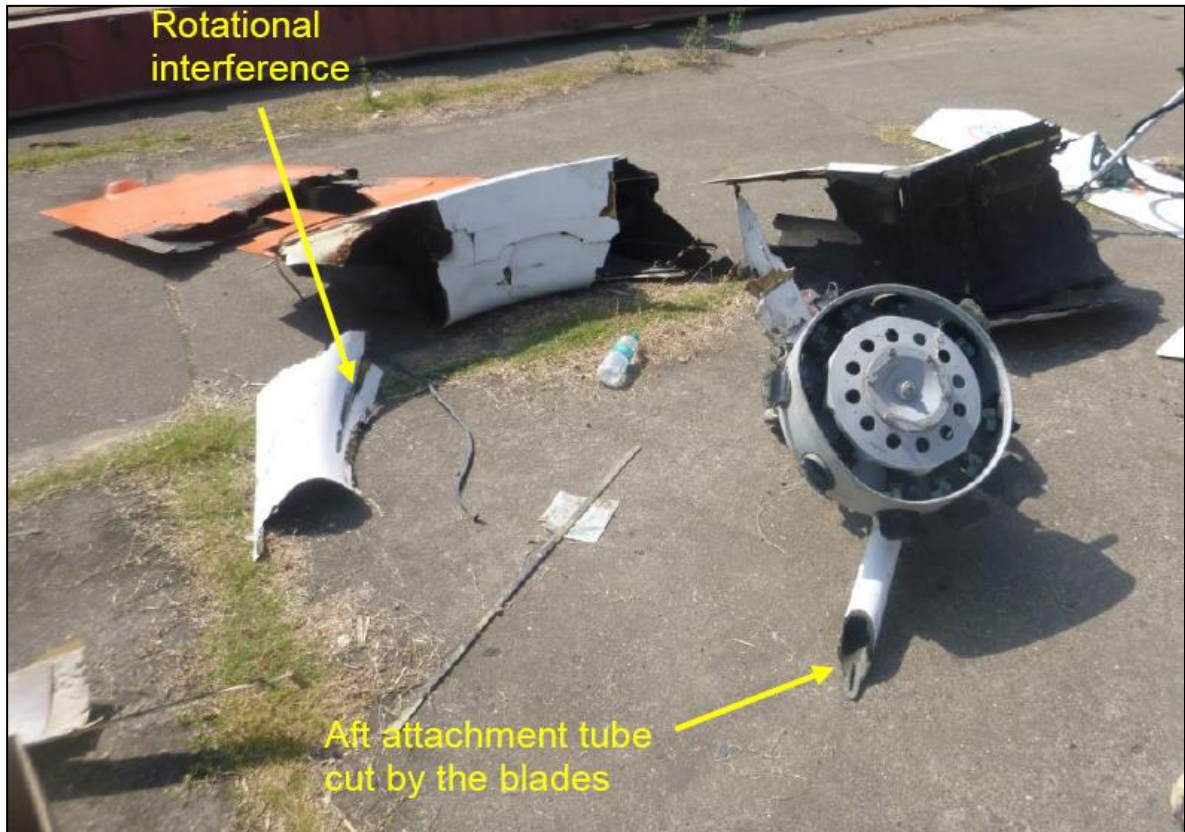
Fenestron assembly

All tail rotor blades were found broken from close to the root. Rotational interference was identified on the fenestron duct due to contact with the blade tips. The tail gearbox aft attachment tube had broken on impact at about half of its length (between the TGB attachment legs) and cut by the blades. Fenestron was rotating and had damaged and deformed the structure of tail rotor. The relative movement of the pitch change control rod and the blades' pitch was found to be in correct sense.

The tail gearbox was dismantled. Magnesium corrosion powder was found inside the casing. The pitch change control mechanism was removed from the TGB and the operation of the pitch change control bearing was found as it should be.

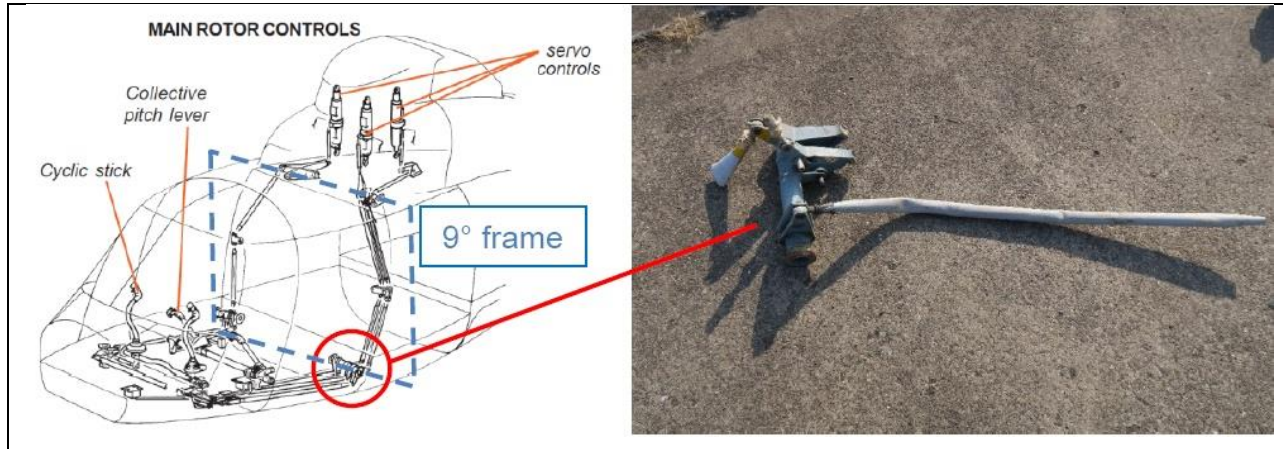
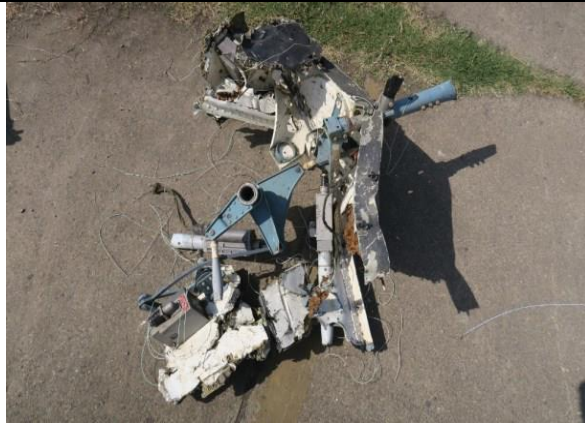
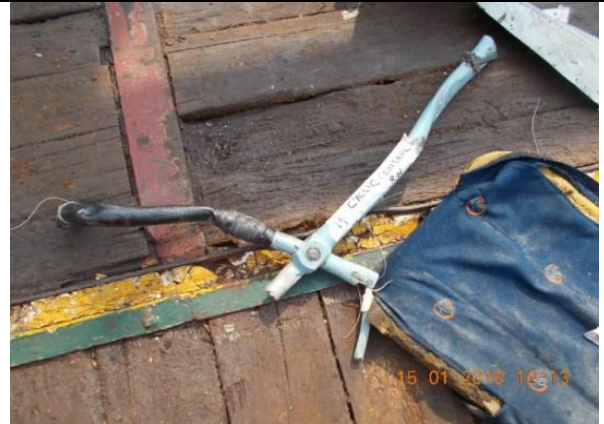
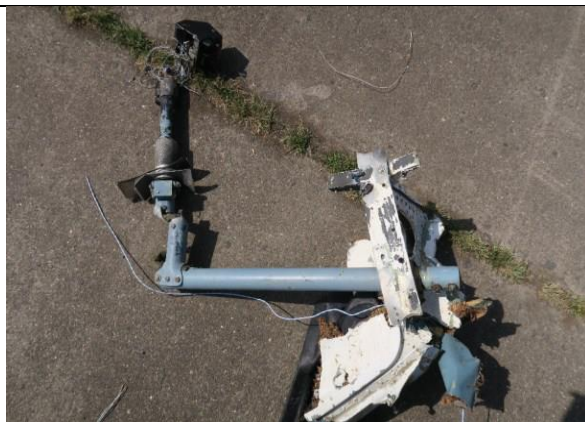
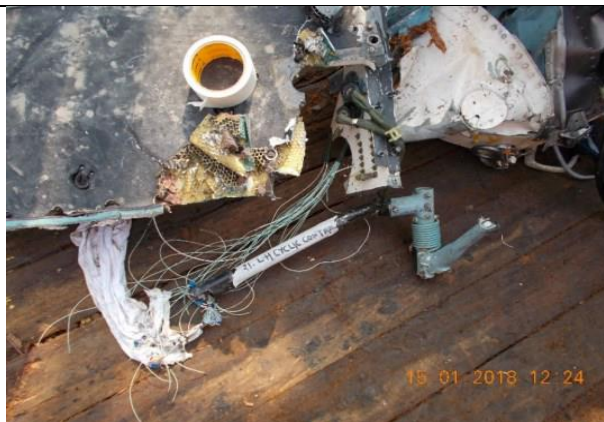
Some parts along the 9° frame and right side of the cockpit could not be located as these might have gone deeper into the sea bed. However from the damages observed, it could be safely concluded that ruptures were post impact and there was no pre-impact damage.

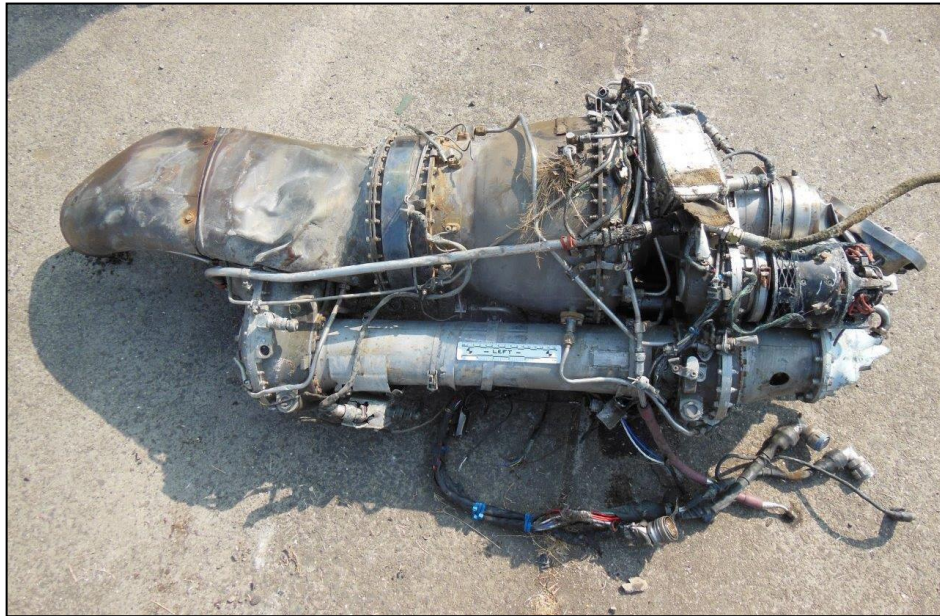
All modules were together with impact damages all over.

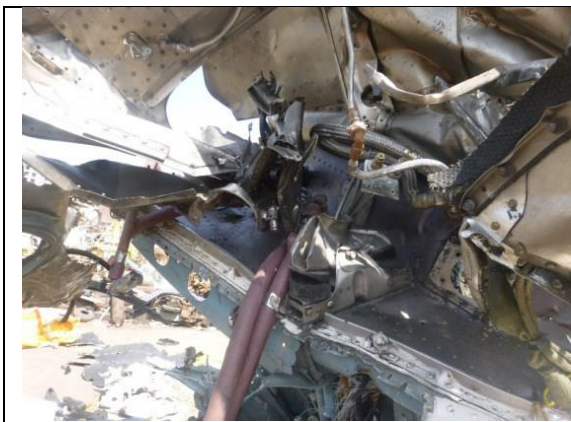
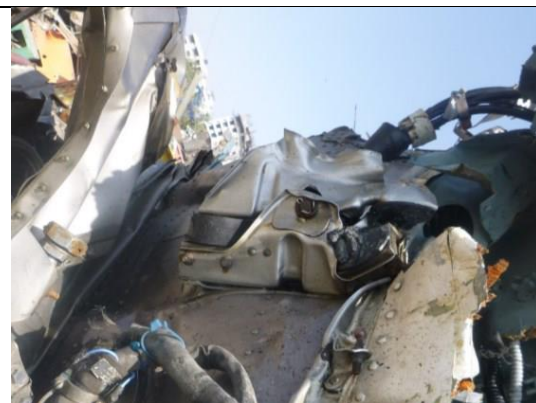
Left engine mount

Right engine mount

Both engines and their supports exhibited damages which were indicative of high vertical impact forces. Other evidences indicated that the engines moved to the right (as seen from the rear) during the accident. Most of the external damage was because of the accident or during the recovery operation. Most of the damages discussed below are to LH engine. Almost similar damages were there to RH engine.

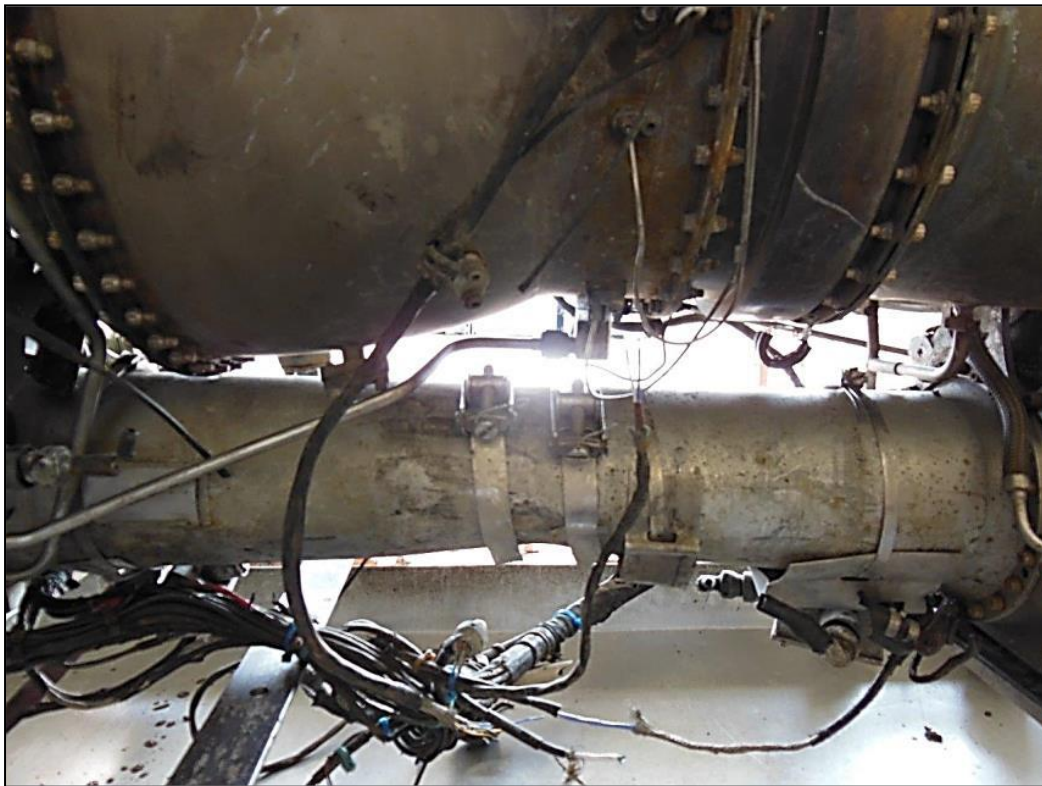
The link tube caved in at rear support level

The power turbine casing was found drifted (angular) downwards with respect to its support arms and flange, which could be caused only by strong downward vertical load. Because of that, the front face of the blades came in contact with the back of the nozzle guide vane. The circular rubbing marks show that the Power Turbine (PT) wheel was rotating at the time of impact.

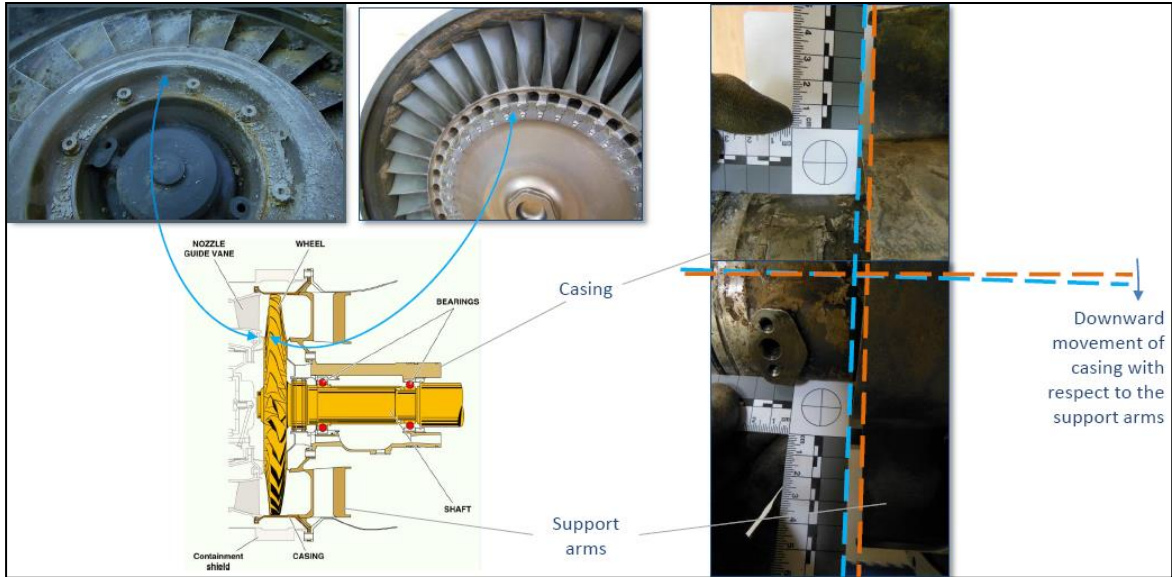
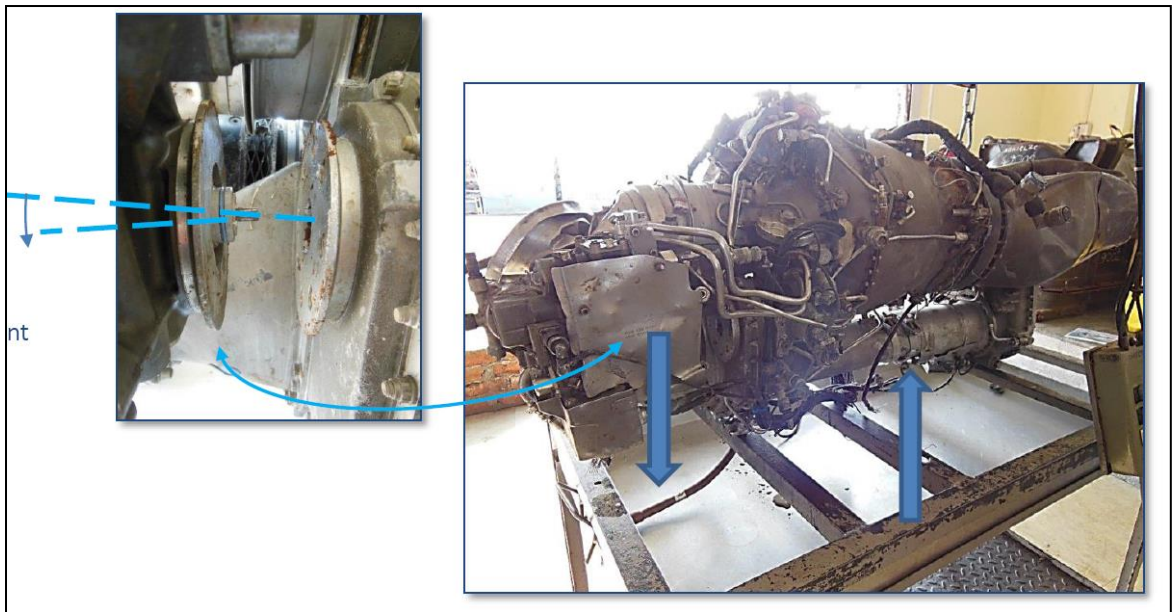
As shown above, the link to caved in near rear support and the HMU got separated from the module 1's casing. The HMU's drive shaft was found bent downwards. The above shows that the engine was subjected to downward vertical force at the time of Accident.

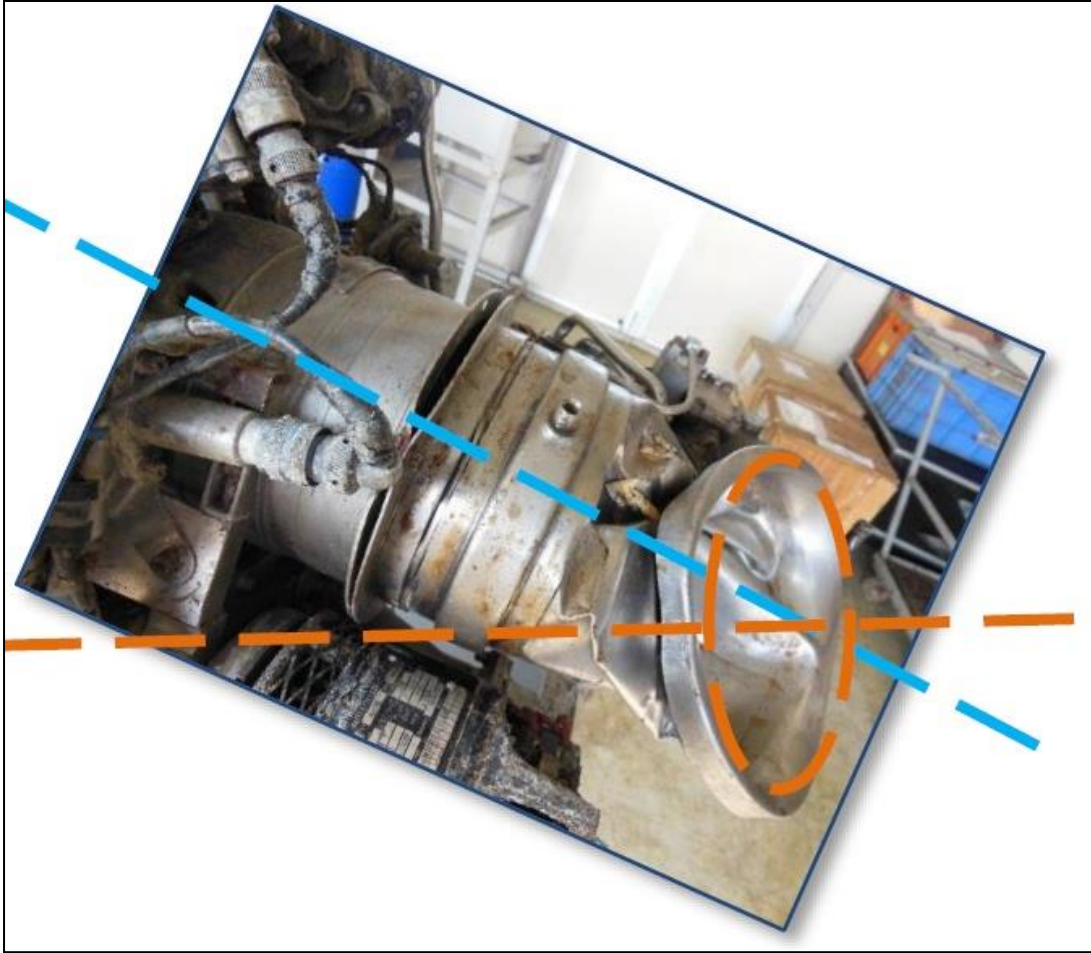
The deformation of air intake as shown above indicated displacement of the engine towards right hand side. At the time of accident, the engine suffered damage due to impact force coming from the right-hand side.
