**INVESTIGATION REPORT ON ACCIDENT INVOLVING CESSNA 172 R  
AIRCRAFT VT-RGC OPERATED BY M/S WINGS AVIATION Pvt. Ltd.  
AT MOKILA (SHANKARPALLY) – NEAR HYDERABAD  
ON 21ST NOVEMBER 2018.**

**FINAL INVESTIGATION REPORT ON ACCIDENT OF M/S WINGS  
AVIATION PRIVATE LIMITED CESSNA-172R AIRCRAFT VT-RGC AT  
MOKILA (SHANKARPALLY) – OUTSKIRTS OF HYDERABAD ON 21ST  
NOVEMBER 2018.**

**The Probable cause of the accident was** “Fracture of the crankcase due to breaking of connecting rod caused engine oil loss thereby causing engine seizure”.

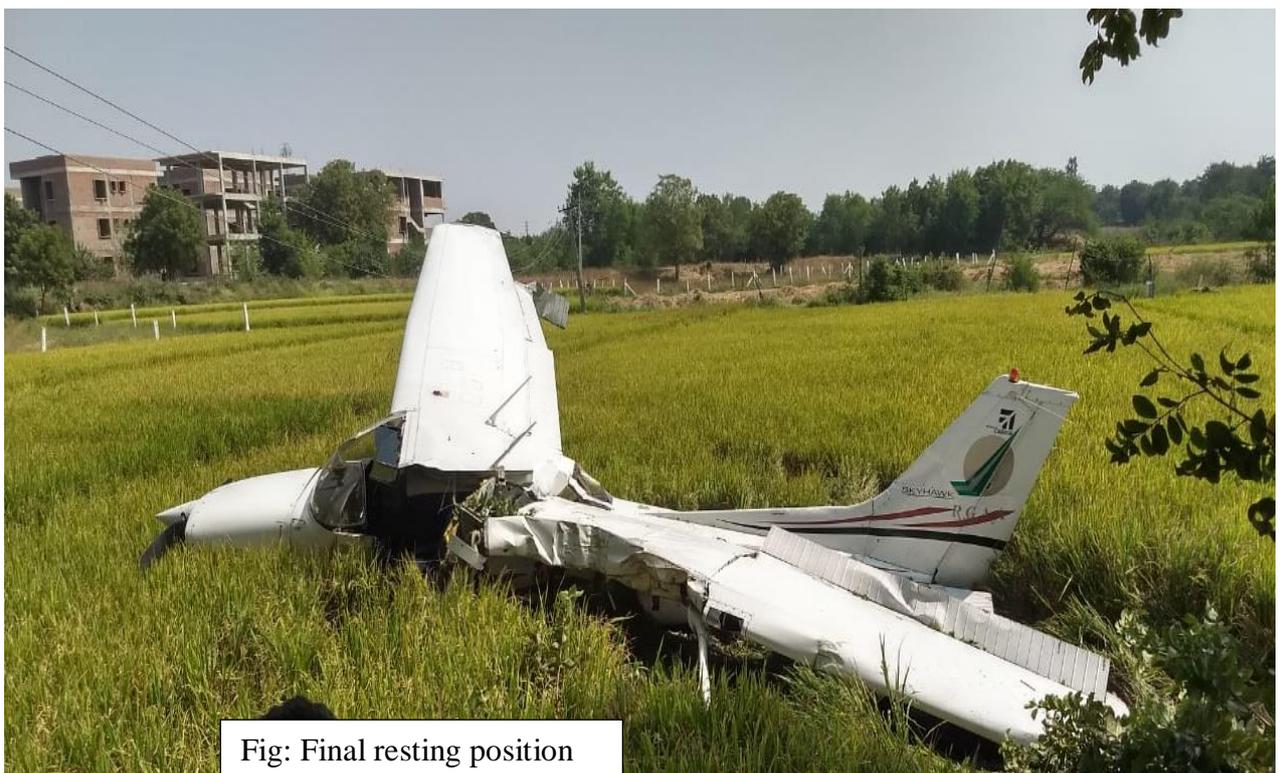
- a) The port (left) wing of the aircraft was detached from the forward fuselage attachment fittings & the fuel line connection was found broken. The leading edge from wing root to wing tip was found badly damaged. The Taxi light lamp was detached. The left wing's leading edge was found smashed in the middle. The left aileron was found badly damaged.
- b) The pitot tube was found broken.
- c) The left side door along with the window was found detached whereas its door frame was found broken.

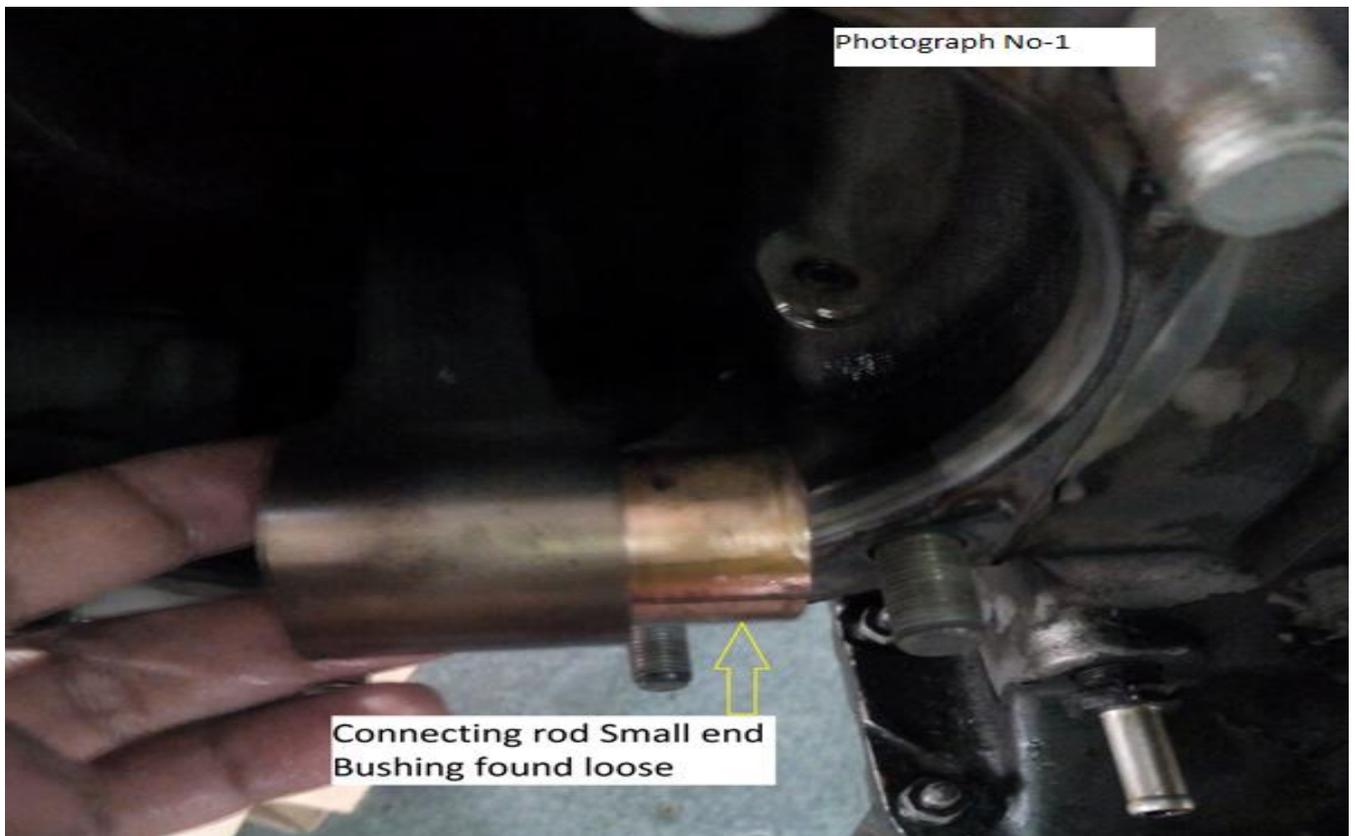
**Photograph No. 1**

- The bushing at piston end of connecting rod was loose in connecting rod No 2 (Please refer **Photograph No.1**).
- There were no signs of Piston No.02 seizure.
- The Piston could be removed from Cylinder in a normal way.
- The intake and exhaust valves were found normal and no sticking was observed.

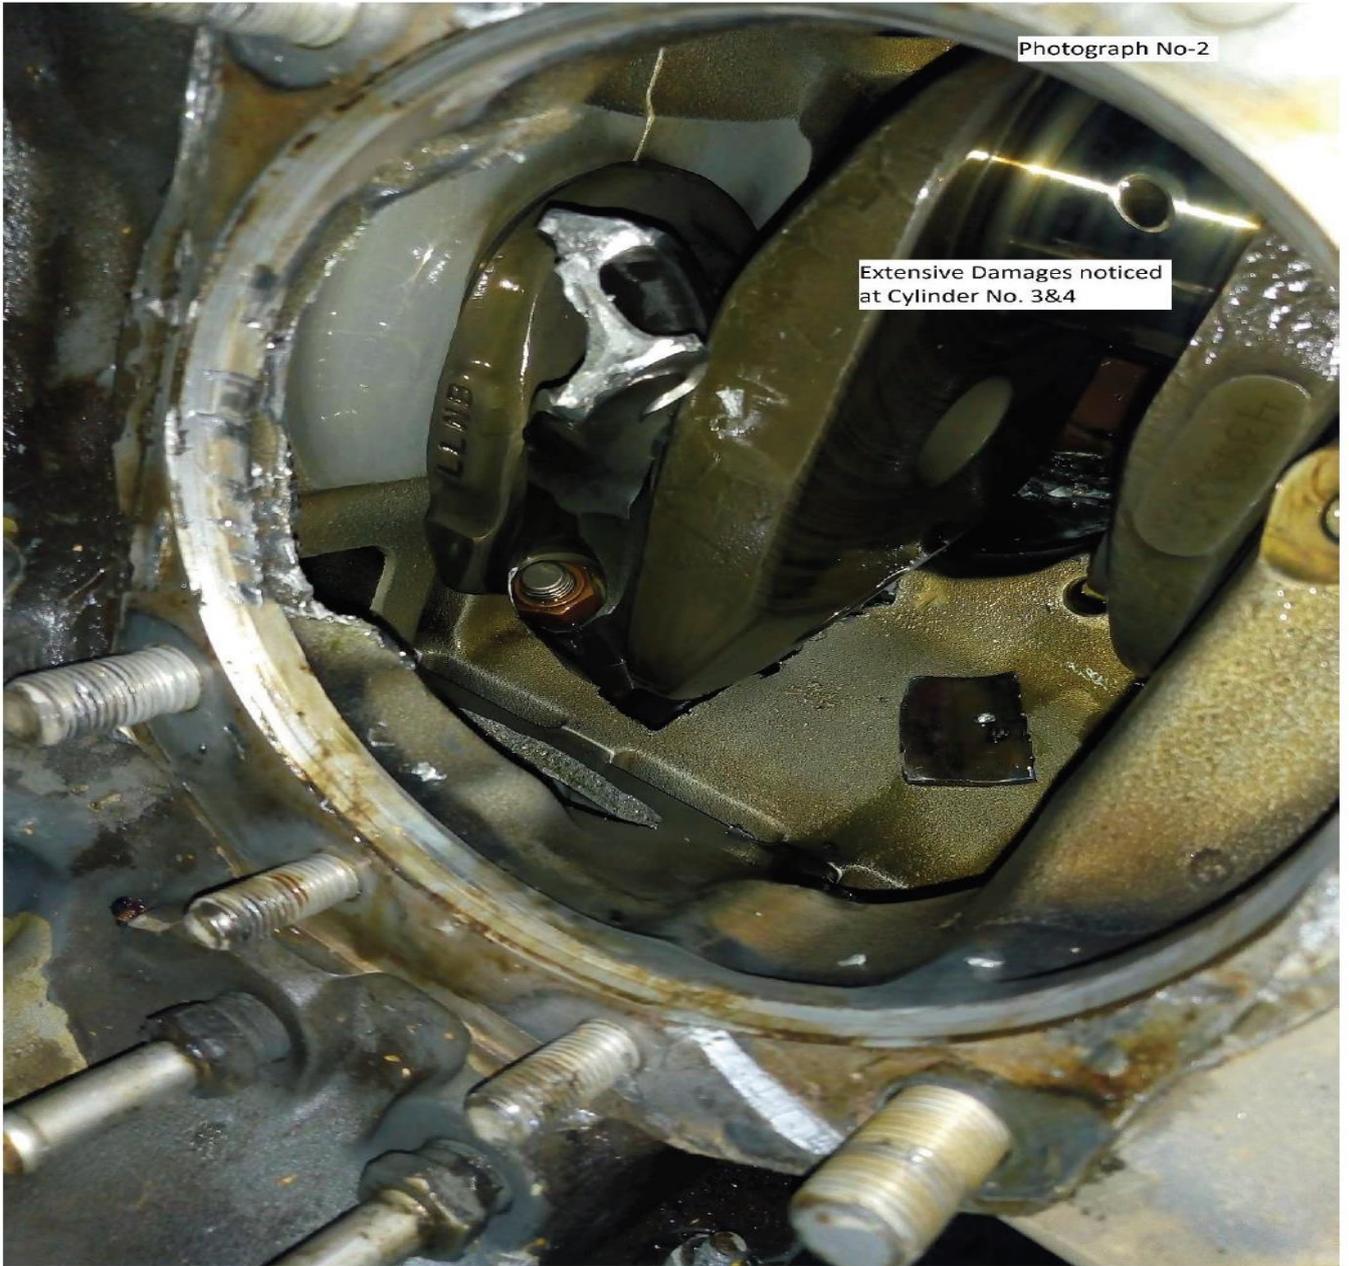
**Photograph No. 2**

- Extensive Damage was observed to the internal part of the Engine Particularly at cylinders No 3 (Please refer **Photograph No.2**).
- The bushing at piston end of connecting rod was loose in connecting rod No 3 (Please refer **Photograph No.1**).
- The Piston was stuck at No 3 Cylinder because barrel skirt was deformed. (Please refer **Photograph No.3**).

Extensive Damages noticed  
at Cylinder No. 3&4

- Extensive Damage observed to the internal part of the Engine Particularly at cylinders No 4 (Please refer Photograph No.2).
- No 4 cylinder could not be removed from the Crankcase as the skirt of the cylinder was flared and was found stuck inside the Crankcase.
- The connecting Rod of No. 4 cylinder was twisted and broken in pieces and connecting rod at piston pin side found lying at the bottom of the Crankcase, with a portion of the broken connecting rod small end dislocated and fused with the connecting rod small end bore (Please refer Photographs No.4a &4b).

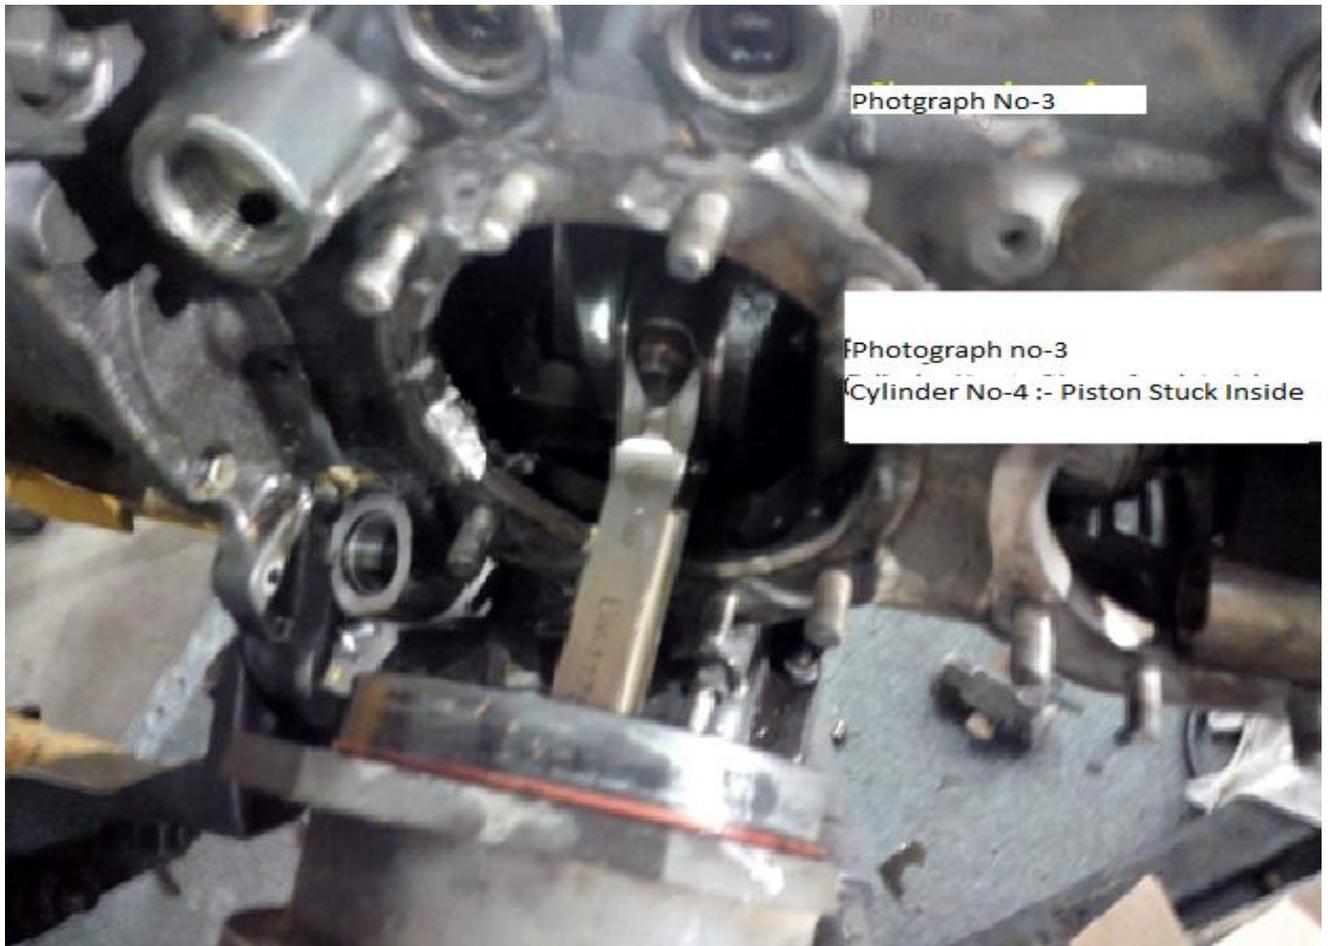
**Photograph No. 3**

- There were no signs of Piston No.03 seizure.
- The Piston “could not” be removed from Cylinder in a normal way and required tapping.
- The reason being that the barrel skirt was found deformed.
- The intake and exhaust valves were found normal and no sticking was observed.

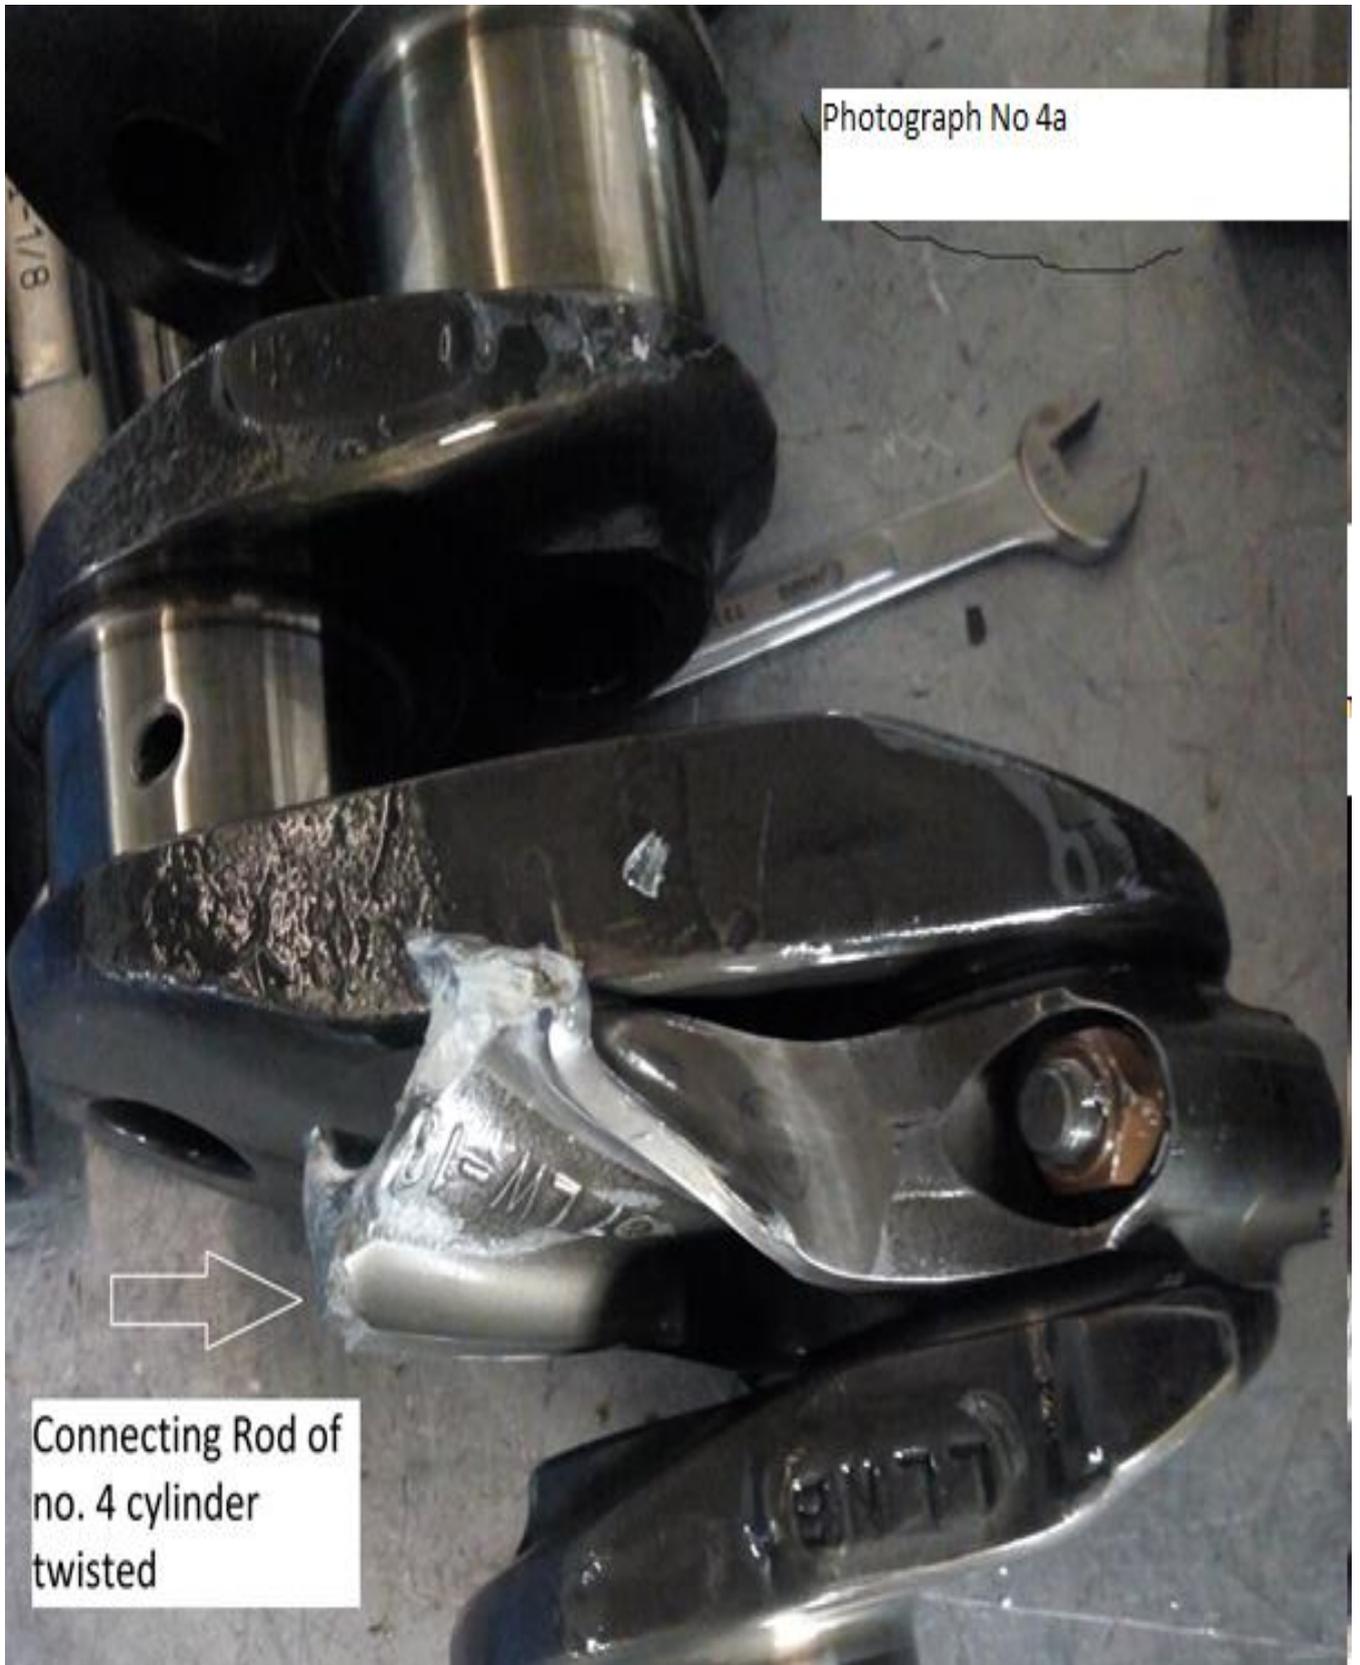
**Photograph No. 4a**

Connecting Rod of  
no. 4 cylinder  
twisted

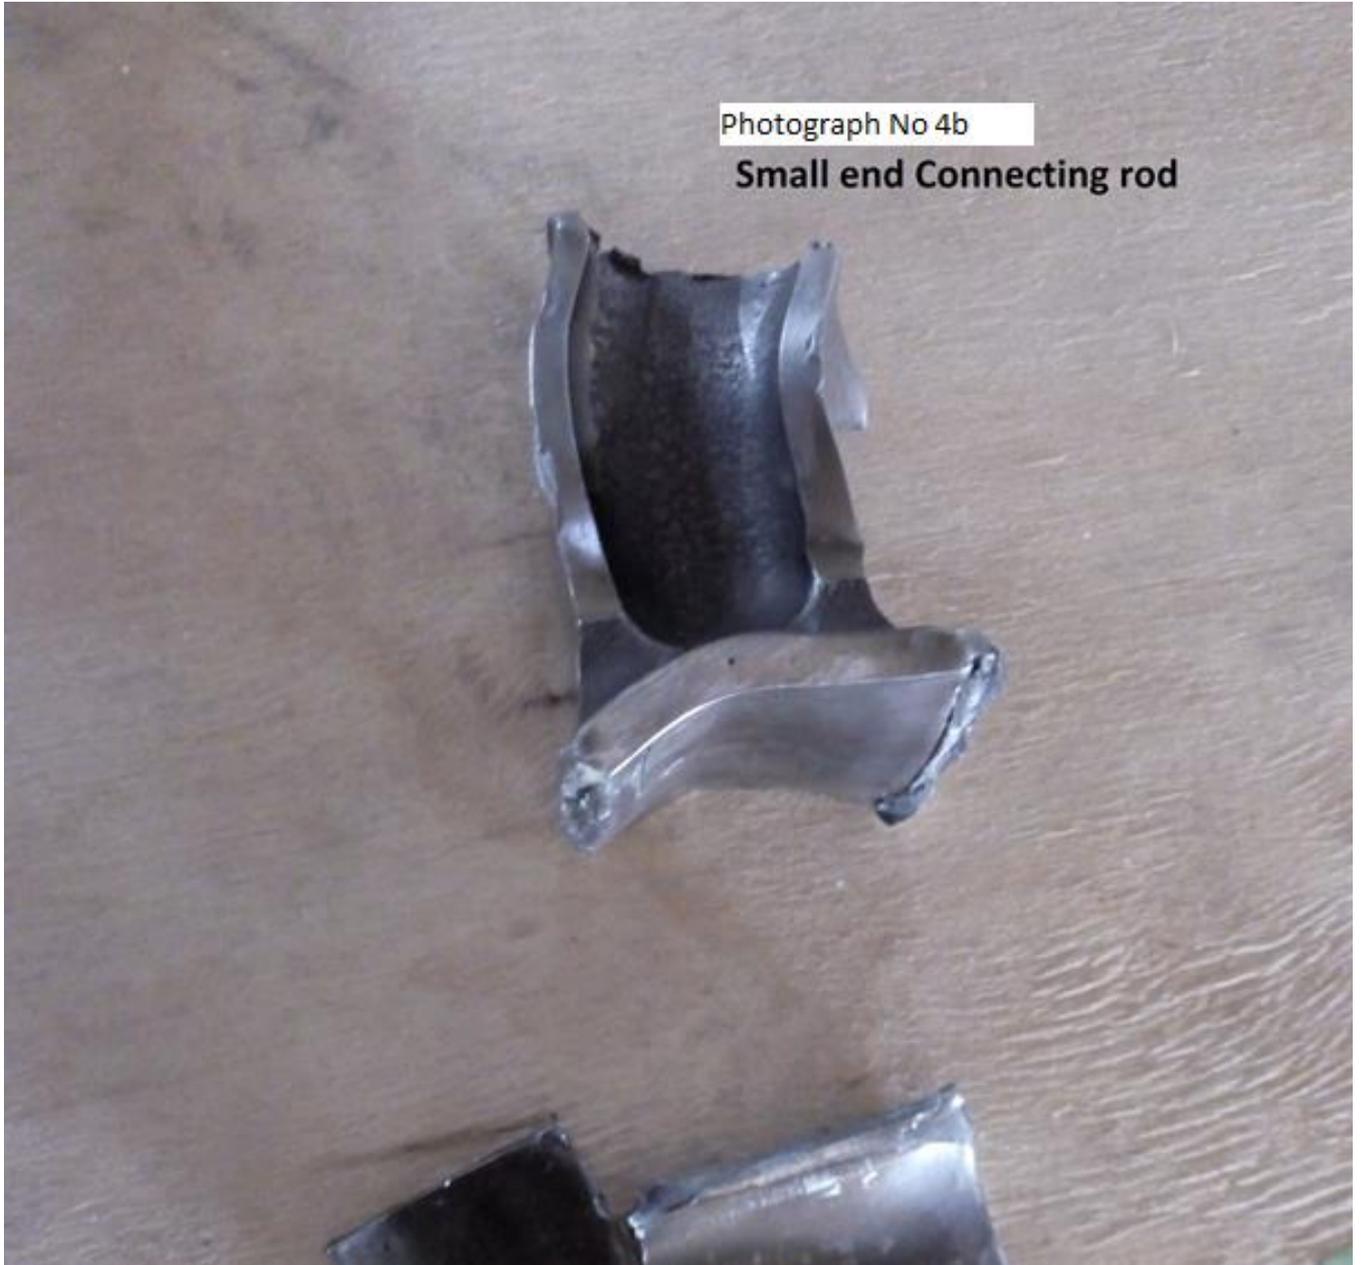
**Photograph No. 4b**

**Small end Connecting rod**

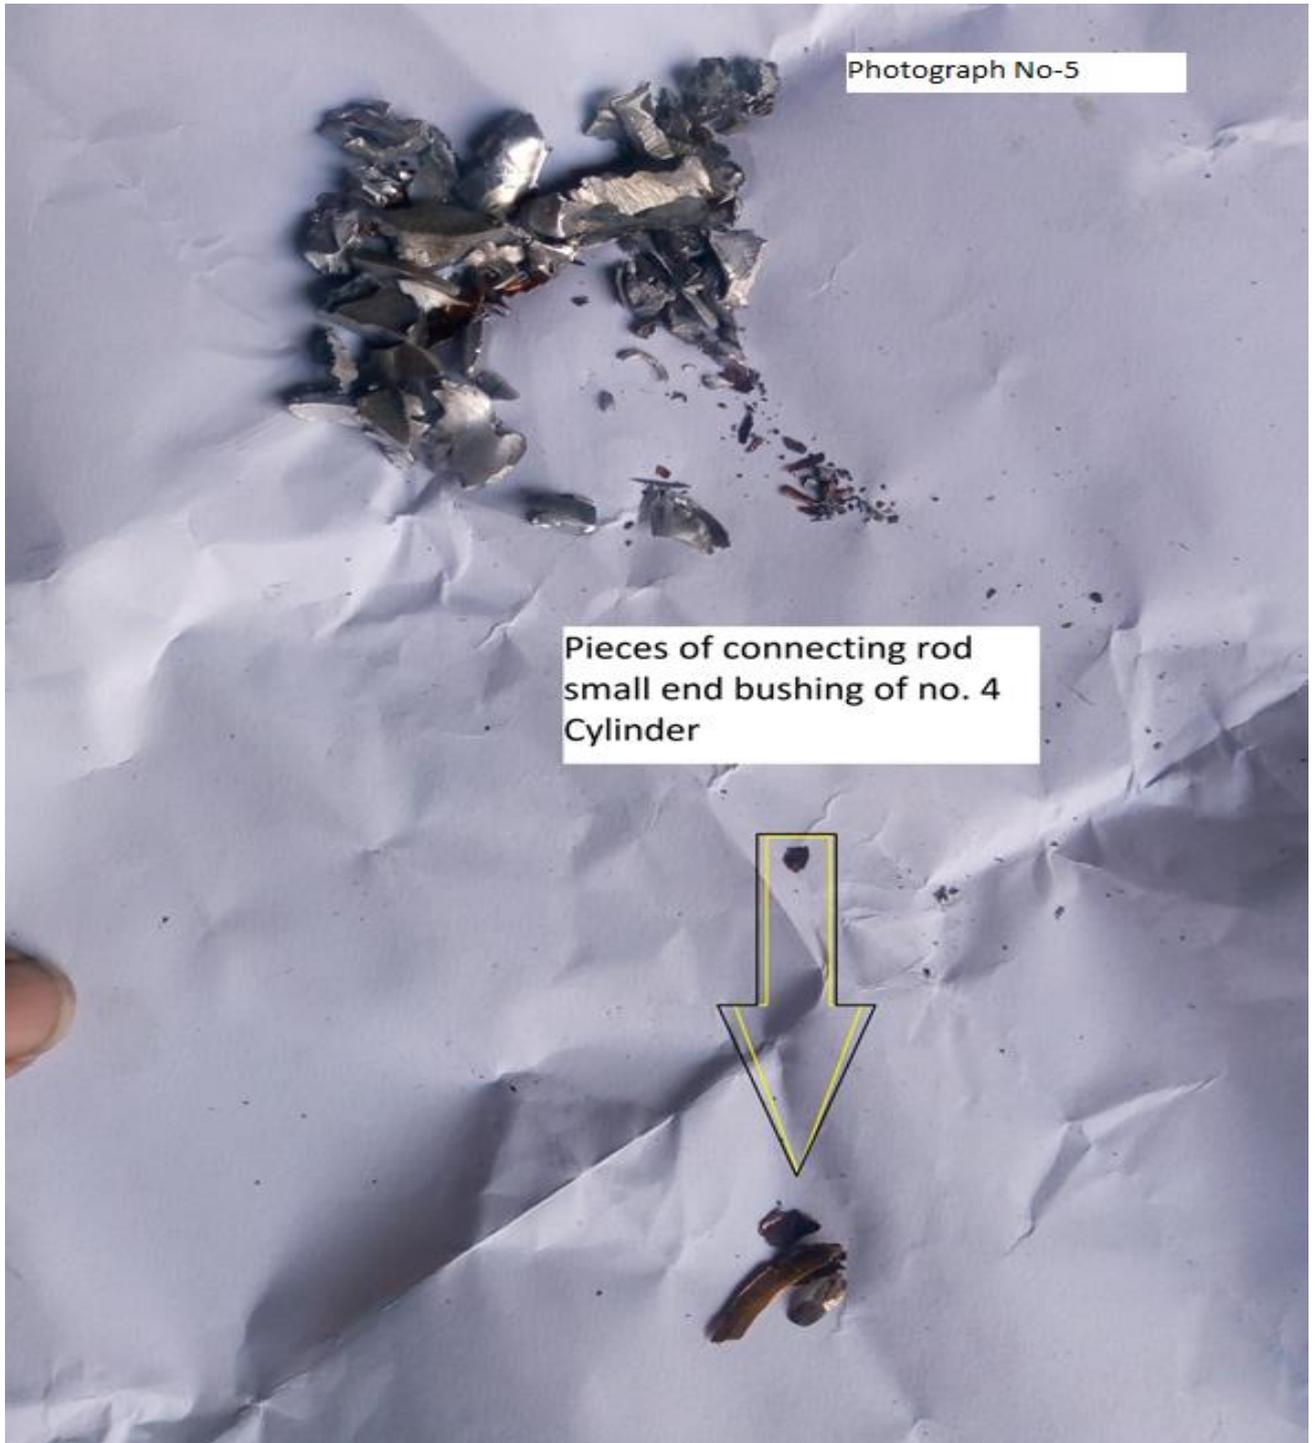
**Photograph No. 5**

- Connecting rod No. 04 piston end copper bushing was found missing.
- The connecting Rod No. 04 small end copper bushings had broken and was converted in to small particles.
- No. 04 Piston Pin plugs were found intact.
- Traces of copper bushing pieces found mixed in the oil in sump along with the other metal particles (Please refer **Photograph No.5**).

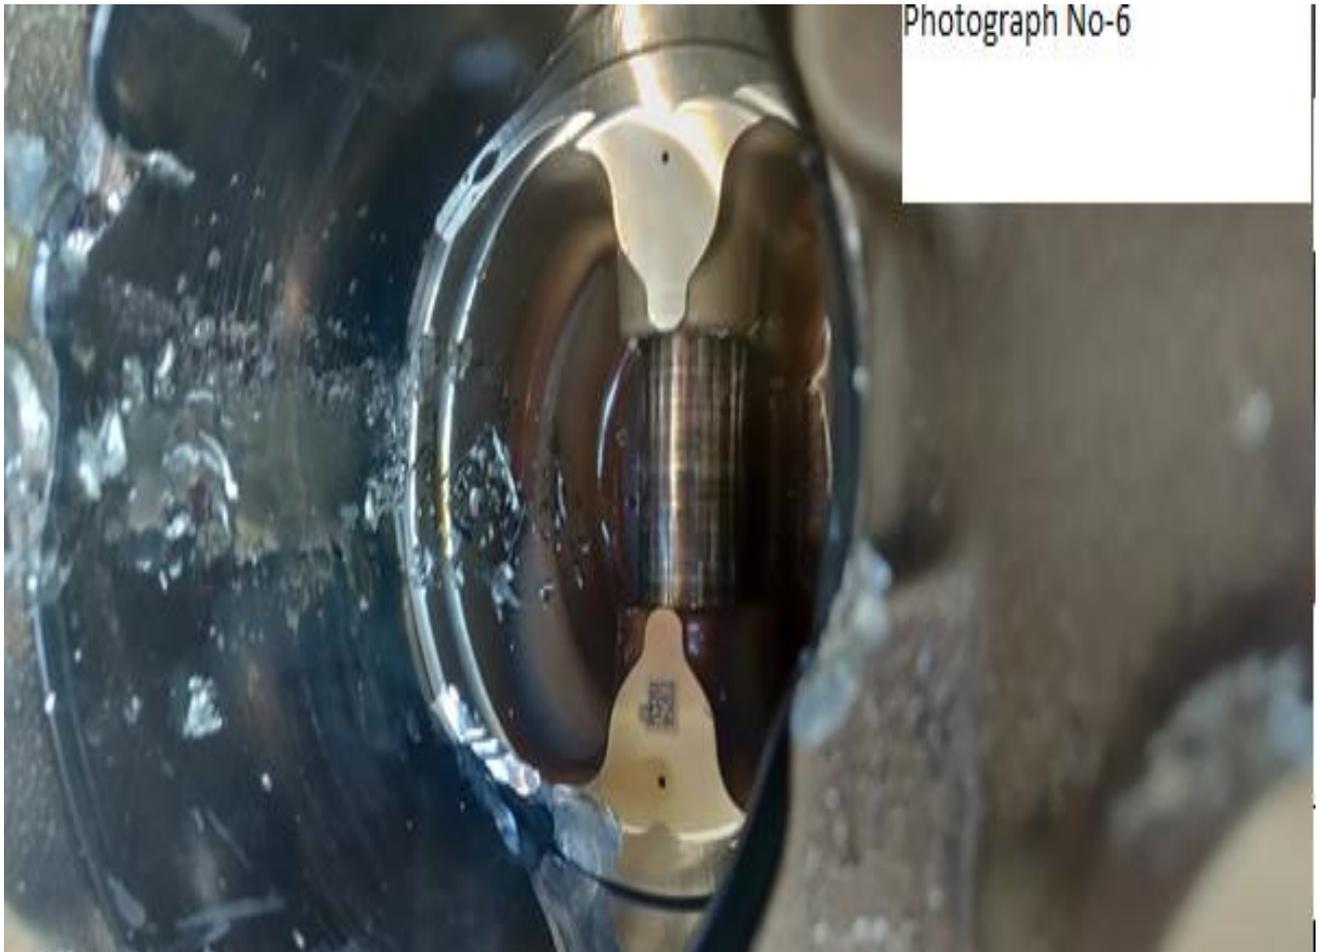
**Photograph No.6**

- No. 04 Piston Pin was full of markings. This might be due to excessive clearance between the connecting rod eye end (small end) and piston pin due to loss of copper bushing (Please refer **Photograph No.6**).

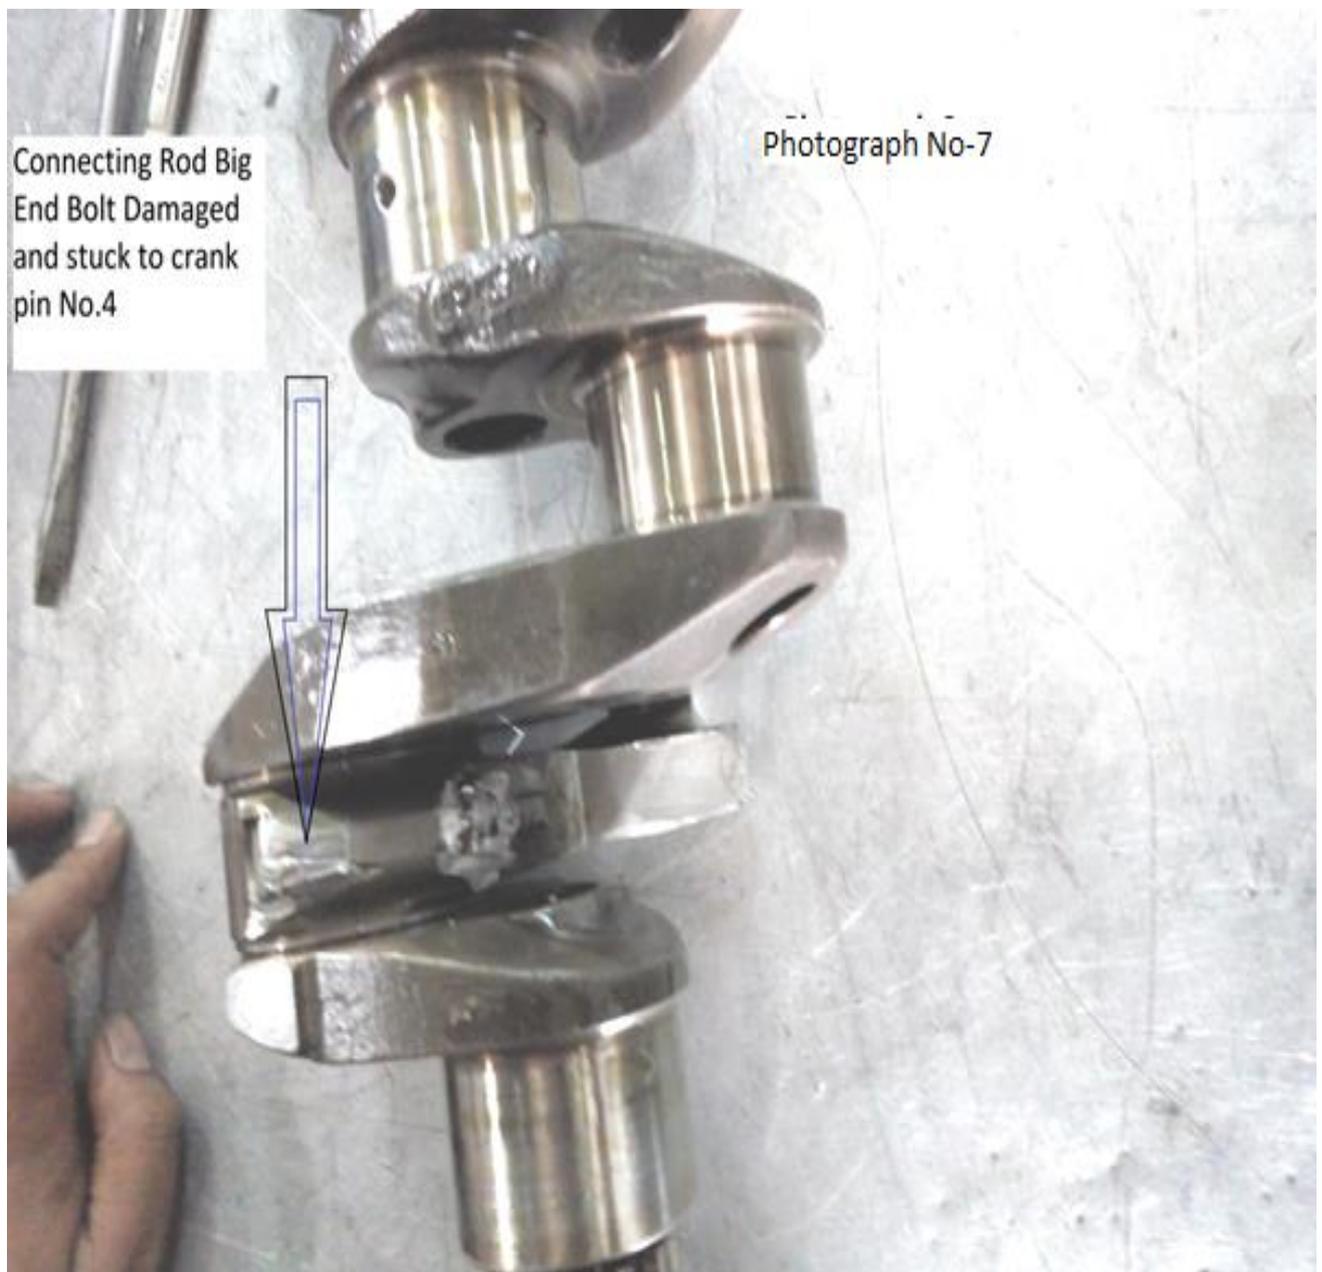
Photograph No-7

- Connecting Rod No. 04 bolt and nut at crank pin No 4 of Crankshaft were found extensively damaged. Hence, the two halves could not be removed (Please refer **Photograph No.7**).

Connecting Rod Big  
End Bolt Damaged  
and stuck to crank  
pin No.4

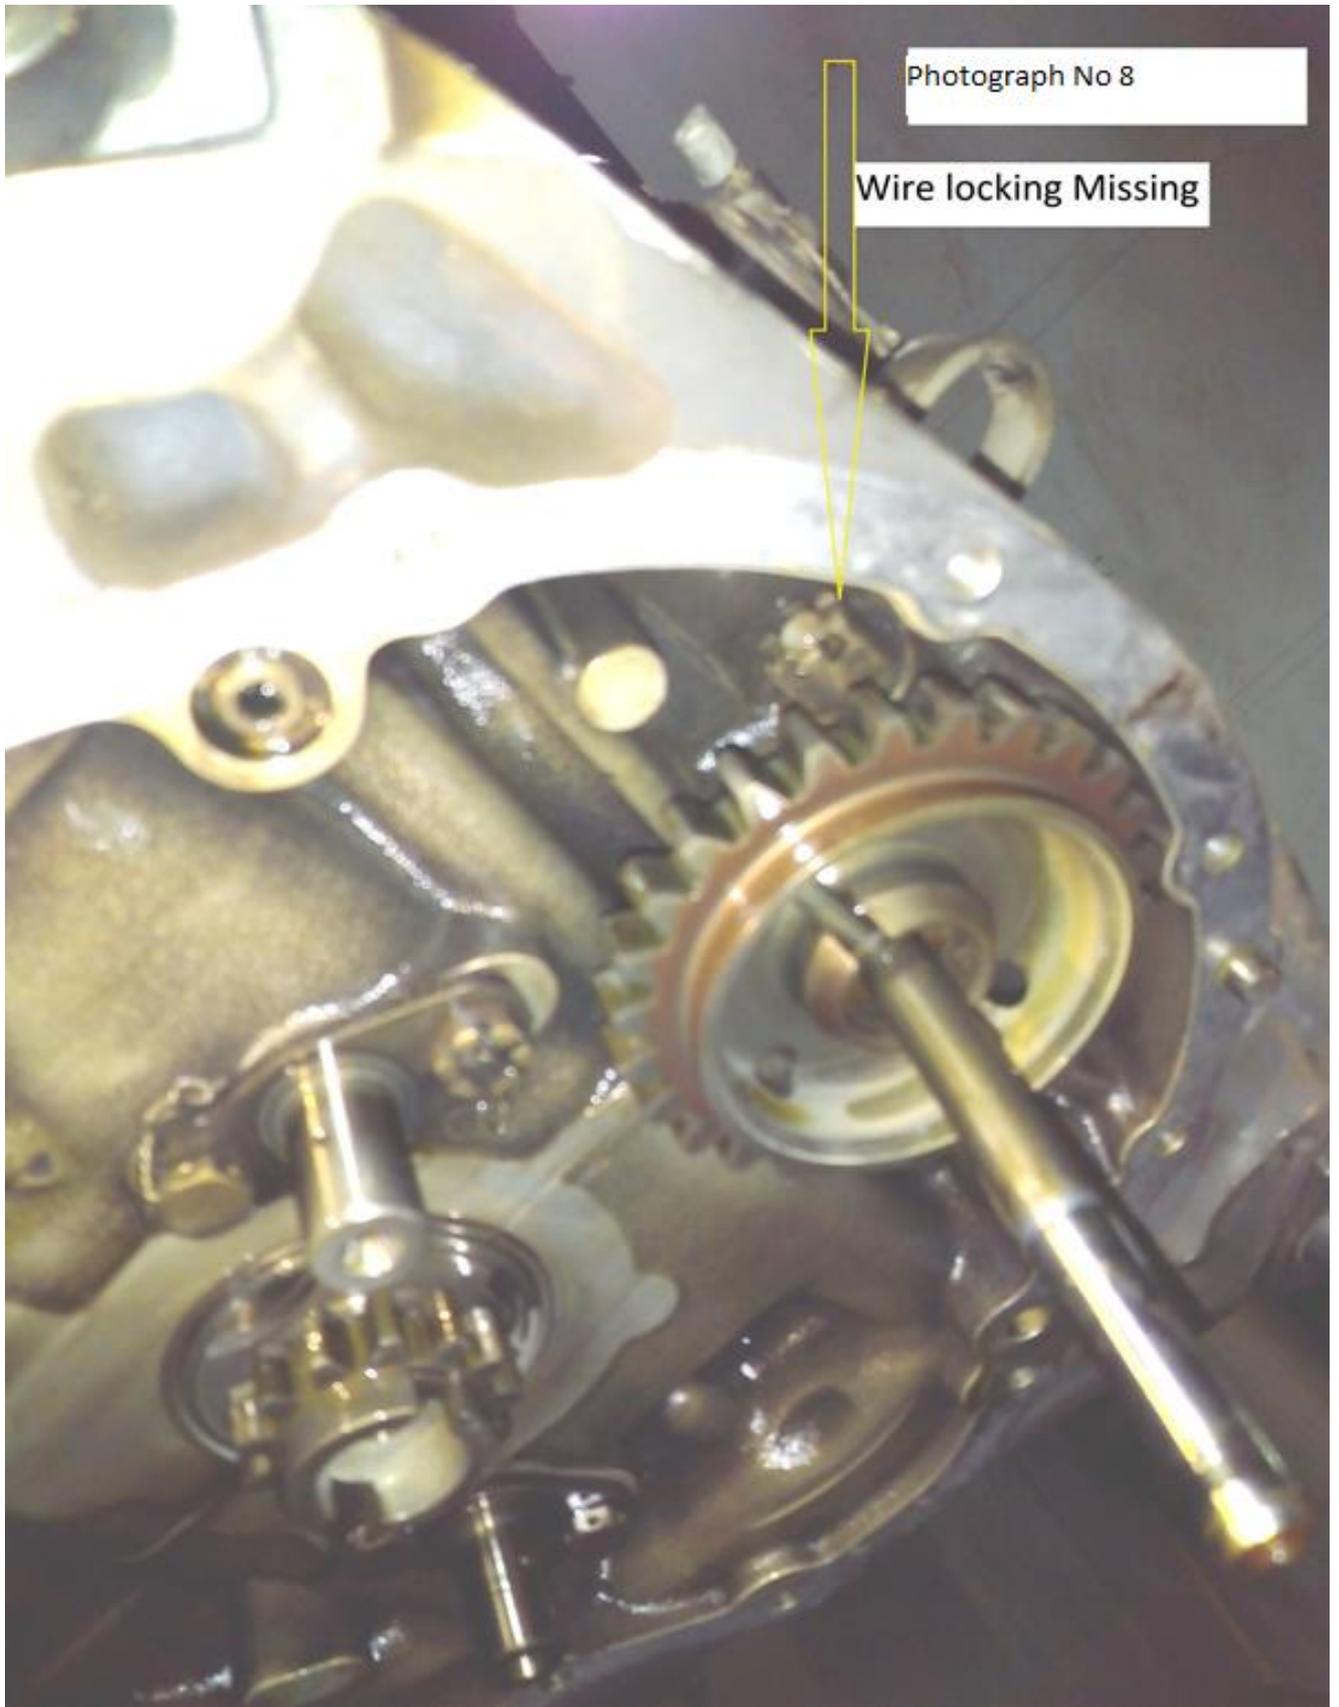
**Photograph No. 8**

- While splitting the crankcase, there was no locking wire at Crankcase top rear castle nut (Please refer **Photograph No.8**).

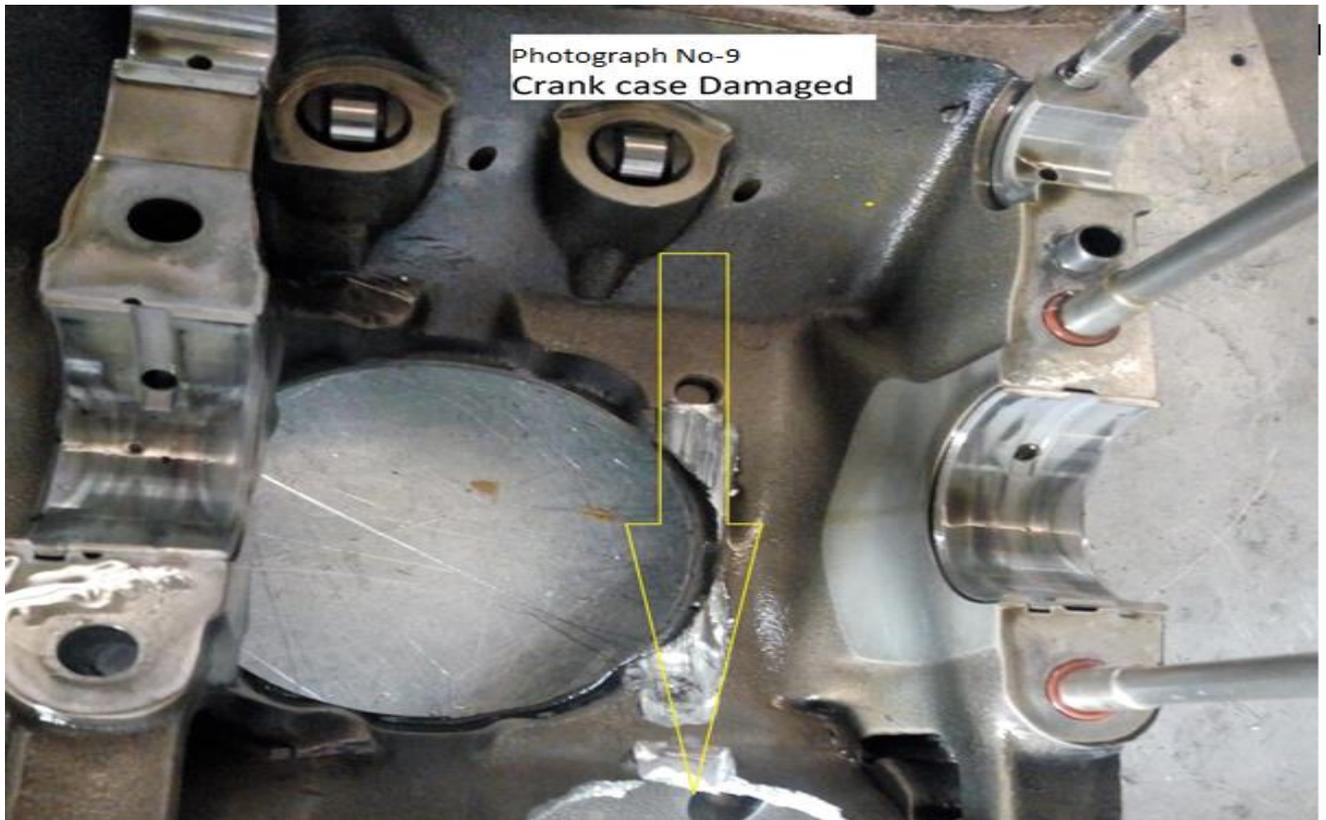
- Damage and hit marks noticed at many places of Crankcase, particularly at No 3- & 4-cylinder area including the lower portion of the Crankcase (Please refer Photograph No.9).

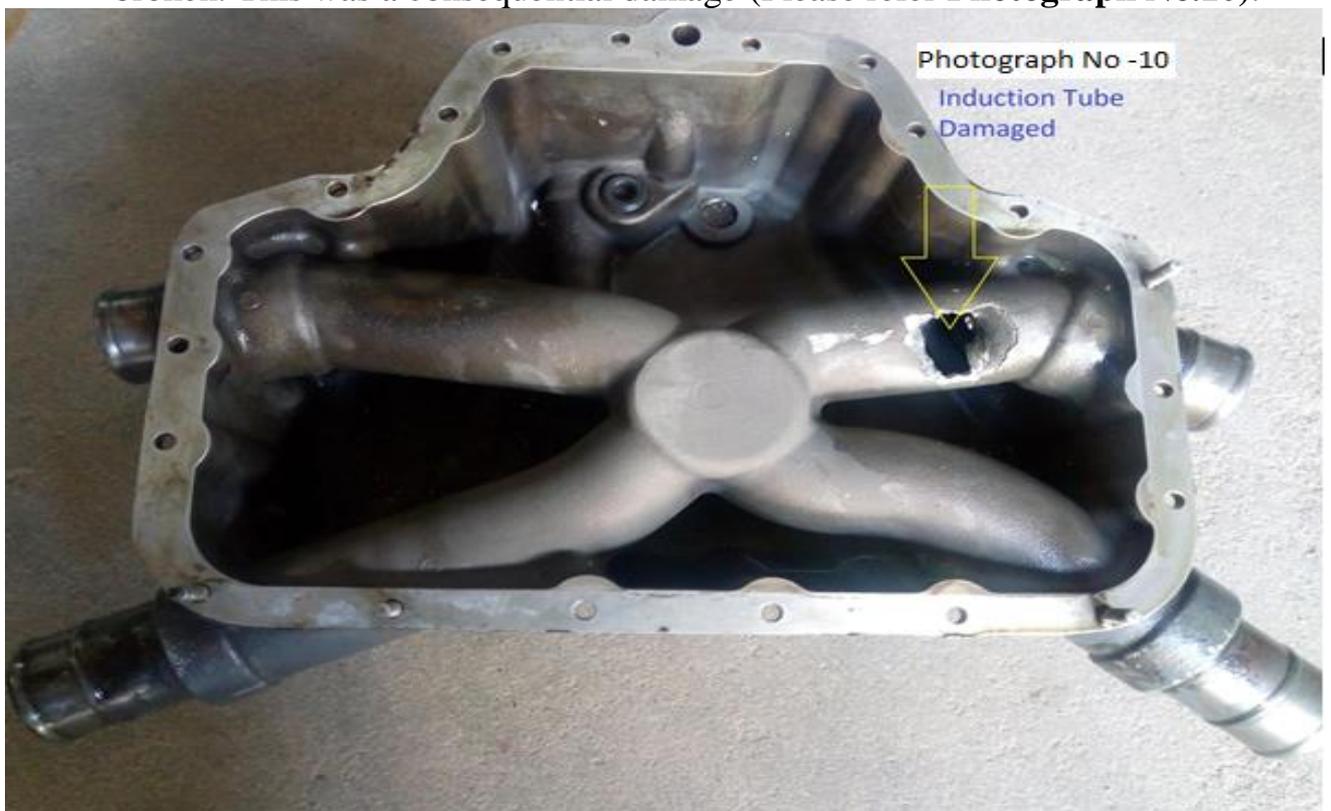
- The induction tube No 04 of the induction Manifold in the Oil sumps was found broken. This was a consequential damage (Please refer **Photograph No.10**).

- Probably the broken part of the connecting Rod No 04 had internally hit and damaged induction tube No. 04
- The visual inspection of journal diameter of crankshaft at No 1,2,3 & 4 cylinder connecting rod location was carried out and no deviations were observed.

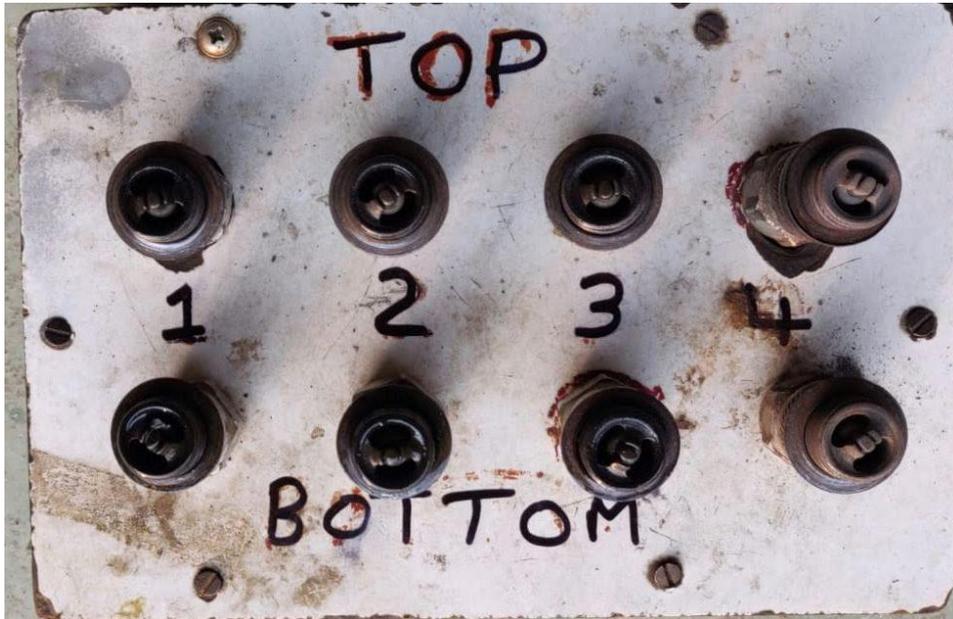
- All plugs were full of oil.

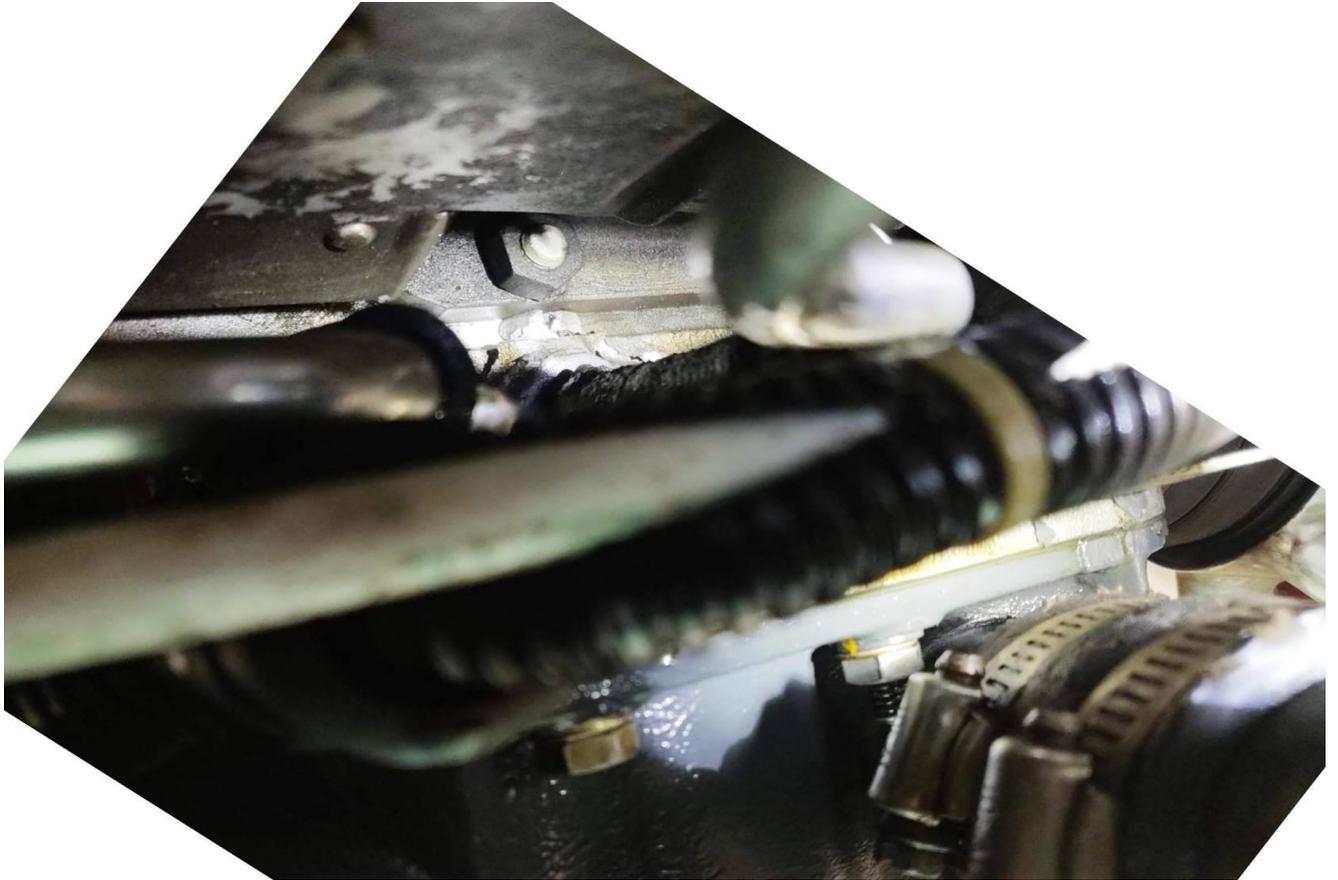
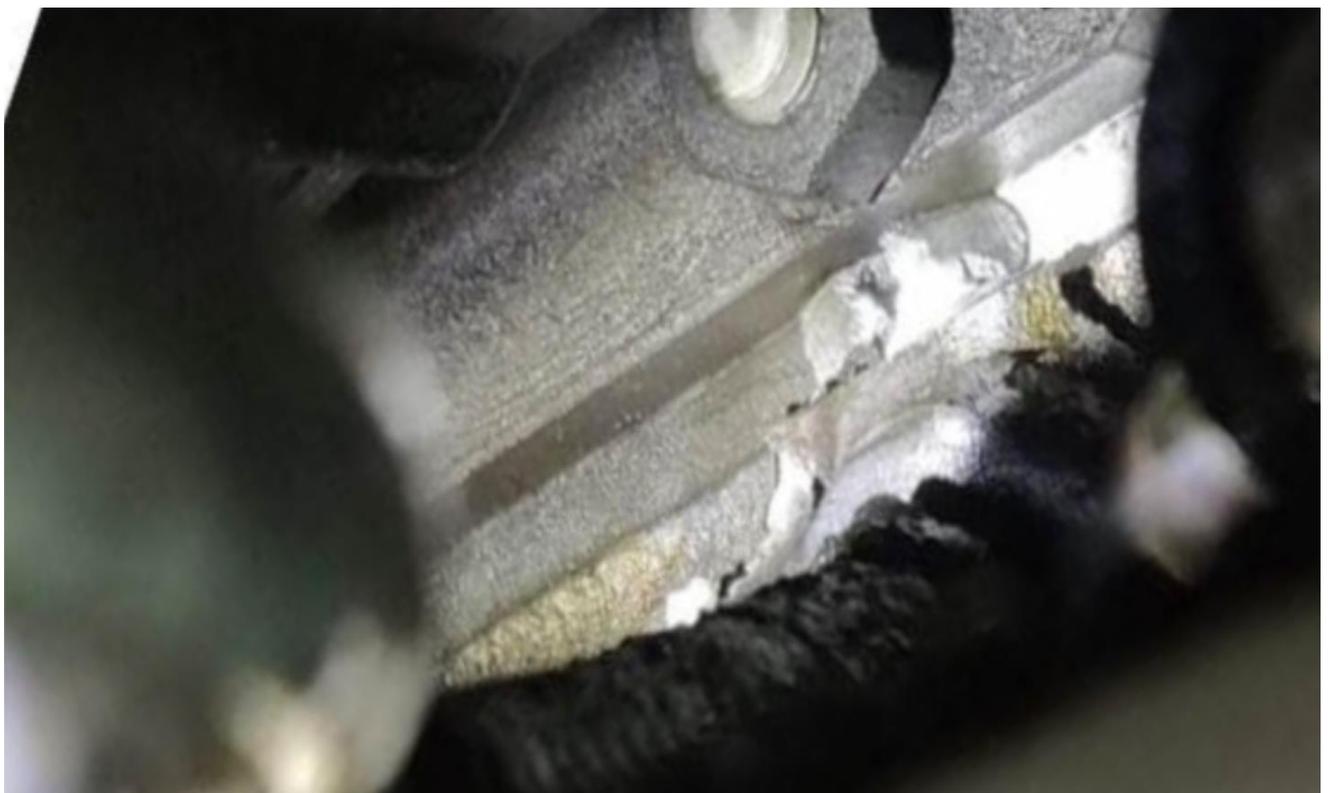
Engine Mount & Fire wall was found twisted and had shifted inwards. There were no signs of oil Splash on the fire wall. Thus, it can be inferred that there may not be any oil leak at the time of take-off.

The only damage observed externally was an oval fracture at the bottom of cylinder No 04 through which there was oil leakage.
