**AIRCRAFT ACCIDENT INVESTIGATION BUREAU
MINISTRY OF CIVIL AVIATION
GOVERNMENT OF INDIA**

**FINAL INVESTIGATION REPORT ON ACCIDENT TO
M/s AIR INDIA EXPRESS B737-800 AIRCRAFT
VT-AYD AT TIRUCHIRAPPALLI (TRICHY)
ON 11 / 10 / 2018**

**FINAL INVESTIGATION REPORT ON ACCIDENT TO M/s AIR INDIA EXPRESS LTD.
BOEING B 737-800 AIRCRAFT VT-AYD AT TIRUCHIRAPPALLI (TRICHY) AIRPORT ON 11-10-2018**

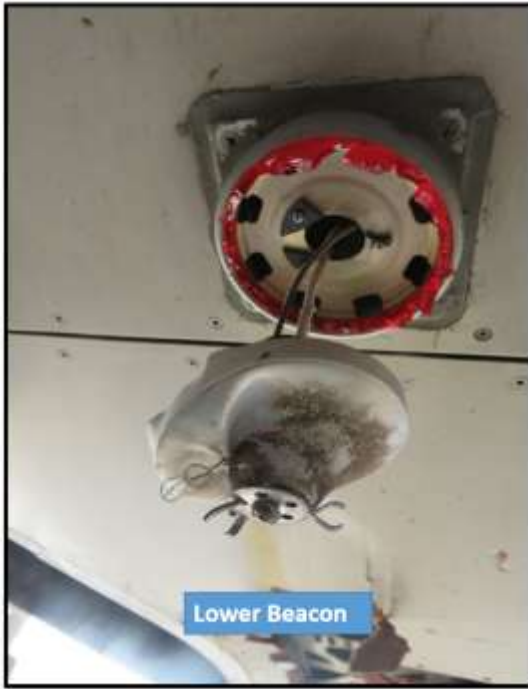
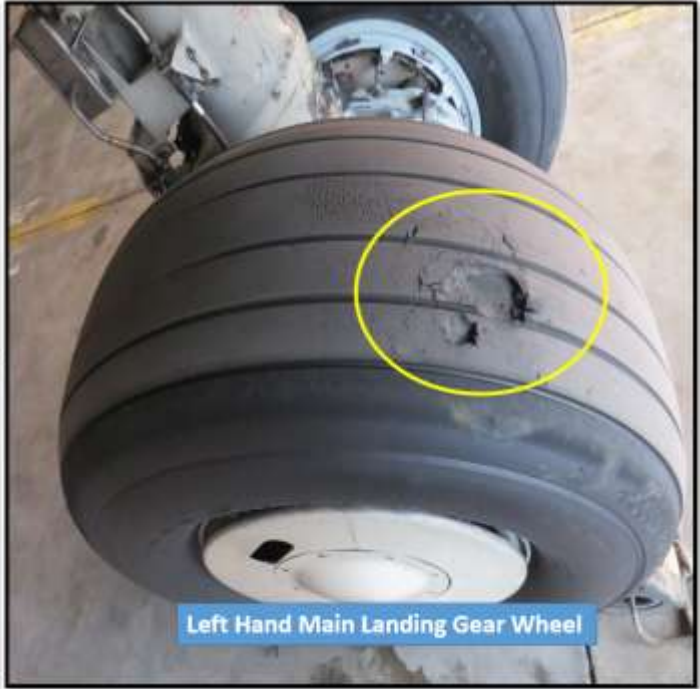
1. Aircraft Lower Beacon was found damaged.
2. VHF – 2 (lower) Antenna found broken at root end.
3. Multiple damages on LH & RH side panels behind aft bulk head of the wheel well noticed.
4. Lower Beacon to VHF lower # 2 Antenna panel was found damaged.
5. At 6 o'clock position on fuselage, dents and scratch marks observed on aft cargo skin.
6. Forward of the aft- cargo around 4 o'clock scratches & dents noticed.
7. LH horizontal stabilizer inboard Leading edge found damaged.
8. Tail skid green & red paint band not visible and scratch marks were present.
9. RH Engine received damages at 6 o'clock at Nose cowl & fan cowl.
10. Aircraft belly was severely damaged (skin ripped off)

Damage on Lower Beacon & LH MLG Tyre

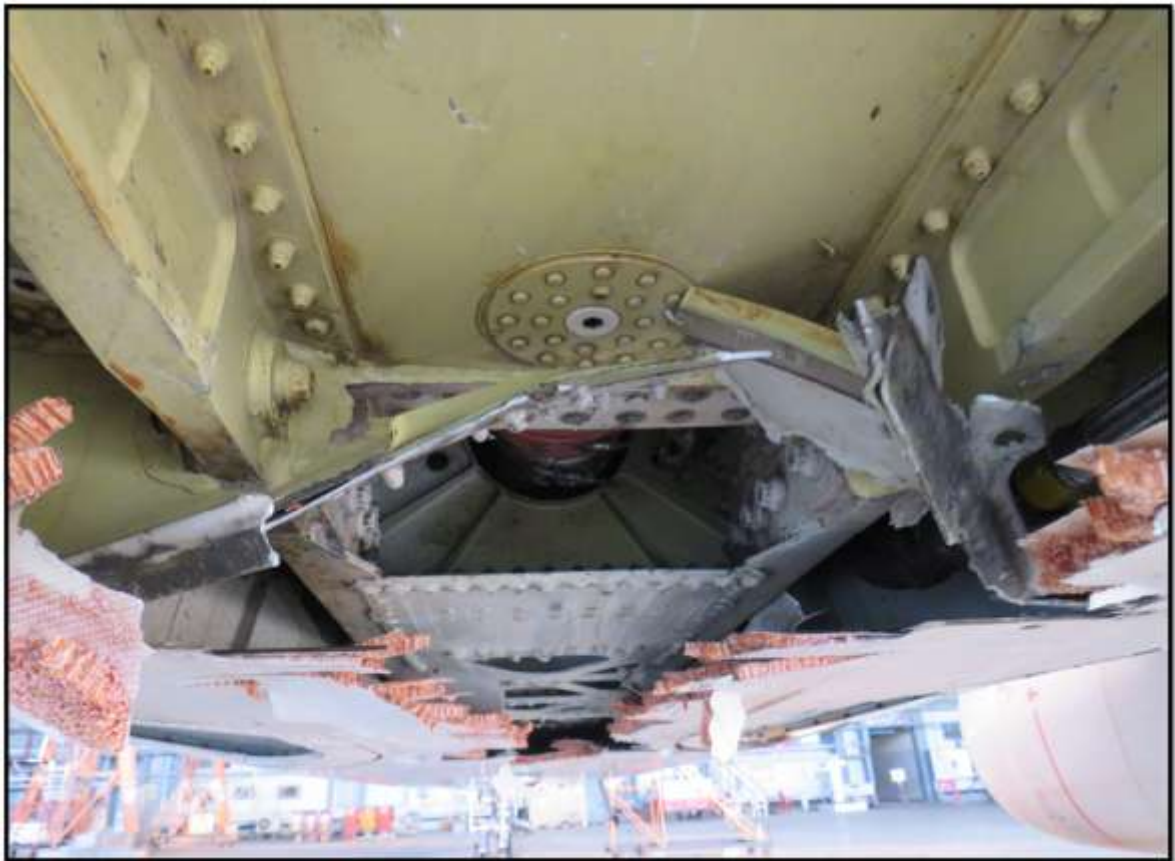
Damage on aircraft belly

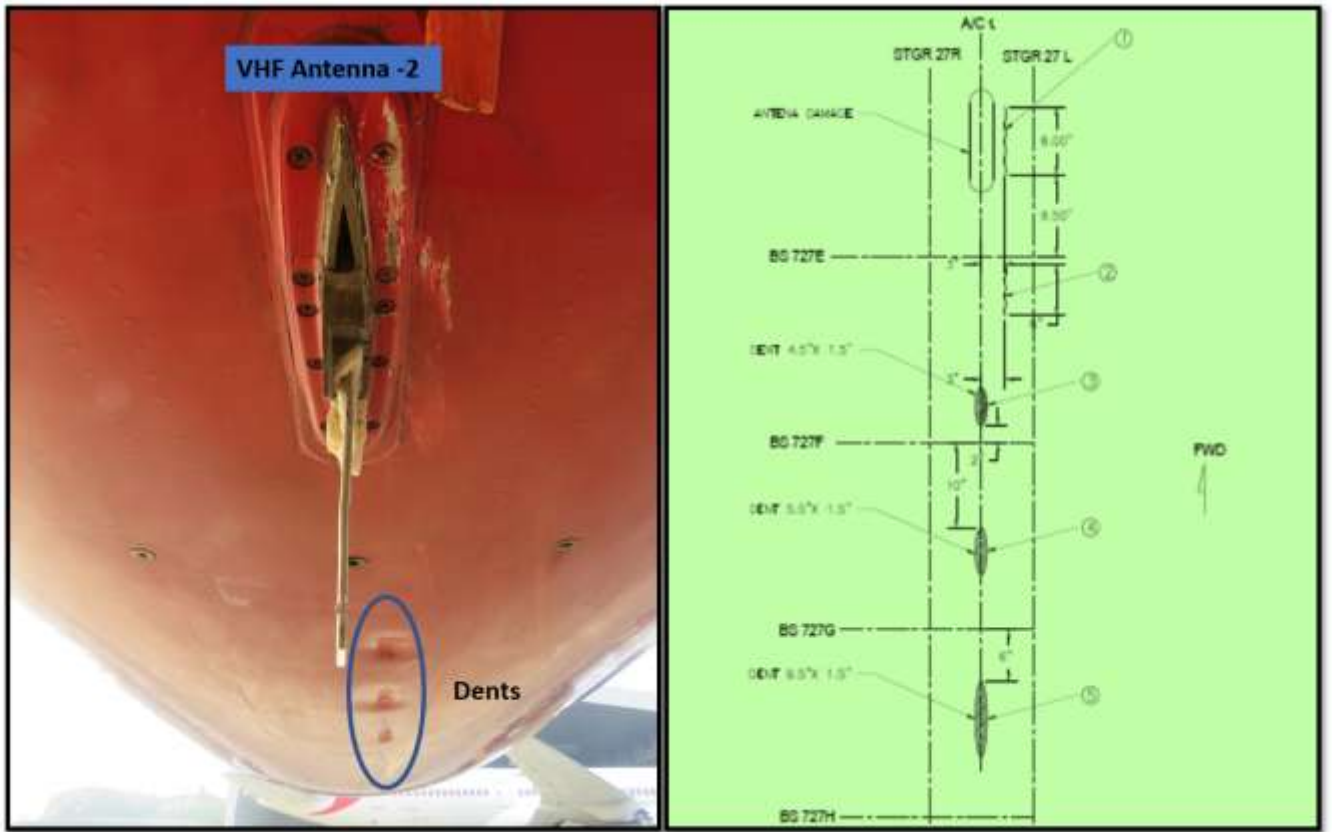
Dents observed on lower aft section of Fuselage

Defect No.	Name of Defective part	Description of Defect	Size of Defect	Location of Damage		
				B.S.	Str. No.	Geometric Location
1	Bottom Fuselage Skin	Dent & Scratch	Length:3.7" Width:2" Max.Depth:0.040"	727D-727E	27L-27R	-----
2	Bottom Fuselage Skin	Dent & Scratch	Length:5.57" Width:2" Max.Depth:0.040"	727E	27L-27R	0.600" Aft of BS 727E
3	Bottom Fuselage Skin	Dent & Scratch	Length:6.47" Width:2.15" Max.Depth:0.040"	727F	27L-27R	2" FWD of BS 727F
4	Bottom Fuselage Skin	Dent & Scratch	Length:5.7" Width:1.45" Max.Depth:0.230"	727F	27L-27R	9.5" Aft of BS 727F
5	Bottom Fuselage Skin	Dent	Length:9.0" Width:2.2" Max.Depth:0.190"	727G-727H	27L-27R	4" Aft of BS 727G

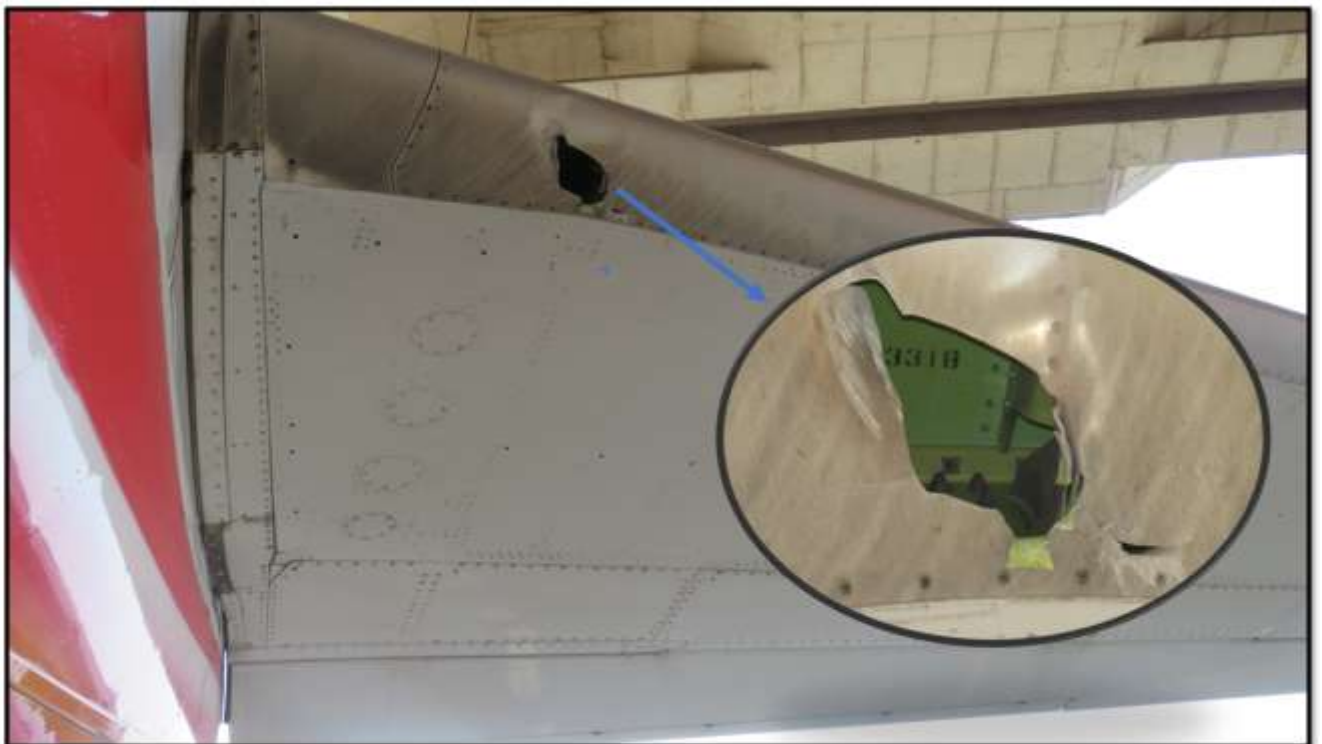
Damage on LH Horizontal Stabilizer

Defect No.	Name of Defective part	Description of Defect	Size of Defect	Geometric Location of Damage
36	LH Hor. Stab. Removable LE Panel Bottom Skin (IB Most)	Puncture + Dent	Length:14" Width:12"	From I/B end 8" and Starting from Lower Edge of Panel
37	LH Hor. Stab. Front Spar Web	Puncture	3"x3"	4.5" From Top End of Web. 3.5" O/B from Rib No.2
38	LH Hor. Stab. Removable LE Panel Skin (# 2 From Inboard)	Dent & Loose Rivet	Length:3" Width:1.5" Max.Depth:0.050"	From I/B end of Panel and 11" From Lower Edge of Panel
39	LH Hor. Stab. Bottom Skin	Dent	Length:18" Width:11" Max.Depth:0.160"	66" From I/B end and 25" From Aft Edge.
40	LH Hor. Stab. Bottom Skin	Dent	Length:4" Width:3" Max.Depth:0.115"	22" From O/B end and Starting From T/E Edge

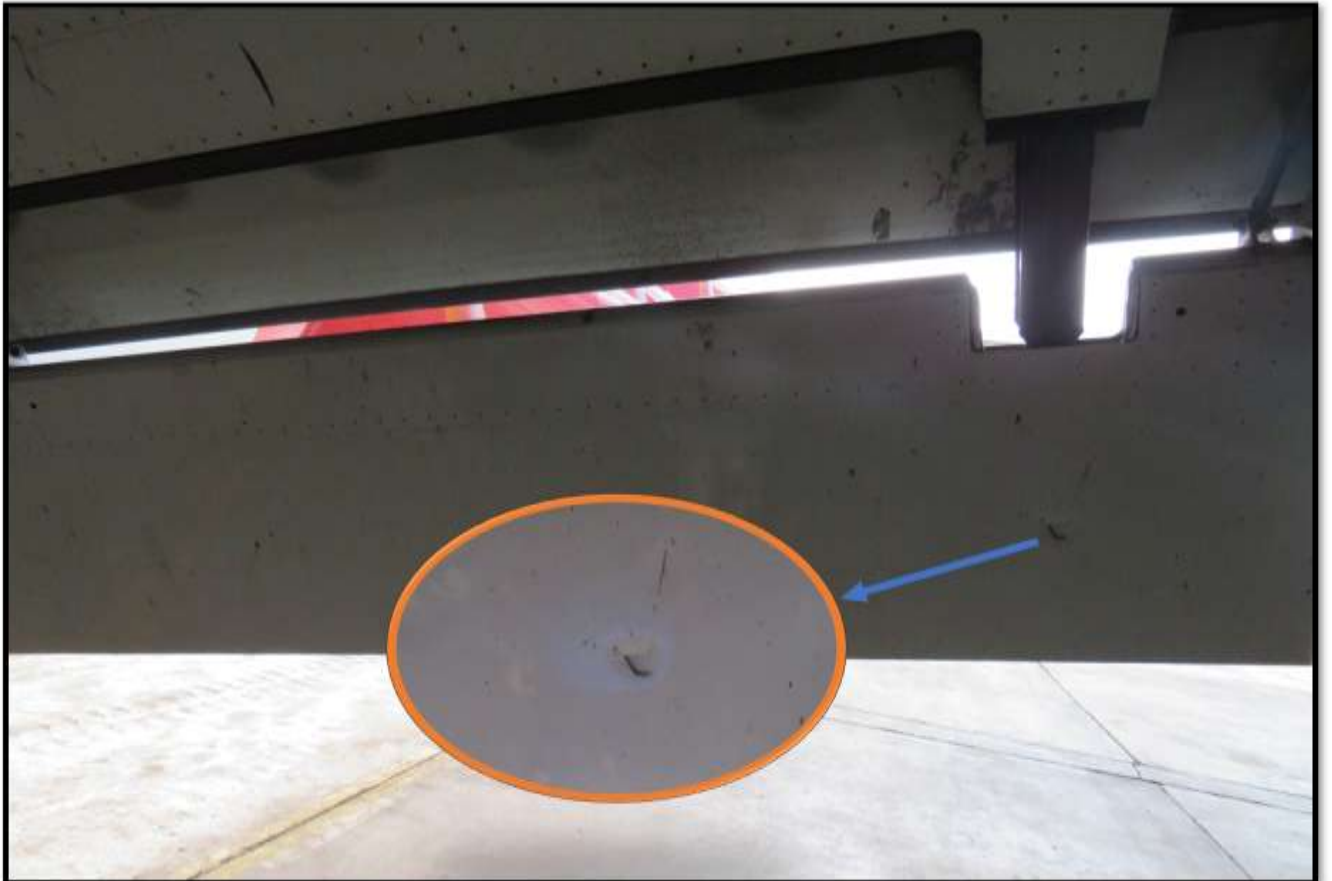
Damage on LH Wing Flap

Defect No.	Name of Defective part	Description of Defect	Size of Defect	Geometric Location of Damage
34	LH Aft I/B T/E Flap Lower Skin	Puncture	Length:6'' Width:4''	From O/B end 8'' and from T/E end 5''
35	LH Inner L/G Door	FWD L/E Portion Sheared off	-----	-----

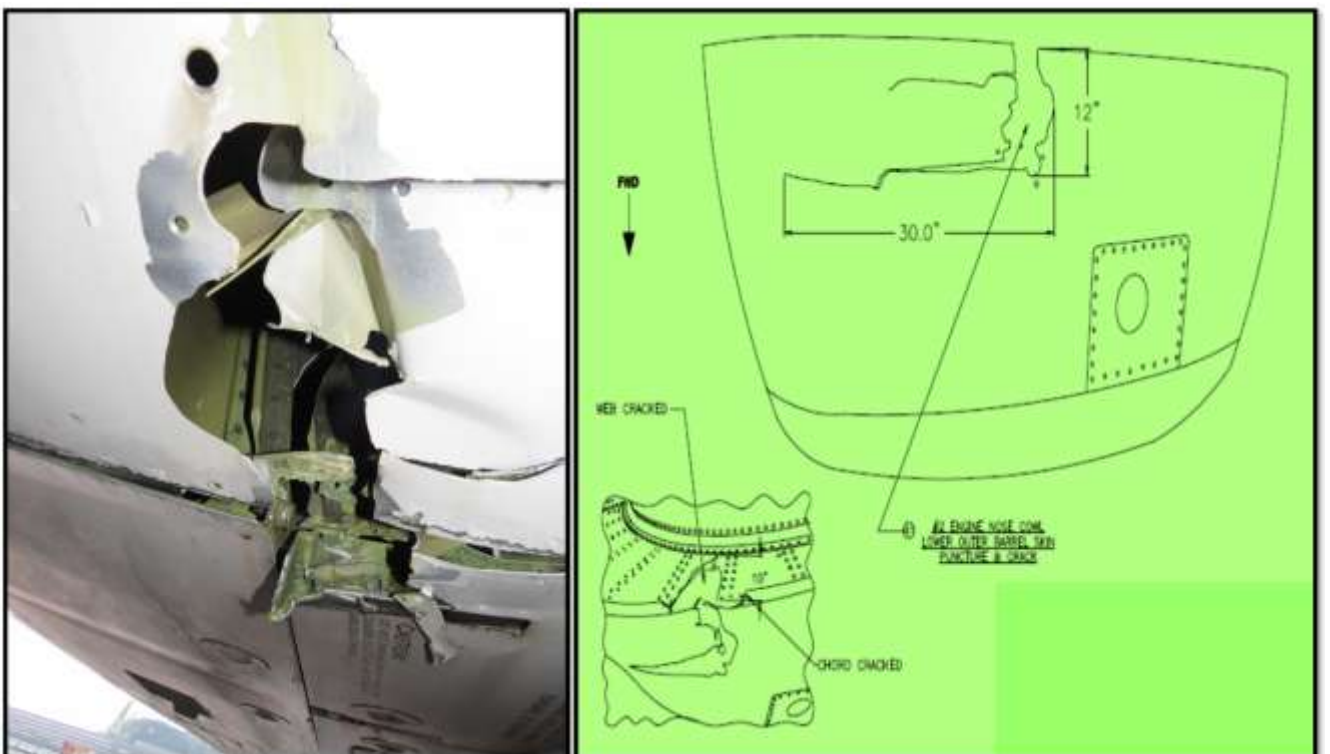
Damages on # 2 Engine

Defect No.	Name of Defective part	Description of Defect	Size of Defect	Geometric Location of Damage
41	# 2 Engine Nose Cowl – Lower Outer Barrel Skin	Puncture & Crack	Length:30" Width:12"	Between 4 O'Clock to 6 O' Clock (Fwd Looking Aft).
42	LH Fan Cowl	Fwd Lwr Corner Skin Crack	Length:10" Width:6"	Bottom FWD Side
42-A	LH Fan Cowl-Access Door	Distorted	-----	Bottom Side
42-B	LH Fan Cowl-FWD Latch	Damaged	-----	Bottom Side
43	RH Fan Cowl Skin (FWD)	Bend	Length:13" Width:3"	Lower FWD Corner

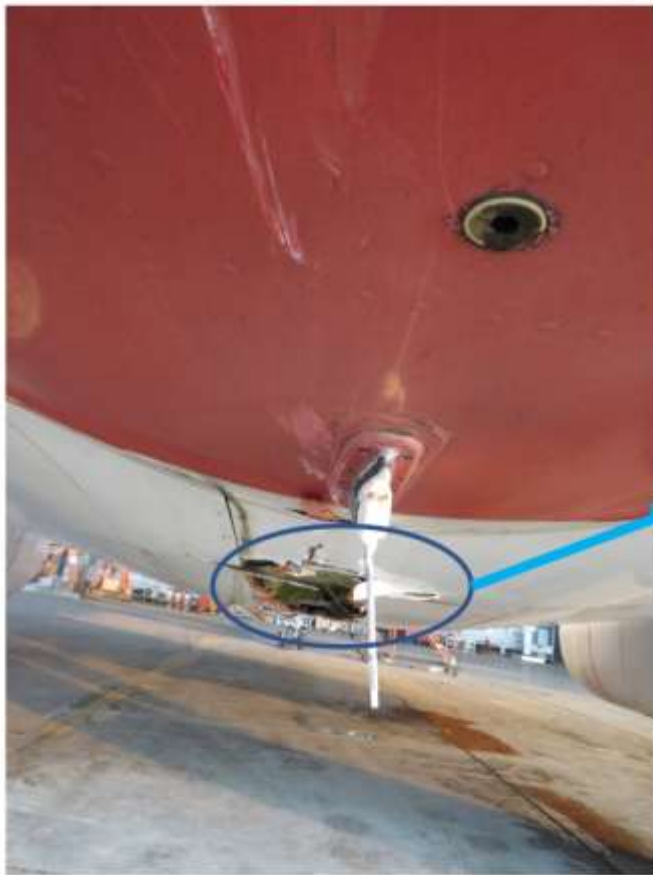
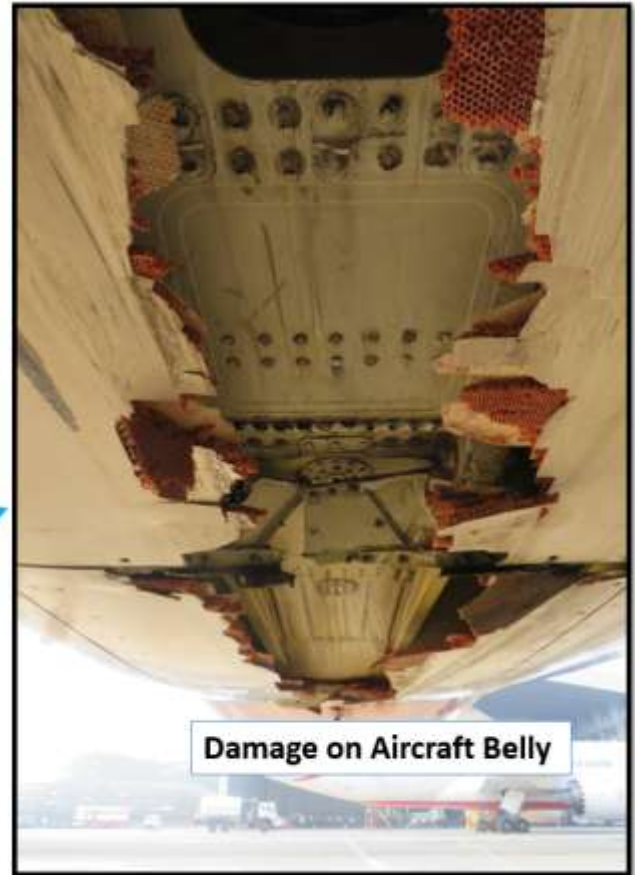
Detailed view of damages observed on Lower Fuselage Section (aircraft Belly)

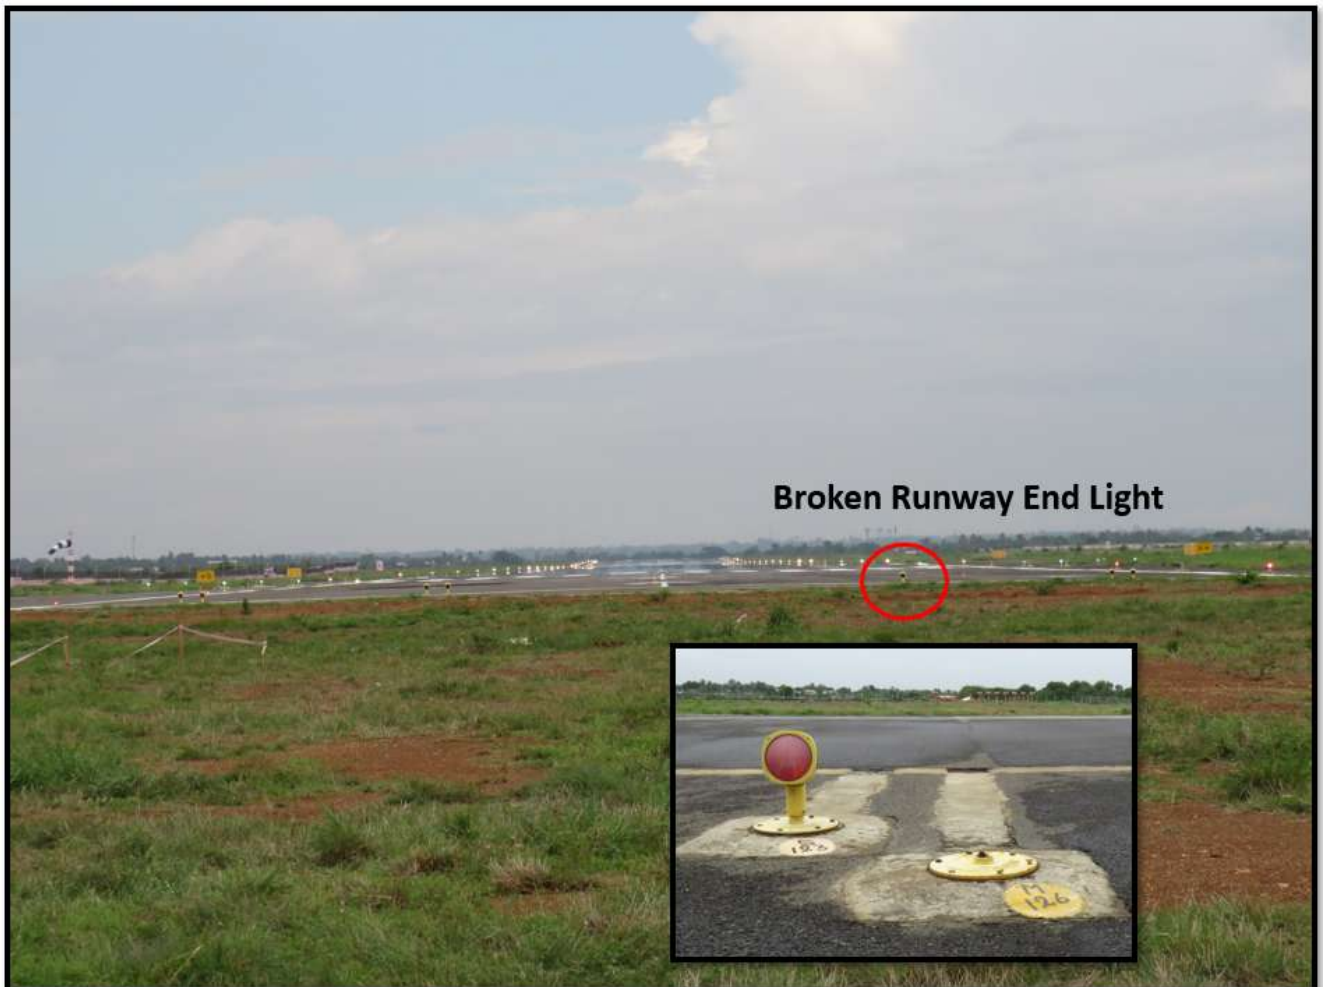
Broken Runway End Light

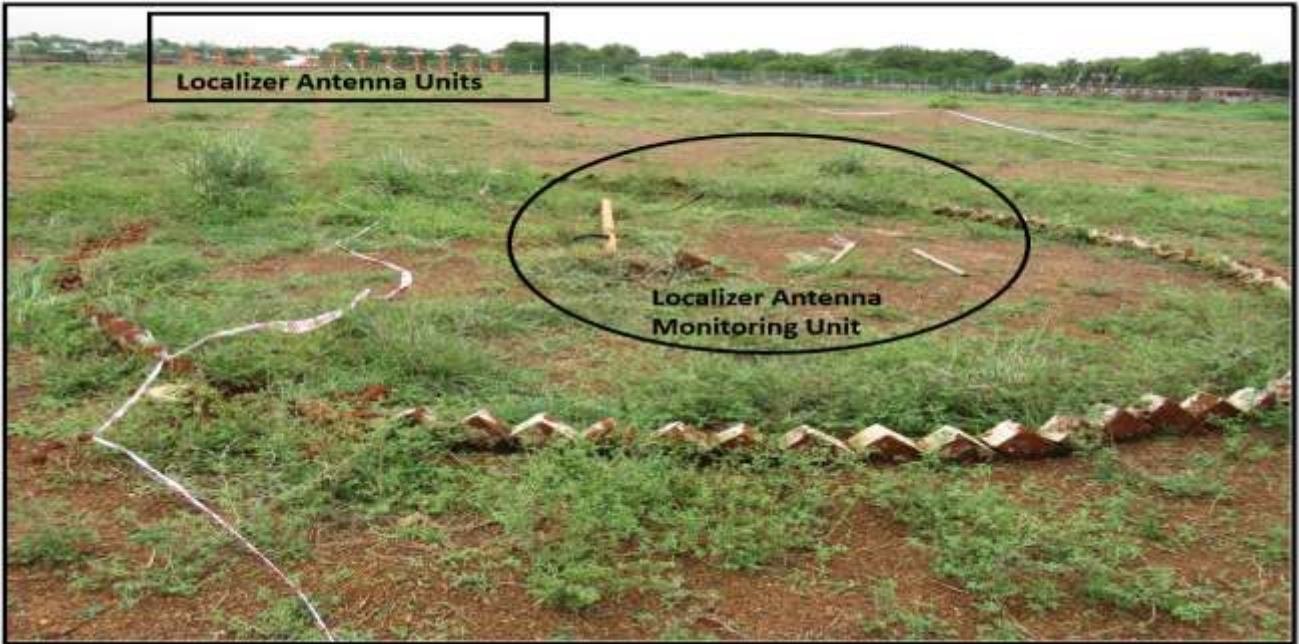
Damaged Localizer Monitoring Antenna

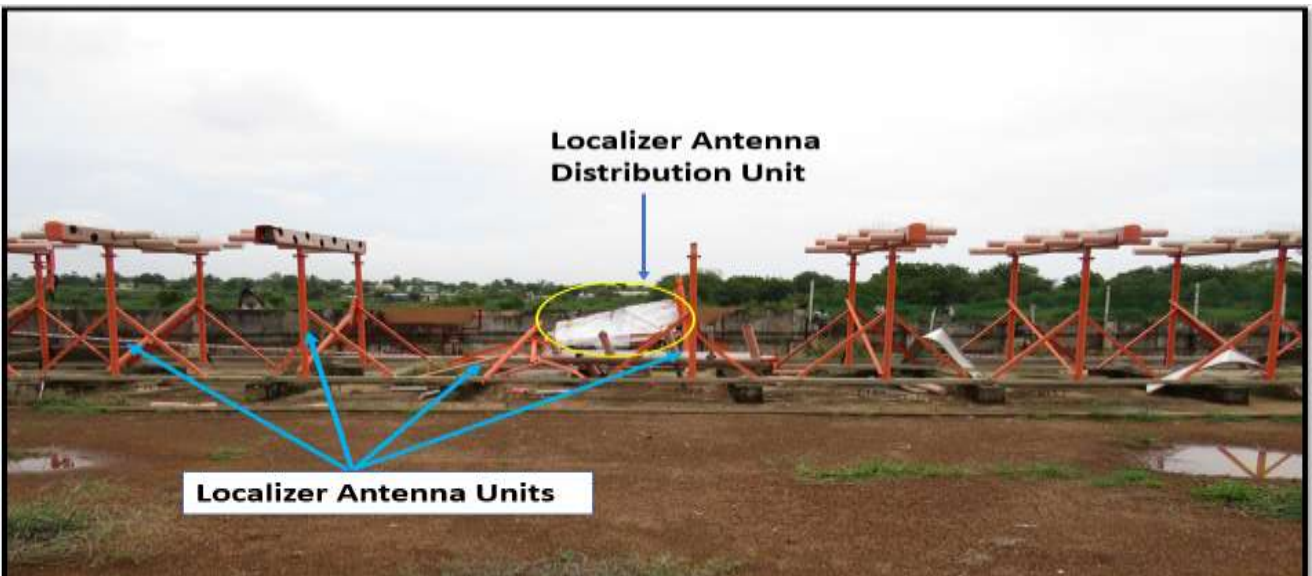
Damaged LLZ unit & Distribution unit

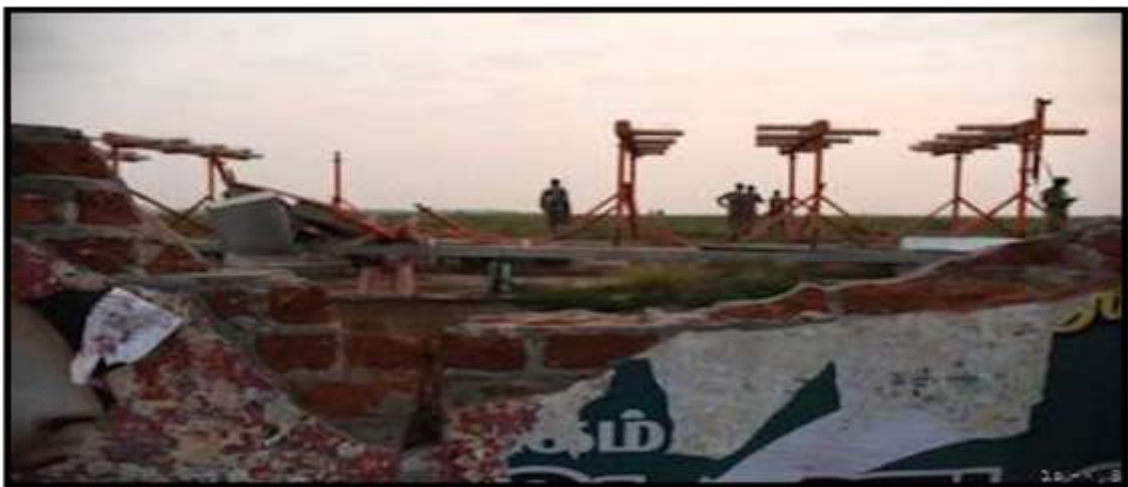
Broken Boundary Wall Portion after impact

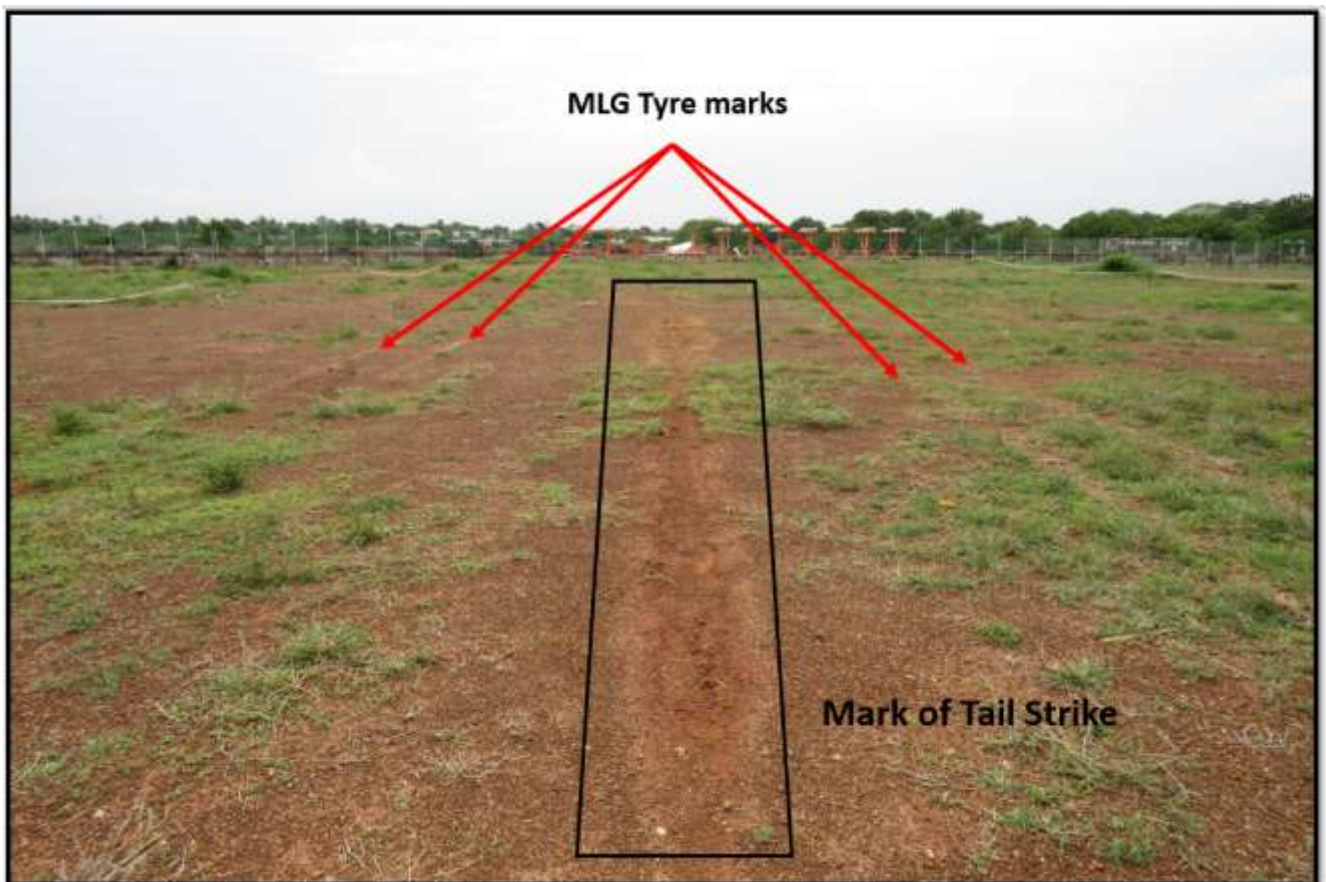
Tail Strike Marks and MLG Marks on Soft Ground

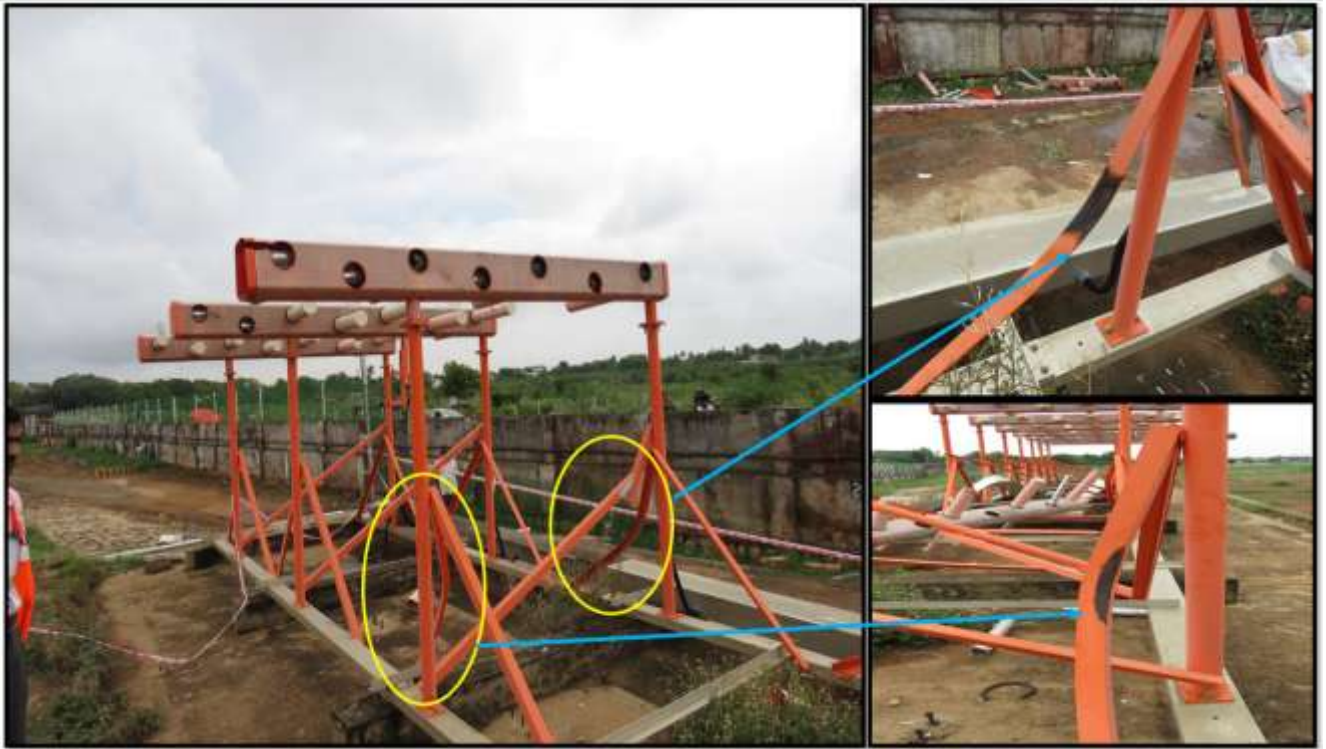
MLG Tyre marks o Antenna

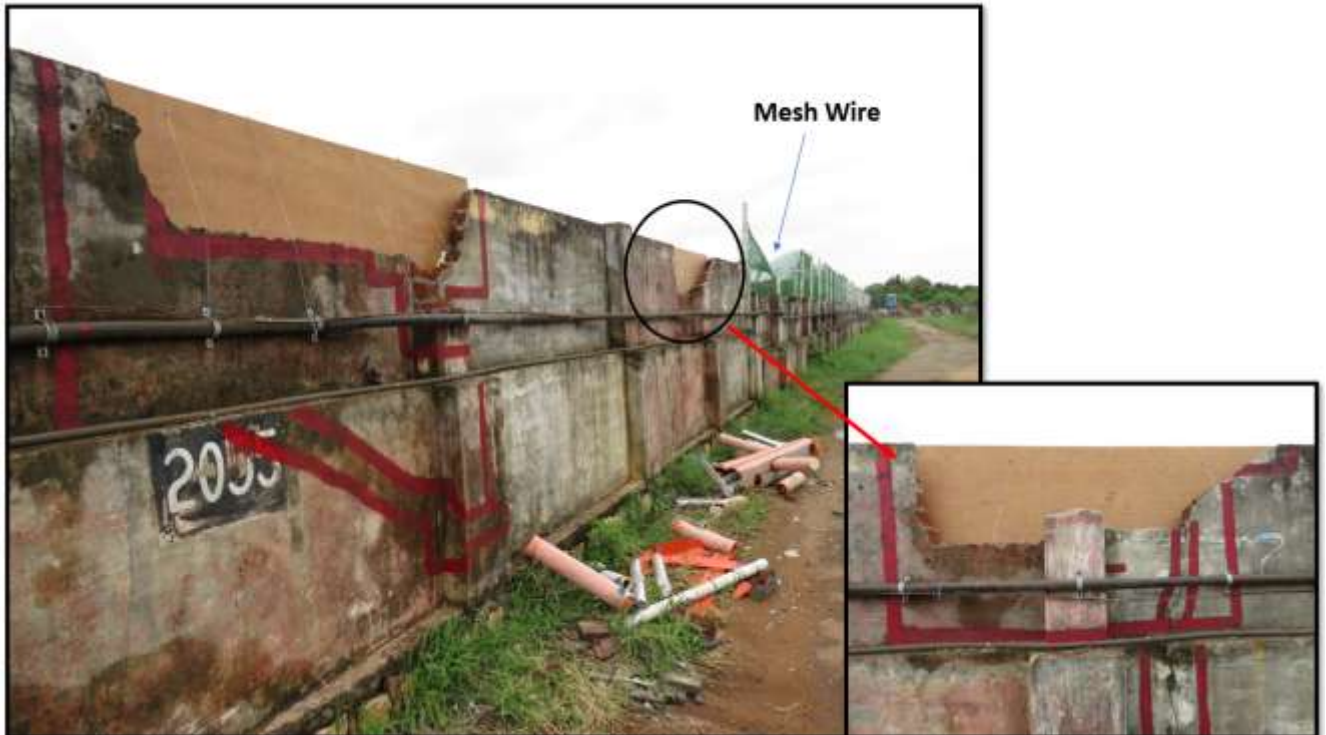
Broken Boundary Wall Portion after impact

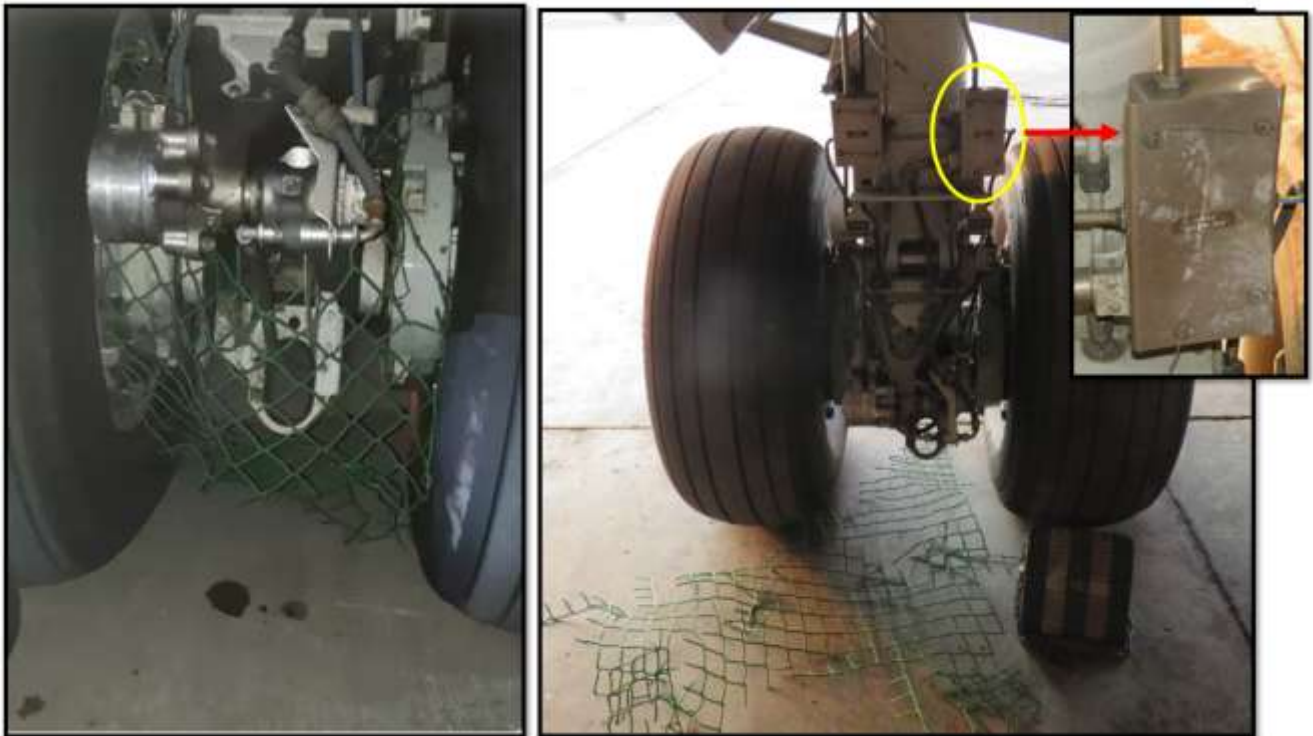
Both MLG of the aircraft impacted the boundary wall and PVC mesh wire erected on the boundary wall. The mesh entangled in landing gear before they got retracted. Due to the impact of the landing gear, the boundary wall was found broken at two locations. The left broken portion was measured 1.9 metres and right side was 1.75 meters. The distance between two broken portions was measured 3.63 meters. The direction of damage pattern to the Perimeter wall and Localizer antenna was in the flight direction indicating that it was hit by the moving aircraft and not from the jet blast of the engine.

Mesh wire found entangled after landing at Mumbai

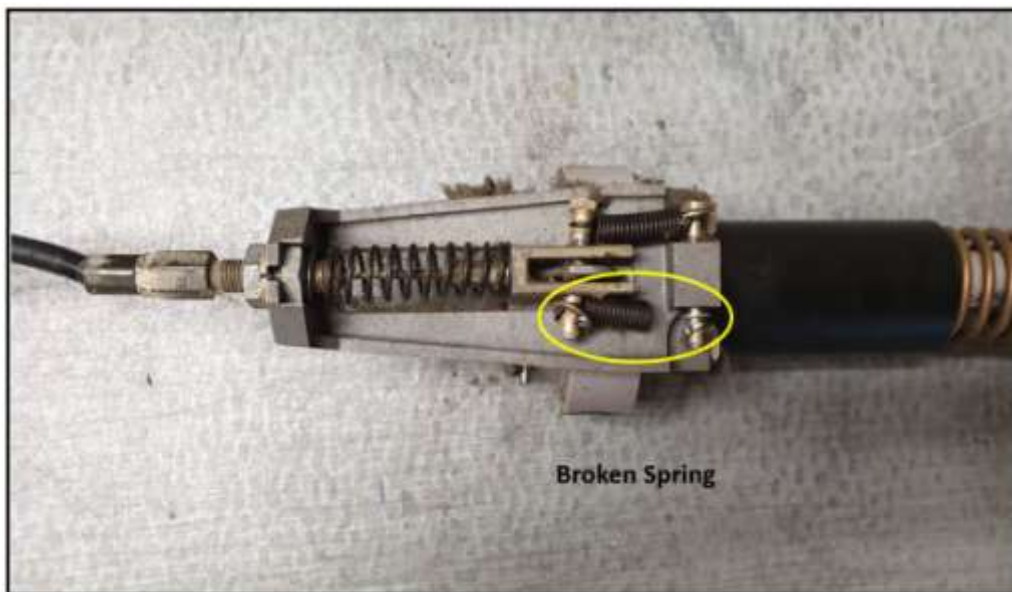
One broken spring

During inspection, it was found that recline unit assembly has one broken spring extension, however, this did not restrict the return of the locking element.

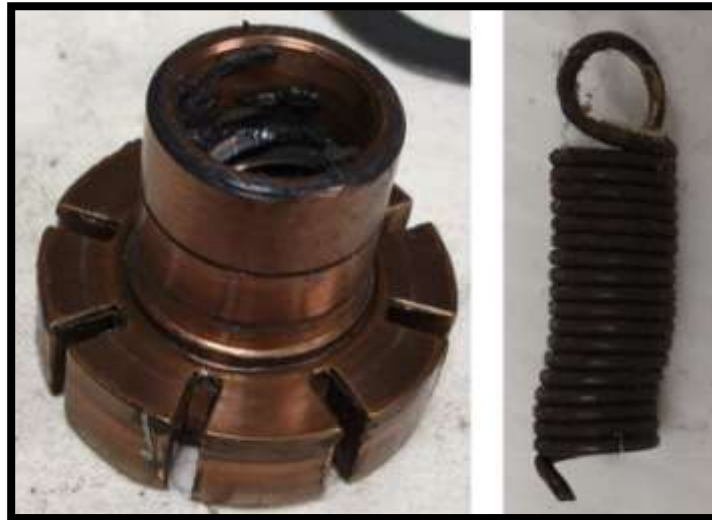
Seat Locking Nut & Spring

While carrying out disassembly on Seat locking Mechanism, OEM observed the nut - recline unit displayed minor burrs on one of the slots. The burr was positioned on the same side of the slot in all positions indicating that it had been caused by movement in one direction only.

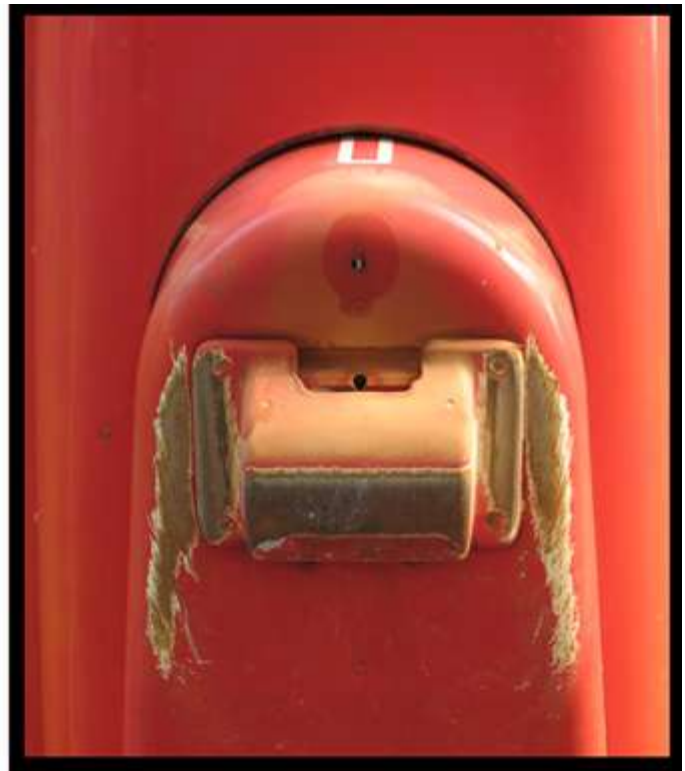
Damaged Tail Skid of the aircraft
