**FINAL INVESTIGATION REPORT
ON ACCIDENT TO BELL 206 L4
HELICOPTER VT-PHD
AT KURGIAKH ON 03 OCTOBER 2018.**

**GOVERNMENT OF INDIA
MINISTRY OF CIVIL AVIATION
AIRCRAFT ACCIDENT INVESTIGATION BUREAU**

**FINAL INVESTIGATION REPORT ON ACCIDENT TO
Pawan Hans Limited BELL 206 L4 HELICOPTER VT-PHD
AT KURGIAKH ON 03 OCTOBER 2018**

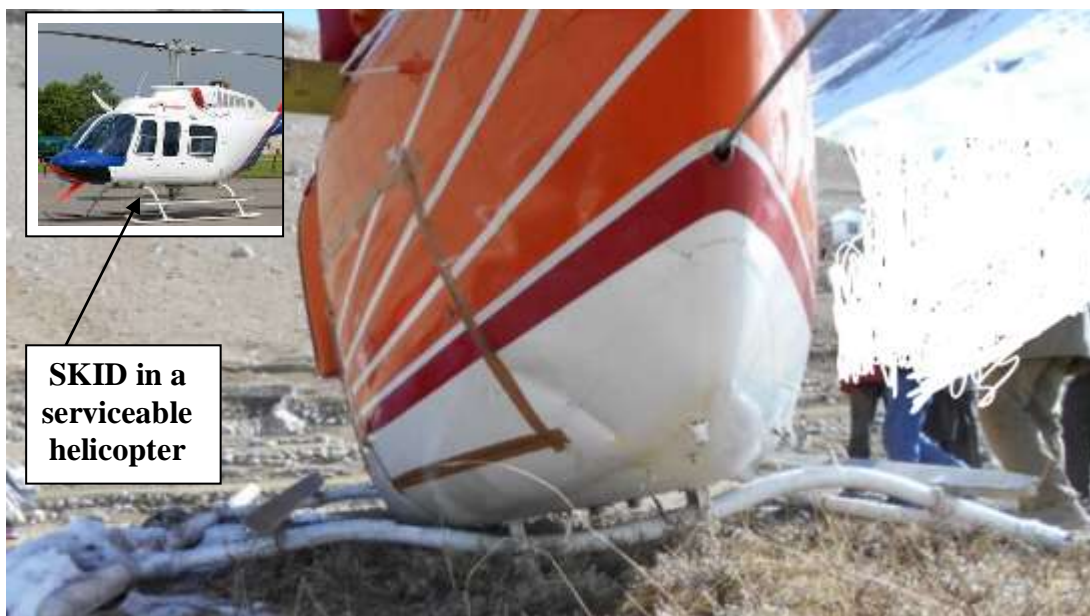
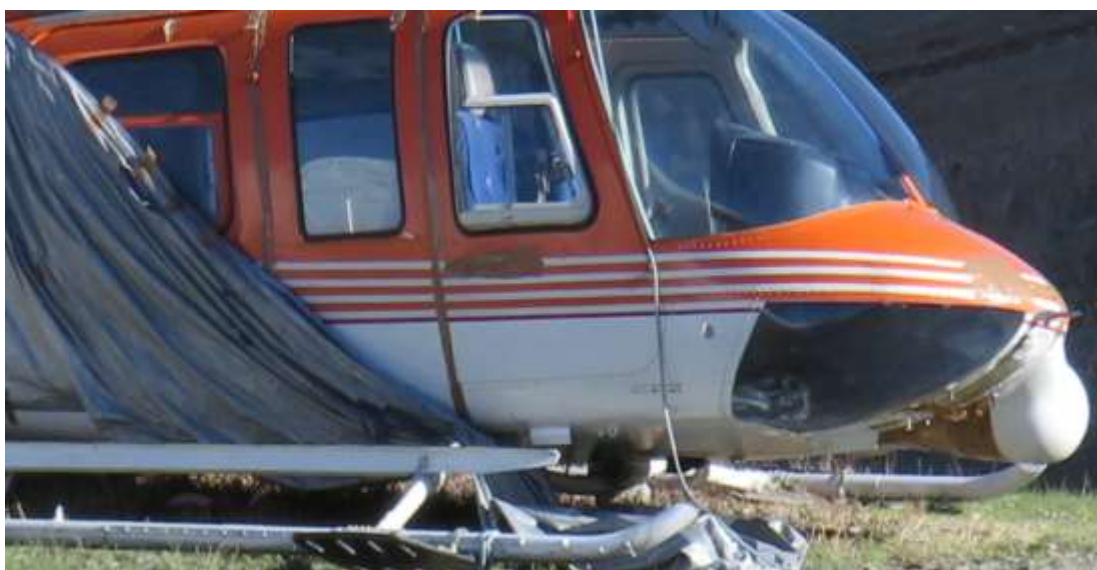
Both skids buckled sideways. Both cross tubes bowed down resulting in huge reduction of ground clearance of the cabin floor

- The helicopter tail skid (longitudinal view) had buckled more on the left hand side than on the right hand side. The flattening of cross tube is more on the left side.
- The tail boom had got damages due impact with hard surface. The irregular puncture type of damage on the bottom portion is due to some protruding (not sharp) hard surface.
- The sheared off tip pieces of the tail rotor blades were found near the helicopter.
- There was no indication of any rubbing of soft material on the tail boom, tail rotor or tail fin.
- The tail drive shaft had given way and failed under excessive contra rotational loads.

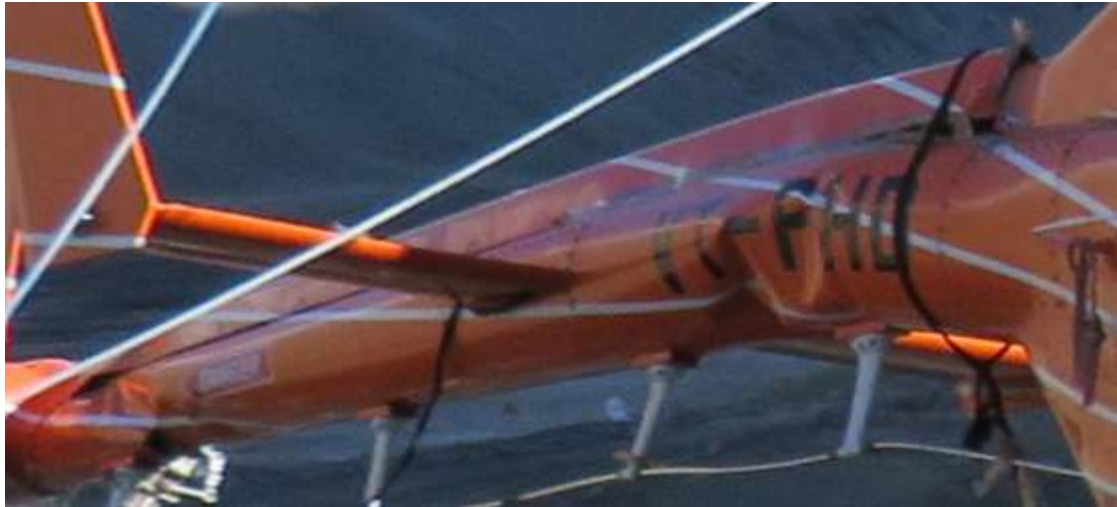
Tail boom dented and cracked at two places. Tail boom buckled downwards from the tail boom joint.

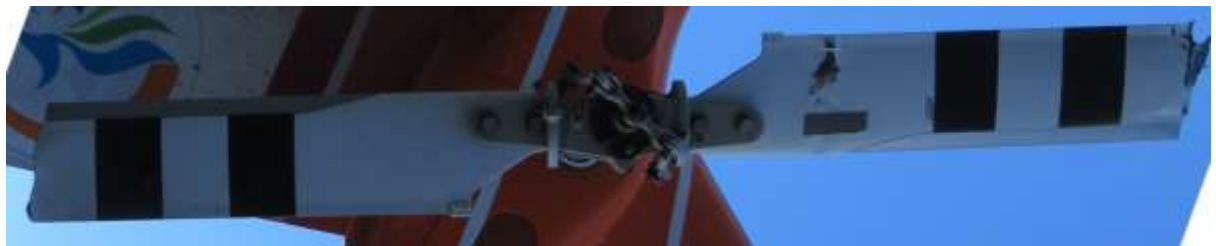
Both tail rotor blades sheared off identically at about 150 mm from tip of the blade.

Laboratory studies (carried out by NAL Bangalore) confirmed that the tail rotor blades fractured as a result of impact with a solid object. The impact occurred on the outboard surface close to the leading edge and the tip in both blades. The impact resulted in localized deformation and flow of material on the

erosion strip. The bending force generated on the blade during impact resulted in fracture in the airfoil of both blades at about 150 mm from the blade tip. Also, there was buckling in the blades close to the root.

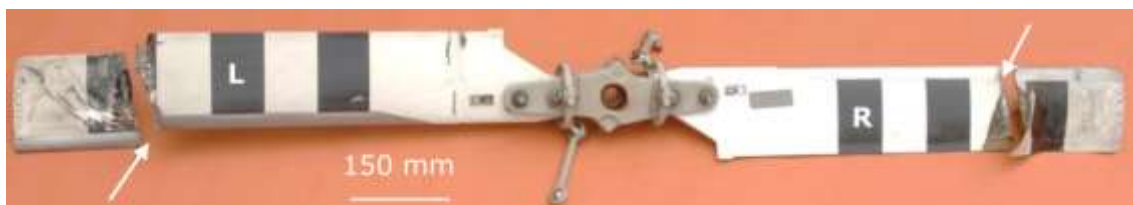
Both the TR blades were found damaged in a similar manner.

Examination revealed that in both blades, the fracture occurred at a similar location which was about 150 mm from the tip. For ease of identification, the blades are designated as 'L' and 'R'.

At the fracture location, the honeycomb structure of the airfoil was found collapsed. In the vicinity of the fracture, there was cracking of the blade on the outboard surface and collapse at corresponding location on the inboard surface. Damage in the form of dent /impact was also observed on the leading edge at the tip. At the impact region, grazing

marks were observed on the airfoil surface as well as the leading edge. The impact resulted in bending and deformation at the tip leading to cracking of the erosion protection strip. The nature of impact and the bending direction suggest that the outboard surface of the blade hit a solid object close to the tip.

The airfoil towards the tip of blade-L had similar damages as those seen on blade-R. In this blade, the leading edge had relatively minor damages compared to blade-R. Graze marks were observed on the outboard surface of this blade as well close to the leading edge. In addition to damages close to the tip, the blade had collapsed in the honeycomb structure in the vicinity of the attachment region with the rotor.

- 3.1.19 The fracture in the tail rotor blades occurred due to impact with a hard, solid object. The solid object was found made of oxides of Si, Al and Ca. These oxides are generally found in soil or stone.

- 3.1.20 Identical damages in both rotor blades suggested that the rotating blades had impacted on hard soil or stone rather than foreign objects hitting the blades.
