**FINAL INVESTIGATION REPORT
OF
ACCIDENT TO SUPREME AIR
CESSNA 208B AIRCRAFT VT-UDN
AT LALGARH ON 07/08/2018**

**AIRCRAFT ACCIDENT INVESTIGATION BUREAU
MINISTRY OF CIVIL AVIATION
GOVERNMENT OF INDIA**

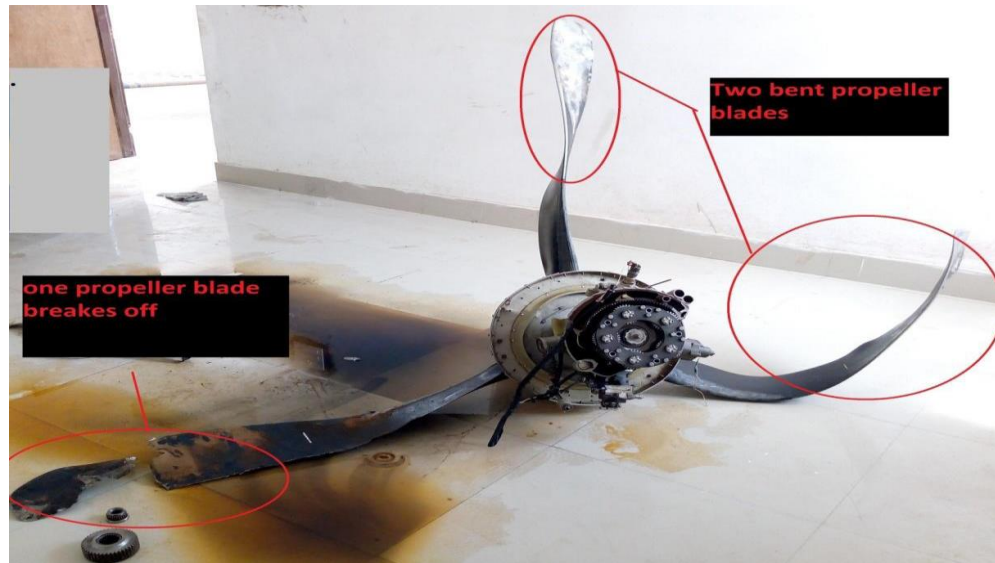
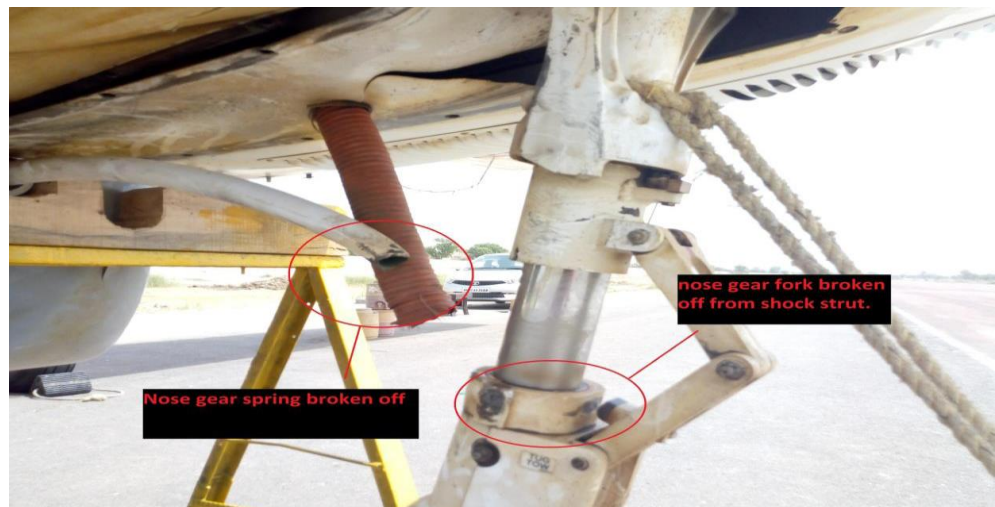
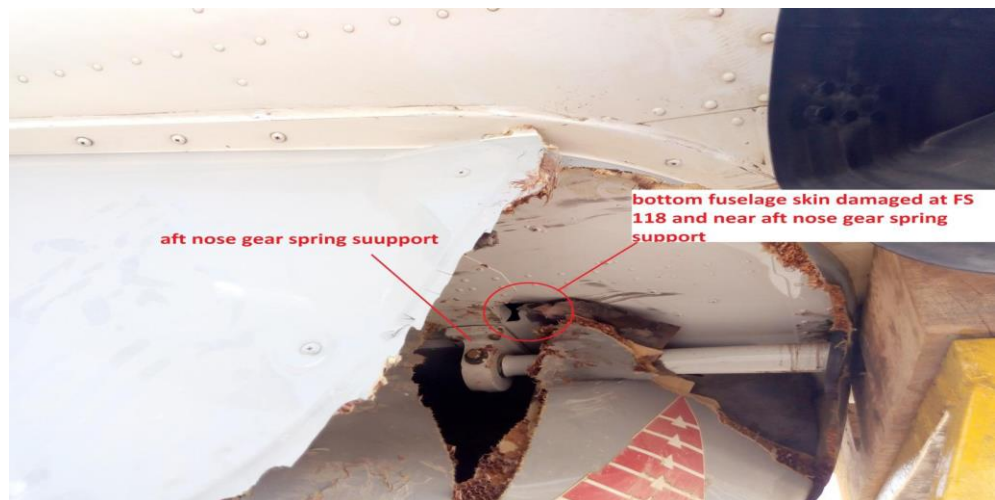
The aircraft suffered substantial damages as given below:

- ✚ Aircraft propeller and reduction gearbox section sheared off from the engine at reduction gearbox area along with all the RGB mounted accessories (propeller governor, over speed governor, torque limiter, RGB chip detector etc...).
- ✚ Secondary exhaust duct assembly was damaged due to collision with tree stem.
- ✚ All engine drains at bottom lower cowls were damaged.
- ✚ LH and RH lower cowl panels were damaged.
- ✚ Two Propeller blades got bent and one had broken due impact with the wall structure.
- ✚ RH nose cap assembly was damaged.
- ✚ Nose gear spring broke off from the middle. Nose gear fork broke off from the shock strut.

- ✚ Front cargo pod area was damaged due to collision with tree stem.
- ✚ Bottom fuselage skin was damaged at FS118 near aft nose gear support.

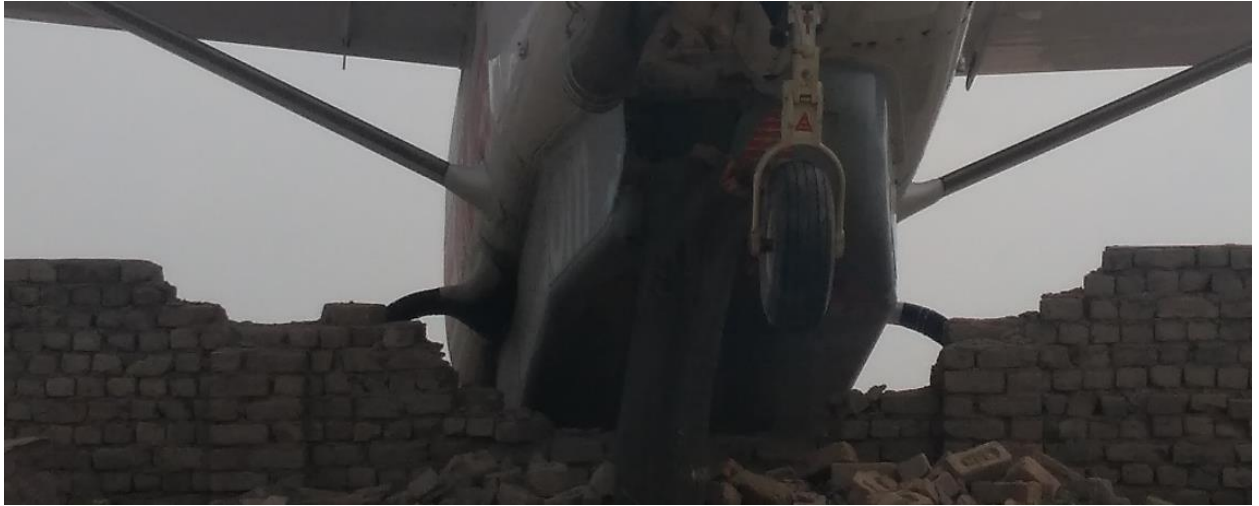
Boundary wall of the airport was broken.

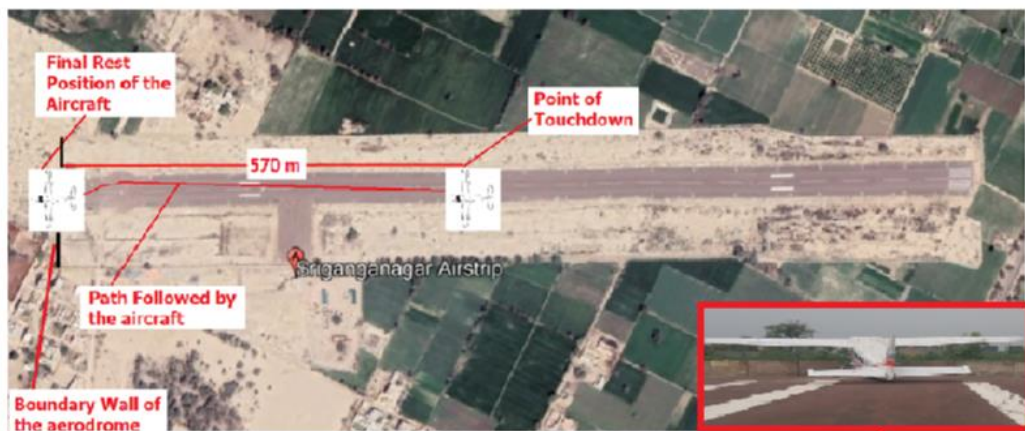
*Tyres marks were not continuous throughout the path followed by the aircraft.

Insert
 Actual rest position of the aircraft

The aircraft during landing overshot the runway. As there is no RESA available, the nose portion of the aircraft hit the boundary wall of the aerodrome. The ground marks indicate that flight crew at the very last moment had tried to turn the aircraft.

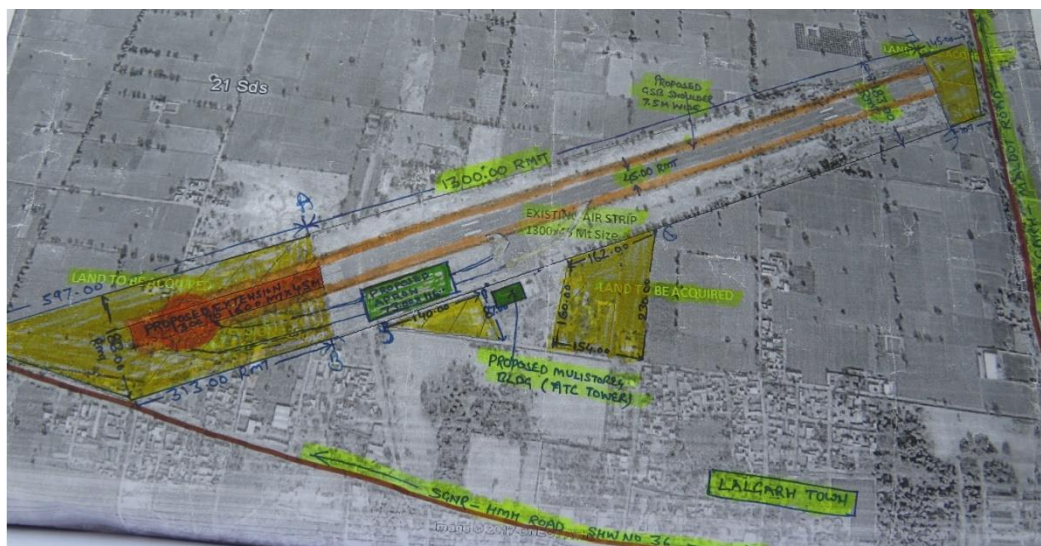
Discussion with the State authorities who were maintaining the airport including airstrip/ runway revealed that there was no expertise available with them as far as runway requirements are concerned. However, it was informed that runway extension work was planned by the State as shown below:

The authorities (PWD) supposed to be carrying out the above extension work were not aware of any safety requirements to be made available at the airport or around the airstrips. There was a water body on one side of the airstrip attracting bird activity.

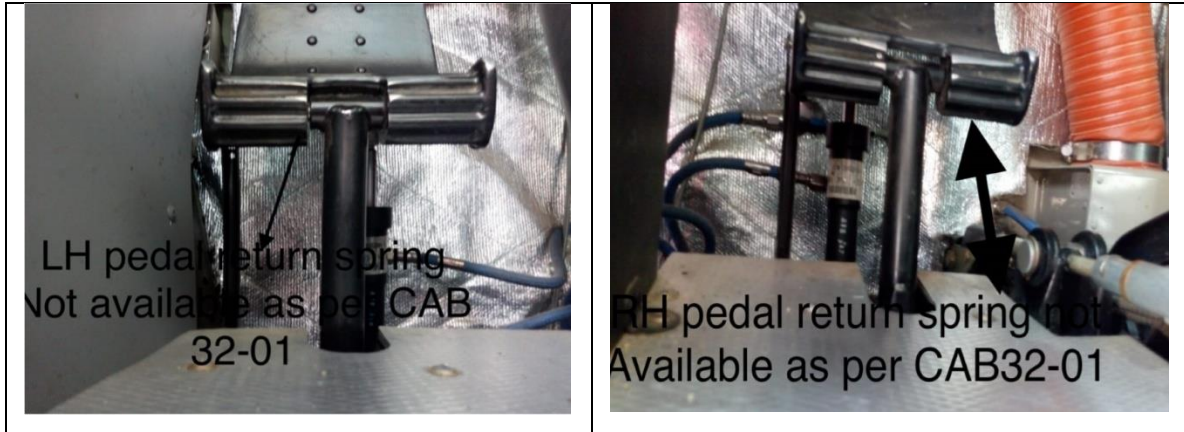
Cessna has issued Service Bulletin CAB-32-01 Revision 1 dated 14.03.2014 for the aircraft which was applicable for the accidented aircraft also. As per this SB, a brake return spring was to be installed to give additional brake return force.

The above SB was to be accomplished within 18 months of issue and as such by the above statement in maintenance transaction record it is indicated that the modification was complied with. During investigation, it was found that the spring was not available on the aircraft, as shown in the photographs below:

SB CAB-32-01 was issued by manufacturer to improve upon the operation of brake system by installing a brake return spring which gave primarily additional return force to pedals. The modification was not for improving the braking, but to assist in operation.
