**FINAL INVESTIGATION REPORT ON
SERIOUS INCIDENT TO M/S JET AIRWAYS
BOEING 737-800 AIRCRAFT VT-JGS
AT MUMBAI ON 20th SEPTEMBER 2018**

**AIRCRAFT ACCIDENT INVESTIGATION BUREAU
MINISTRY OF CIVIL AVIATION
GOVERNMENT OF INDIA**

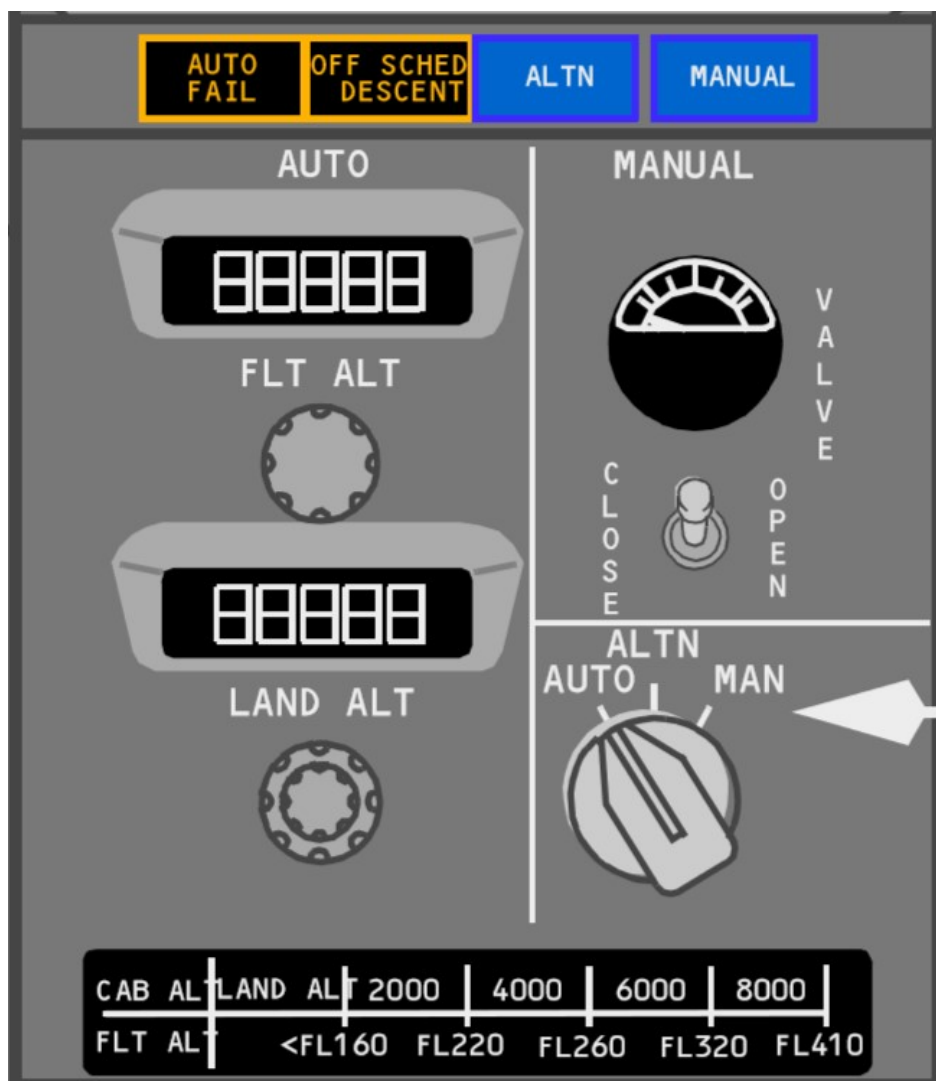
CABIN ALTITUDE PANEL

The pressurization system (mechanical) of B-737 aircraft consists of Air-Conditioning packs, an outflow valve, overpressure relief valve and a negative pressure relief valve. Cabin pressurization is controlled during all phases of airplane operation by the cabin pressure control system. The cabin pressure control system includes two identical automatic controllers which are available by selecting AUTO or ALTN and a manual (MAN) pilot-controlled mode. The system uses bleed air supplied to and distributed by the air conditioning system. Pressurization and ventilation are controlled by modulating the outflow valve and the overboard exhaust valve. The overboard exhaust valve is open on the ground and closes when cabin differential pressure reaches a certain value except during smoke over ride mode.

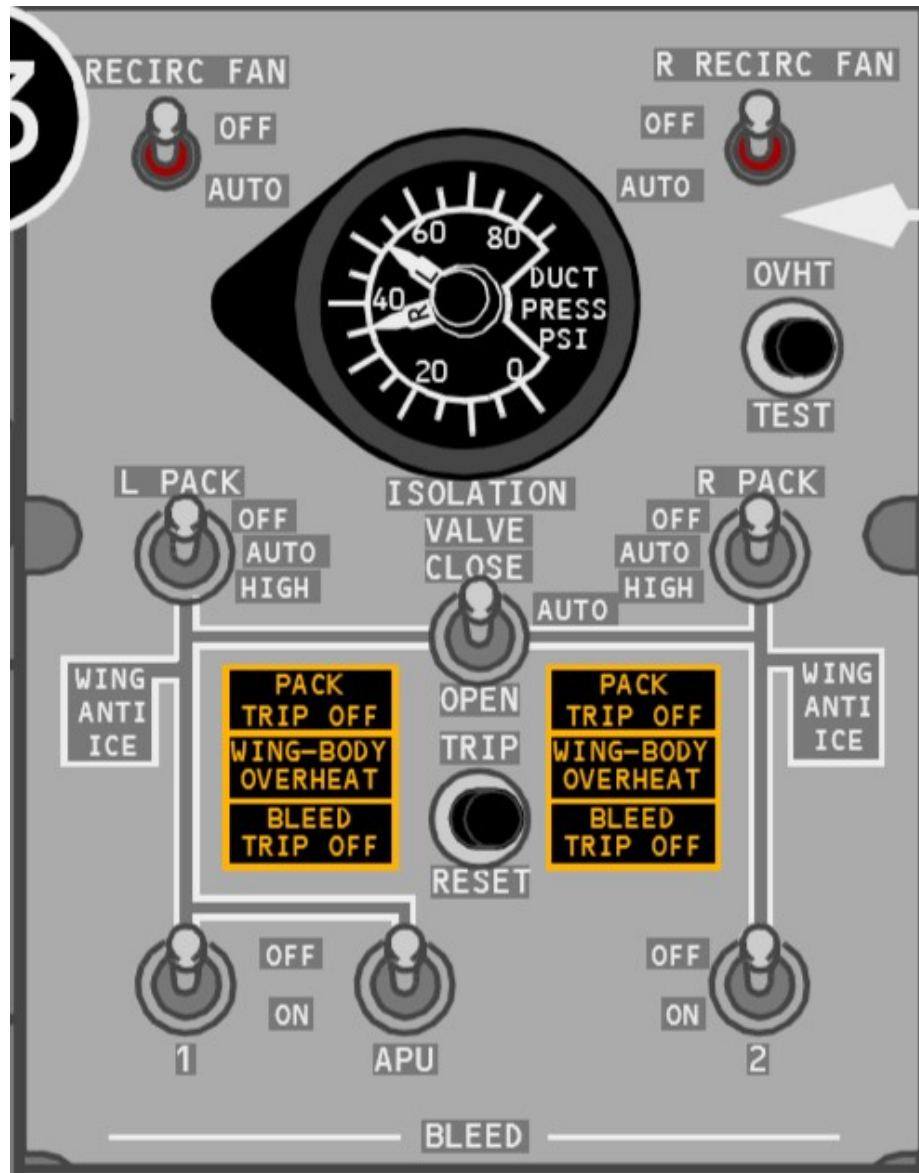
As per the schedule, the AME on duty (night shift) was required to put the bleed switches to the OFF position prior to carrying out the task. After completion of the schedule, he was required to normalise the aircraft switches which required that the bleeds be put to ON position. The AME forgot to put back the bleed switch to ON position. After recording the parameters of pack temperature, the aircraft was released by him for departure.

- Prior to departure of the aircraft, pack temperature monitoring task was carried out by AME on duty as per the work order issued for the aircraft. The task required that the bleed switches be put to OFF position which the AME did prior to performing the pack temperature monitoring. The task card in the end requires that the aircraft be restored back to its normal configuration though no specific steps have been mentioned to bring the system to its original configuration, as were given to be undertaken in the beginning of temperature monitoring task. The AME forgot to put back bleed switches to ON though he normalized other switches.

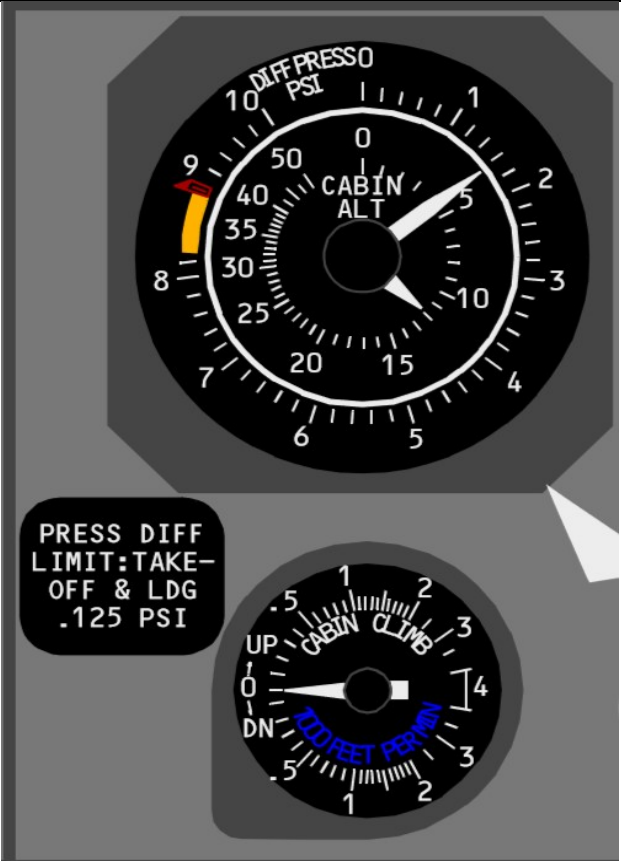
<p>CABIN Altimeter (ALT) Differential Pressure (DIFF PRESS) Indicator</p> <p>Inner Scale – indicates cabin altitude in feet.</p> <p>Outer Scale – indicates differential pressure between cabin and ambient in psi.</p> <p>CABIN Rate of CLIMB Indicator</p> <p>Indicates cabin rate of climb or descent in feet per minute.</p>

The operating and indication panel system of the digital cabin pressure control system is a part of overhead panel in the cockpit. There are indications for the cabin altitude and differential pressure, the cabin rate of climb indicator (Maximum 4000 ft. /min) and the outflow valve position indicator.
