**FINAL INVESTIGATION REPORT
OF
SERIOUS INCIDENT TO GO AIR
AIRBUS A320 AIRCRAFT VT-WGJ
AT BANGALORE ON 01/09/2018**

**AIRCRAFT ACCIDENT INVESTIGATION BUREAU
MINISTRY OF CIVIL AVIATION
GOVERNMENT OF INDIA**

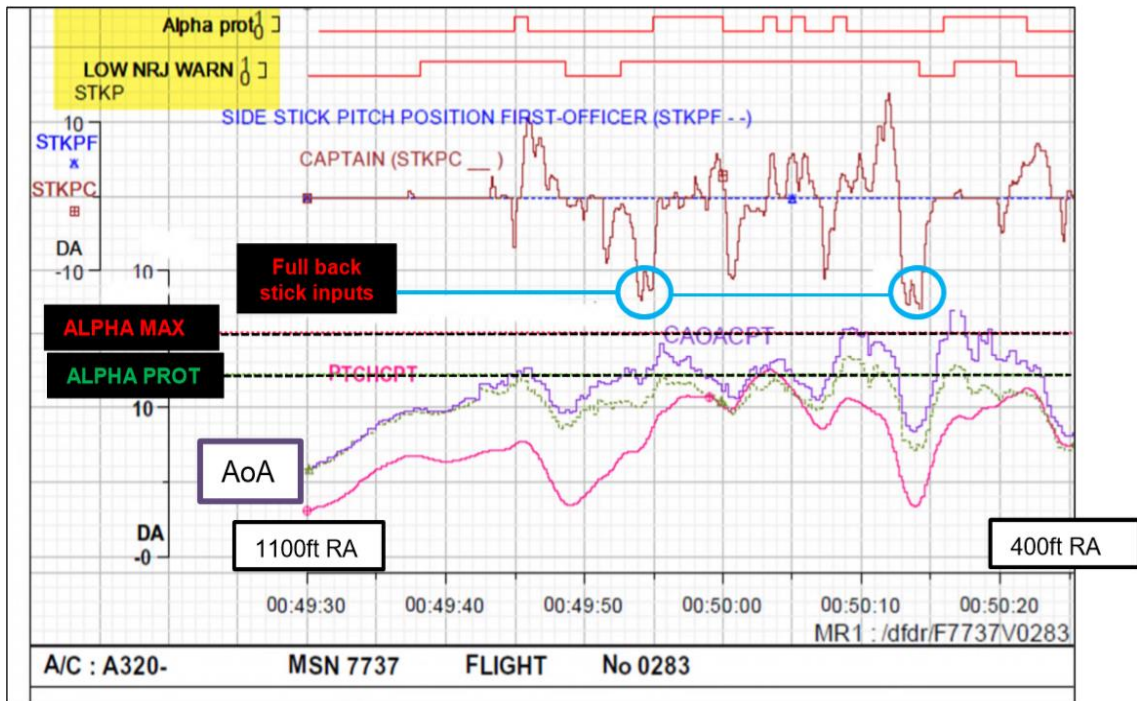
At 00:49:37, when the aircraft was at 1000 ft RA (decreasing), AP 1 & 2 was disconnected by the flight crew. CAS was 125 kts. Both FDs were engaged in GS/ LOC modes and the aircraft was aligned to the glide slope and localiser.

PF carried out manual approach. Between 1000 ft to 400 ft RA, high activity was recorded on Pilot Flying side stick. Pitch varied between 3° and 12° nose up and Roll varied between 0° and 10° (right wing down). Vertical descent rate varied between 0 ft/ min and 1600 ft/ min. CAS varied between 125 kts and 113 kts (VLS was 127 kts).

During this period, low energy aural warning “SPEED SPEED SPEED” triggered 4 times. Thrust was manually increased on engine #2. Aircraft started to dip under the glide slope by 1.4 dots and EGPWS aural warning “GLIDESLOPE” was triggered at 620 ft RA for 14 seconds. Glideslope deviation reached 2.7 dots below glide slope at 400 ft RA. Alpha protection was activated 6 times. AoA reached 12° (Alpha Prot) and 15° (Alpha Max).

The approach was continued despite the aircraft being unstable in attitude, below the glideslope by 2.7 dots and its speed below VLS. In accordance with the FCOM stabilisation criteria a go-around should have been performed.

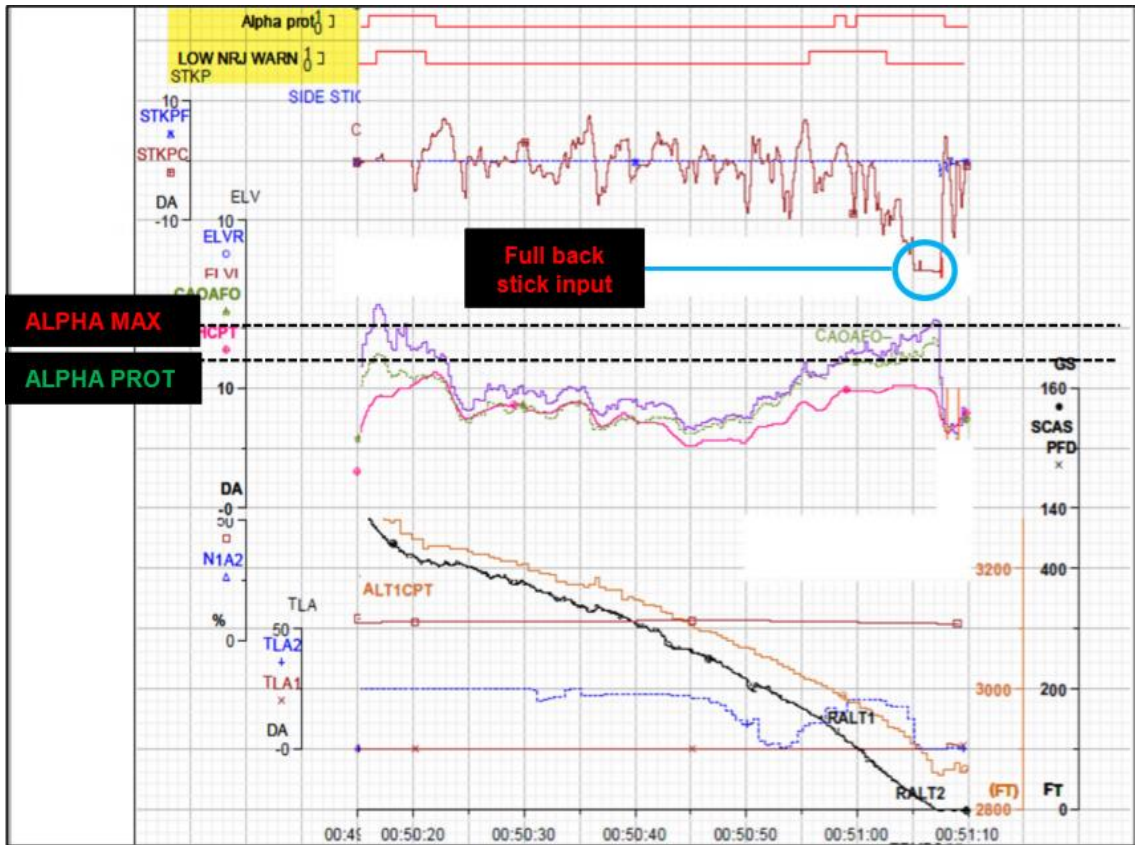
When the aircraft was at 400 ft RA, engine # 2 thrust was controlled manually between idle and CL detents. At 250 ft RA, engine # 2 TL was progressively reduced (reached to IDLE detent at 200 ft RA) then moved to the CL detent before being set at IDLE detent again at 40 ft RA. Pitch increased from 5° to 10° nose up. CAS reduced from 130 kts to 110 kts at landing (VLS -17kts). Roll varied between 6° right wing down and 2° left wing down. Flare was performed while full back stick order was applied. Alpha Prot was active. AoA increased from +12.8° to +15.7° (= AoA max). Alpha Prot limited the AoA from increasing further

At the time of touch down, CAS was 109 kts (VLS -18kts), vertical descent rate was -752 ft/ min, recorded VRTG was 2.68 g, pitch was 10° nose up and AoA was at Alpha Max (15°)
