FINAL INVESTIGATION REPORT ON SERIOUS INCIDENT OF
AIRPROX BETWEEN M/s SAUDI ARABIAN AIRLINES ,
SVA862 (B77W AIRCRAFT HZAK14)AND M/s UNITED
PARCEL SERVICE AIRLINES, UPS15 (B744 AIRCRAFT
N578UP) AT KOLKATA FIR ON 16/10/2018

KUNJ LATA
INVESTIGATOR-IN-CHARGE

K. RAMACHANDRAN
INVESTIGATOR

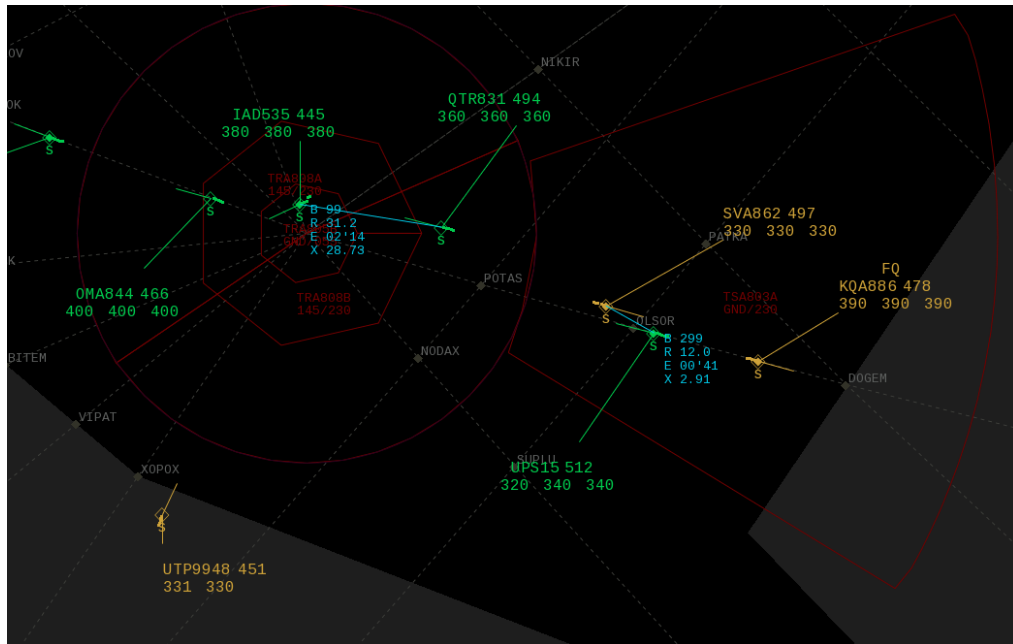
Later, when UPS15 again asked for a climb, Radar Controller forgot the immediate traffic and gave the climb. He was in the impression that the traffic is UTP9948 which was in his Radar scope which was also maintaining FL330.

Figure showing UTP9948 near XOPOX and SVA330 near OLSOR, both aircraft maintaining FL330.

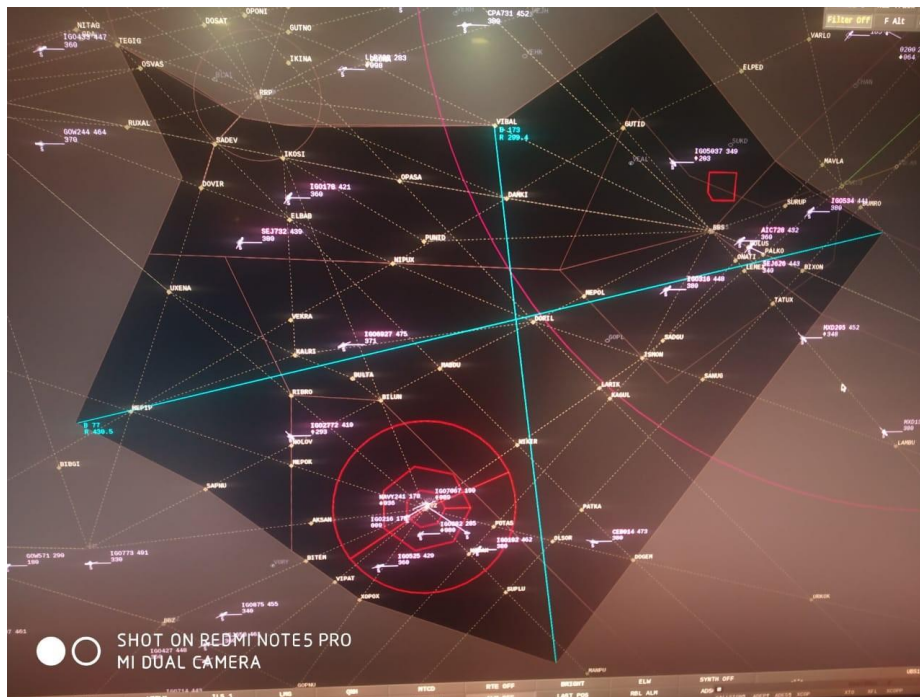
UBS showing area to be scanned

UBS Controller has to provide separation in larger area and normally traffic density is high. In this scenario, the controller has to be more vigilant as chance of committing error is more.

In this incident also, the controller misjudged the immediate traffic and gave the climb which resulted in breach of separation.

1. Suitable corrective training may be imparted to Radar controller giving emphasis on different traffic situations specially in peak hours.
2. Airports Authority of India may study the volume of traffic in all sectors during peak hours for bifurcating or merging of the airspace.

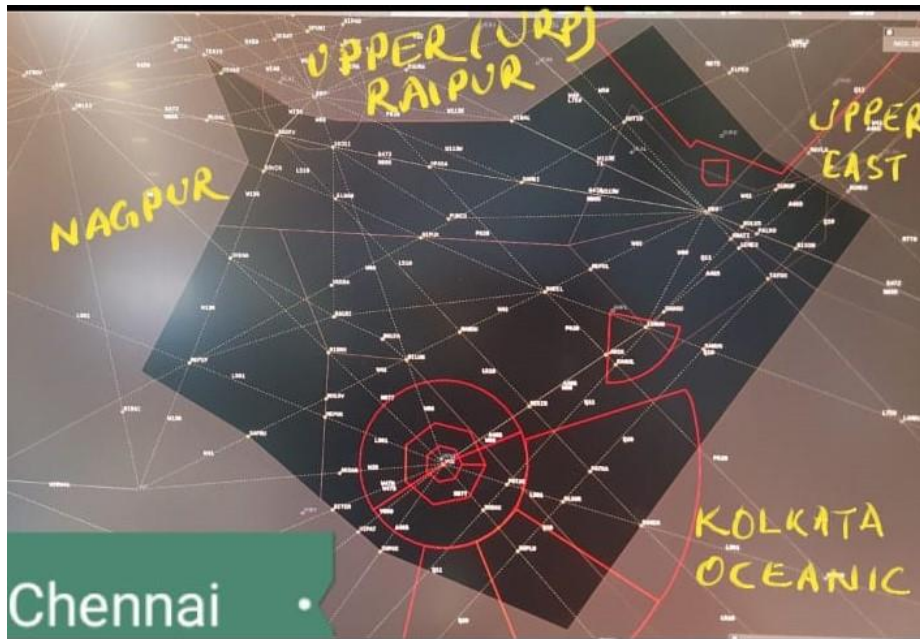
UBS is surrounded by Upper Raipur Area, Nagpur Area, Upper Eastern Region, Chennai Control and Kolkata Oceanic Region. It has a narrow channel through which aircraft are handed over and taken over to and from Guwahati Control Region. Either side of this channel is Nepal control and Bangladesh control. Due to narrow channel and International boundaries, the controller is required to be more vigilant while handling aircraft in this area.

Figure showing different sector bounded by Kolkata UBS

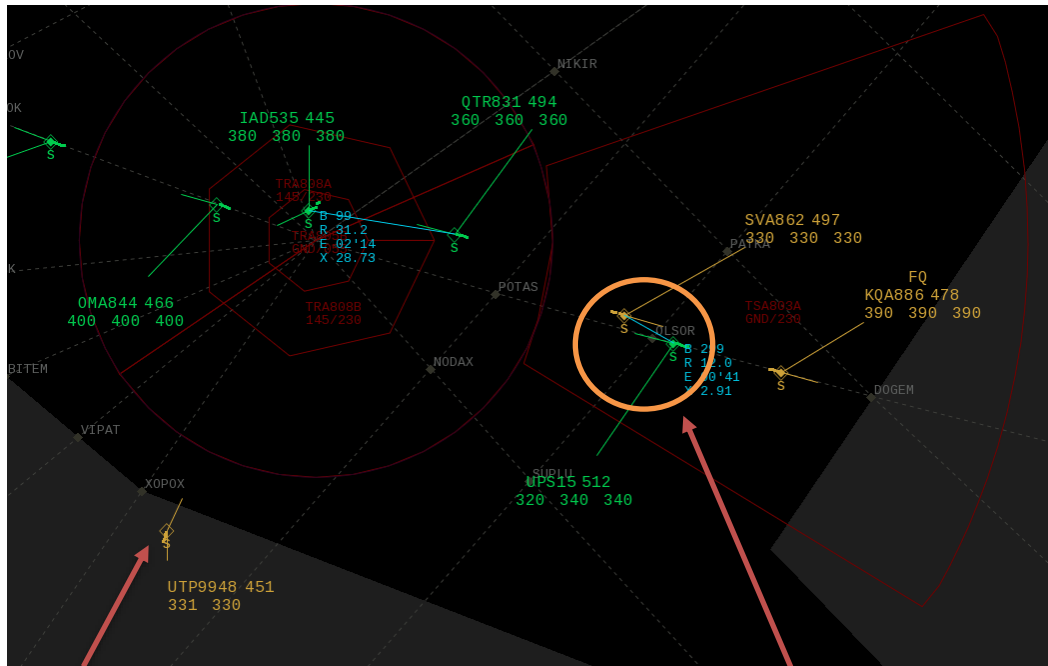
At 0428 UTC, UPS15 again asked for a climb to FL340 and Radar Controller missed the immediate traffic which was on reciprocal track and 2.9 NM apart. The separation of 2.9 NM could be established at this particular time because SVA862 was slightly offset of track. As UPS15 started its climb and reached FL322, Traffic Advisory alert got generated at 04:29:16 UTC.

UTP9948, FL330 near XOPOX

SVA862,FL330 and UPS15, FL320 near OLSAR

Figure showing positions of aircraft before Traffic Advisory came

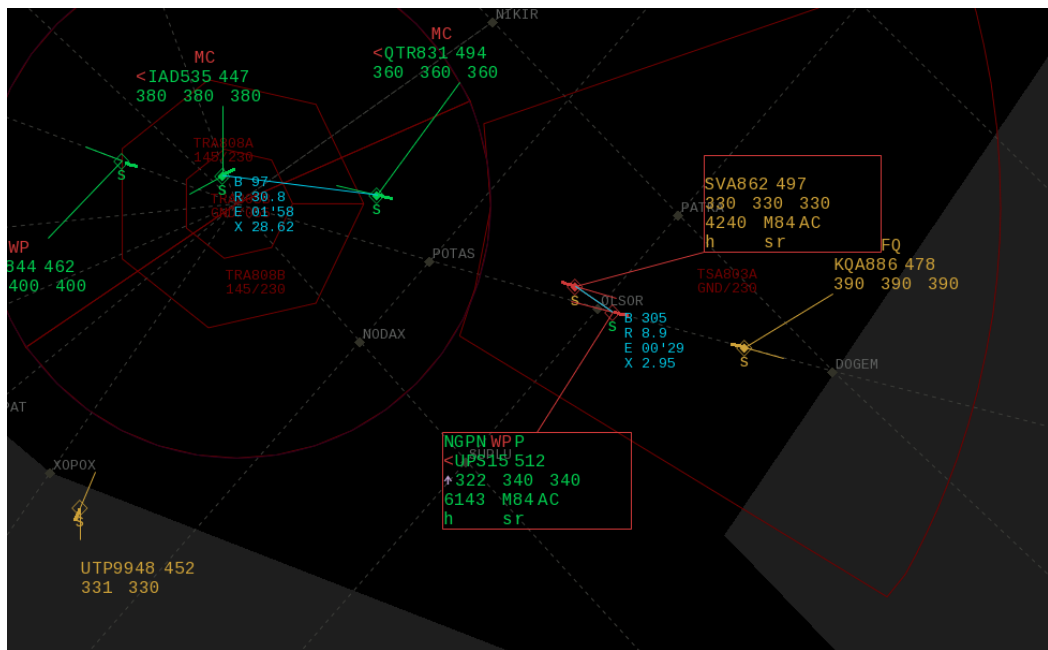
Figure showing breach of separation between SVA862 and UPS15

Minimum lateral separation between aircraft was 2.5 NM and vertically 300 feet, whereas Standard Minimum Separation between the aircraft prescribed is 1000 feet vertical and 10 NM horizontal. Neither of the aircraft reported RA. The aircraft reported “Clear of traffic ” at 04:29:58 UTC when UPS15 descended to FL320.

Incident happened due to momentarily loss of situational awareness by Radar Controller while issuing climb to UPS15. The controller got himself engaged in other traffic and forgot the immediate traffic on reciprocal track i.e. SVA862. While he was aware that it is a traffic to UPS15 and did not give a climb when UPS15 asked for a climb for the first time.
