**FINAL INVESTIGATION REPORT  
OF  
AIRPROX INCIDENT BETWEEN  
FLIGHT HK053 and IGO647 IN  
CHENNAI ACC  
ON 21/05/2018**

**AIRCRAFT ACCIDENT INVESTIGATION BUREAU  
MINISTRY OF CIVIL AVIATION  
GOVERNMENT OF INDIA**

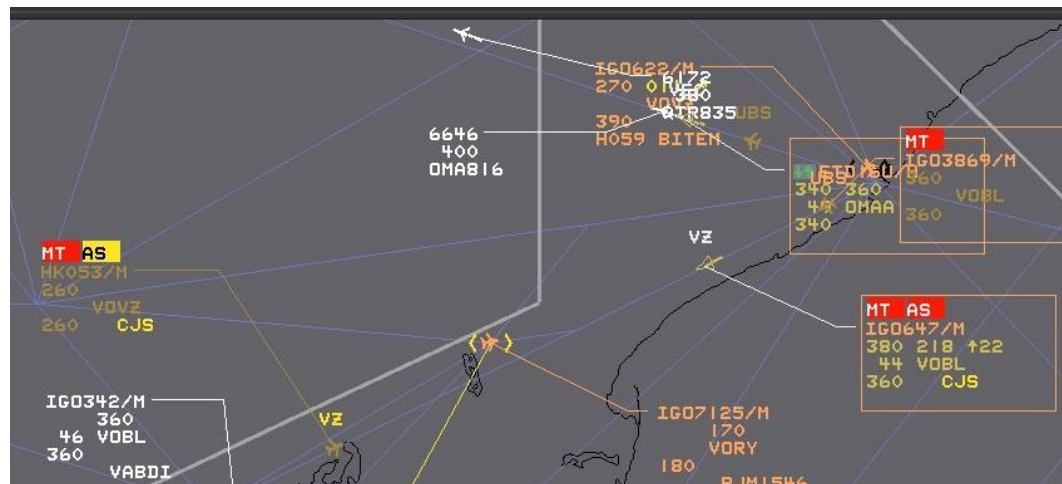
- 16:10:55 Snapshot of UMM-R shows IGO647 passing FL218 and the synthetic track of HK053 now outbound from BBZ to VOVZ with assigned level FL260.

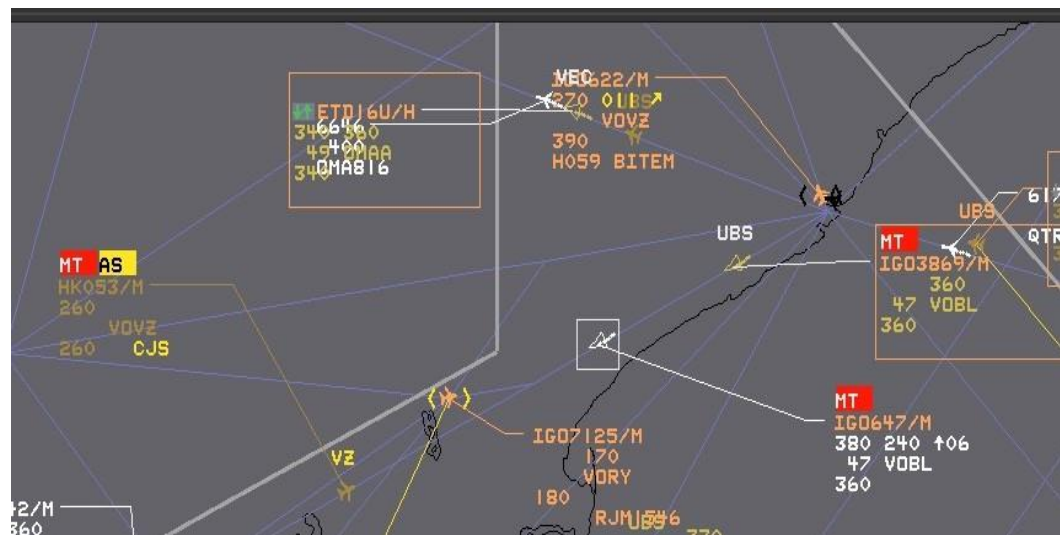
16:12:50 Snapshot of UMM-R shows IGO647 reaching FL240 and since the assigned level was still wrongly showing as FL380, the system generated MTCD warning between IGO647 and HK053 & IGO3869.

IGO647 had called UMM-R at 1608 UTC informing that they have been released by Vizag ATC and requested for FL380, to which ATC replied "Stand By". At 1611 UTC IGO647 was passing FL218 and the synthetic track of HK053, at that time was outbound from BBZ to VOVZ with assigned level FL260. At 161250 UTC, IGO647 was at FL240, but the assigned level on UMM Radar for it was still showing as FL380, so the system generated Mild Term Conflict Detection (MTCD) warning between IGO647, HK053 & IGO3869.

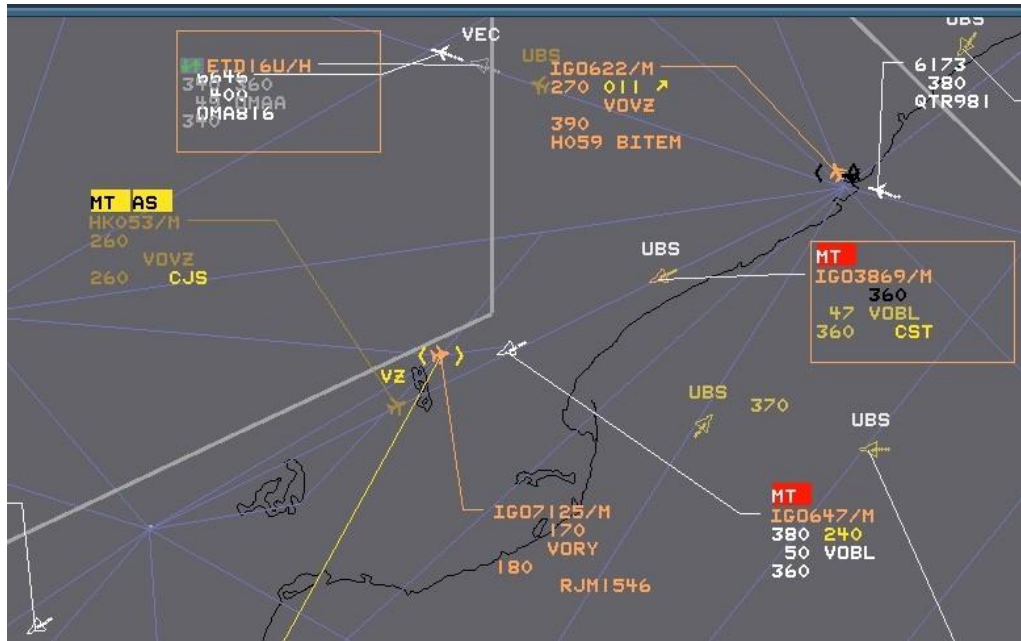
16:15:21 Snapshot of UMM-R shows IGO647 maintaining FL240

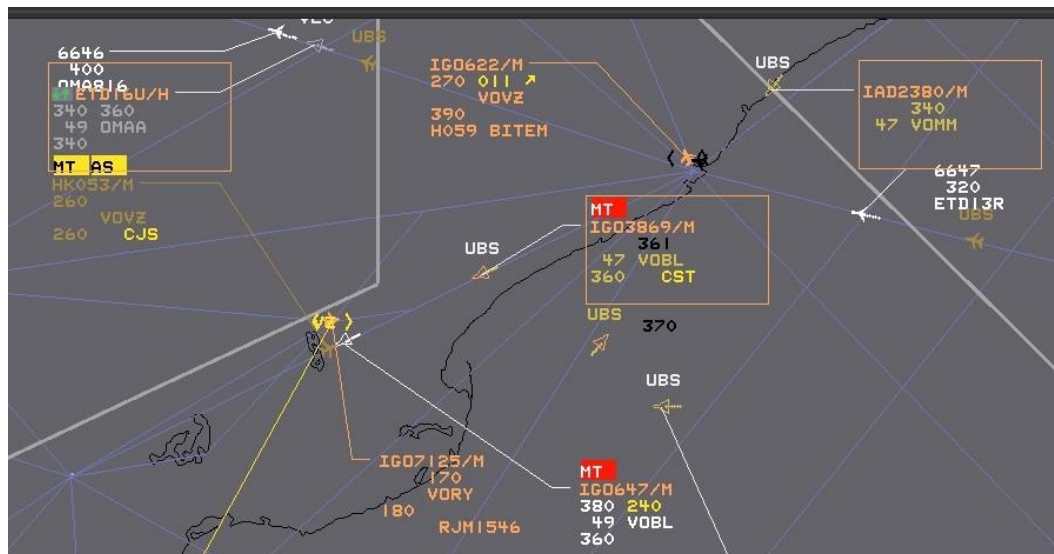
- 16:15:39 UMM-P calls Vijaywada ATC and wants to know radial & distance of HK053. Vijaywada ATC reports ETA Vizag is 1631, Radial 067 and aircraft has been changed over to Chennai and aircraft also just now reported he is in contact with Chennai.
- 16:16:29 IGO342 calls Chennai and informs that company aircraft behind is maintaining FL240, position BITEM and requesting higher level up to FL380. UMM-R replies copied and advises aircraft to stand by.
- 16:16:50 Snapshot of UMM-R shows IGO647 maintaining FL240 and system track of reciprocal HK053 right in front of him.

Snapshot of UMM-R at 161650 showed that while IGO647 was maintaining FL240, the system track of reciprocal HK053 was right in front of IGO647. After 8 seconds, IGO647 received Traffic Advisory while flying at FL240. Snapshot of

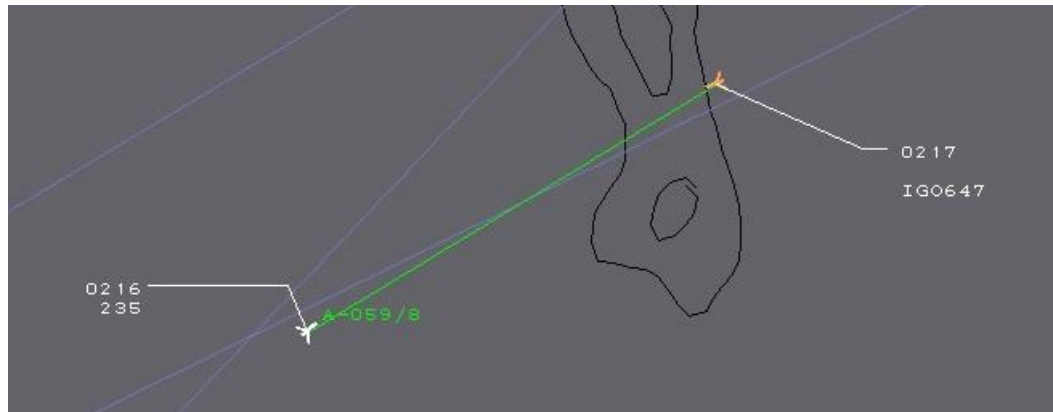
- 16:17:18 UMM controller calls Vizag ATC and passes ETA VOVZ of HK053.
- 16:17:19 IGO647 informs IGO642 about receipt of traffic advisory at FL240.
- 16:17:28 Hawk 053 calls UMM-R and reports proceeding from Vijayawada to Vizag climbing FL250. No response from UMM-R
- 16:17:30 Snapshot of active replay of UMM-R shows HK053 now picked up by Radar, passing FL235 and 8NM reciprocal to IGO647.

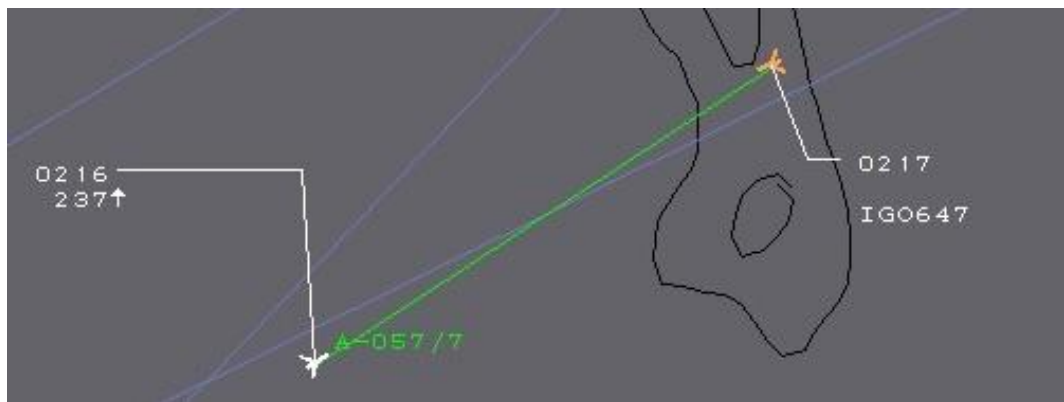
- 16:17:32 Snapshot of active replay of UMM-R shows HK053 passing FL237 and 7NM reciprocal to IGO647.

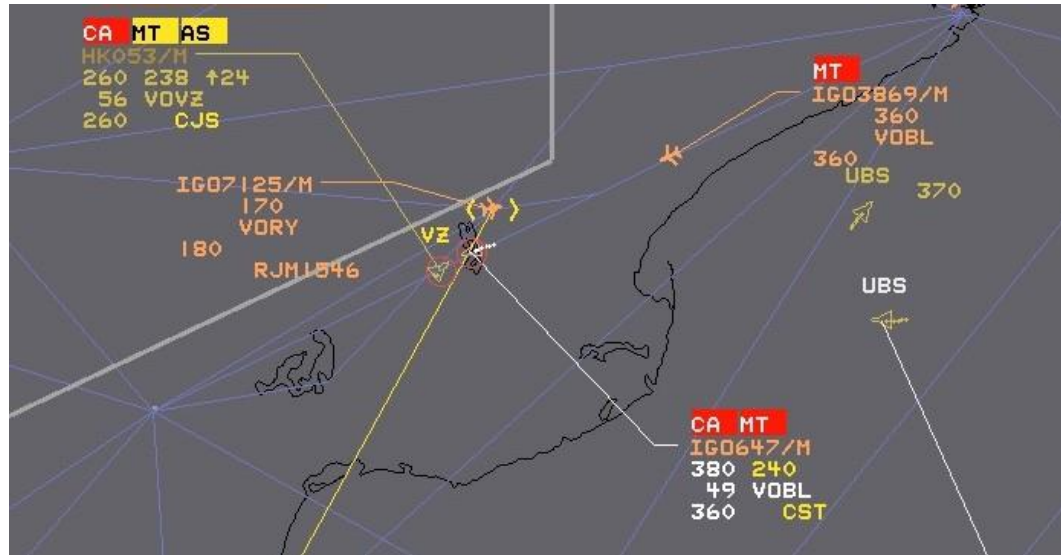
- 16:17:36 Snapshot of UMM-R shows system has started generating Conflict Alert (CA) between HK053 now passing FL238 (climbing at the rate of 2400 feet per minute) and IGO647 maintaining FL240.

UMM-R of 161736 showed that system has started generating Conflict Alert (CA) between HK053 when passing FL238 (climbing at the rate of 2400 feet per minute) and IGO647 maintaining FL240. HK053 in the meantime kept on calling UMM-R but there was no response from UMM-R.

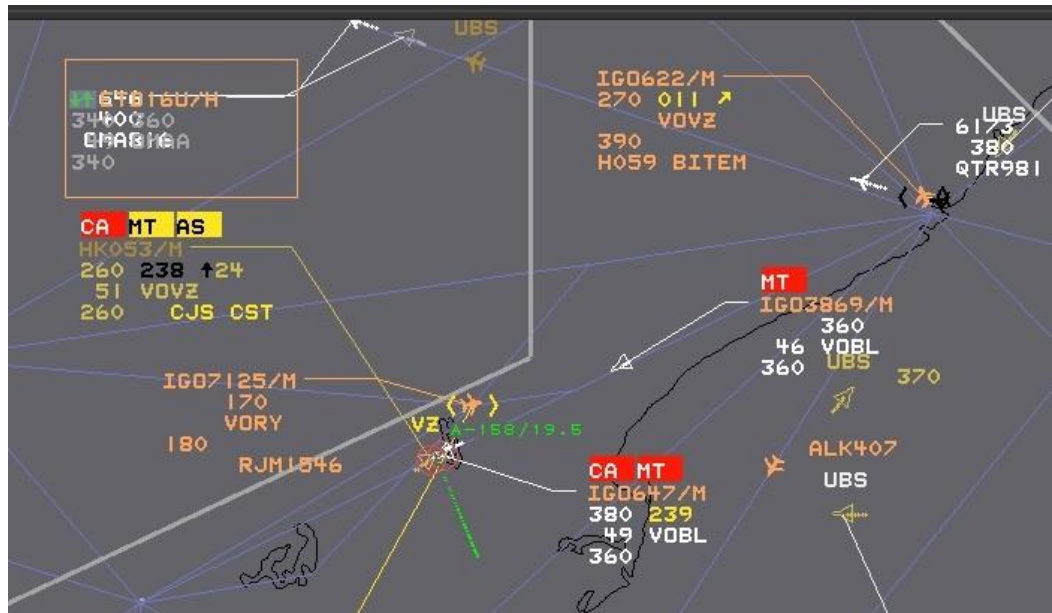
16:17:56 Snapshot of UMM-R shows tracks of HK053 & IGO647 crossing each other and Mode-C level of IGO647 is FL239. The Mode-C level of HK053 was not updated.

Snapshot of UMM-R of 161756 showed tracks of HK053 & IGO647 crossing each other with Mode-C level of IGO647 as FL239. 13 seconds later, CA stopped and tracks of HK053 & IGO647 had passed each other with IGO647 at FL239 and Mode-C level of HK053 still not updated. At 161812, IGO647 reported TCAS RA without any response from UMM-R.

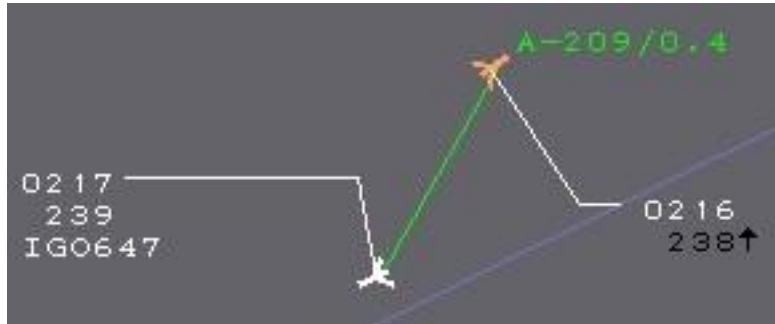
16:18:02 Snapshot of active replay of UMM-R shows HK053 had passed abeam IGO647 with both aircraft to the right of each other and IGO647 at FL239 and Mode-C level of HK053 not updated.

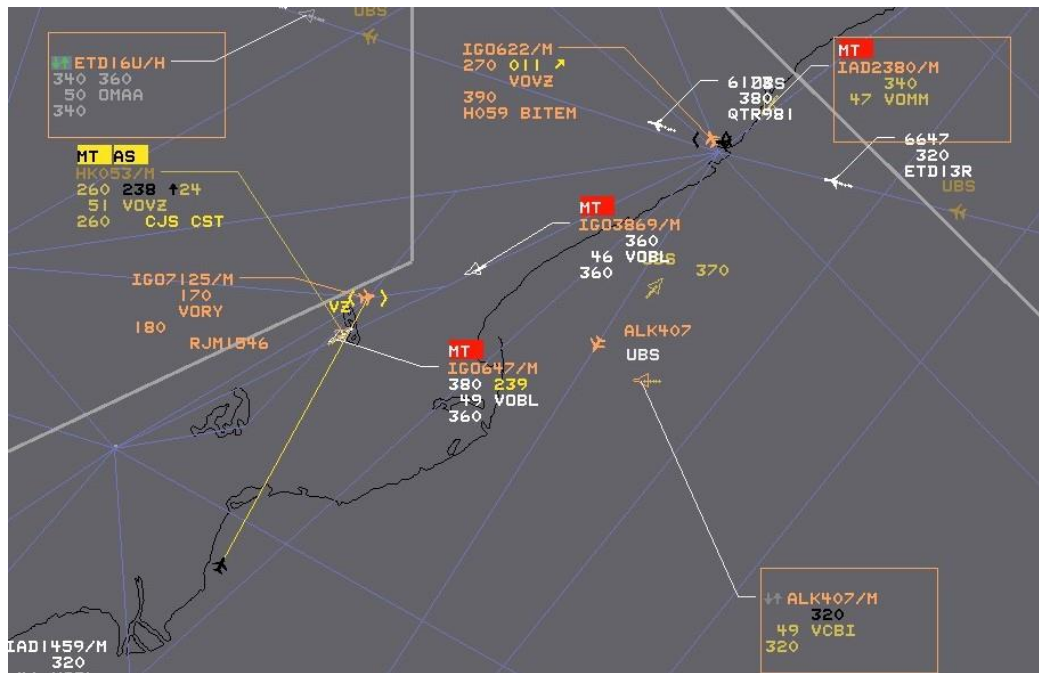
16:18:09 Snapshot of UMM-R shows CA has stopped and tracks of HK053 & IGO647 had passed each other with IGO647 at FL239 and Mode-C level of HK053 still not updated.

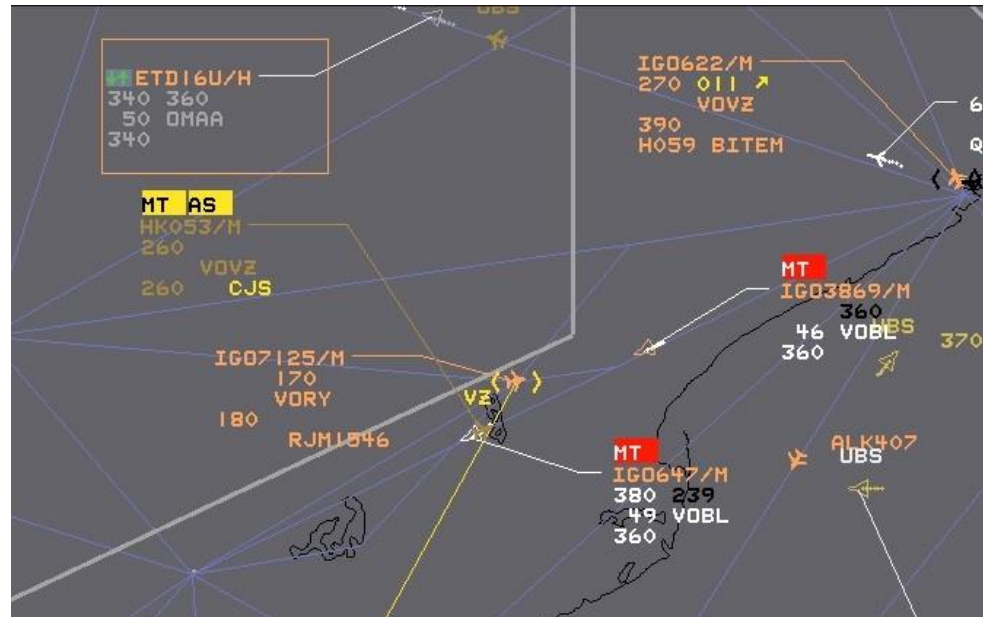
16:18:20 Snapshot of UMM-R shows that the radar track of HK053 has now dropped
