**FINAL INVESTIGATION REPORT
OF
AIRPROX INCIDENT BETWEEN
FLIGHT VT-WGE and VT-IGK IN
VARANASI ACC ON 23/04/2018**

**AIRCRAFT ACCIDENT INVESTIGATION BUREAU
MINISTRY OF CIVIL AVIATION
GOVERNMENT OF INDIA**

FINAL INVESTIGATION REPORT OF AIRPROX INCIDENT BETWEEN FLIGHT VT-WGE and VT-IG IN VARANASI ACC ON 23/04/2018

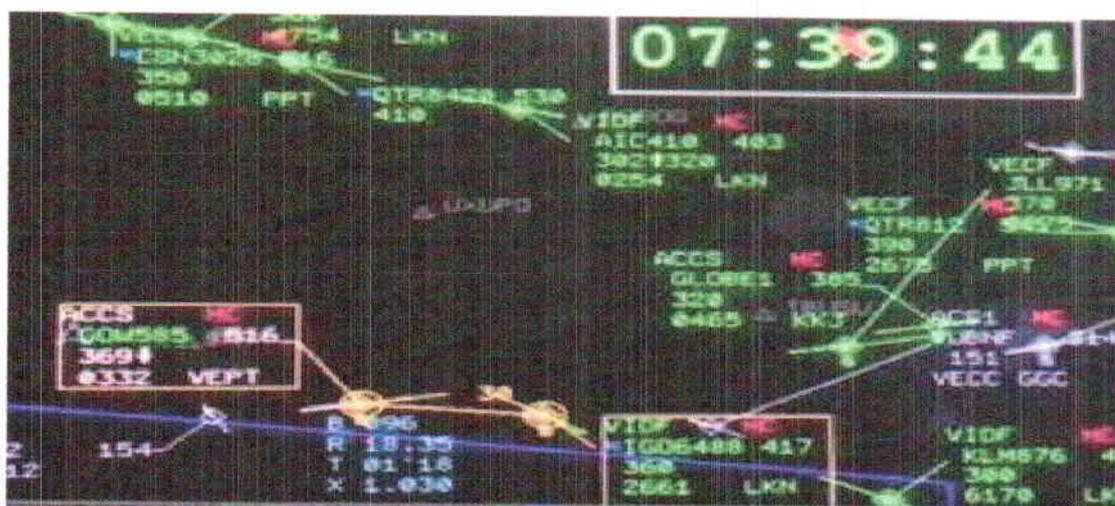
GOW585 with Jurisdiction mismatch crossing the path of IGO6488
