**FINAL INVESTIGATION REPORT  
ON  
SERIOUS INCIDENT (AIRPROX) BETWEEN AIRBUS  
A320 AIRCRAFT VT-IEH (M/S INDIGO) & BOEING  
777-300 AIRCRAFT A6EPJ (M/S EMIRATES) AT  
NAGPUR ACC ON 28.01.2018.**

**Final Investigation Report on Serious Incident (Airprox)  
Between M/s Indigo Airbus A320 flight IGO334 & M/s Emirates  
Boeing 777-300 flight UAE353 at Nagpur ACC on 28.01.2018.**

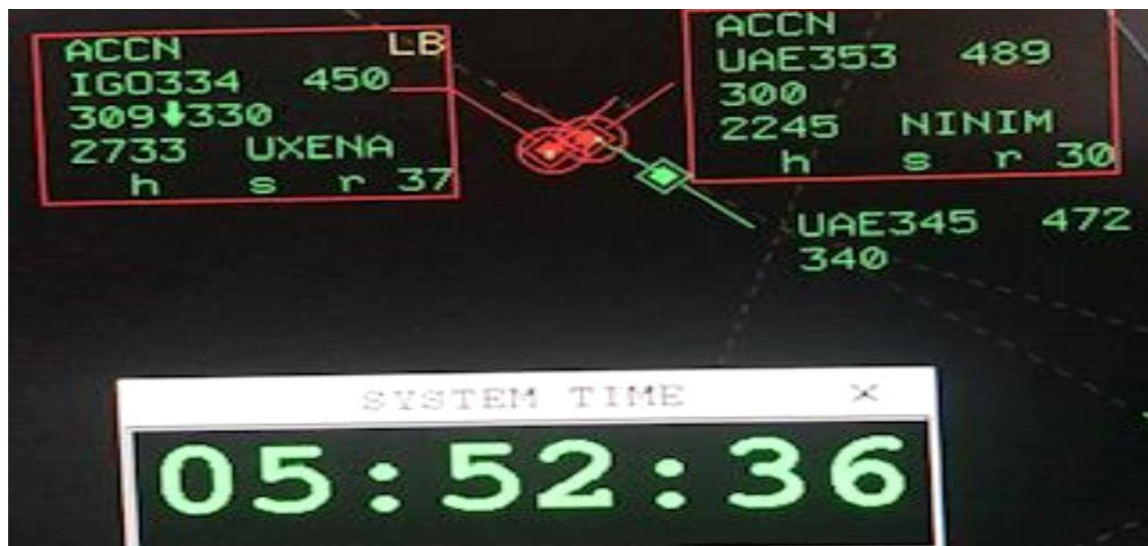
At 055228 UTC, IGO334 initiated descend from FL330 to FL250. At 055132 UTC, Level Burst (LB) appeared on Radar SDD while IGO334 was passing FL319. At 055236 UTC, STCA (red) appeared on the Radar Screen (SDD), when IGO334 was passing FL309. No predicted STCA (Yellow) warning appeared on the Radar Screen.

**Fig: At 055236 UTC, STCA (Red) appeared on Radar Screen.**

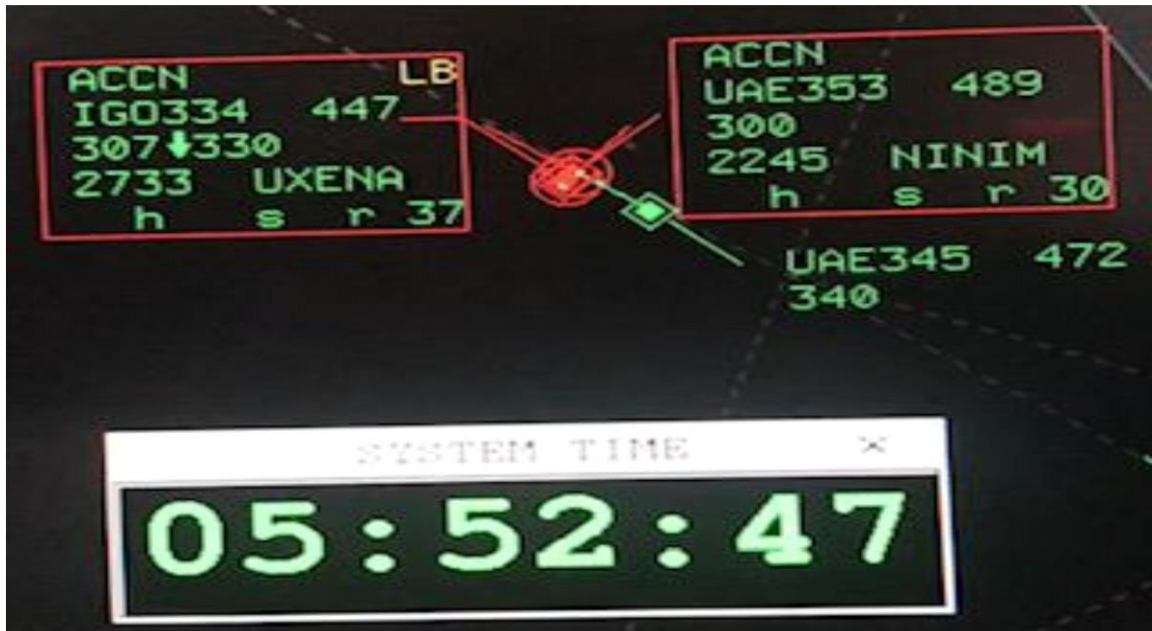
**Fig: At 055247 UTC, RPS of IGO334 & UAE353 were almost superimposed.**

Thereafter, the Radar Controller 2 had stood back (Behind Radar Controller 1 seat) and was observing the scope. At 055256 UTC, IGO334 stopped descent at FL307 and UAE353 was maintaining FL300 with both the RPS almost superimposed. UAE353, reported getting TCAS RA to ATC at 055251UTC and IGO334 reported getting TCAS TA and RA at 055305 UTC. UAE353 followed TCAS RA procedures and descended to FL296. As observed from the radar scope, IGO334 descended to FL307 and then Climbed to FL311. At 055258 UTC, the Radar Controller 1 again started transmitting on the Channel and at time 055322 UTC transmitted **“IGO334 Radar Re Cleared FL 305”** to IGO334 when both the aircraft were following TCAS RA. At time 055529 UTC, UAE353 re-affirmed getting TCAS RA **“As checked, we have TCASRA at time 055300 UTC and we descended to FL295.”**
