FINAL INVESTIGATION REPORT
ON
SERIOUS INCIDENT TO M/S INDIGO
AIRBUS A320(NEO) AIRCRAFT VT-ITR
AT KOLKATA ON 10th DECEMBER 2018

AIRCRAFT ACCIDENT INVESTIGATION BUREAU
MINISTRY OF CIVIL AVIATION
GOVERNMENT OF INDIA

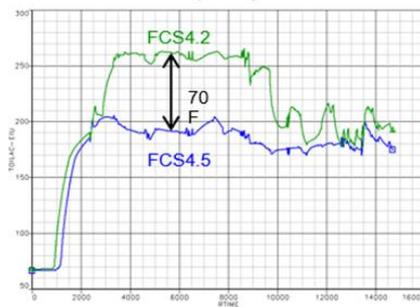
Interim measure to reduce event frequency

In the report, P&W came up with a corrective action plan to eliminate reoccurrence of such types of failure in future. The said report also mentioned that the carbon seal wear correlates with high temperature exposure Rig data and flight tests. It was also confirmed that current design operates at higher than desired temperature. As per the Corrective Action Plan, interim measure to reduce event frequency was to implement software change to increase cooling.

Implement FCS4.5 software change to increase cooling.
 SB 73-00-0032 issued Nov 1st 2018

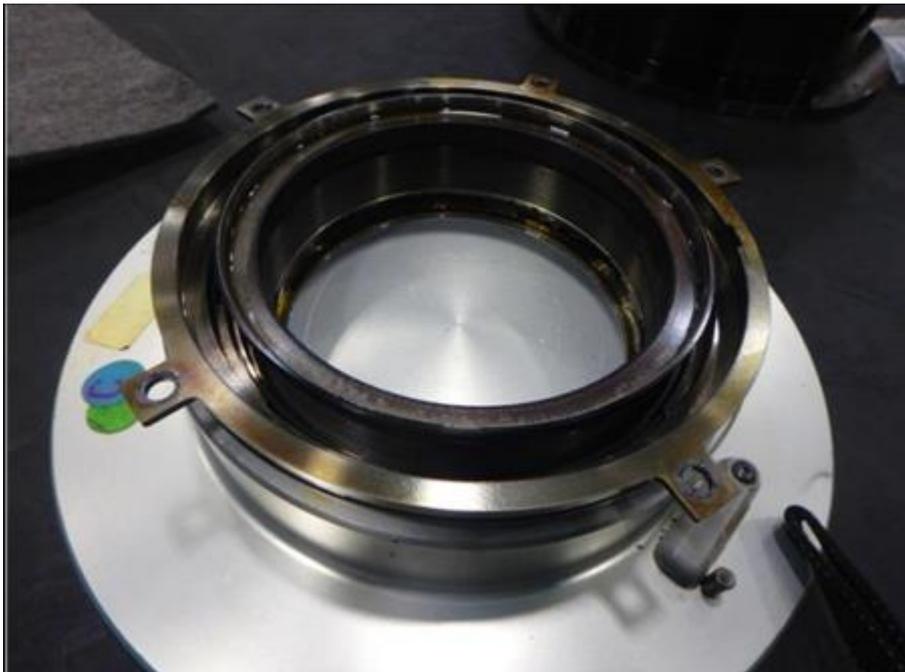
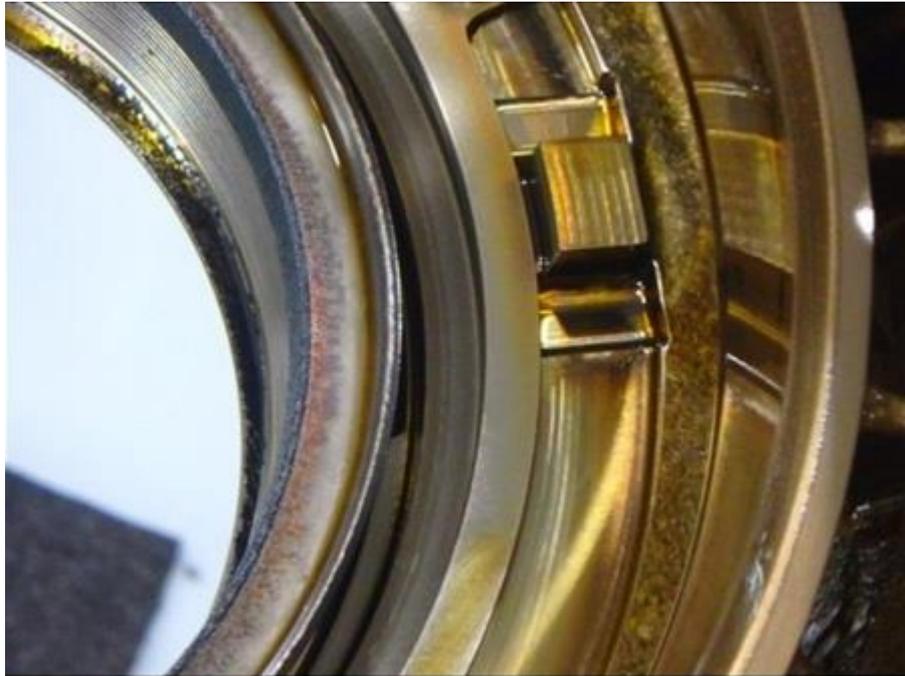
No. 3 bearing Rear Carbon Seal

The actual condition of no. 3 bearing rear carbon seal of the involved engine (BSI carried out at CEC)

“Tear Down Inspection” of the engine was carried out by OEM and it was observed that #3 bearing rear carbon seal had worn out. It was also opined by the OEM that wearing out correlates with high temperature exposure than the desired (designed), observed during flight tests.

This wear of rear carbon seal resulted into the seal seat to position itself inside ('nest') the carbon seal housing without contacting the face of the seal carrier assembly causing excessive seal clearance and a loss of air pressurized sealing. The loss of sealing subsequently resulted in internal oil leakage into the higher temperature zone i.e. compressor secondary air systems and engine bleed air system. The oil then leaked into

The incident occurred due to wearing out of No. 3 Bearing Rear Carbon Seal, causing oil leak into the gas path and release of oil fumes/ smoke into the aircraft cabin & cockpit through the Bleed Valves.

On 30th Sept 2019, in order to eliminate the re-occurrence of smoke events and early capturing of the wear, Service Bulletin (SB) on “Engine - Air Seal Assemblies, No. 3 Bearing, Front and Rear - Inspection of the Air Seal Assemblies through the Main Gearbox Housing Breather Manifold Assembly (LB30) Compressor Intermediate Case Port” was issued.

The SB required that for engines with less than 3000 hours of operation on the No. 3 bearing front and rear seals, BSI of the no. 3 bearing front and rear carbon seals be carried out at every oil filter change.

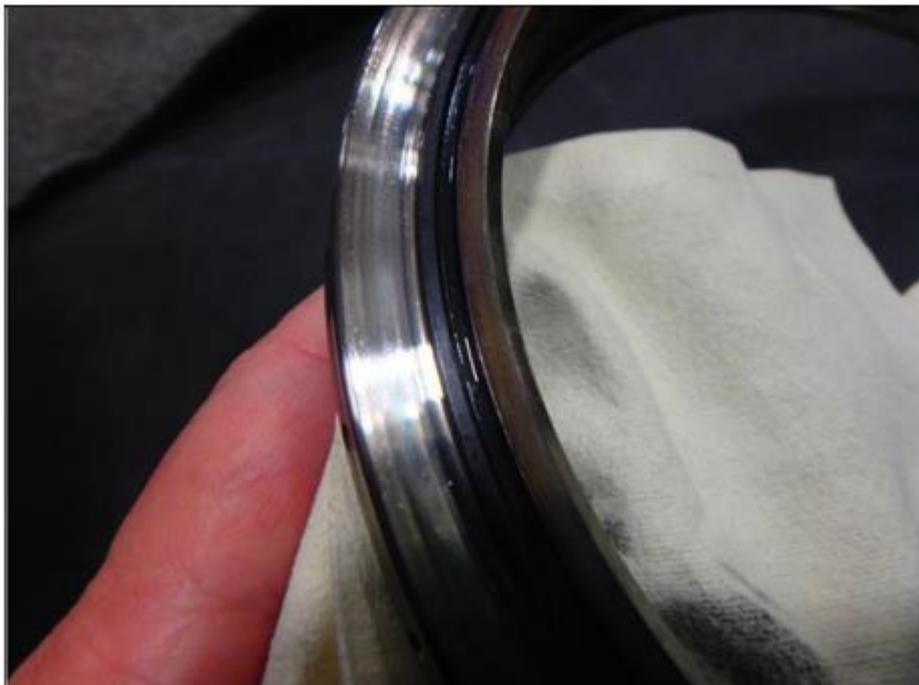
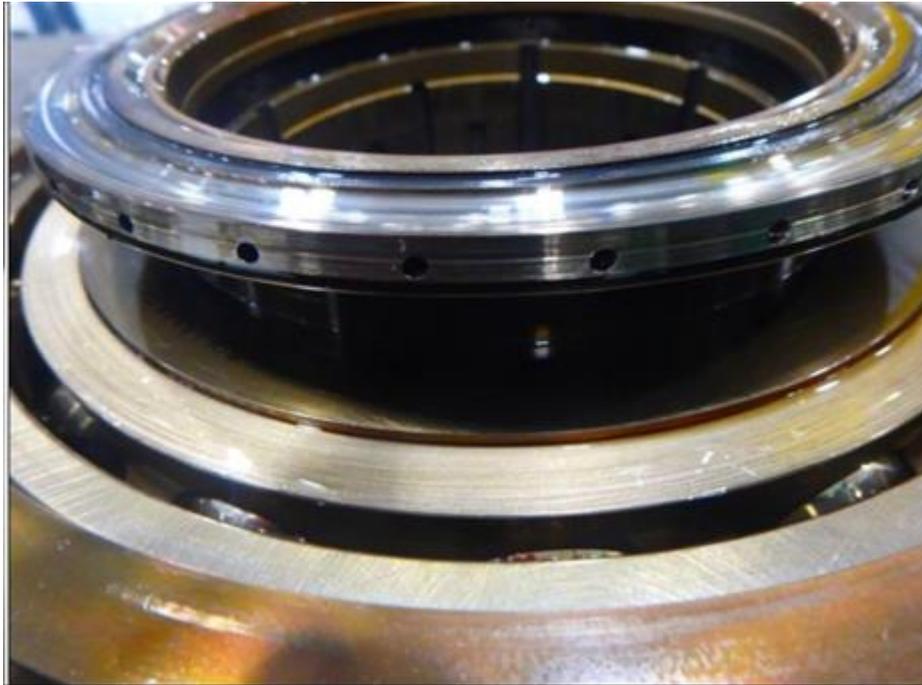
No. 3 Bearing Rear Seal Seat

The reason of these premature wear events was that the seal seat could position itself inside ('nest') the carbon seal housing without contacting the face of the seal carrier assembly.

The actual condition of no. 3 bearing rear carbon seat of the involved engine (BSI carried out at CEC)
