**FINAL REPORT ON SERIOUS INCIDENT INVOLVING
AIRPROX BETWEEN M/S JET AIRWAYS' B777 AIRCRAFT
VT-JLJ AND AIR INDIA'S A319 AIRCRAFT VT-SCP IN
MUMBAI AIRSPACE ON 07.11.2018.**

**Jasbir Singh Larhga
Investigator-in-Charge
Deputy Director, AAIB**

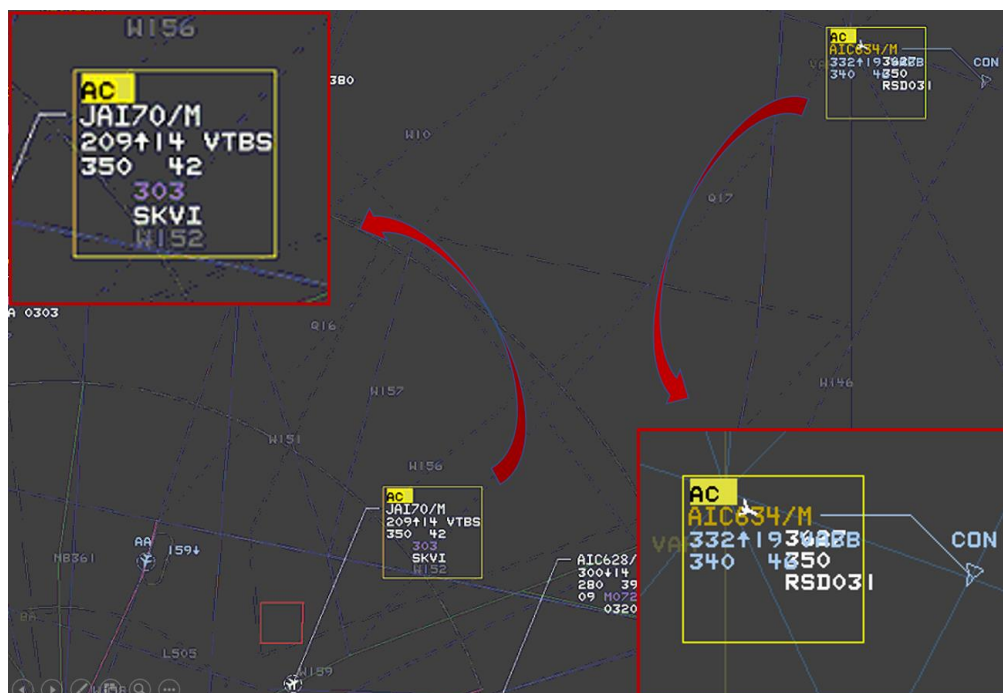
Figure 2: Radar Snapshot at 025841 UTC, with Flight Blocks zoomed-in

Radar snapshots of the incident were obtained from Mumbai Radar. As per the Airprox Report by AAI, STCA predicting conflict between JAI70 and AIC634 was triggered at 025830 UTC causing the Flight Block on Situation Data Display to turn Yellow. The snapshot taken for time 025841 UTC given in the Figure 2 below, shows JAI70 cleared for FL350 and climbing through FL209 on Route Q19, while AIC634 is cleared for FL340 and climbing at FL332 on Route W146.

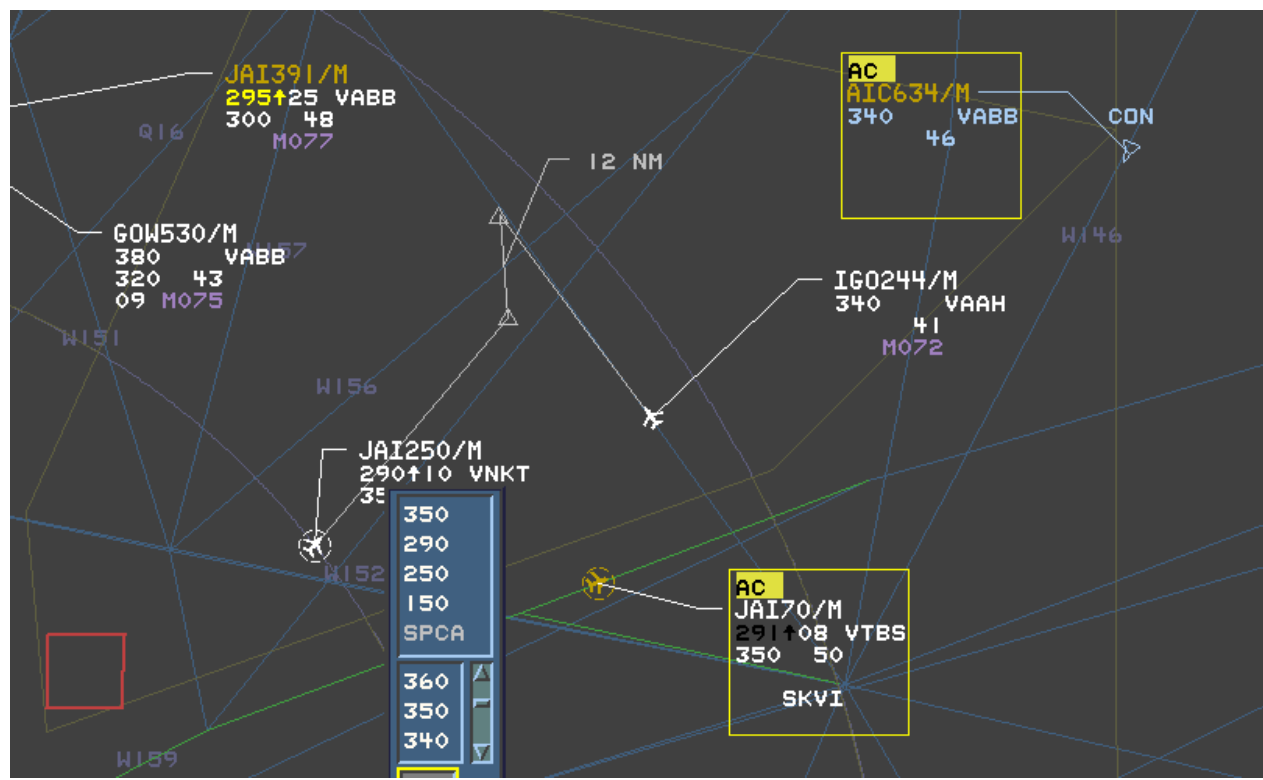
Figure 3: Radar Snapshot at 030700 UTC

The snapshot for time 030700 UTC shown in Figure 3 below, shows that JAI70 was not displaying Mode C information, and current altitude of aircraft was not being displayed.

JAI70 came in contact of RSR(N) at 025708 UTC and was cleared for FL350. At 025830 UTC conflict warning between JAI70 and AIC634 was triggered. Thereafter, Mode C information was also lost on Radar Screen from 030700 UTC to 030744 UTC, however, Radar Controller neither took any action on the Conflict Warning, nor on the loss of Mode C information.

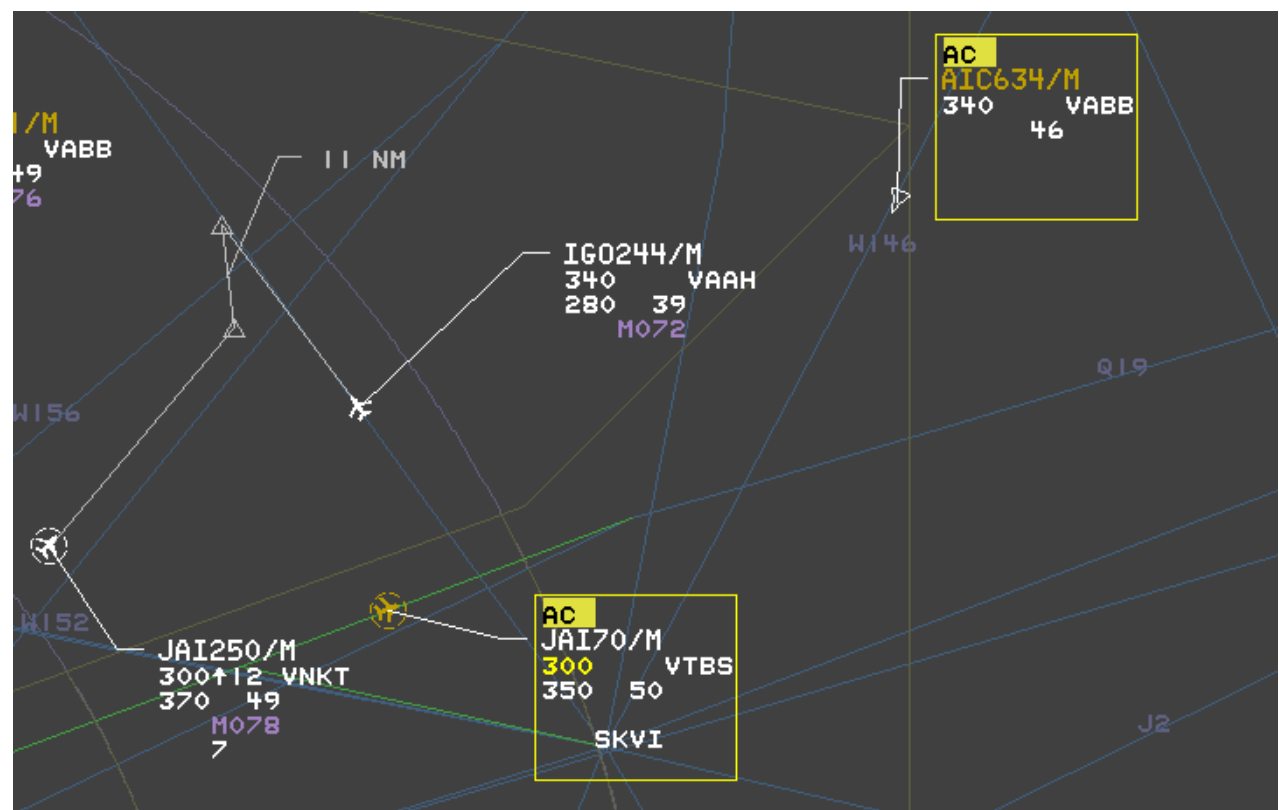
Figure 4: Radar Snapshot at 030749 UTC

The Mode C information was not available till time 030749 UTC, and Figure 4 below shows JAI70 at FL300 when Mode C information became available again.

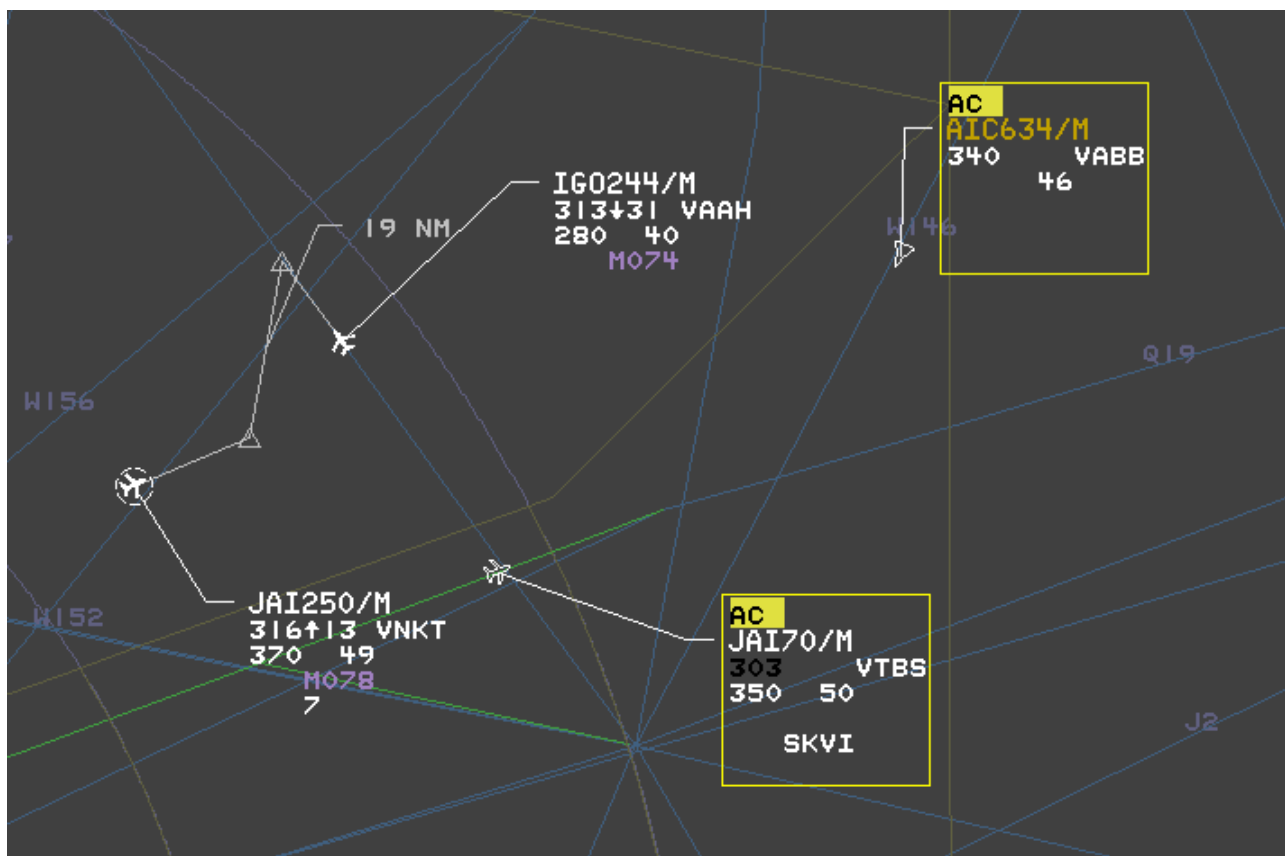
Figure 5: Radar Snapshot at 030857 UTC

Mode C information from the aircraft was lost again at 030857 UTC and the same is shown in the Figure 5 below.

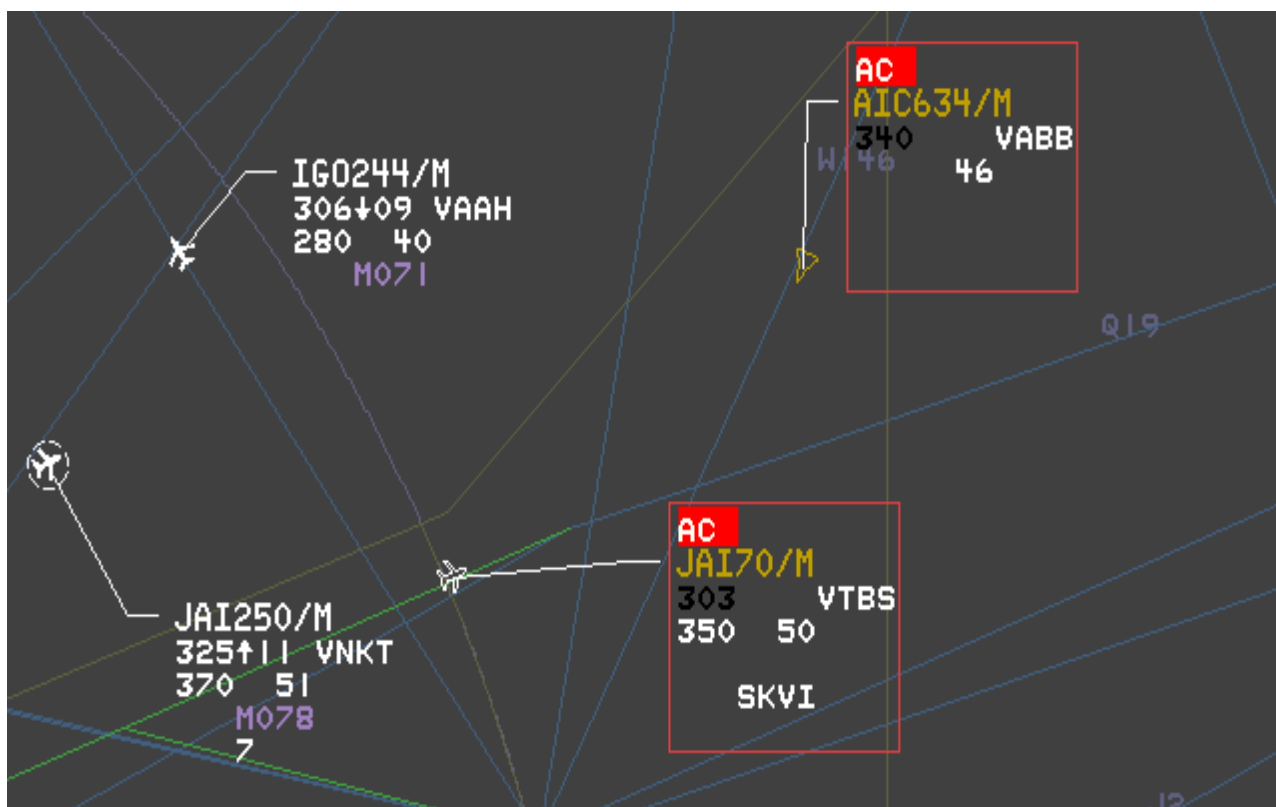
Figure 6: Radar Snapshot at 030947 UTC

While the Mode C information was still not available when the Flight Block for JAI70 turned red indicating violation status of STCA at 030947 UTC as shown in the Figure 6 below.

The conflict warning continued for 11:15 minutes, with no corrective action by the Radar Controller. While the alert was still active, Radar Controller terminated the Radar Service and transferred the control of aircraft to Nagpur Radar without resolving the conflict. The action was not in accordance with the MATS Para 15.7.2.2.

4.1 Radar Controller shall be given appropriate corrective training in Surveillance techniques, STCA procedures, Radar Service Termination procedures etc. and handling of aircrafts in exigencies.

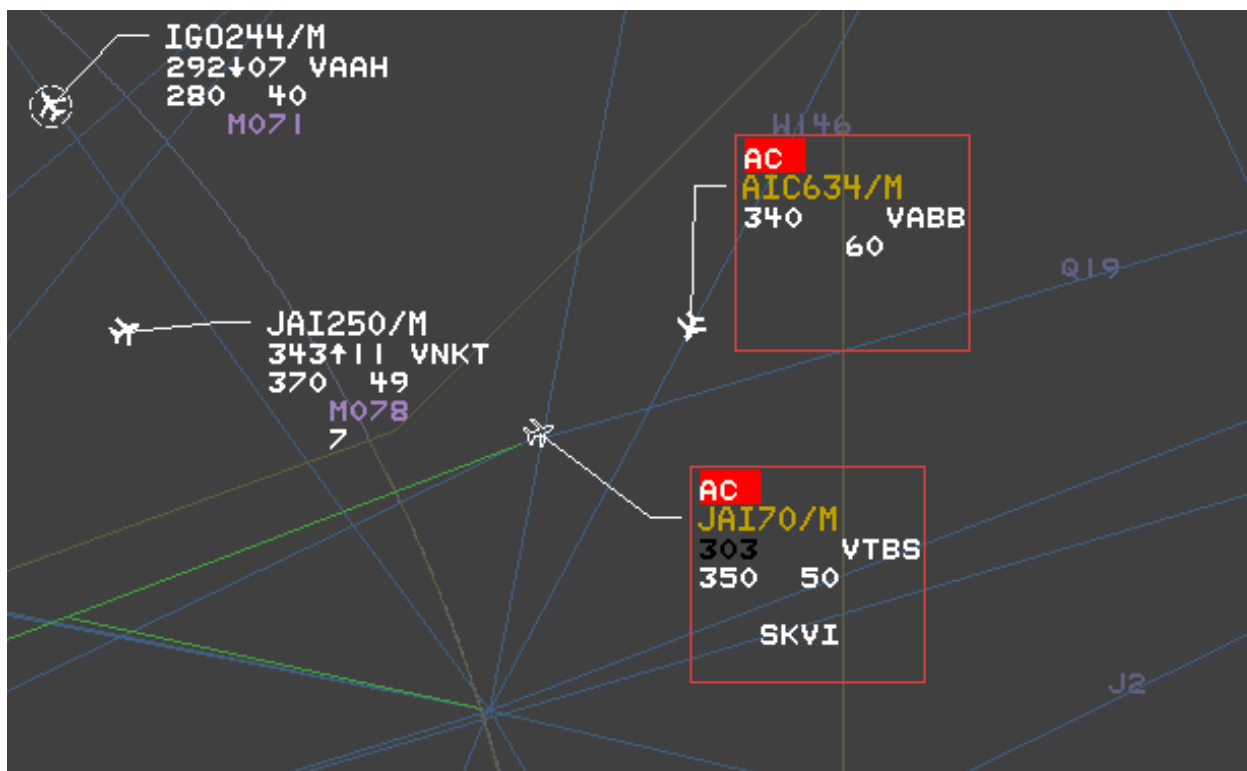
Figure 7: Radar Snapshot at 031131 UTC

This STCA continued to be displayed in red till 031131 UTC and the same can be seen in the Figure 7 below.

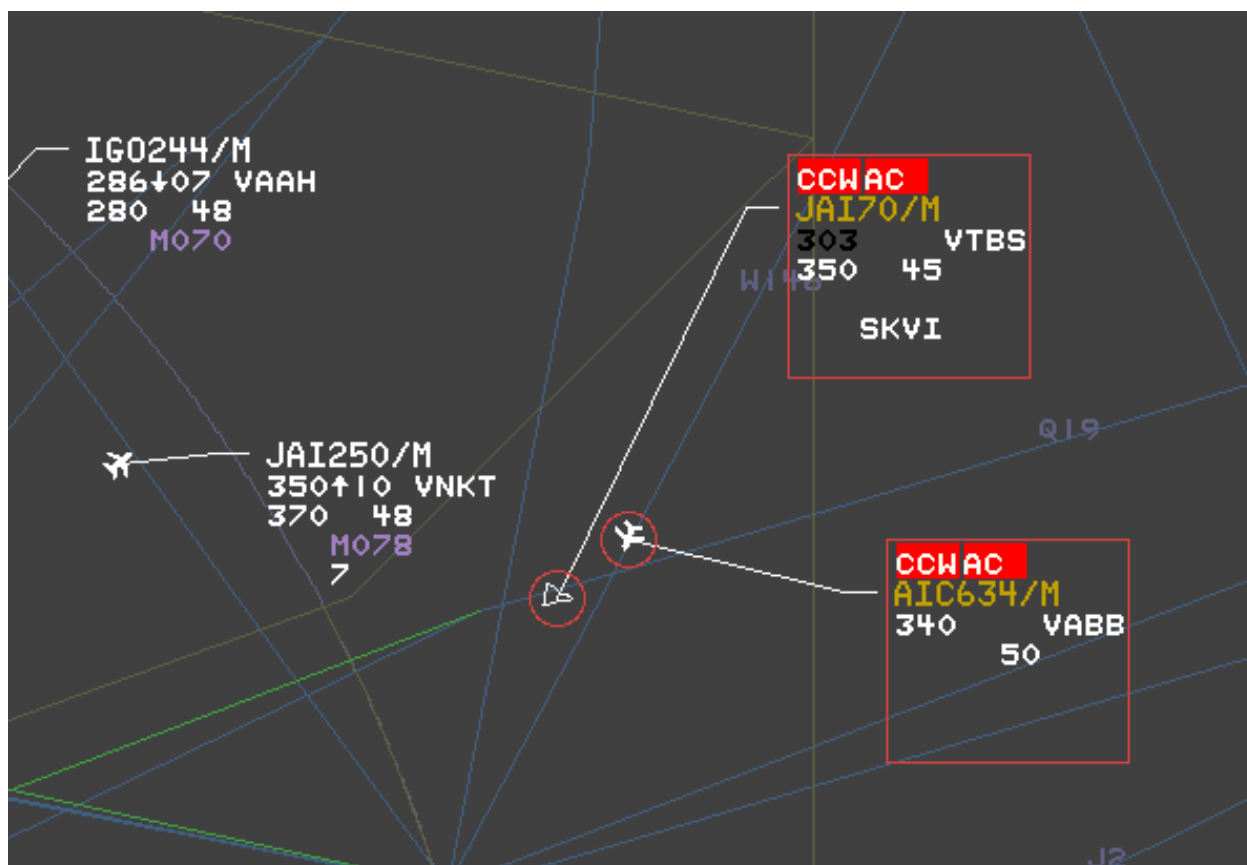
Figure 8: Radar Snapshot at 031211 UTC

At 031211 UTC, CCW was also triggered along with STCA and the Mode C information was still not available for JAI70. The same is shown in the Figure 8 below.

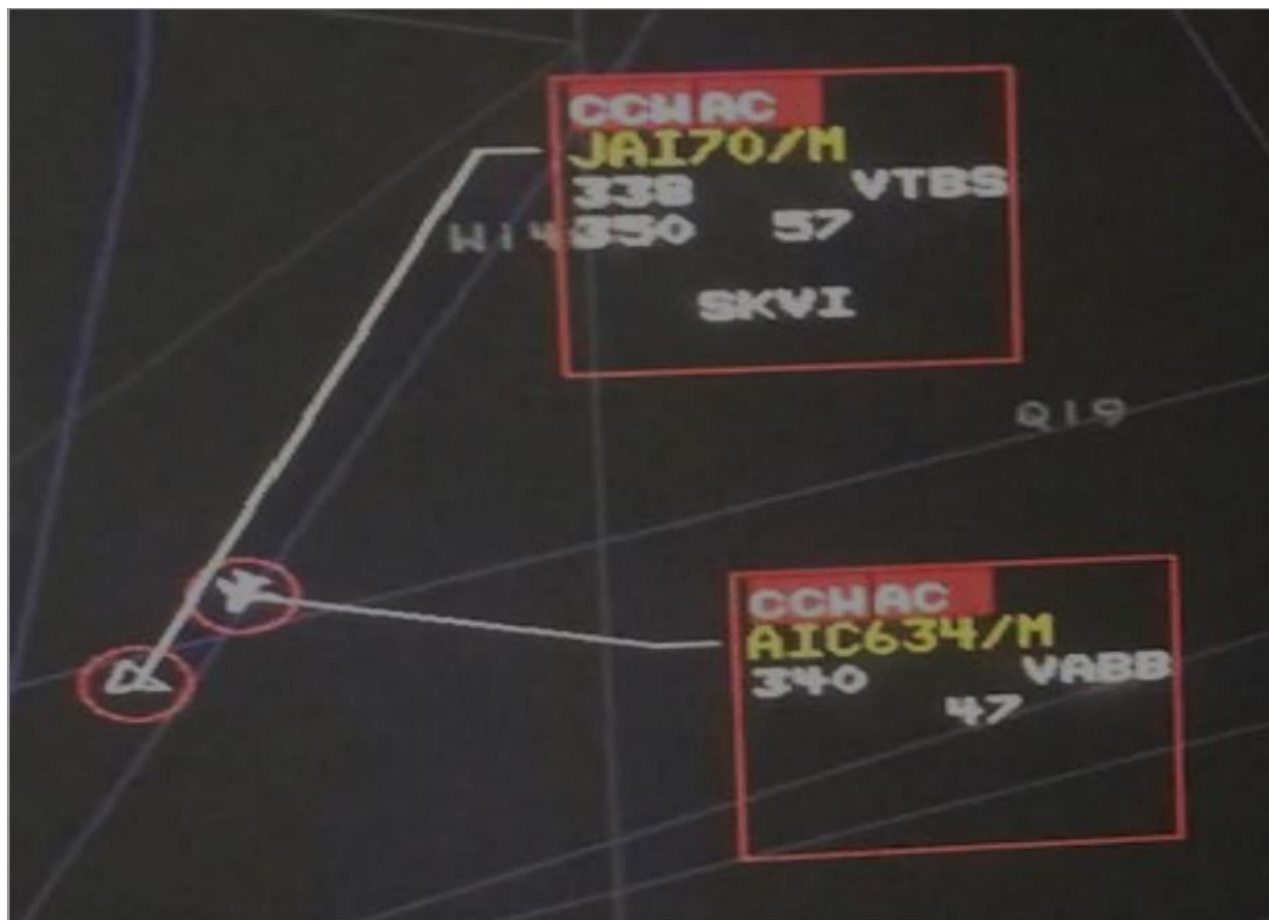
Figure 9: Radar Snapshot at 031214 UTC

The standard lateral and vertical separation of 10NM and 1000 feet respectively between the reciprocal aircraft was breached and reduced to 3NM and 200 feet respectively. Incident took place on Radial 066, 164 NM from Mumbai VOR/DME (BBB).

The Mode C information was regained at 031214 UTC and it can be seen in the Figure 9 that vertical separation between JAI70 and AIC634 was reduced to 200 feet.
