FINAL INVESTIGATION REPORT ON
SERIOUS INCIDENT TO M/s ALLIANCE AIR
ATR-72 AIRCRAFT VT-AIX AT SHIRDI
AIRPORT ON 21/05/2018

| 6. Place of Incident | : Shirdi Airport |
| 7. Date & Time of Incident | : 21 st May 2018, 1118 UTC |
| 14. Type of incident | : Runway overrun |

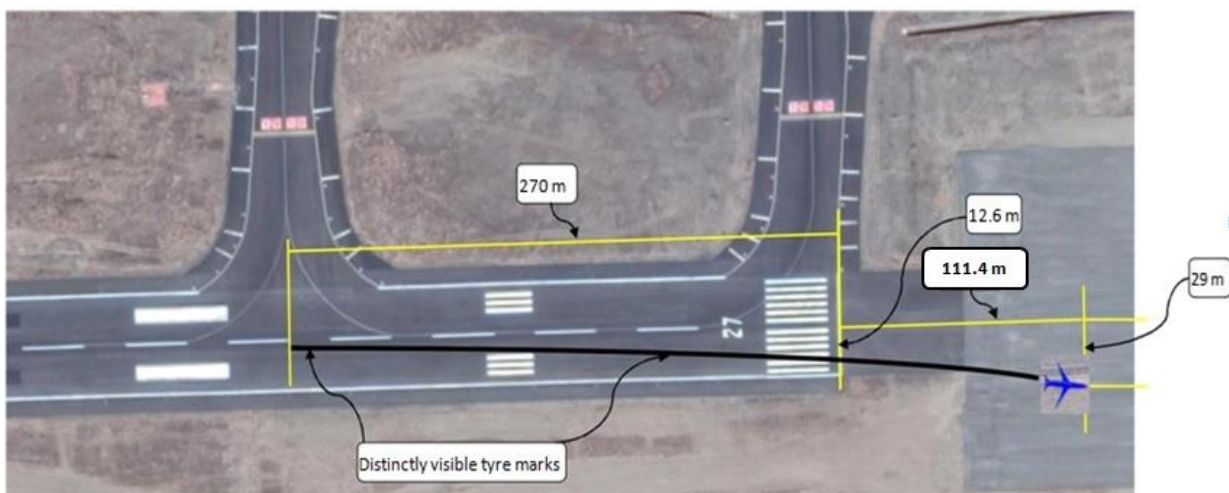
Crew also said that due to unavailability of required runway length, they were not able to take the decision on Go-around. Aircraft overshot the runway 09 and came to a halt on the unpaved surface available under RESA.

Fig: Final rest position of the aircraft

16. Aircraft’s longitudinal excursion inside the RESA area was 51.4 m and offset distance from the runway centreline was 29 m.
17. The aircraft sustained no damage.

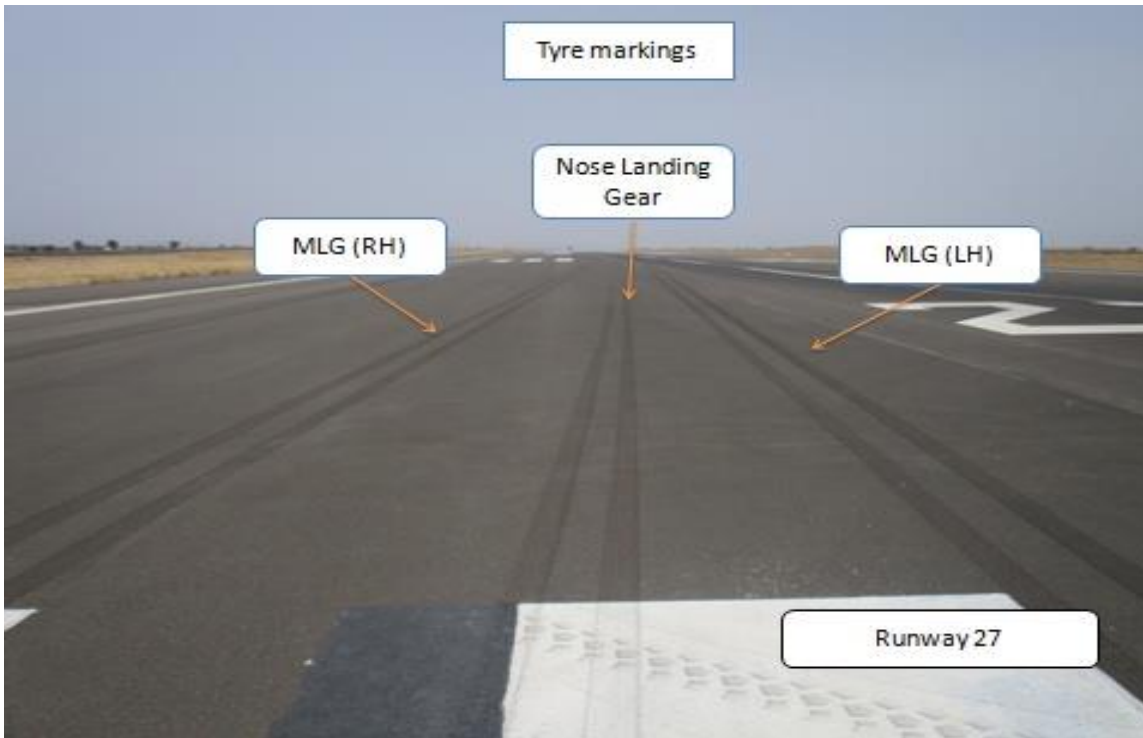
1. Distance of aircraft touch down on RWY 09 from threshold: 1595.1 m
2. Distance of aircraft from end of runway 27 in soft ground (after blast pad): 51.4 m
3. Tyre rub marks visible on Runway and upto stop point on RESA: 381.4 m.
4. Maximum Deviation of aircraft w.r.t Runway centre line : 29 m

Fig: Landing gear's Tyre markings on runway

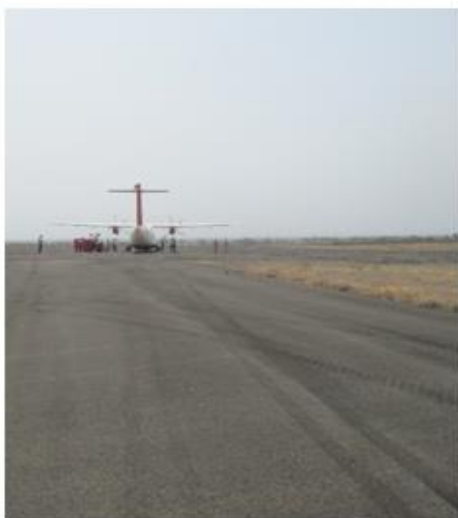
Aircraft overshoot the runway

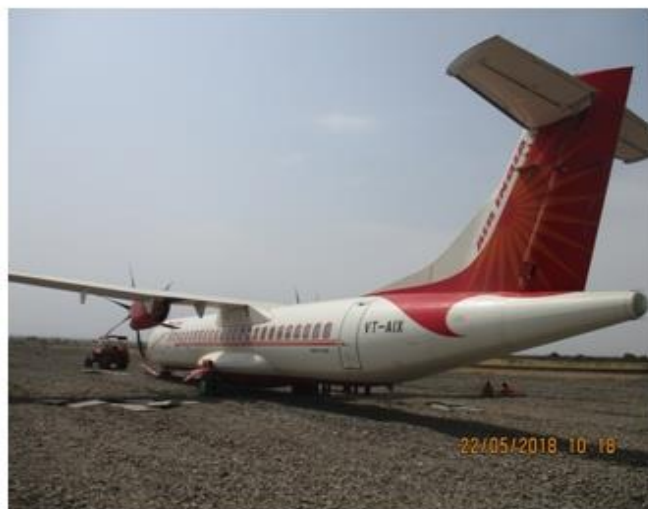
Final rest position of the aircraft

There was no damage to the aircraft. Further, there was no external damage due to overrun other than the runway end lights.

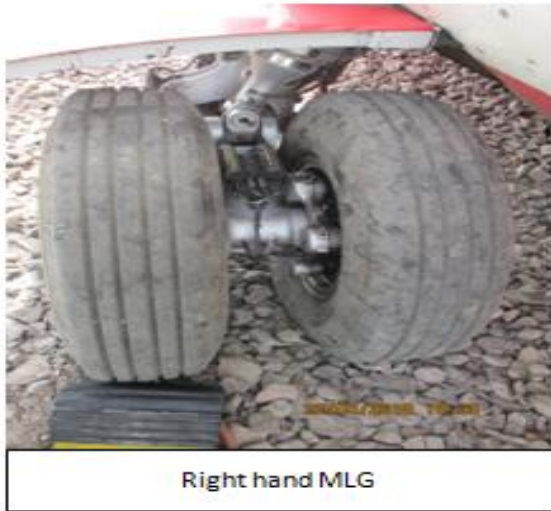
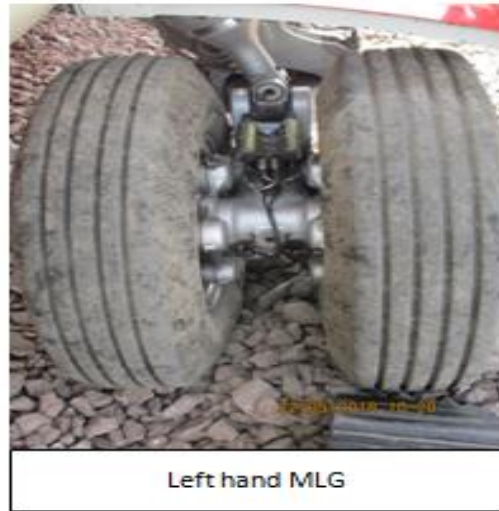
LH Main Landing Gear		Nose Landing Gear		RH Main Landing Gear	
Portside	STBD side	Portside	STBD side	Portside	STBD side
123 psi	124 psi	65 psi	64 psi	120 psi	125 psi

The condition of the tyres and their pressure were checked after the incident and the same was found within the limits.

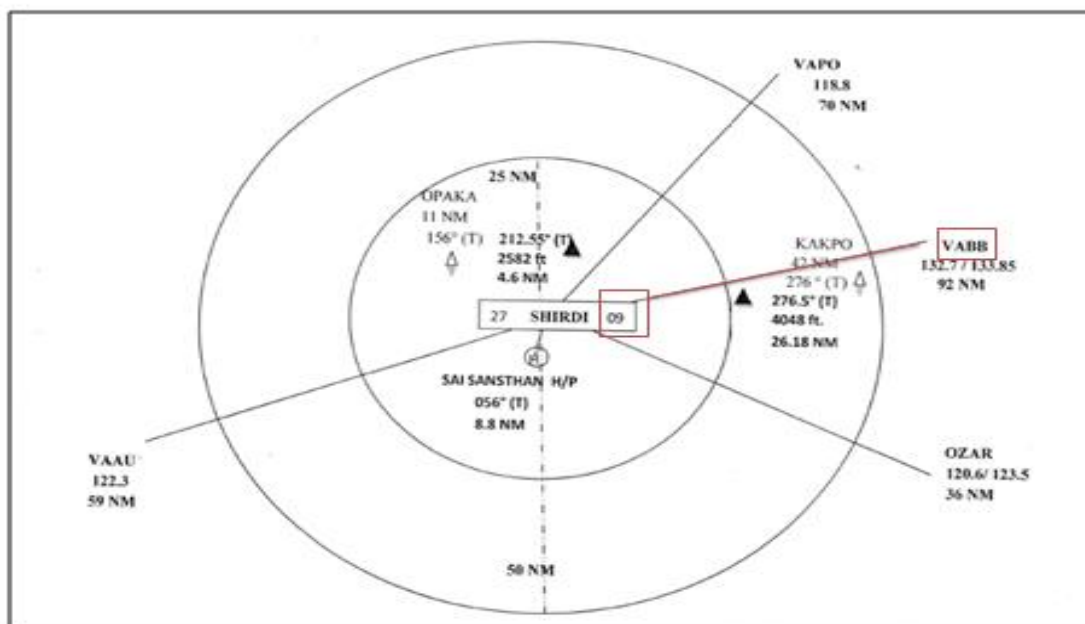
Fig: Direct approach VT-AIX followed for Shirdi Airfield

From the above figure, it is evident that when aircraft approach towards Shirdi from Mumbai, runway 09 is straight in approach and reduces the flight time.

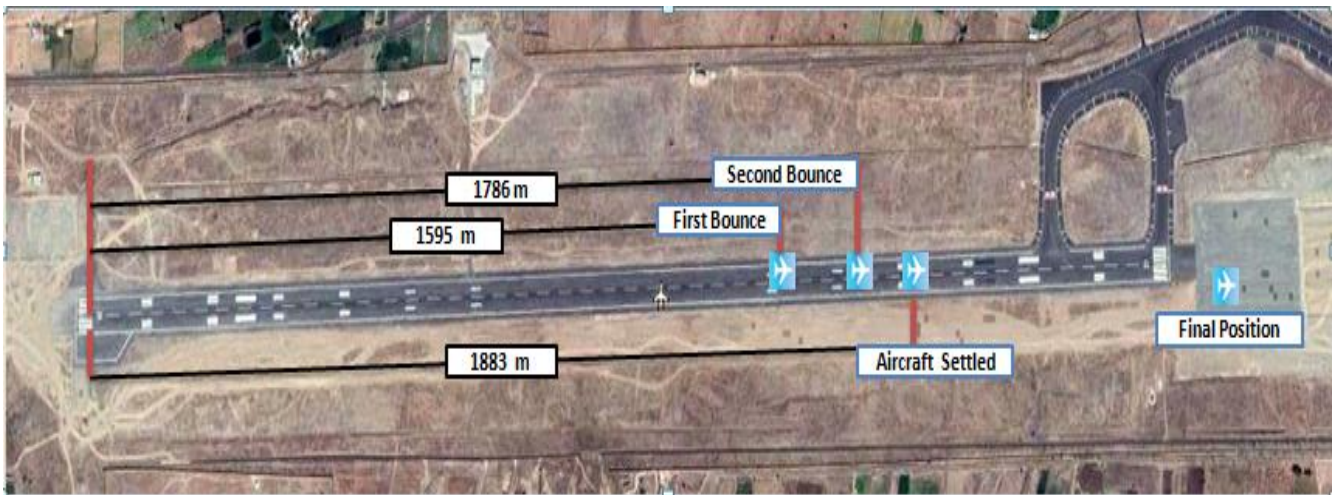
Fig: Landing profile of the aircraft VT-AIX

- a. The actual landing distance required, taking into account the wind and the airport elevation at the time of the event, was 2,542 feet or 775 m.
- b. The runway threshold was overflowed by the aircraft at a height of 50 feet and at an indicated airspeed of 128 kt.

As per the prevailing conditions, the distance required to stop the aircraft on the runway was around 775 metres. However, when the aircraft landed on the runway only 604 metres were left for the aircraft to stop. Even though the PIC applied full brakes, the aircraft did not stop on the runway and eventually exited the runway and entered the RESA due tailwind component.
