**FINAL REPORT ON SERIOUS INCIDENT**

**M/S AIR INDIA BOEING B777-300 ER AIRCRAFT**

**VT-ALN**

**AT MUMBAI ON 15.10.2018**

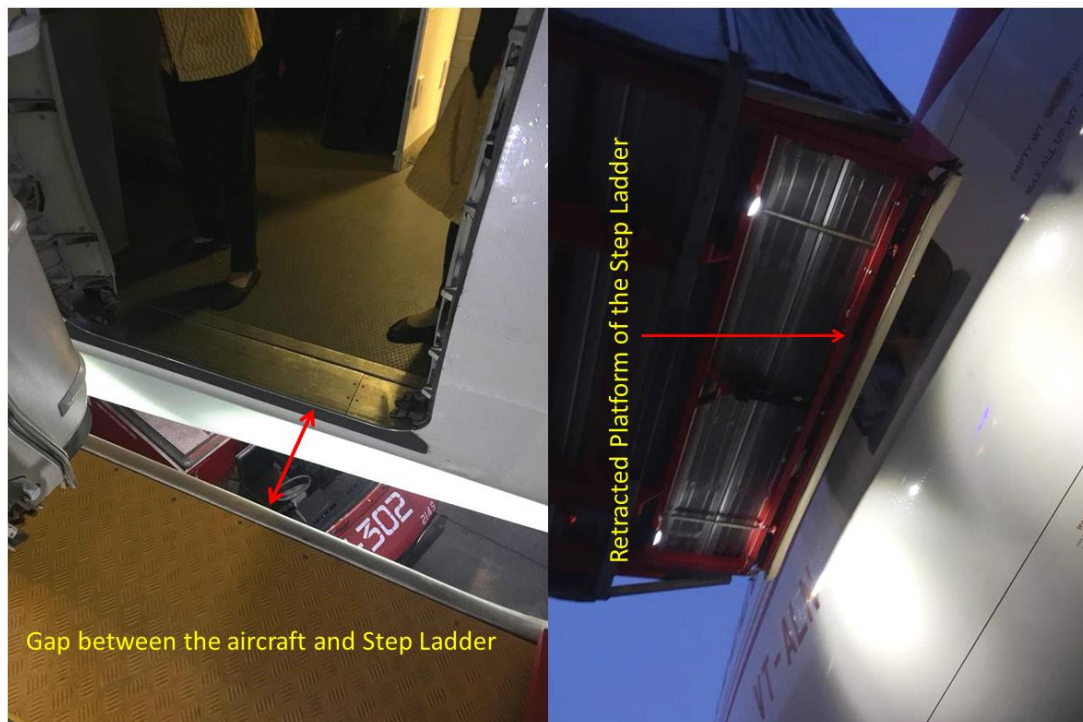
*Fig. 1: Picture showing gap and movable platform in retracted position*

On reaching the top of the step ladder, this set of cabin crew noticed the gap between ladder and the aircraft, and communicated the same to the ground handling personnel who was adjusting the movable platform of the step ladder to reduce the gap. CC-1 and CC-2 interacted with the ground handling personnel while he was trying to align the movable platform.

The statements of Ground Handling Personnel are conflicting with statements of Cabin Crew as to whether Ground Handler directed CC-1 to give clearance for opening the door. However, it is clear from the photograph of step ladder (Fig. 1) that the movable platform had not been aligned with the aircraft. It could be a possibility that CC-1, owing to his medical condition related to hearing, misunderstood the communication with the Ground Handling Personnel and gave clearance to open the door on his behalf.

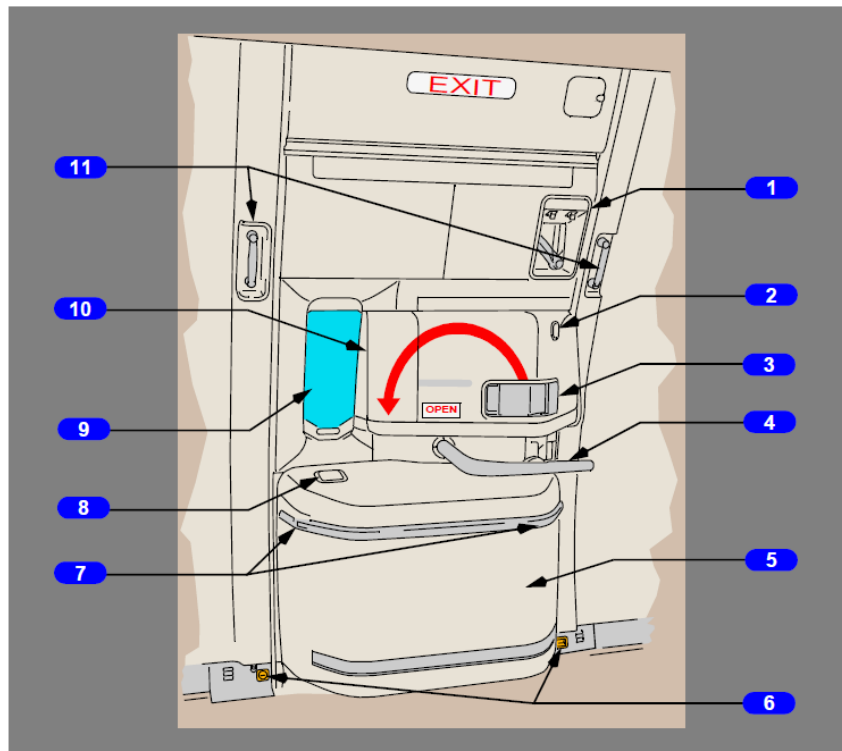
*Fig. 3: Passenger Entry Door from Flight Attendant Manual*

The description of various controls on the passenger entry door as per the Flight Attendant Manual Rev 0 dated Jan 21, 2019 is shown in the Fig. 3 and described below.

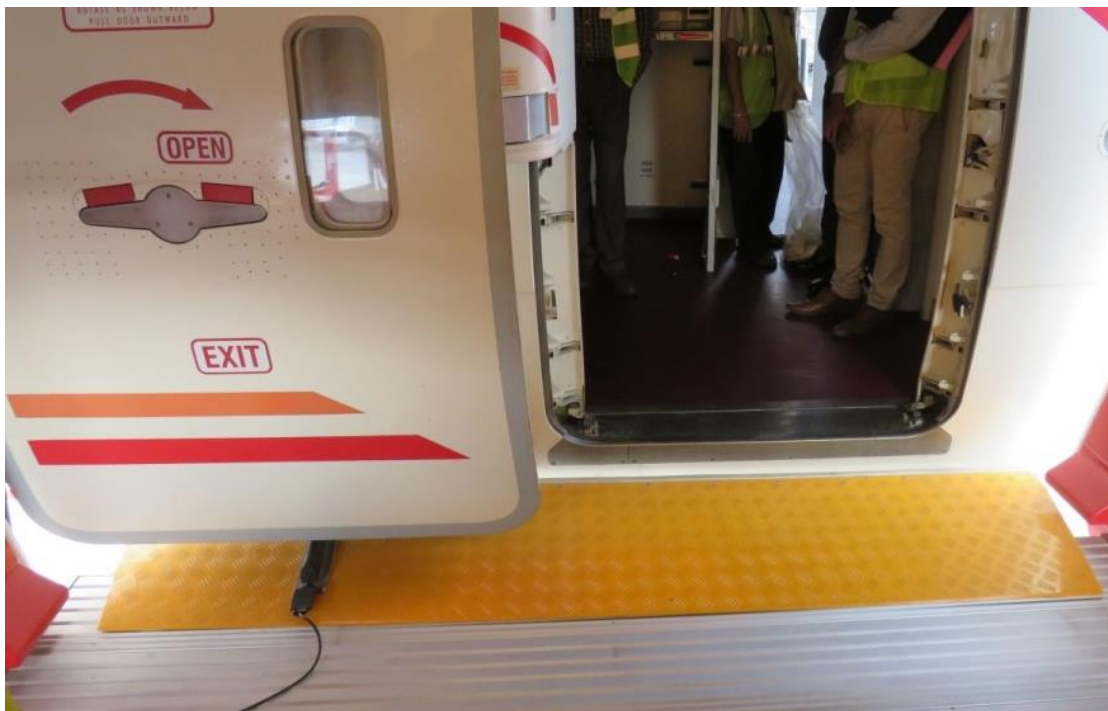
The procedure to align the step ladder with the aircraft is given at Para 3.6.13 of the Manual. As per the SOP, the step ladder is aligned with the aircraft and stopped approximately 09 inches away from the

aircraft door. The movable platform of the step ladder is then adjusted to close the gap between the aircraft and the ladder.

*Fig. 5: Step Ladder with movable platform aligned to the aircraft*

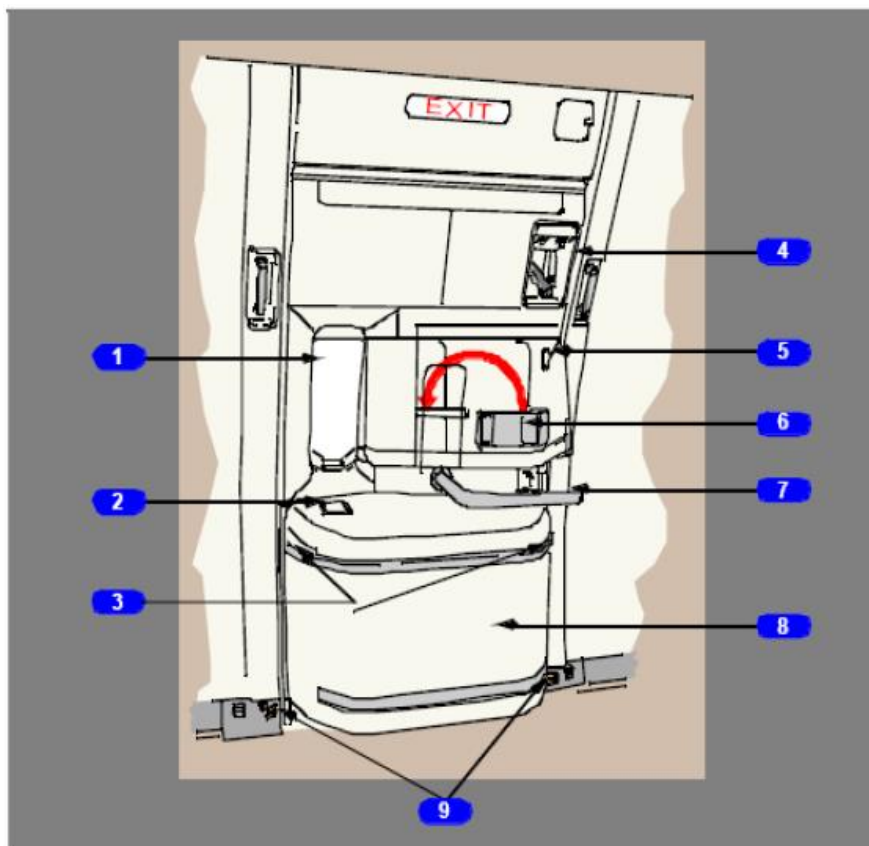
Fig. 6: Passenger Entry Door from SEP Manual

The SEP manual does not give description of Assist Handle and contain no caution or warning to use Assist Handle during Door Opening. Such warning or caution is also not available in the Flight Attendant Manual referred by the operator. The latest Rev 01 dated Jan 21, 2019 of Flight Attendant Manual, however, does contain following warning and advises personnel to use appropriate measure. *“A fall hazard exists anytime a door is open without properly positioned fall protection such as a boarding gateway, stair, stand or equivalent in place outside of the doorway. Use appropriate measures to prevent injury to personnel.”*
