FINAL INVESTIGATION REPORT ON SERIOUS INCIDENT (AIRPROX) BETWEEN AIRBUS A320 AIRCRAFT VT-DEL (M/S AIR ASIA LTD) & AIRCRAFT VT-IHJ (M/S INDIGO LTD) AT KOLKATA ON 15.10.2018.

Final Investigation Report on Serious Incident (Airprox) between Airbus A320 Aircraft VT-DEL (M/s Air Asia Ltd) & Aircraft VT-IHJ (M/s Indigo Ltd) at Kolkata on 15.10.2018.

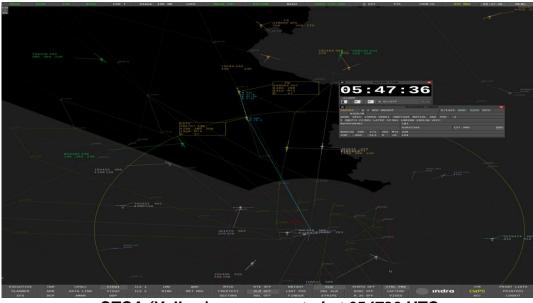
not notice that the Executive Controller has assigned same level (FL290) to both the Aircraft. At 054736 UTC STCA alert was generated when both aircraft were 17.4 NM and 57 seconds to cross each other. IAD583 was descending passing FL309 and IGO797 had just reached FL290.

STCA (Yellow) was generated at 054736 UTC

- STCA was generated when both aircraft were 17.4 NM and 57 seconds to cross each other, when IAD583 was descending passing FL309 and IGO797 had just reached FL290.

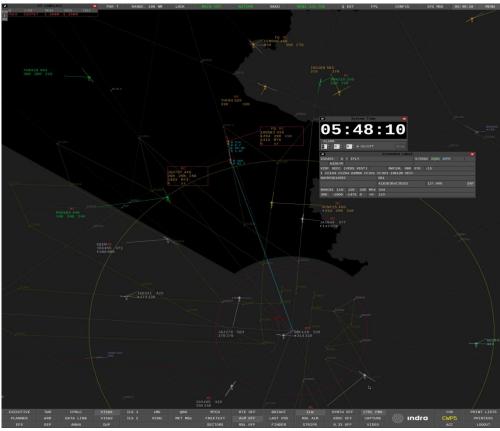
At 054743 the RSR controller instructed IAD583 to turn left heading 090 and simultaneously instructed IGO797 to turn left heading 270. Both the aircraft had read back the same. IAD583 was observed to have changed the heading to 120 and IGO797 was continuing with the same heading. However at 054825 UTC both the aircraft reported TCAS RA and followed RA procedures. IAD583 climbed to FL294 while IGO797 descended to FL285.

STCA (Red) was generated at 054810 UTC

The minimum separation between IAD583 and IGO797 was:

- At 054822 UTC—5.8 NM horizontal and 200 feet vertical.
- At 054827 UTC—4.9 NM horizontal and 500 feet vertical.
- At 054840 UTC-2.8 horizontal and 800 feet vertical.

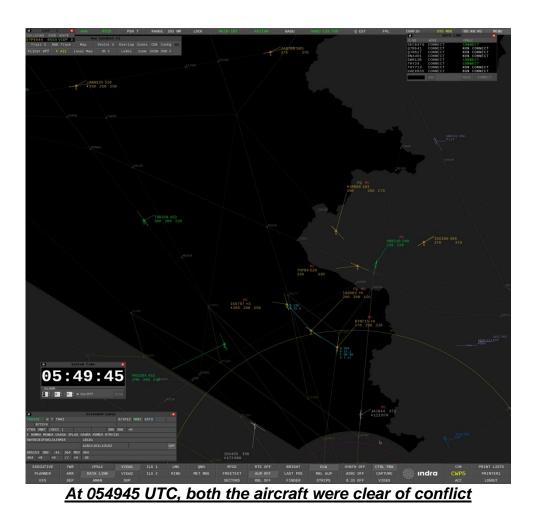
At 054945 UTC, both the aircraft were clear of conflict when IAD583 was climbing past FL 297and IGO797 was descending through FL285.
