**FINAL INVESTIGATION REPORT
OF
SERIOUS INCIDENT TO M/S INDIGO
ATR 72-600 AIRCRAFT VT-IYD
AT HYDERABAD ON 28th MARCH 2018**

**AIRCRAFT ACCIDENT INVESTIGATION BUREAU
MINISTRY OF CIVIL AVIATION
GOVERNMENT OF INDIA**

FINAL INVESTIGATION REPORT OF SERIOUS INCIDENT TO
M/s INDIGO ATR 72-212A (600) AIRCRAFT VT-IYD AT HYDERABAD
ON 28/03/2018

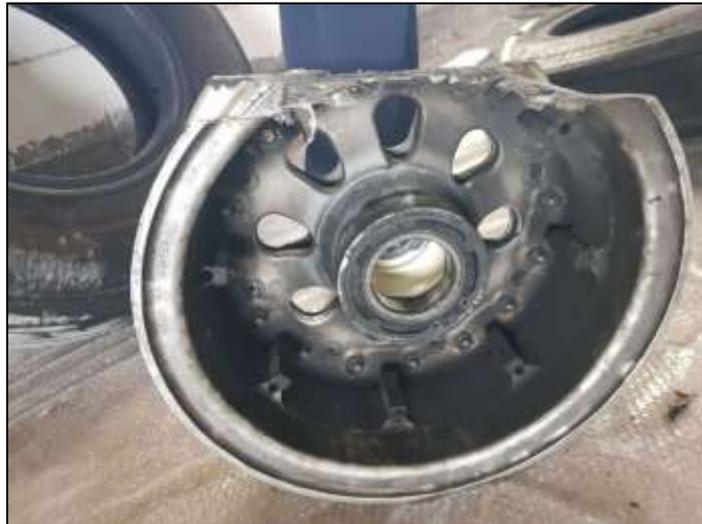
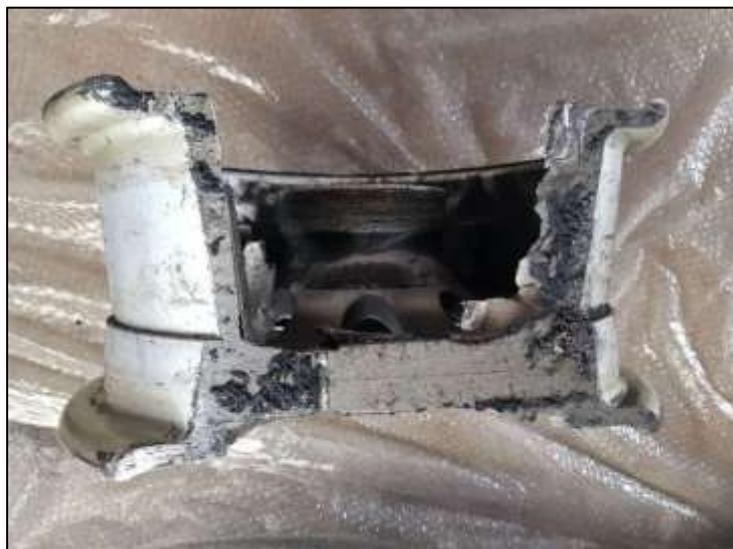
- No. 1 main wheel tyre worn out till the hub from the bottom and No. 2 main wheel tyre got burst completely.
- No. 3 & 4 main wheel tyres worn out from the bottom including approx. 20% of hub.
- Brake hydraulic line LH side above the axle got deformed.
- LH side main landing gear door had a dent in the aft edge at root.

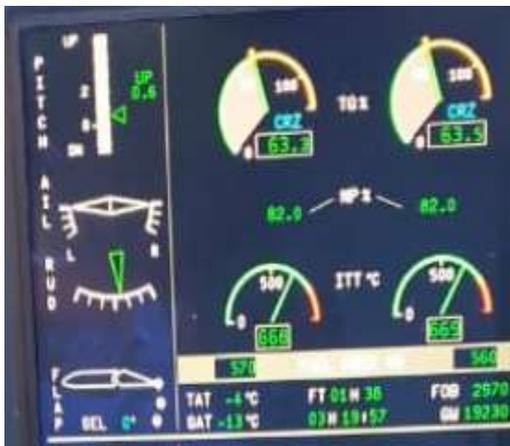
PARKING BRAKE OFF (72-600)

The location of the Flaps indication in the cockpit is just below where the indication of “USE EMER BRAKE, PARKING BRAKE ON” will appear in AMBER colour. The two situations are as shown.

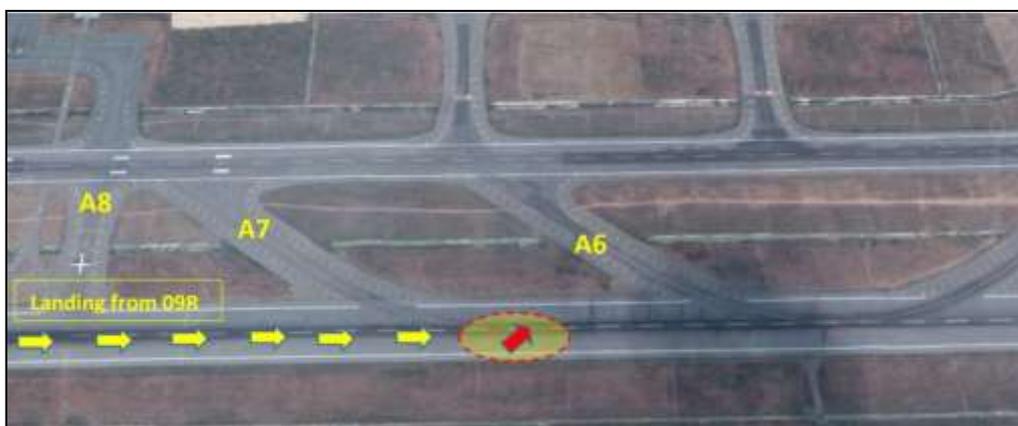
The aircraft landed in the touchdown zone and during the landing roll stopped on runway at approximately 1550m from 09R threshold. As per the runway skid marks, it was observed that the aircraft after touch down veered to the right and thereafter turned toward the runway center line.

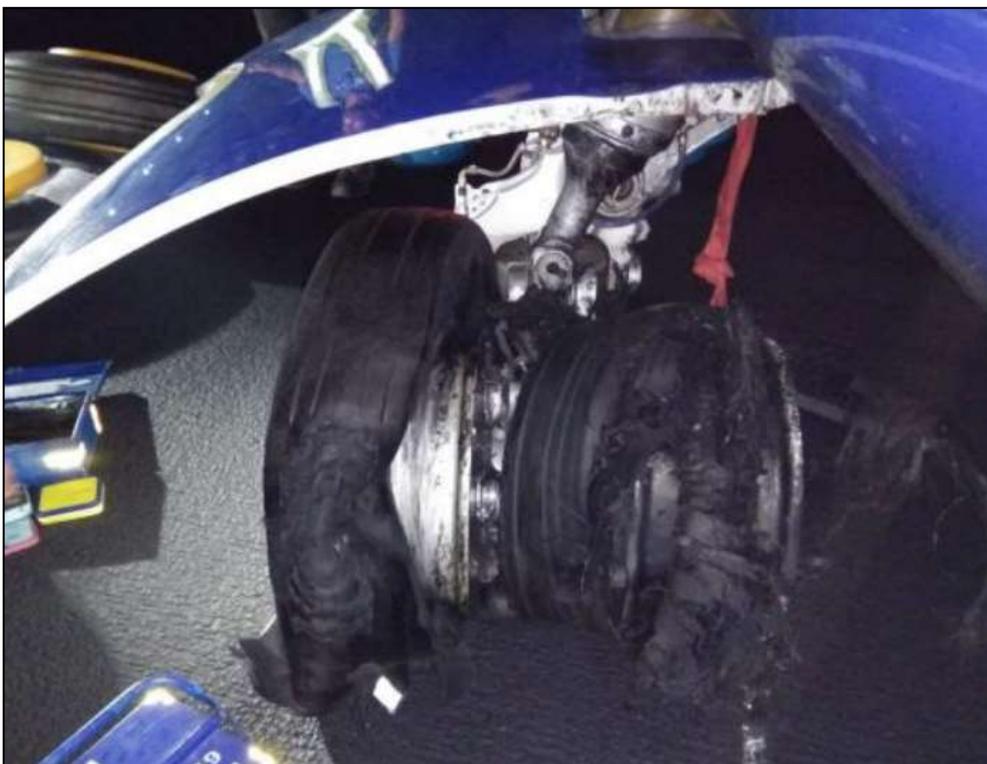
During touchdown, all four tyres of the main under carriage had burst shredded. Both port and starboard side wheel hubs had sustained substantial damage. On the port side, the worn out tyre material got stuck in between the axle and the ground leaving very minimal ground clearance for any direct access to position the MLG adaptor for lifting the wheel. Similarly, on the starboard side the bottom portion of the wheel-hub was heavily eroded because of its continuous rubbing on the runway surface after the tyres had burst. This again resulted in very minimal or no adequate clearance to place the MLG adaptor for lifting the wheel.

DAMAGE TO PORT MAIN WHEEL ASSEMBLY

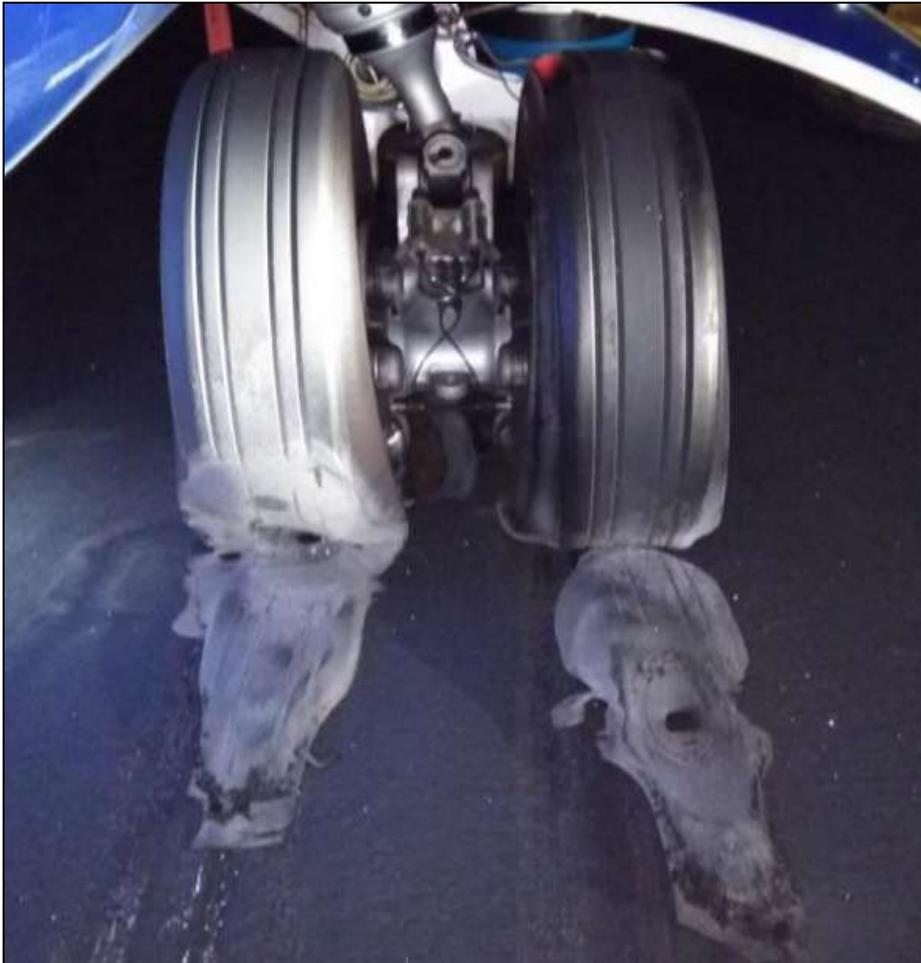
DAMAGE TO STARBOARD MAIN WHEEL ASSEMBLY

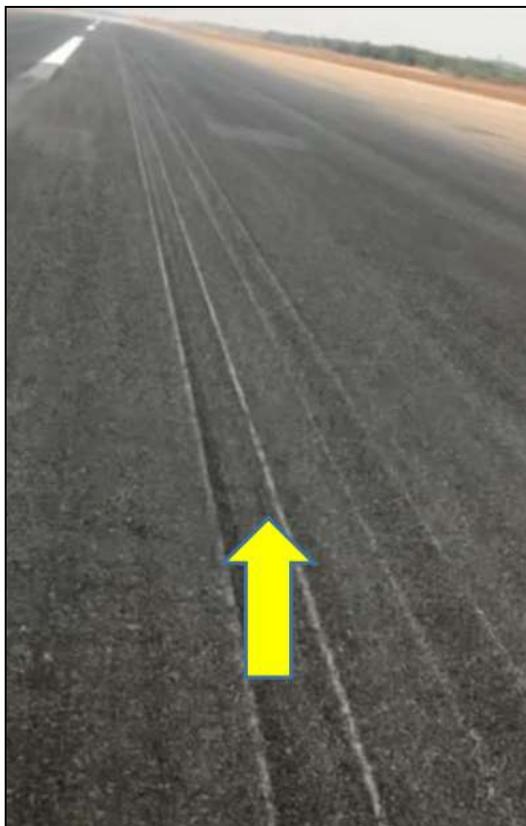
STARBOARD WHEEL/ RIM RUB MARKINGS ON RUNWAY

The starboard side markings were highly prominent till the stop position. There was corresponding damage to the wheels and hubs. The port side wheel marks on runway surface were initially faint with traces of rubber deposits which gradually increased in prominence and became significant during the last 50 meters of the skid. Shortly before the stop position, the aircraft gradually drifted towards the right side from the runway centerline and the aircraft swung to the left just prior to coming to halt.
