FINAL REPORT ON SERIOUS INCIDENT INVOLVING M/s JETAIRWAYS'

ATR 72-500 AIRCRAFT VT-JCN AT INDORE ON 06.12.2018

M/s Jet Airways ATR 72-500 aircraft VT-JCN was involved in an Air Turn Back due to RH engine fire warning in cockpit while operating Flight 9W-794 from Indore to Delhi on 06.12.2018. There were 66 passengers on board. There was no injury reported to any of the occupants.

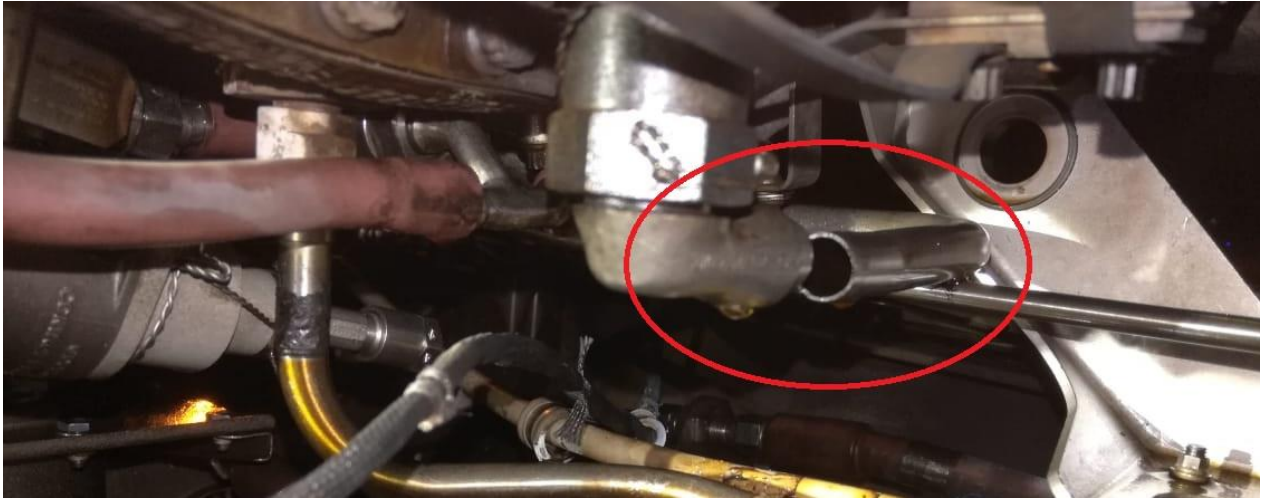
Figure 1

- (i) Rubbing Marks on Impeller tip and oil stains were found on aerofoil surface.
- (ii) No. 6 and No. 7 Oil Scavenge Tube were found broken with engine oil splashed on the bottom cowling (Figure 1).

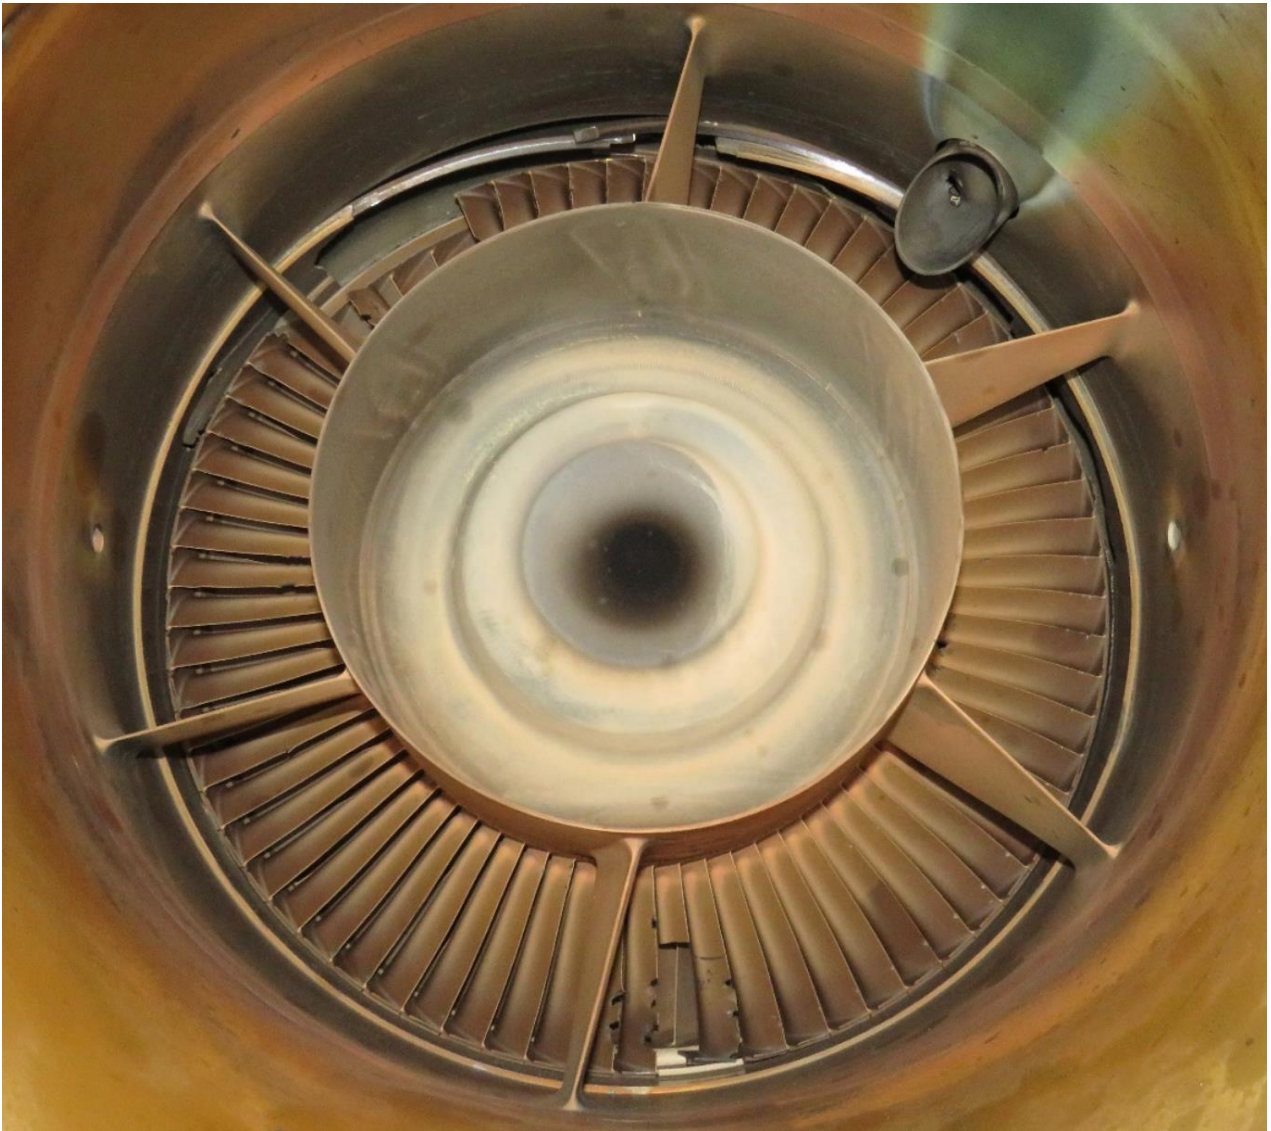
Figure 2

- (iii) Thirteen Power Turbine (PT2) Blades were found damaged (Figure 2).
- (iv) Turbine Casing was cracked (Figure 2).

- (v) Damage was observed on Breather Tube Outlet with some material missing (Figure 2).

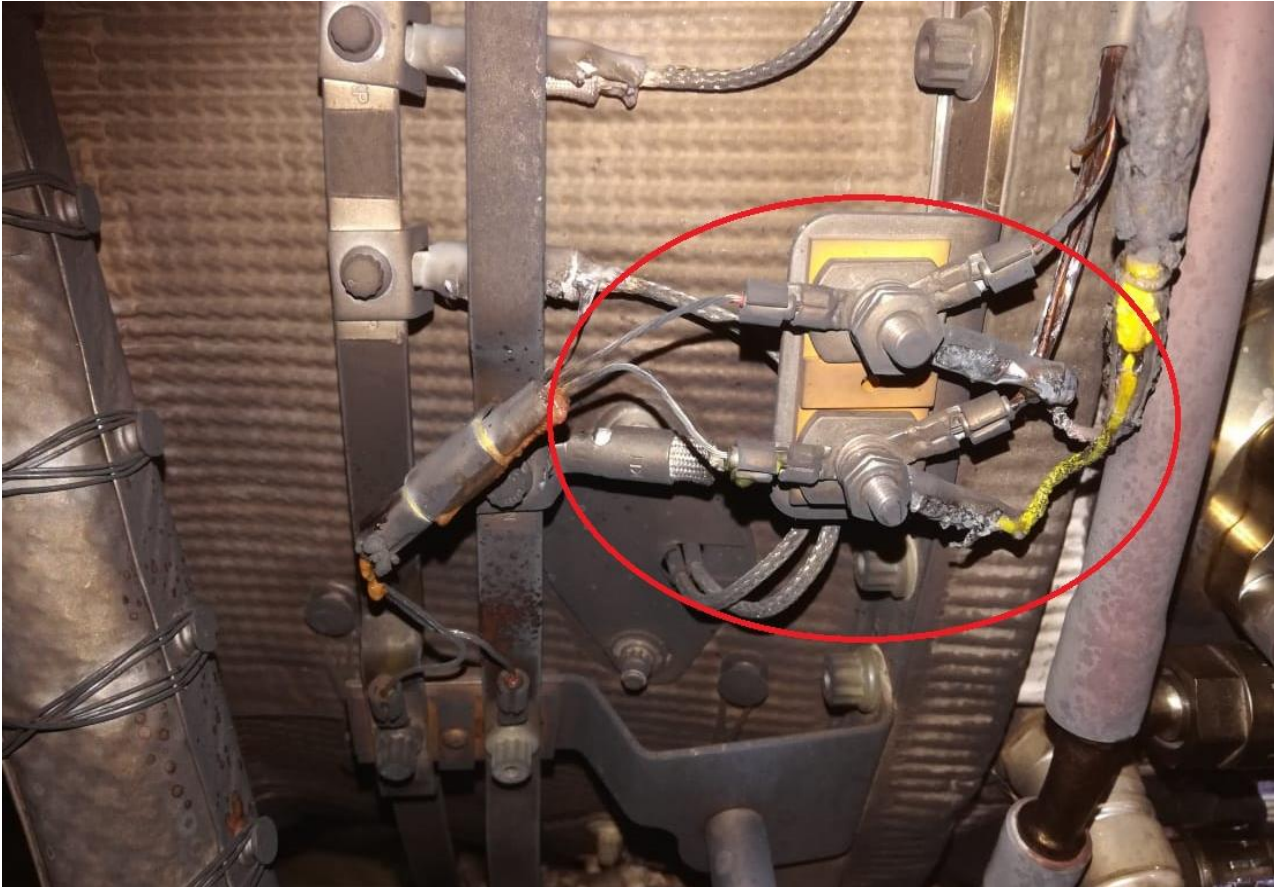
Figure 3

(vi) QEC#3 Harness was found burned near ITT thermocouple junction (Figure 3).

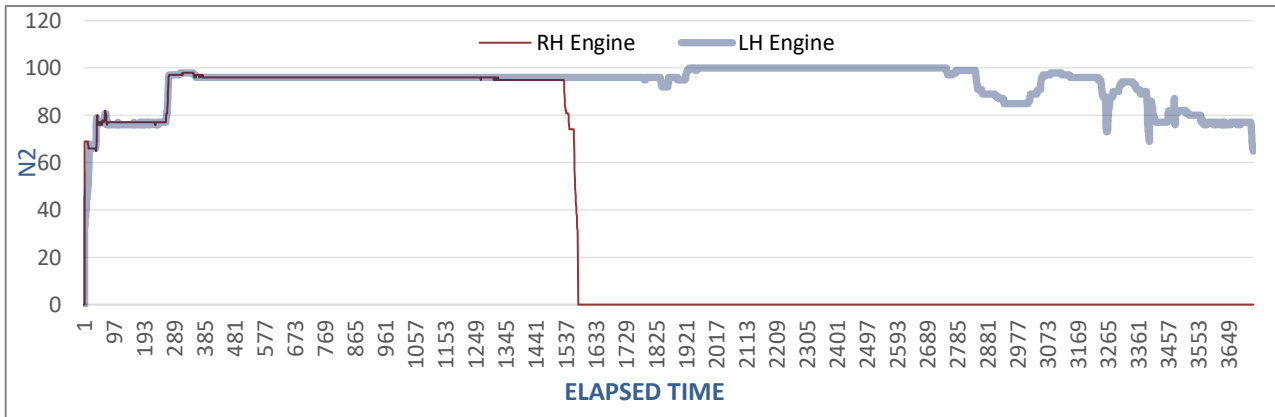
Figure 6

Aircraft was equipped with L3 Communication DFDR having part number 2100-4043-00 and Serial No. 000603289. The DFDR was removed from the aircraft post-incident and downloaded at CVR/FDR Lab of DGCA. As per the DFDR data, RH Engine was shut down at 15:14:42 UTC. The LH Engine continued to give normal power till touch down. The Engine N2 plot is given in Figure 4 below:-
