**FINAL INVESTIGATION REPORT ON ACCIDENT TO
M/s CARVER AVIATION PVT LTD CESSNA -172S
VT-RDX AT BARAMATI ON 05 FEB 2019**

**AIRCRAFT ACCIDENT INVESTIGATION BUREAU
SAFDARJUNG AIRPORT, AUROBINDO MARG
NEW DELHI - 110003**

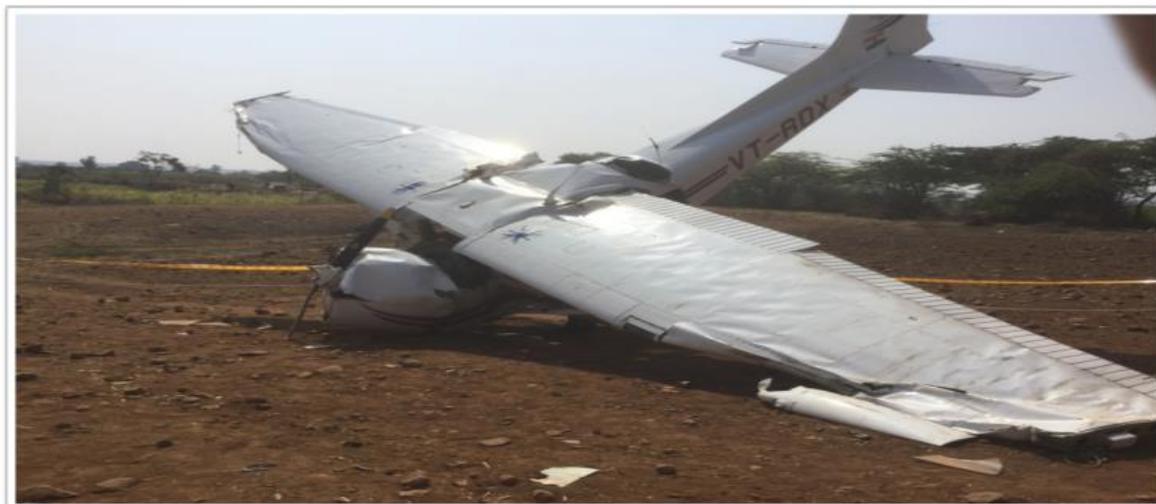
nose wheel got stuck in a small pit. The nose landing gear suffered extensive damage. Due to momentum and nose landing gear in stuck position, aircraft turned to 90 Degrees. Finally, aircraft stopped in engine ploughed into the ground and tail up position as shown in the figure below.

Fig: Final rest position of Aircraft

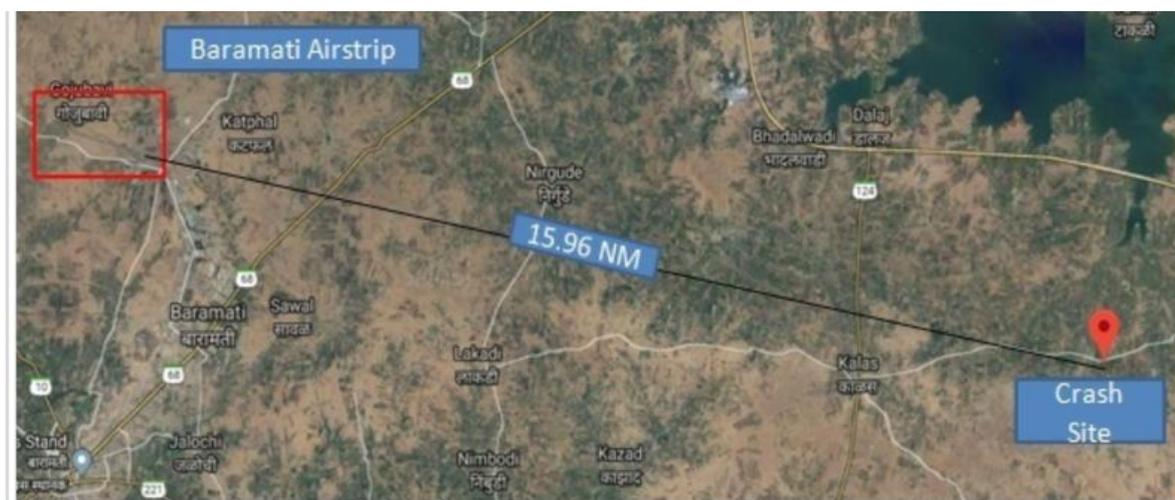
Fig: Accident Site

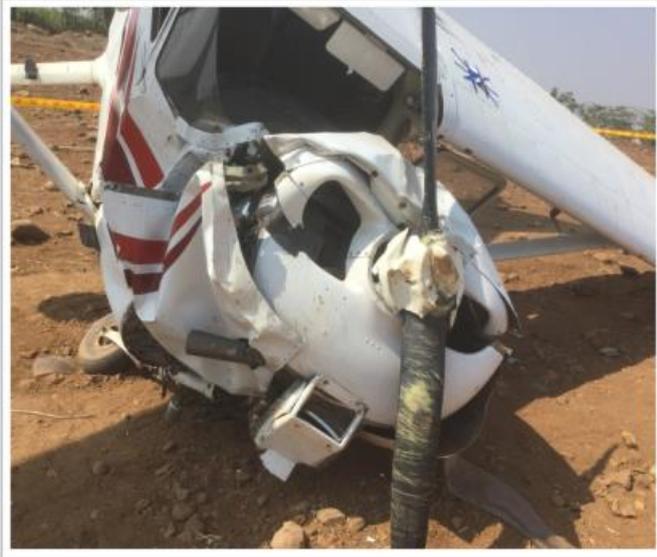
The nose landing gear was broken by impact which caused severe external damage to the engine compartment. The windshield was exploded, the Nose section crushed and right wing twisted. The propeller blades were only slightly damaged, also confirming that the engine delivered no power during impact.

Fig: Impact on Aircraft Nose

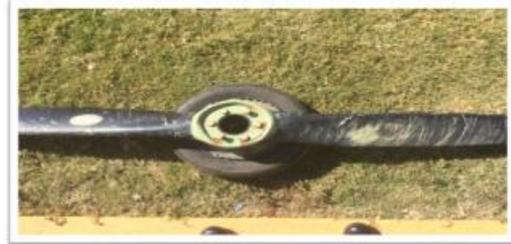
Fig: Rubbing marks on Blades

- (k) There was no significant damage noticed on the propeller blades other than rubbing marks.
- (l) The Load and trim Sheet was not found in the aircraft as well as in the operation office. The said sheet could have given a clear picture of Fuel on board.

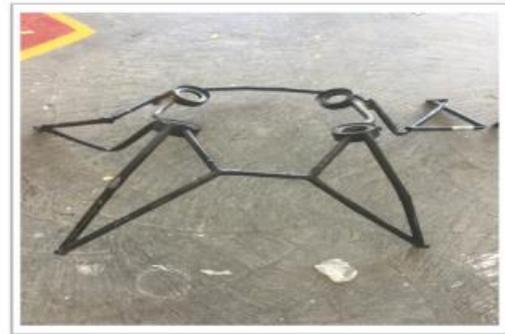
Fig: Broken Engine mount

- (j) The engine was examined in the hangar (DGCA approved) and visual inspection was carried out and no significant damage was observed on the engine. However, engine mount bracket found damaged at 02 places due to impact.

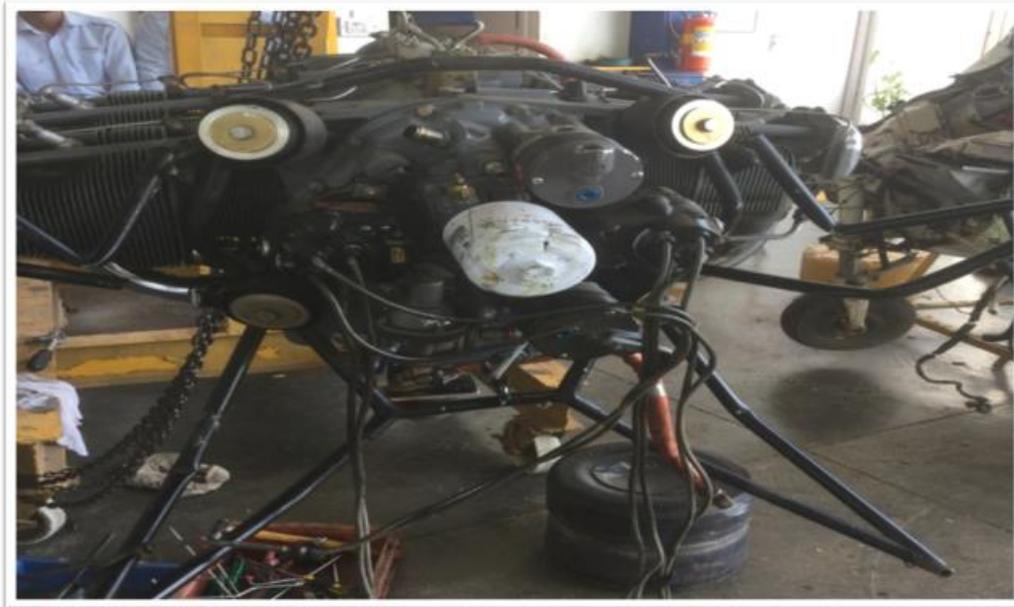
- (a) The fuel filter was opened and inspected but no clogging or obstruction or slug formations were found. The carburettor was removed and opened. Due to the impact and the turnover of the aircraft, no fuel could be found in the float chamber. Nevertheless, the chamber was free of damage and debris. The throttle valve was difficult to move but this was because the valve shaft was damaged during impact. The nozzle was removed but no blockage was found. The general condition of Engine was good.

- (c) All 8 spark plugs were removed and checked for their serviceability on test bench and found fully serviceable and functional.
- (d) All fuel pipelines in the engine were intact and in good condition.

Fig: External Engine condition

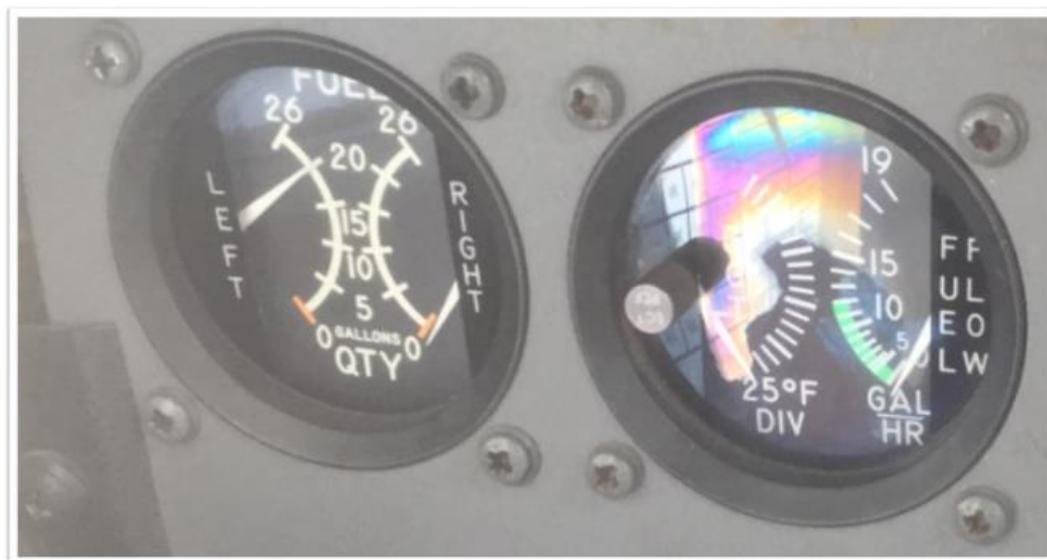
Removed Fuel Quantity Indicator and Fuel Flow Indicators were tested on a serviceable aircraft (VT- ICE) and tested on ground with running engine. During ground running, both meters were found fully functional.

Fig: Fuel gauges

The test of the fuel quantity indicators didn't show any anomaly. The fuel quantity Indicator were tested on a serviceable aircraft and found fully functional. It is generally known that the fuel quantity indicators are reliable and that they are only calibrated (On condition) to give a representative value in a straight and level flight.

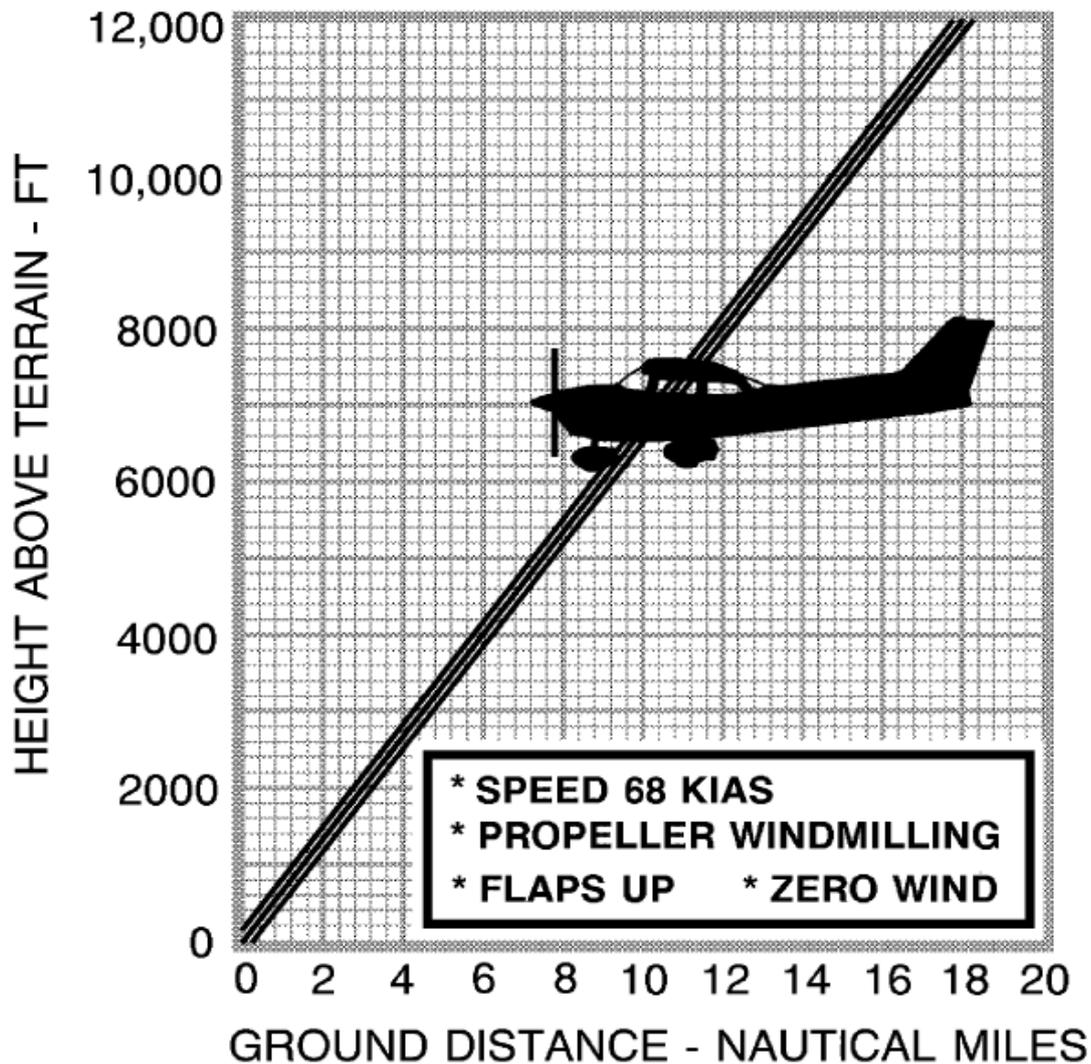
Fig.3: Maximum Glide (Distance) Chart

The maximum glide distance is as per POH can be calculated. It can be seen from POH glide distance graph that the altitude needed to reach a distance of 17nm is approx. 11000 ft. However, this is only valid under the condition that flaps are up and there's zero wind. In this case, flaps were already selected to 20° and there was an upwind between 5 to 11 knots. The aircraft would have never reached the runway and the PIC took the right decision to choose forced landing area.
