**FINAL INVESTIGATION REPORT ON  
ACCIDENT TO CESSNA 172R AIRCRAFT  
VT-TEH OF M/s SHA-SHIB FLYING  
ACADEMY ON 14 FEB 2019 AT GUNA  
AIRFIELD, MADHYA PRADESH**

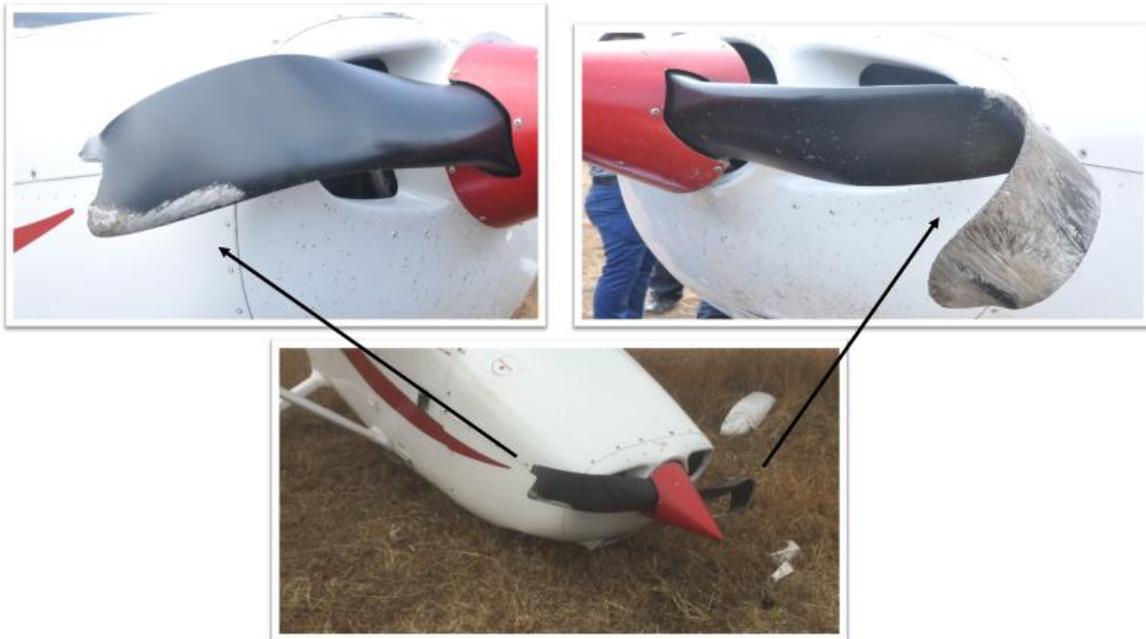
- Propeller – Tips of both propeller were bent in S-Shape, thereby indicating engine was on power.

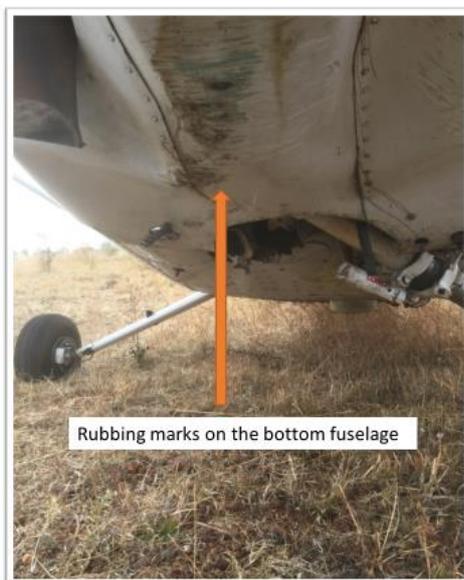
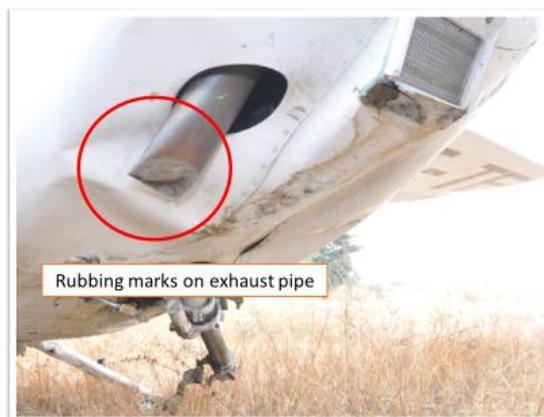
- Top inner RH side Engine Cowl was found cracked 1 inch (approx).
- Bottom Engine Cowling was found damaged due to rubbing.
- Exhaust pipe was found bent.

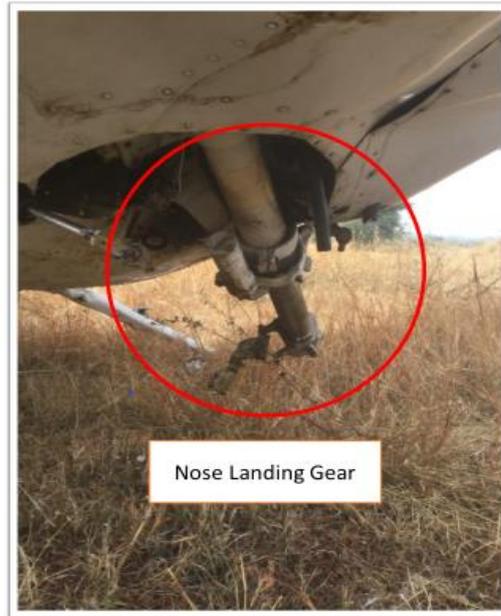
- **Nose wheel assembly** was found damaged. Hydraulic oil leak was noticed which was due to broken pipelines.

Broken wheel

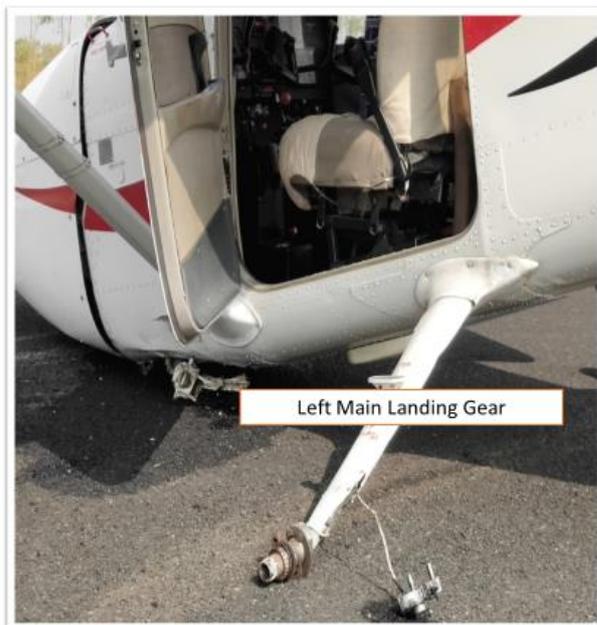
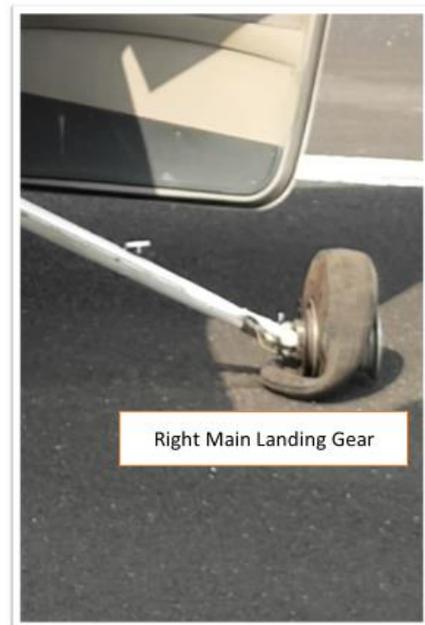
- **RH Tyre** : - Tyre was found deflated due to impact.
- **LH Main Landing Gear** – LH landing gear axle was found broken and wheel assembly detached from aircraft. Brake pipeline was found bent.

- (vii) The airplane landed on runway threshold itself with left bank on LH Main Landing Gear resulting into the left wing tip damage. Due to impact, the LH MLG came out of axle and moved out of runway but as a reaction, the aircraft bounced to the right. However, LH main wheel tyre didn't deflate.

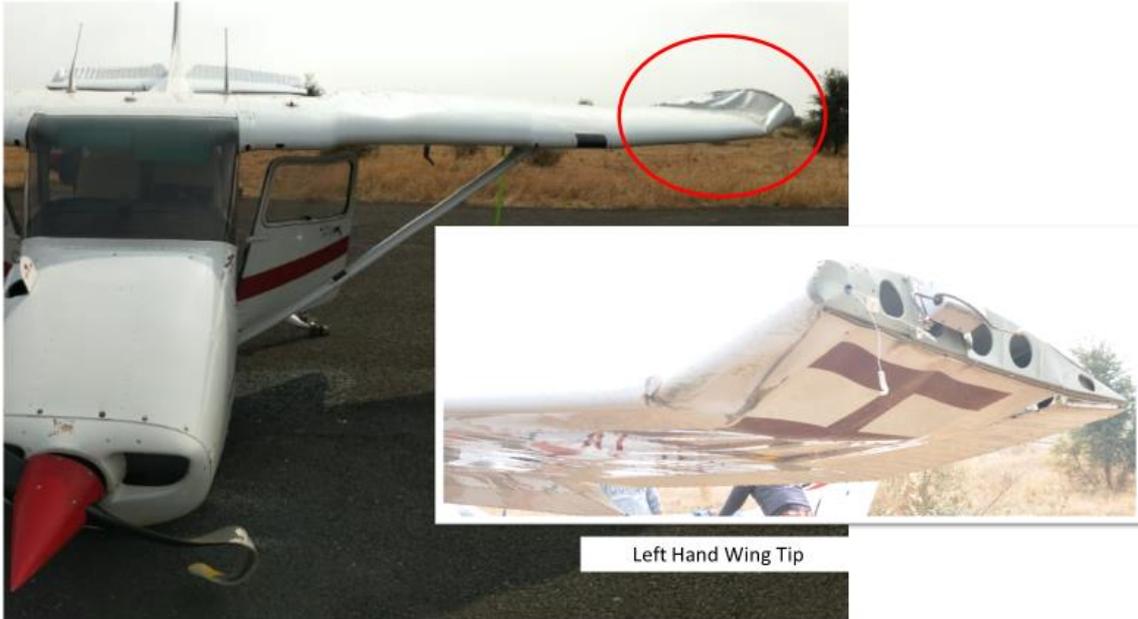
- **LH Wing:** – LH wing spar from second station (viewed from tip) was found bent, which signifies that RH wing hit the runway during landing. LH wing tip was found detached from the wing. Aileron towards wing tip side was found bent.

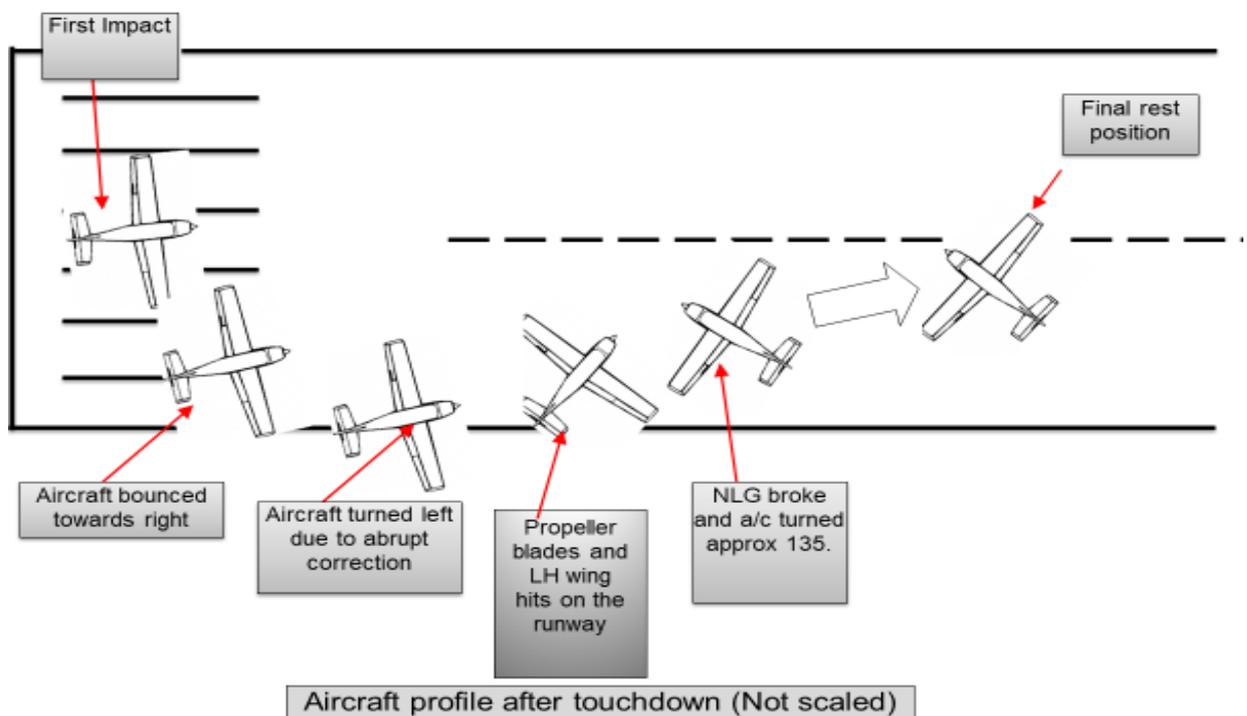
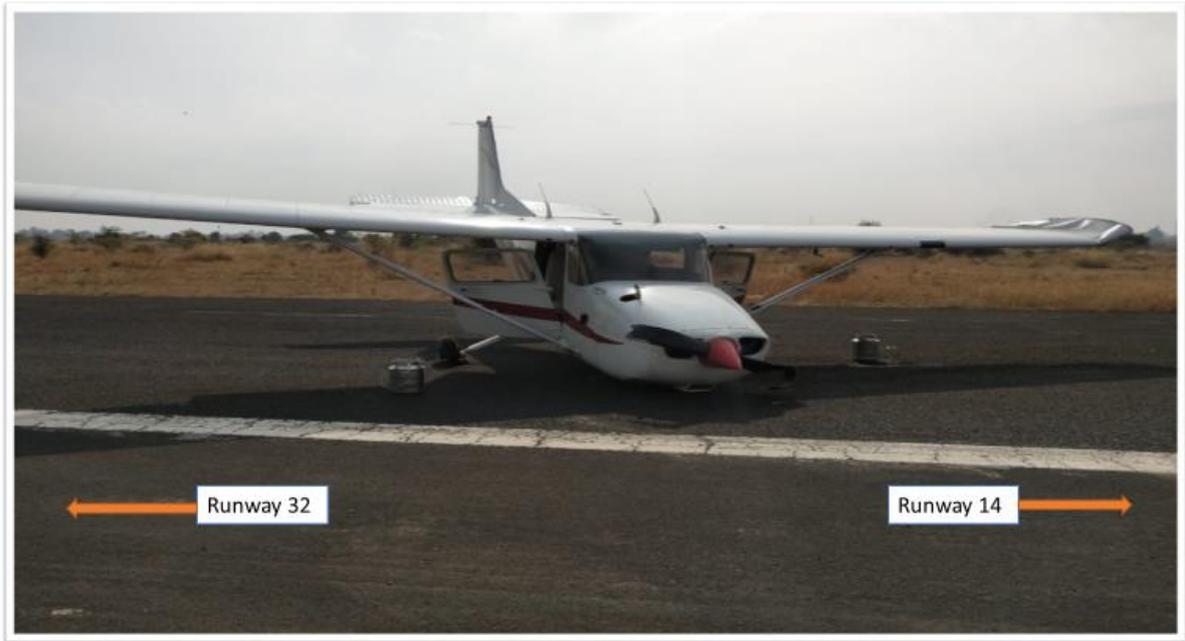
### **Final Resting position of VT-TEH**

For landing, the aircraft approached from runway 14. The aircraft first came in contact with the runway surface at threshold of runway 14 with the propeller blade marks after collapse of nose gear. At the time of first bounce at threshold point, the LH wing Tip hit runway and aircraft bounced again with a yaw towards right. Propeller rubbing marks were present from second bounce impact onwards which had continued upto 45 feet on Runway. The aircraft finally stopped at 55 feet from the beginning of Runway 14 making an arc. Aircraft had dragged around 40 feet on the runway before coming to final stop. The flap lever was found at 20° position in the cockpit. The rubbing marks were found towards the right of centerline of the runway indicating that during final approach the aircraft was not aligned with the runway.

- (viii) Due to correction applied by Student Pilot after first bounce, aircraft turned towards left. Thereafter, aircraft hit the runway at right edge and turned approx 135° with reference to runway centreline. After impact, Propeller blades bent in 'S' shape. Scooping marks of propeller blades on runway surface while moving forward indicate that engine was in power.

- (ix) The aircraft stopped around 55 feet from threshold point for runway 14.
