FINAL REPORT ON ACCIDENT TO
IGRUA ZLIN242L AIRCRAFT VT-IGM
ON 21ST OCT 2019 AT FURSATGANJ
AIRFIELD, UTTAR PRADESH

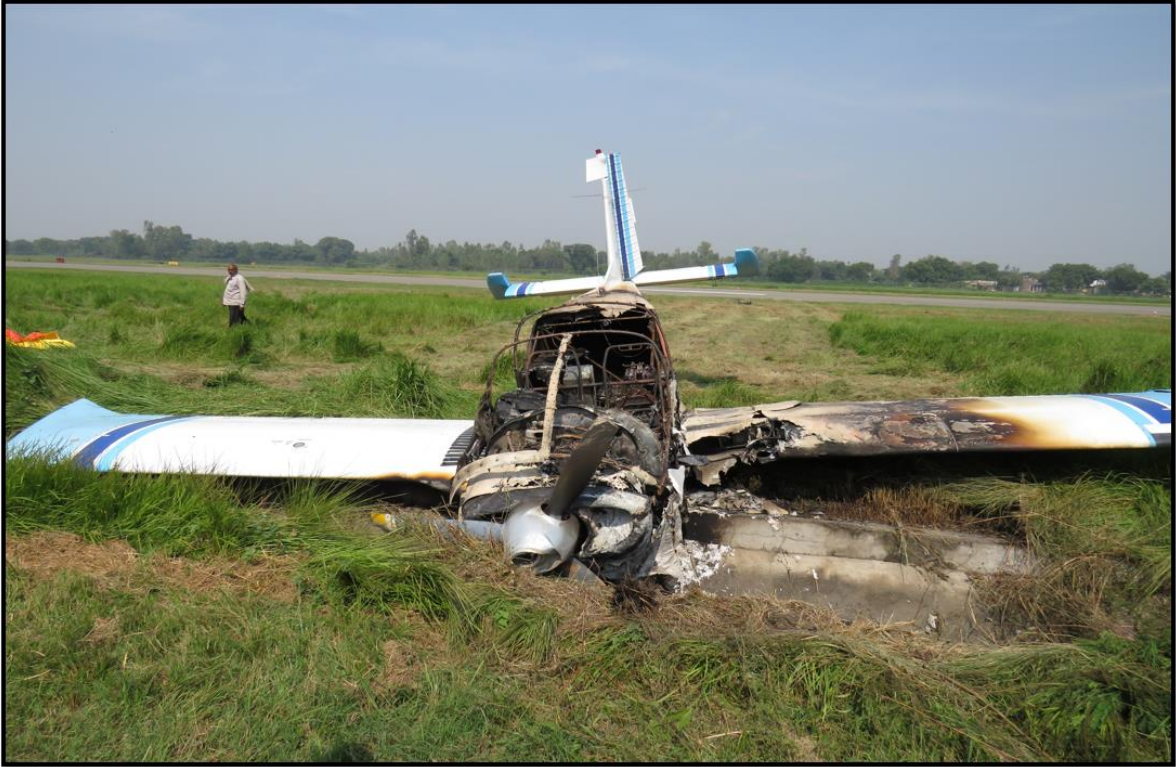
- (a) Aircraft was completely burnt in the front section including the canopy, seat, instruments and displays.
- (b) Fire marks and cracks were present on the LH wing surface.
- (c) Propeller was found to be twisted with scratch marks. The propeller was found to be resting on the drain wall.
- (d) On the runway, broken pieces of left-wing navigation light were found.

Fig: Front view of the damaged aircraft

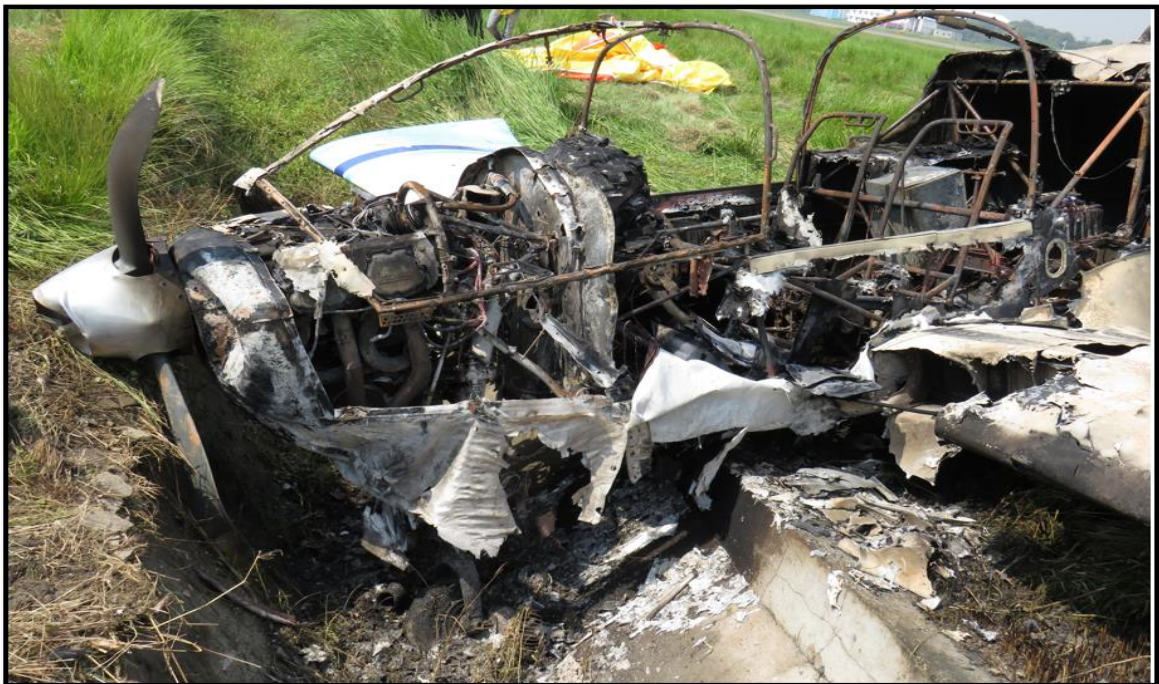
- (e) Both main landing gears were found intact with aircraft.
- (f) Engine and its cowling were found completely damaged due to fire.
- (g) Nose Landing gear was found intact with aircraft structure but broken.

Fig: Side view of Engine and Propeller

- (xii) The first impact was at **1300 feet** away from the threshold runway 27 and approx. 30 feet from the runway centerline.
- (xiii) The damage on Propeller indicated that engine was on full power when aircraft nose impacted the monsoon drain.

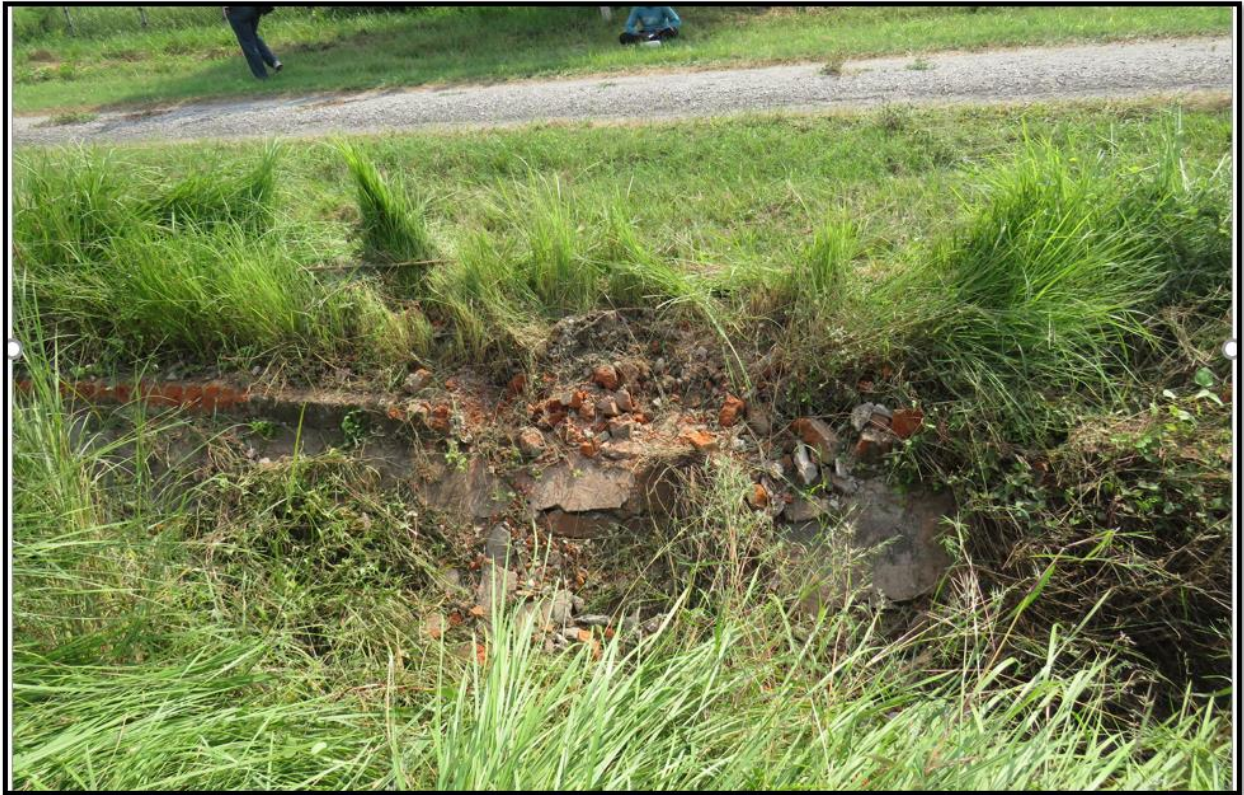
Due to impact of the aircraft with the edge of monsoon drain, a small portion of the drain was damaged.

Fig: Damaged Monsoon Drain

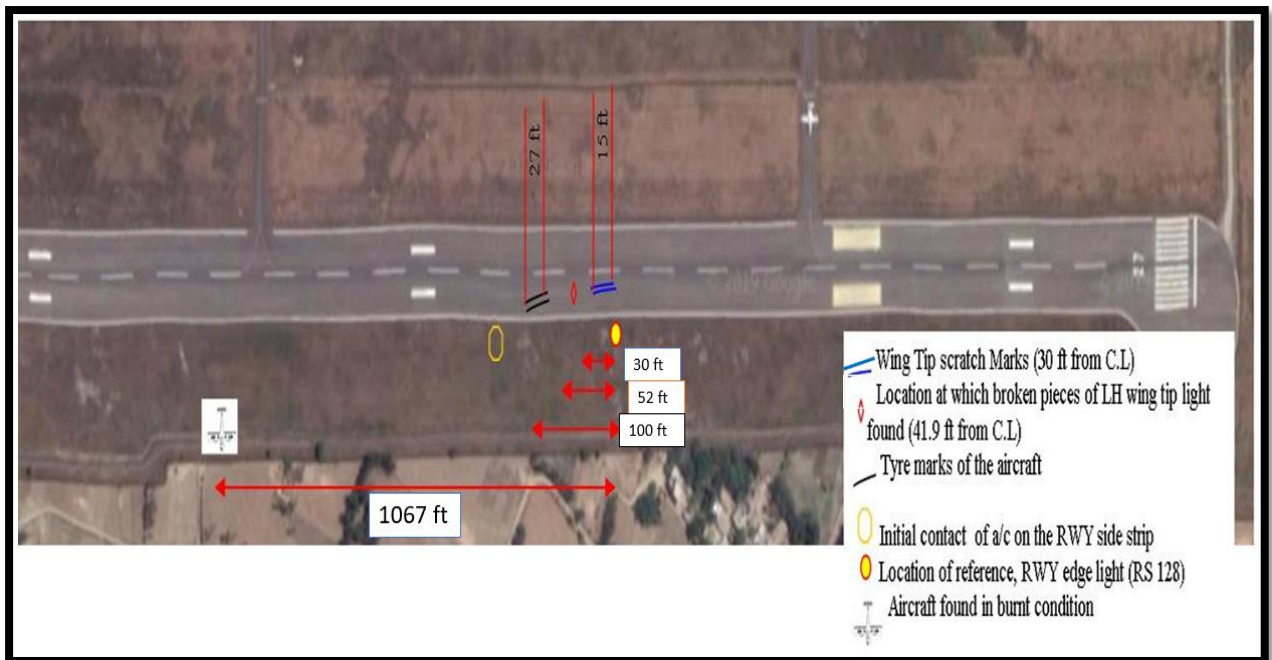
Fig: Aircraft Final Rest Position

- (xiv) The final rest position of aircraft was around 2360 feet from end of runway 27 and 160 feet from the edge of runway.
- (xv) Aircraft was completely damaged due to post impact fire. However, Student Pilot sustained nil injuries.

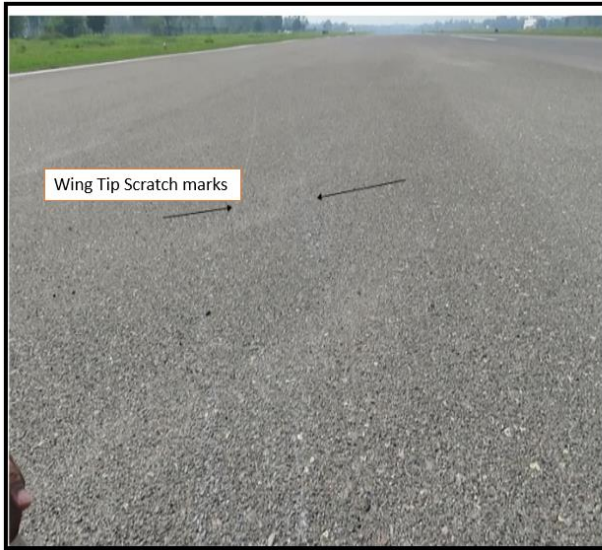
The initial impact mark observed on the runway was of the LH wing tip and the marks were found turning towards left. The mark on the runway were at a distance of 30 ft from the runway centerline and continued for a distance of 15 ft. Further, scratch marks of balance mount of LH wing were also noticed on the runway.

Wing Tip Scratch Marks on Runway

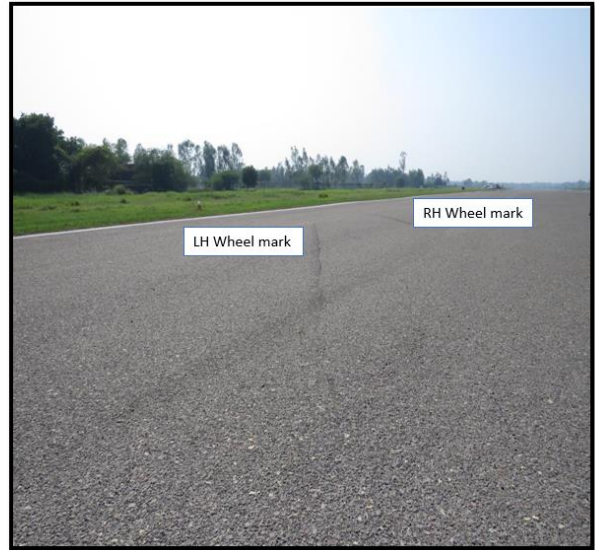
The LH & RH Main Wheel tyre marks of 28 feet and 26 feet were observed on the left side of runway centerline respectively which indicated continuous veering of aircraft towards the left.

MLG Tyre marks on Runway

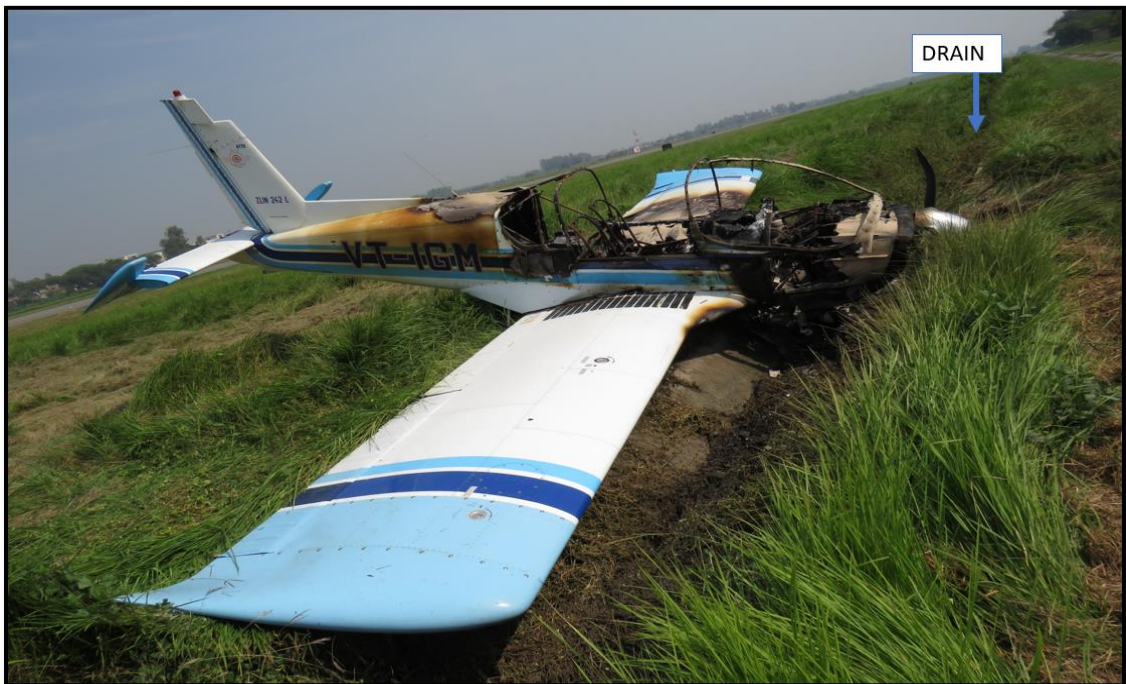
The aircraft finally rested at a distance of 1067 ft in the longitudinal direction from runway edge light No. RS128 and 180 ft approx. on the LH side of the runway edge line where the drain is located. The elevator was found in down position and the rudder was tilted to the left.

Fig: Final Rest position and damages on VT-IGM
